Sustainable Stream Management in North-East Queensland:

Stabilisation for Rehabilitation

JAMES COOK UNIVERSITY

**Land & Water
Resources
Research &
Development
Corporation**

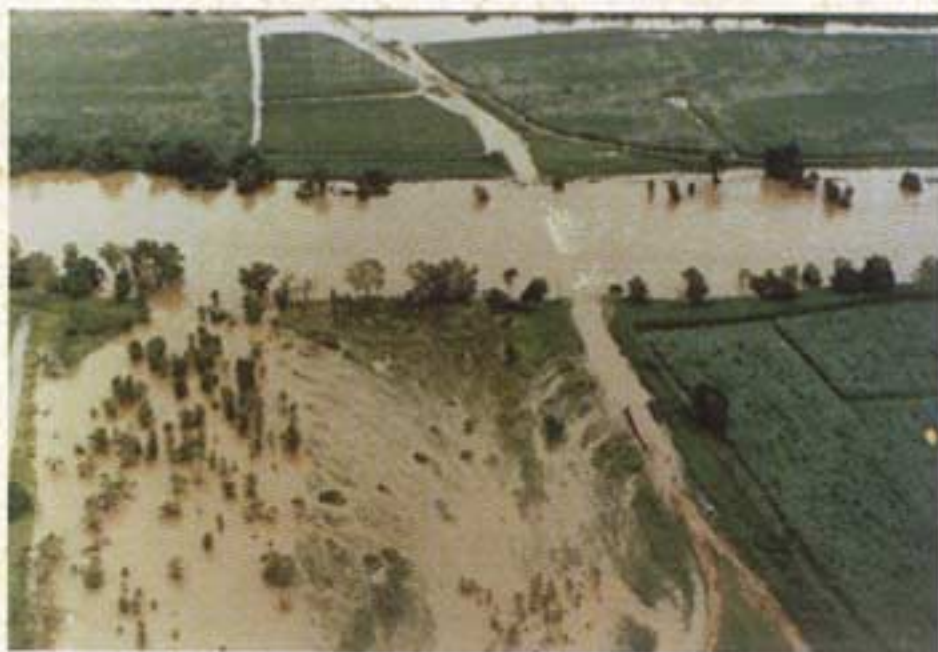
Overbank erosion from flood outflow on Haughton River near Gien

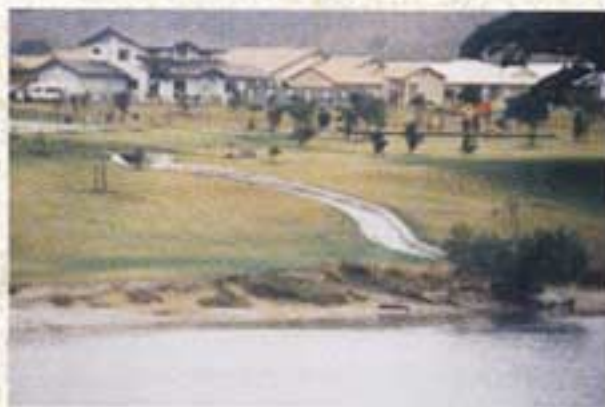
Direct Pressure: Urbanisation on the Ross River in Townsville

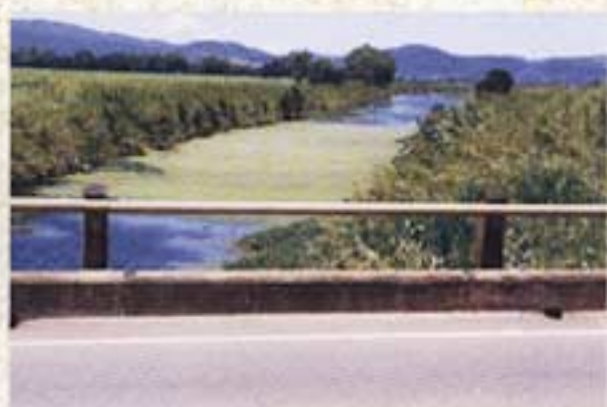
Degraded riparian land on Pineapple River

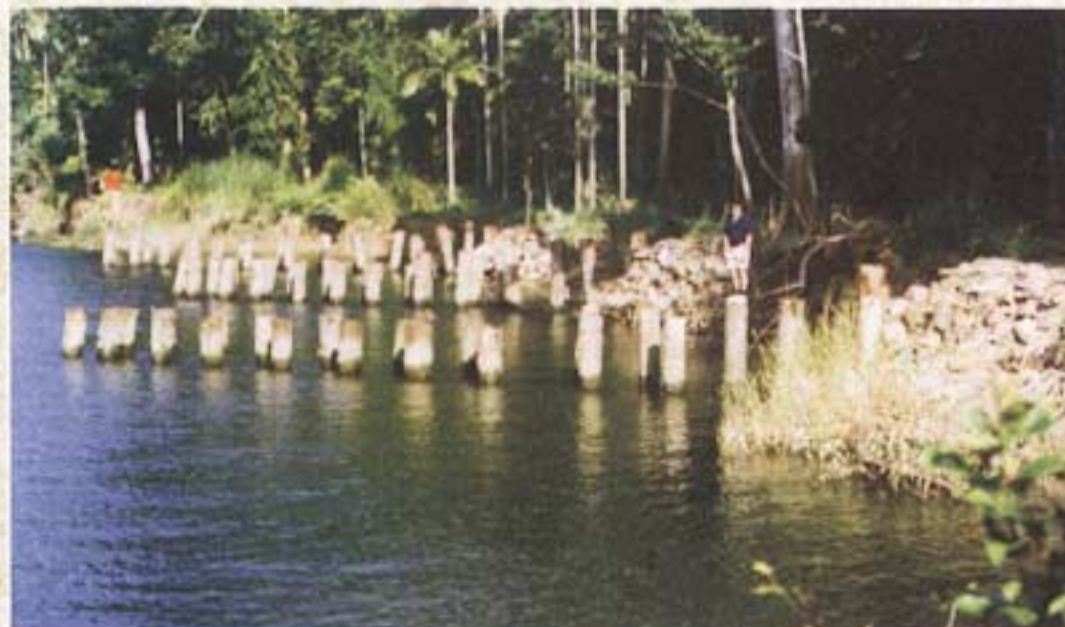
Pile groynes on the Mulgrave River

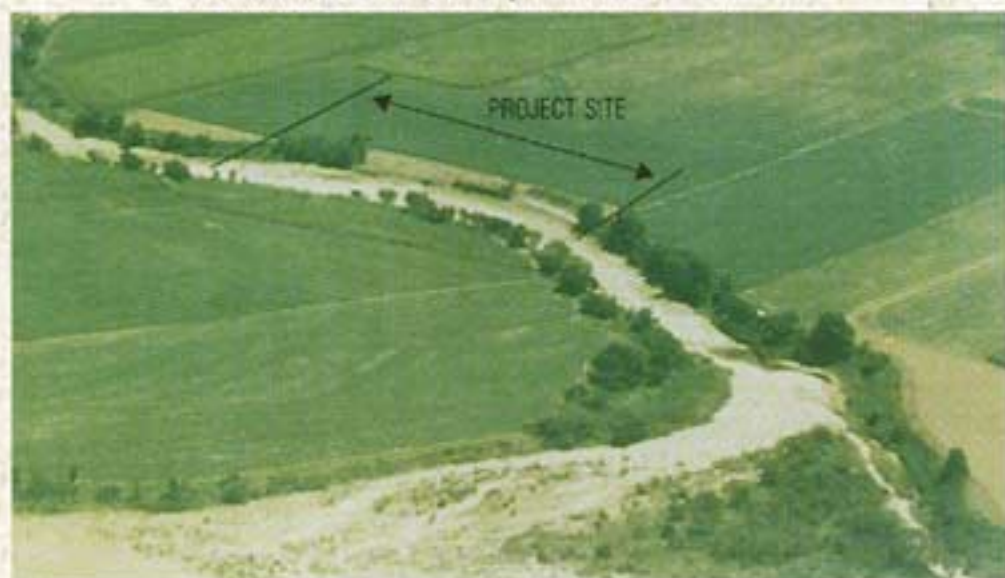
Aerial view of site: Herbert River in the foreground

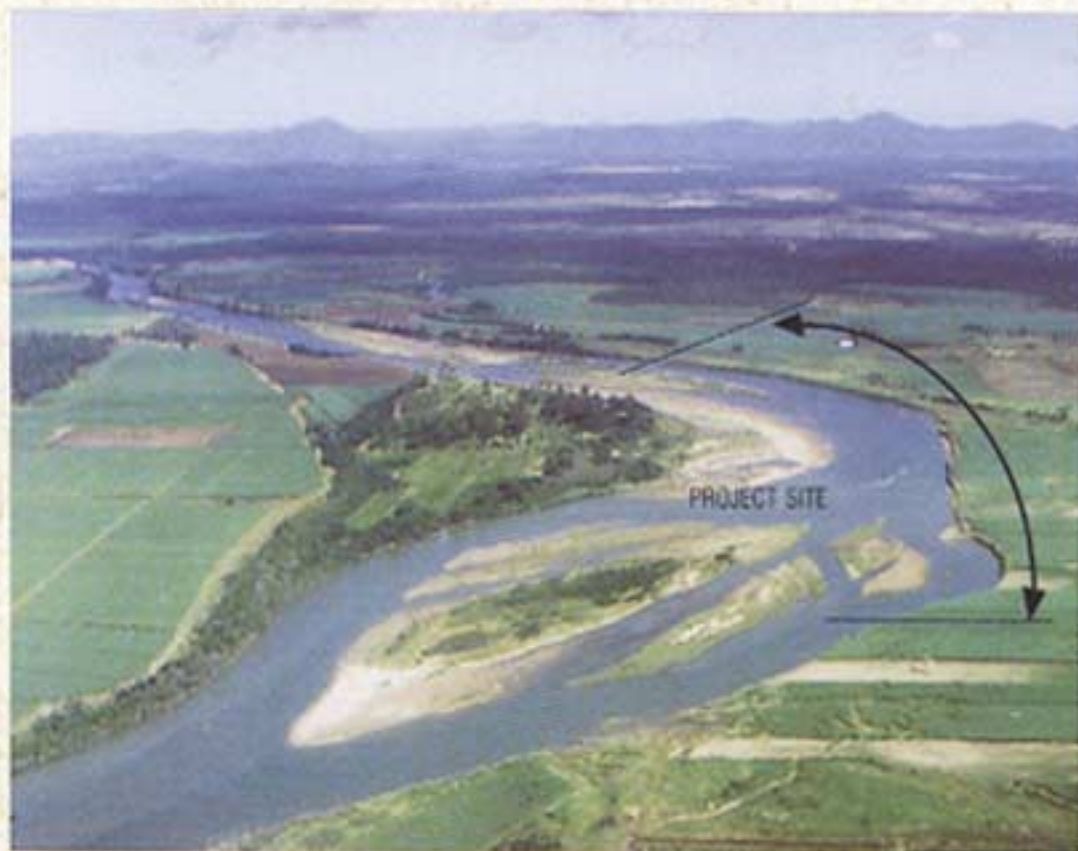
Aerial view of site. Bank erosion extending into cane land on right
