# **Boodjidup Brook Action Plan**

**Prepared for the Cape to Cape Catchments Group (CCG)**

July 2009

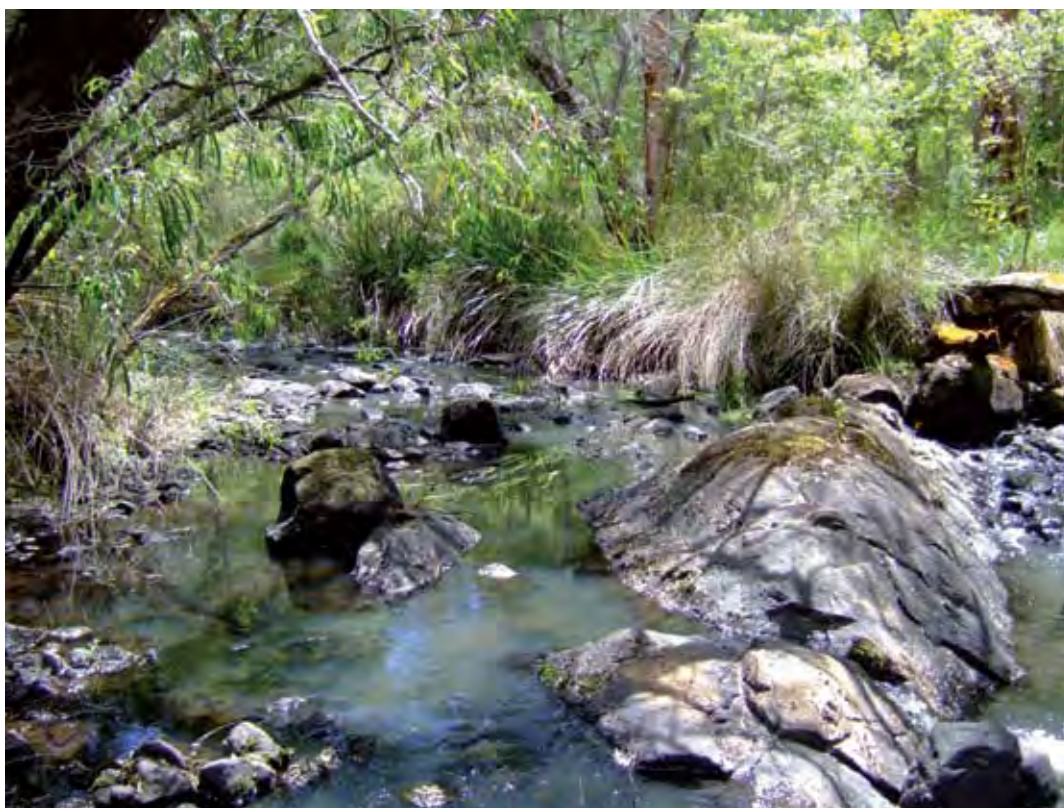
A grade foreshore: Rocky riffle section of the main channel of the brook with a diverse range of rushes and sedges and dense understorey.

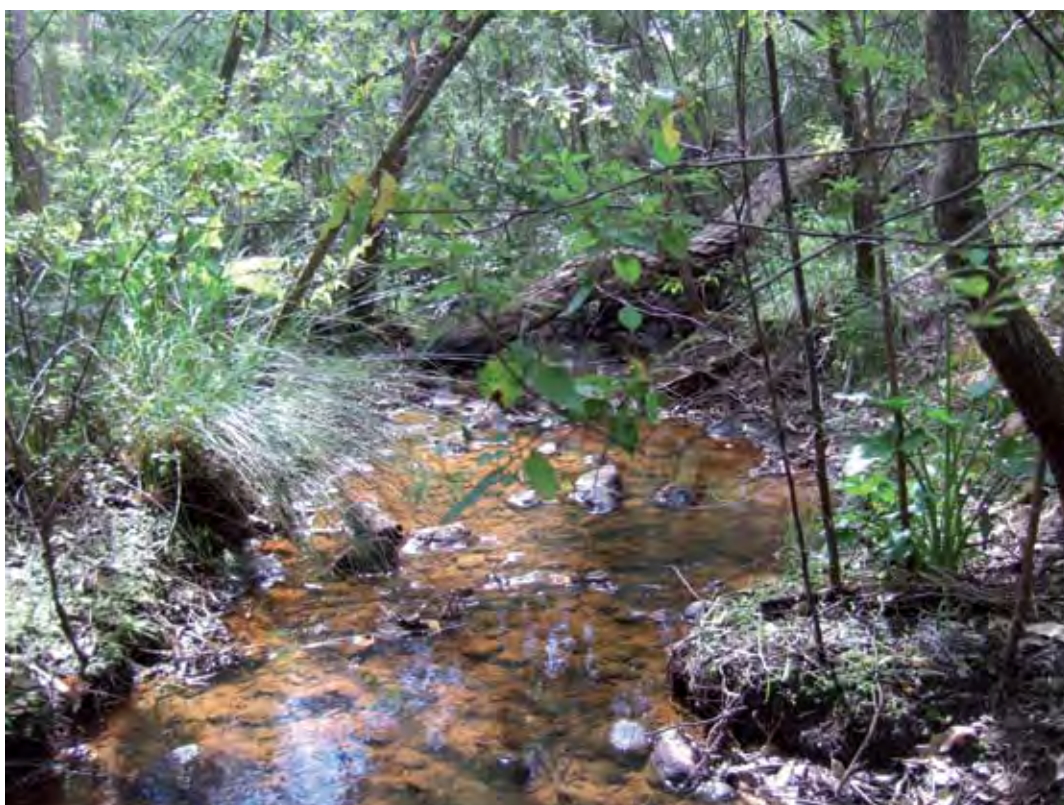
B1 grade foreshore: Native vegetation is still dominant on the banks with minor weed invasion (arum lily). It is a priority to control weeds as they will out-compete native species.

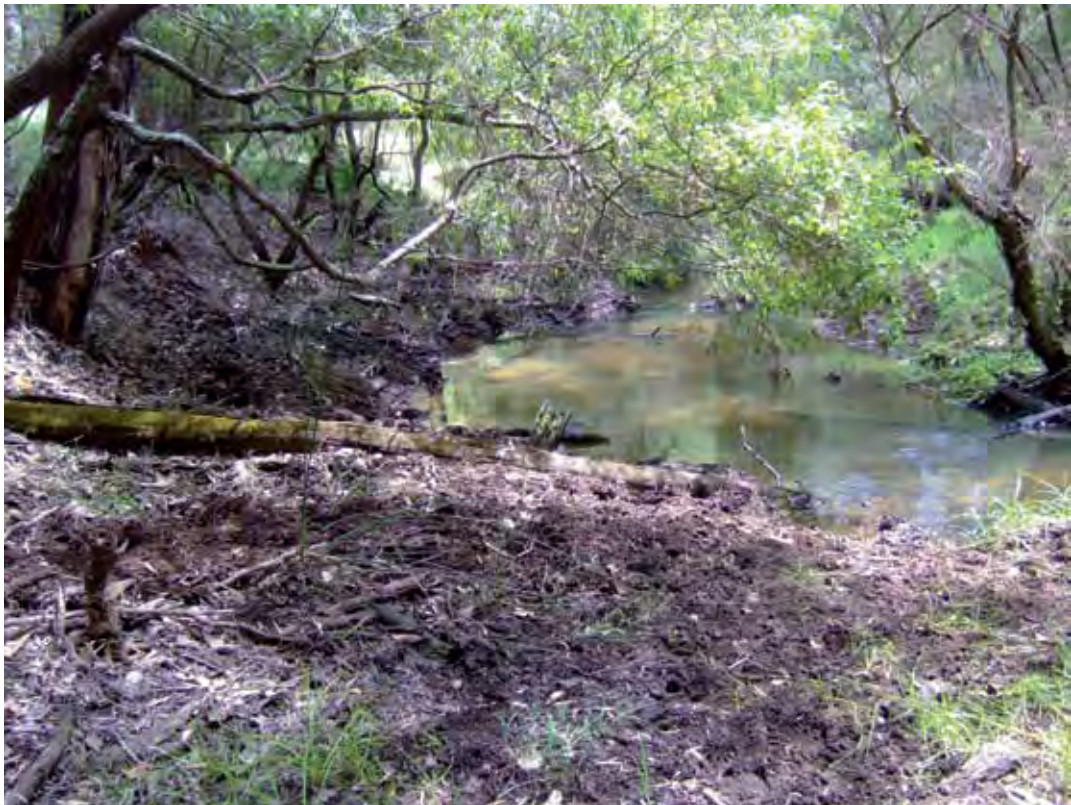
C2 grade foreshore: An overstorey of peppermints and marri remains and stock has removed all understorey vegetation including grasses, exposing and pugging the soil.

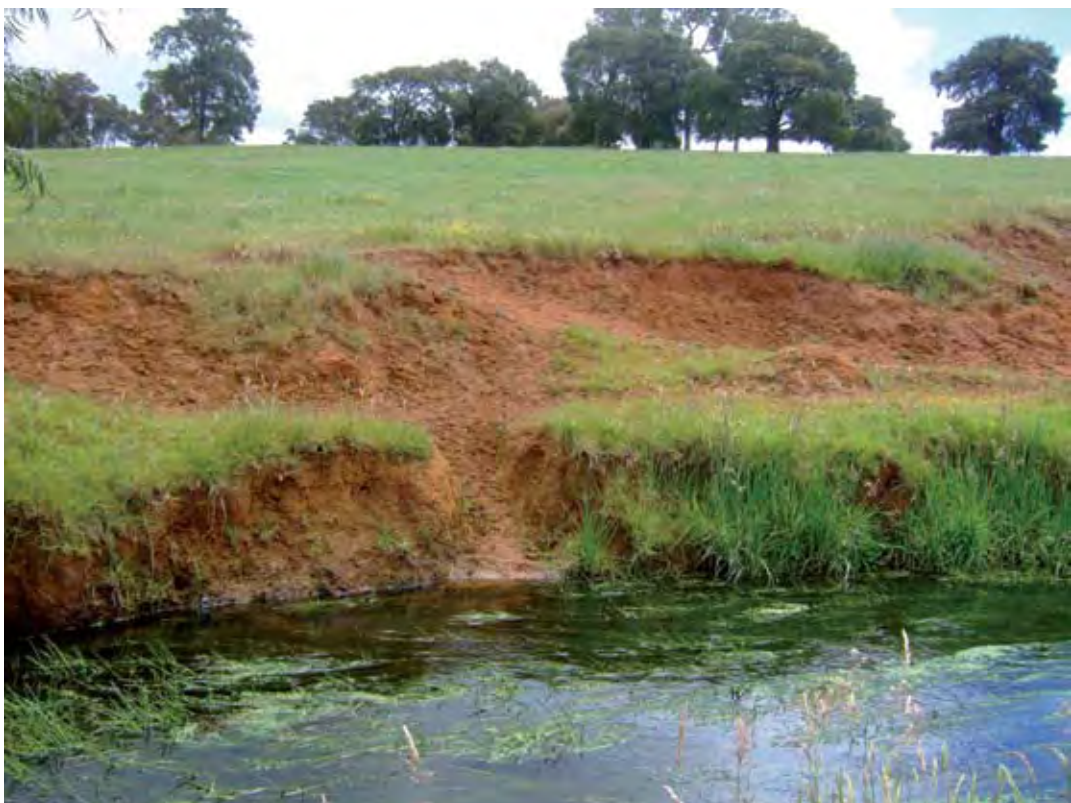
D2 grade foreshore: No fringing vegetation remains and stock have destabilised the banks. The channel is freely eroding.

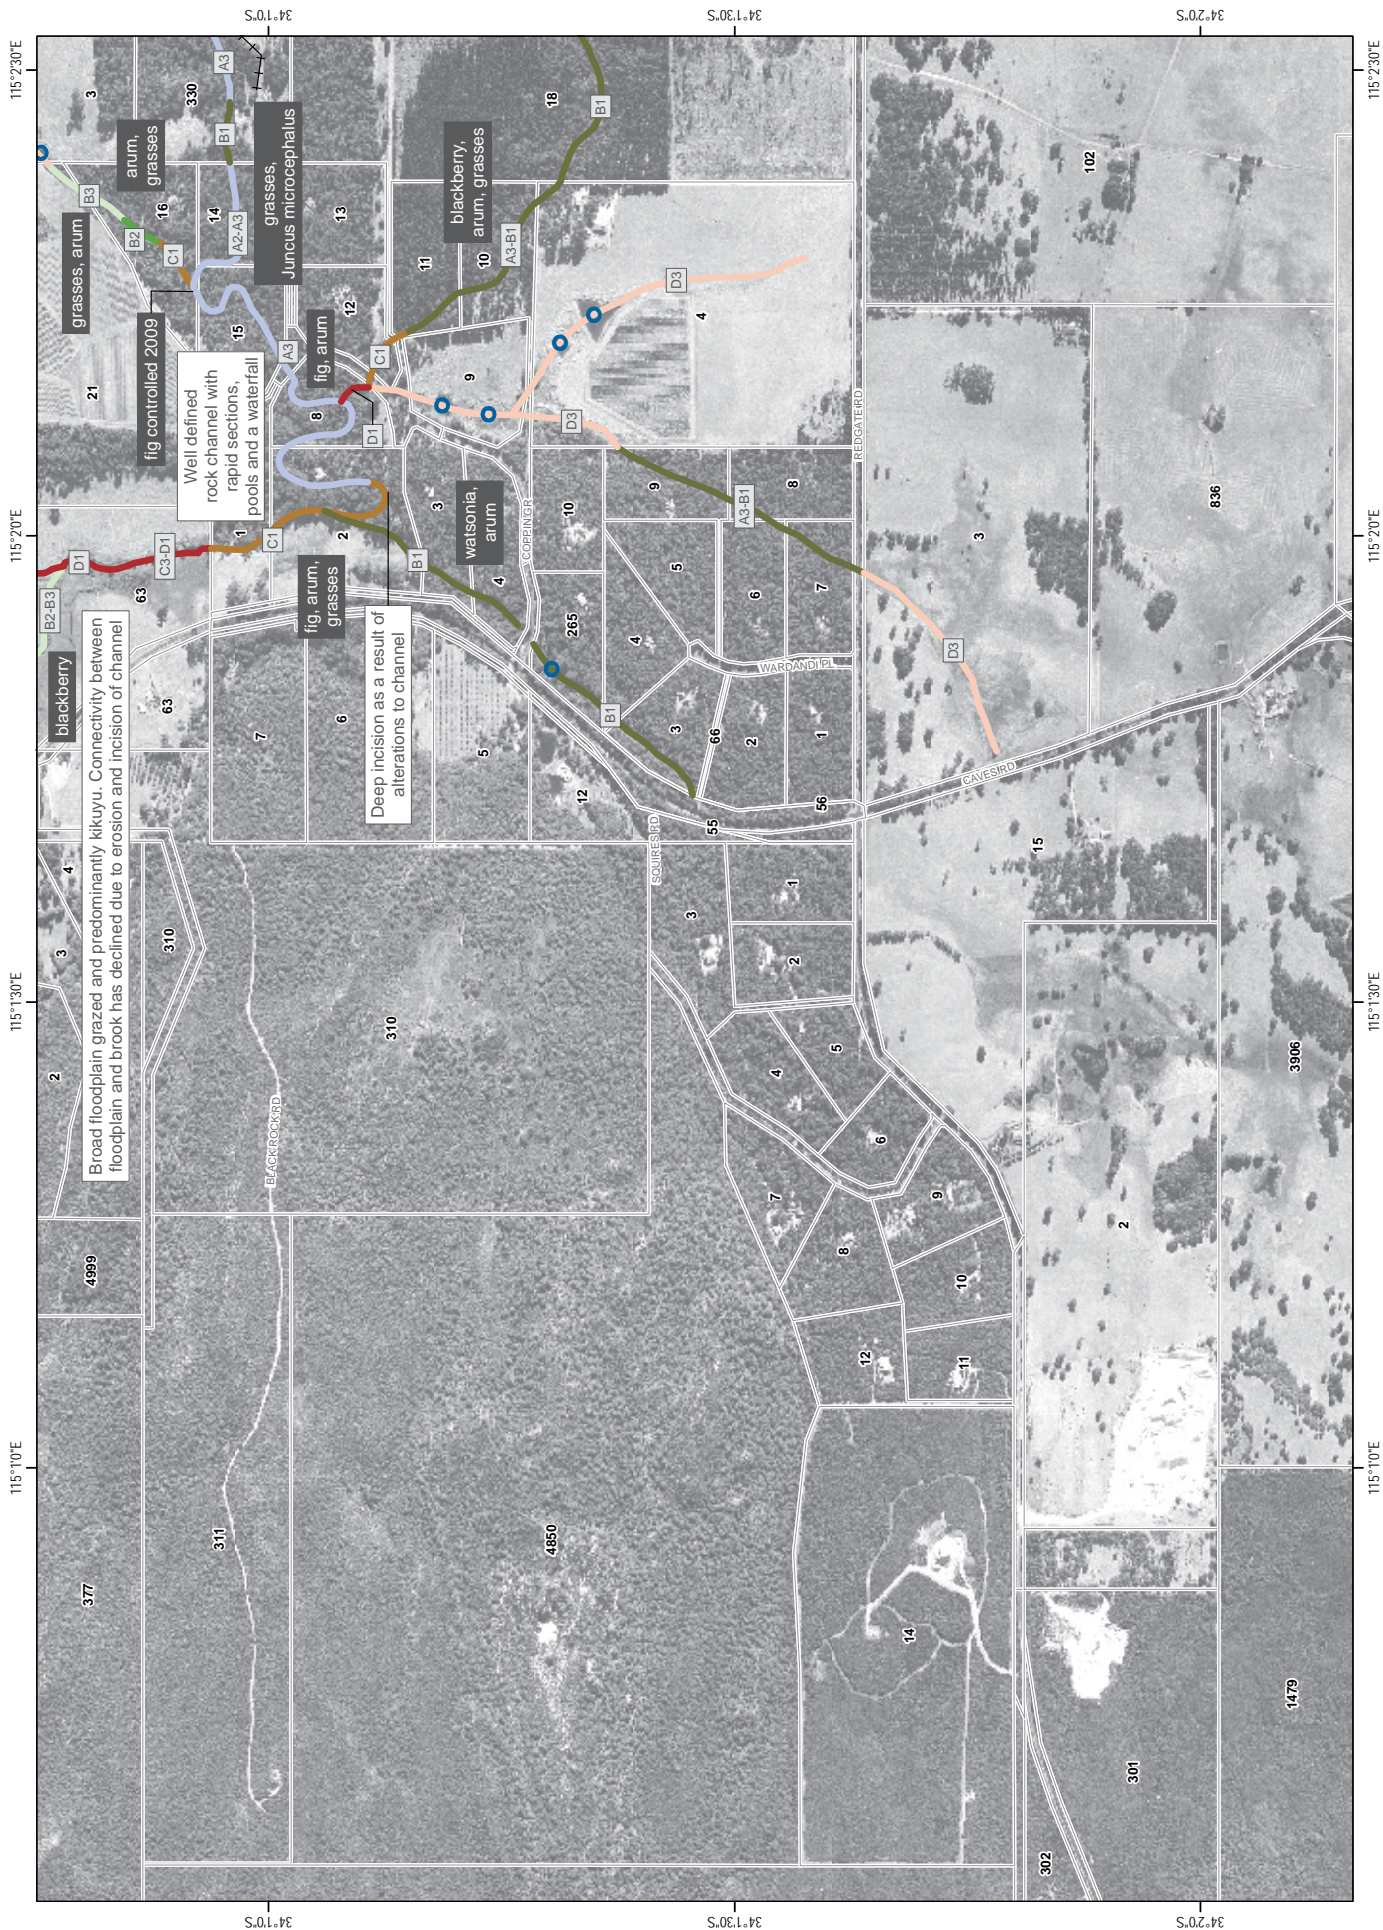
Boodjidup Brook Map 12

3. Parts of the brook on Lots 63, 1 and 2 are actively eroding. Controlling this erosion will require management of stock access on Lots 63 and 1. In areas where the creek is not deeply eroded keeping stock out may allow grasses to colonise and provide an easy solution to erosion. Monitoring will be required to determine if erosion control aims are being met. Other techniques such as revegetation with native species and construction of riffles to slow water velocity will be required in more deeply eroded areas or areas where grass does not recolonise and stabilise banks. See Section 6 regarding fence location.
