Donnelly River Action Plan

2006

Prepared for Warren Catchments Council- Southern Forests Landcare
and
the Manjimup Land Conservation District Committee

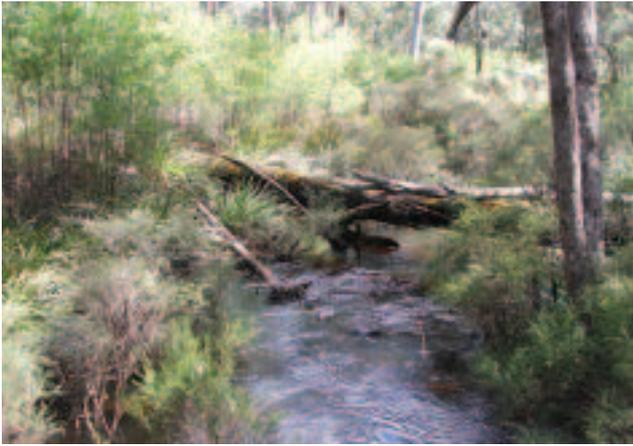
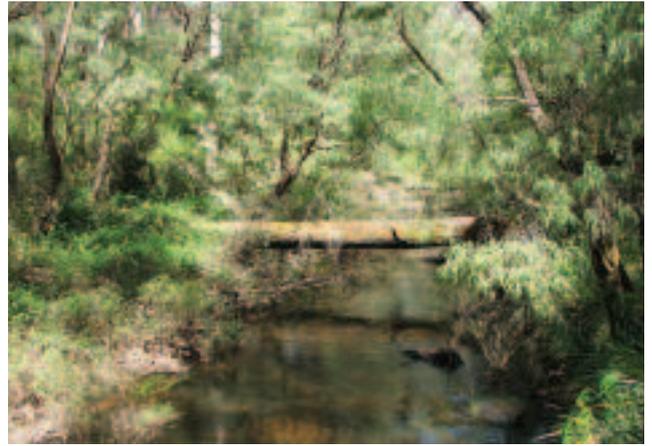
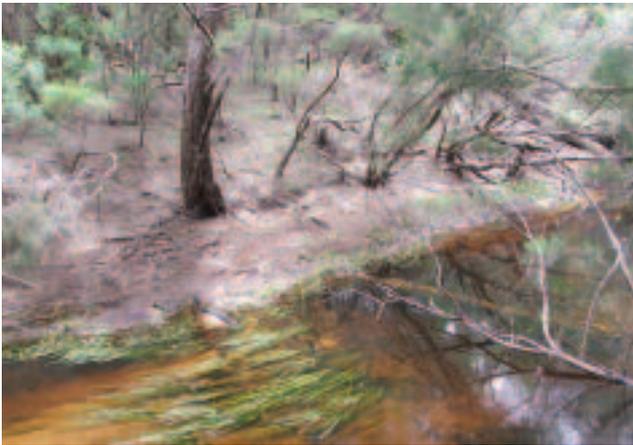
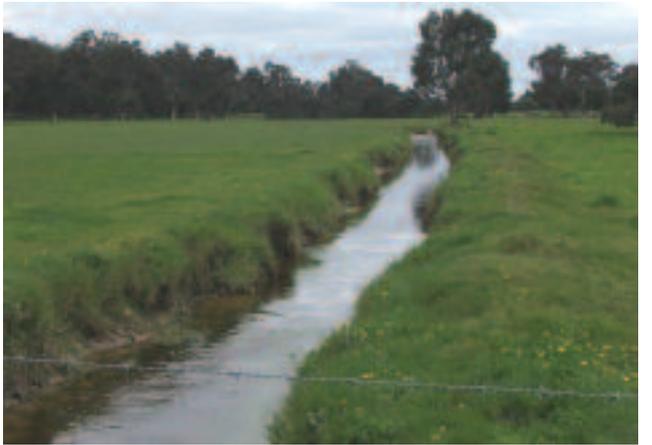
Figure 3: Foreshore condition of the Donnelly River (photos- Jenni Munro)

A grade section

B grade section

C grade section

D grade section

Bank erosion

Natural bank erosion occurs freely on rivers and this process is evident along the length of the Donnelly River. The erosion process becomes exacerbated and cause for management concern when supporting riparian vegetation is cleared and banks become further destabilised, leading to erosion and sedimentation downstream. Severe erosion is not a significant problem for the Donnelly River; however there are several areas

Serious erosion is not a major problem for the Donnelly River; however there are areas of potential concern where natural erosion has become exacerbated. Much of the river retains a dense and supportive riparian zone and erosion observed is mainly occurring adjacent to access points or in areas of past or current stock access. Revegetation of unstable banks is the easiest way to combat erosion; however engineering solutions involving modification of channel flow may be necessary if revegetation proves inadequate. If deemed necessary, site-specific advice and relevant legal approvals should be obtained prior to instigating any
