Department of
Environment and Conservation

Acid Sulfate Soils Guideline Series

IS MY HOUSE BUILT ON ACID SULFATE SOILS?

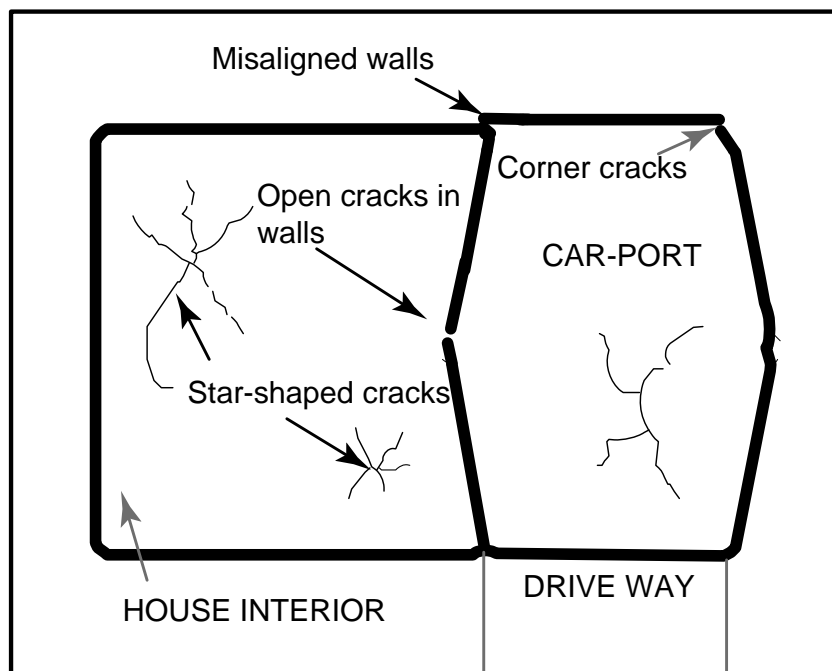
Figure 1. Typical pattern of cracking of floors and walls caused by the oxidation of pyrite beneath house foundations (adapted from ACQC, 1999).

The best place to start looking for signs of structural damage is outside of the house in carports, garages or on concrete patios. The most obvious signs of damage caused by swelling of soil beneath house foundations are star-shaped cracks in concrete paving and floor surfaces (Figure 1). The floor may also bulge upwards in the vicinity of these cracks – check by using a large spirit level. There is often a fine white 'chalky' deposit around the edges of the cracks that can be seen to consist of a mass of needle-like crystals when viewed with a magnifying glass. These crystals are very delicate and disintegrate as soon as they are touched.

Large cracks may eventually also appear in the middle of external walls. Often the brickwork on one side of these cracks bulges out more than on the other side of the crack – the amount of displacement can be tested with a large spirit level. Occasionally whole sections of wall are displaced outwards, and although they run parallel to the main body of the wall, they may be misaligned by a few millimetres (Figure 1).

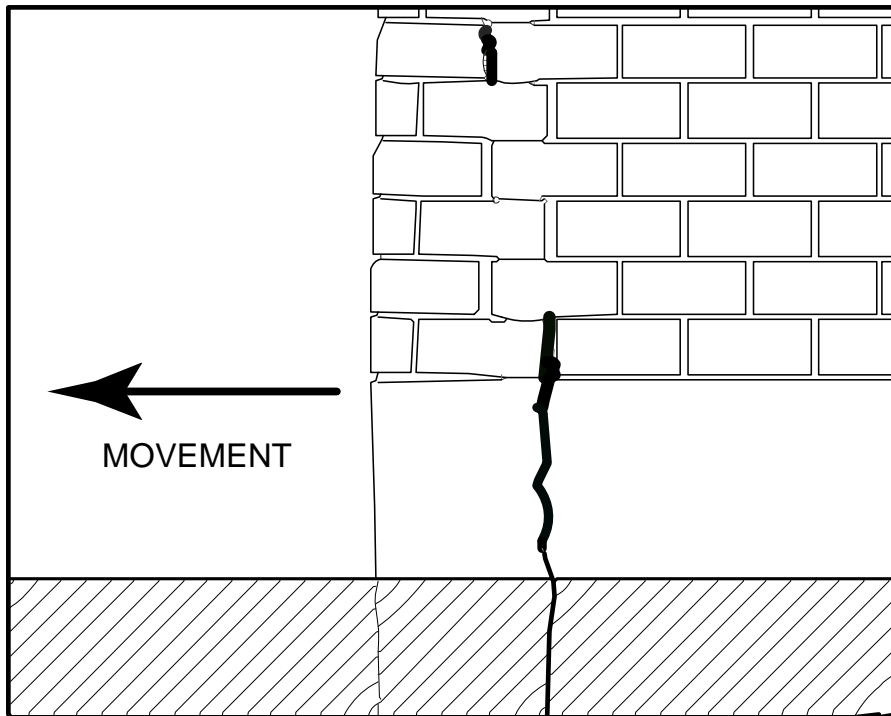
Figure 2. Cracking and increased lateral displacement of basal courses of bricks or stonework (adapted from ACQC, 1999).

The lateral forces exerted on walls by swelling pyritic soils may also displace lower courses of bricks more than bricks higher in the wall, causing cracking near corners, and slumping of some sections of brickwork (Figure 2).

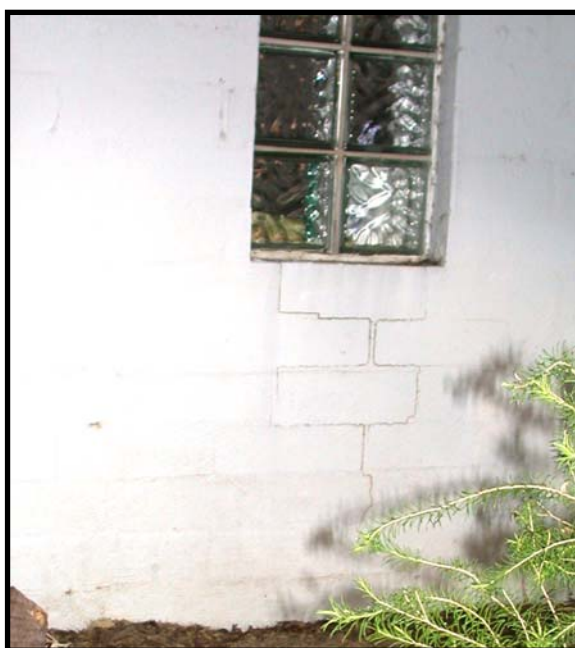
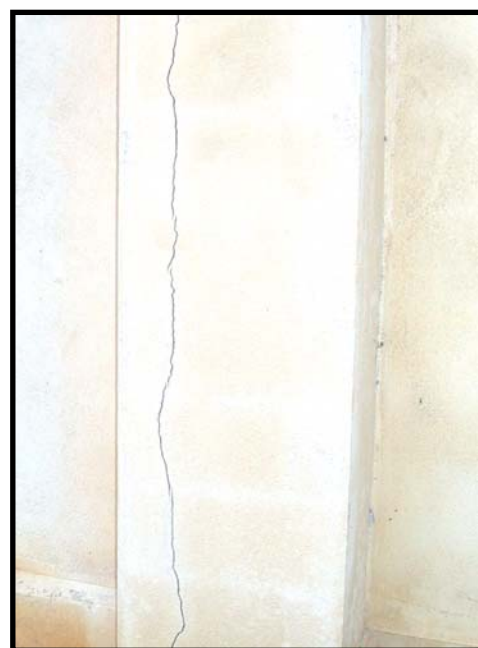
Figure 3. Cracks in external walls

The large lateral forces that can be generated by swelling soils can exert very large stresses on walls that can lead to cracking and displacement of brickwork. Cracking in walls is often first seen in the corners of carports or garages, and it often appears as if one wall is 'peeling away' from another, with the cracks progressively increasing in size over a period of months or years.

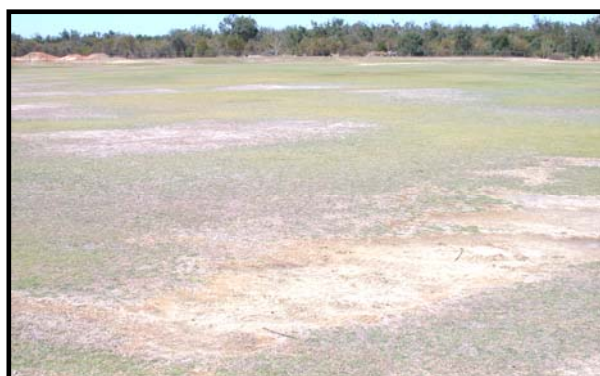
Figure 4. Acid scalds in turf

The first visual indications of oxidising acid sulfate soils in gardens are often the appearance of bare patches in lawns or garden beds. These patches differ from patches caused by water repellent soils or lawn beetle attack in that they are often covered with an oily looking black slime in winter. These bare patches (Figure 3) are acid scalds, and in summer the surface soil may be very acidic, and contain soluble aluminium at levels that are toxic to most plants. The slime that forms in winter consists of iron monosulfide minerals that form from the chemical reaction of iron and sulfate with organic matter in the lawn. The slime layer usually disappears in dry weather, sometimes leaving a thin rusty layer or 'fluffy' white sulfate salt crystals on the soil surface.

If you dig into an acid scald in summer, soil just beneath the surface may have brown rusty looking mottles, and often contains bright yellow streaks and mottles. The yellow material is an iron sulfate mineral called jarosite. This mineral only forms when soil is very acidic (a pH of less than 3.5). Always wear gardening gloves when digging in very acidic soil and avoid skin contact with this material as it may cause skin irritation in sensitive individuals.

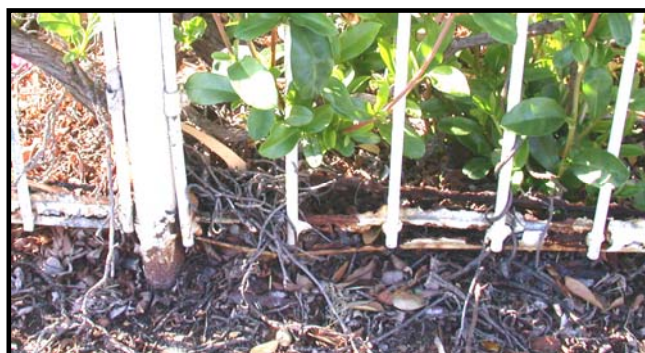
Figure 5. Corroded metal fence

The disintegration and disappearance of iron monosulfide black slime layers in summer releases acid that can cause intense corrosion of metal posts and sheds in gardens. The corrosion typically only occurs in a distinct layer at ground level (Figure 4).
