## Site audit and decommissioning of surface water and climate monitoring data loggers – Toolibin Lake Catchment

Hydrology report series WCP-HR-2017-02  
September 2017

### **2017 surface water monitoring infrastructure site audit**

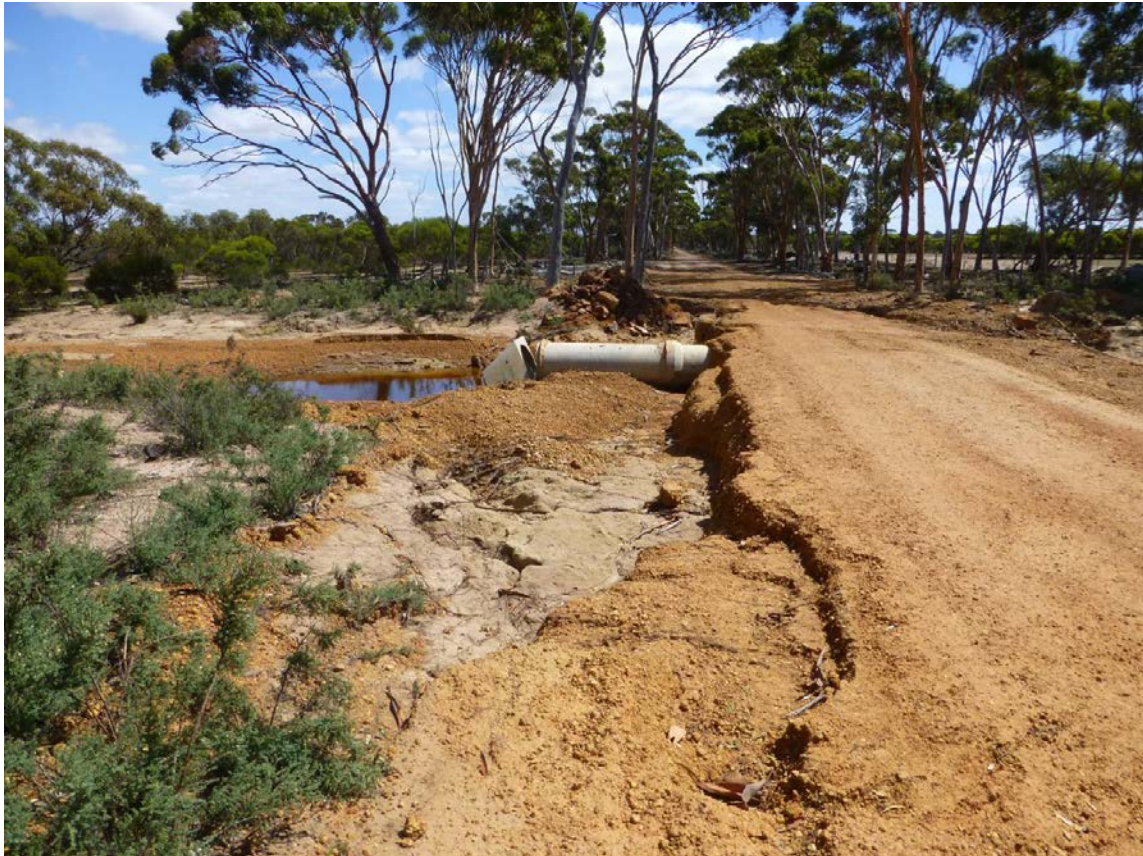
**Figure 2. Severe erosion occurring on Brown Road, located immediately up-gradient from the West Drain (DWER site ID 609038), as a consequence of surface water flows occurring in February 2017.**

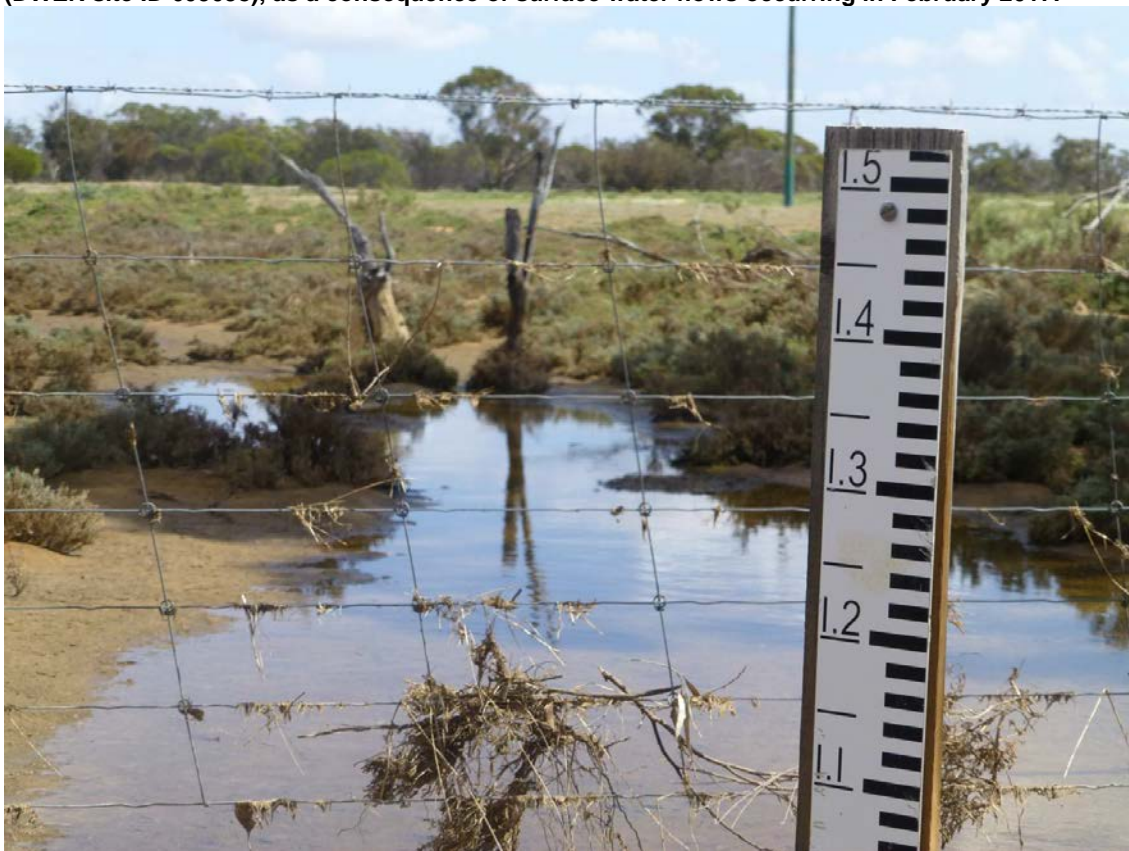
**Figure 3. Westwards photograph of site 01DEC01, located at outlet of the western tributary of Management Area MA1. Note the trash evident on the fence line, estimated to be at 1.45 m on the staff gauge (photograph Darren Farmer).**

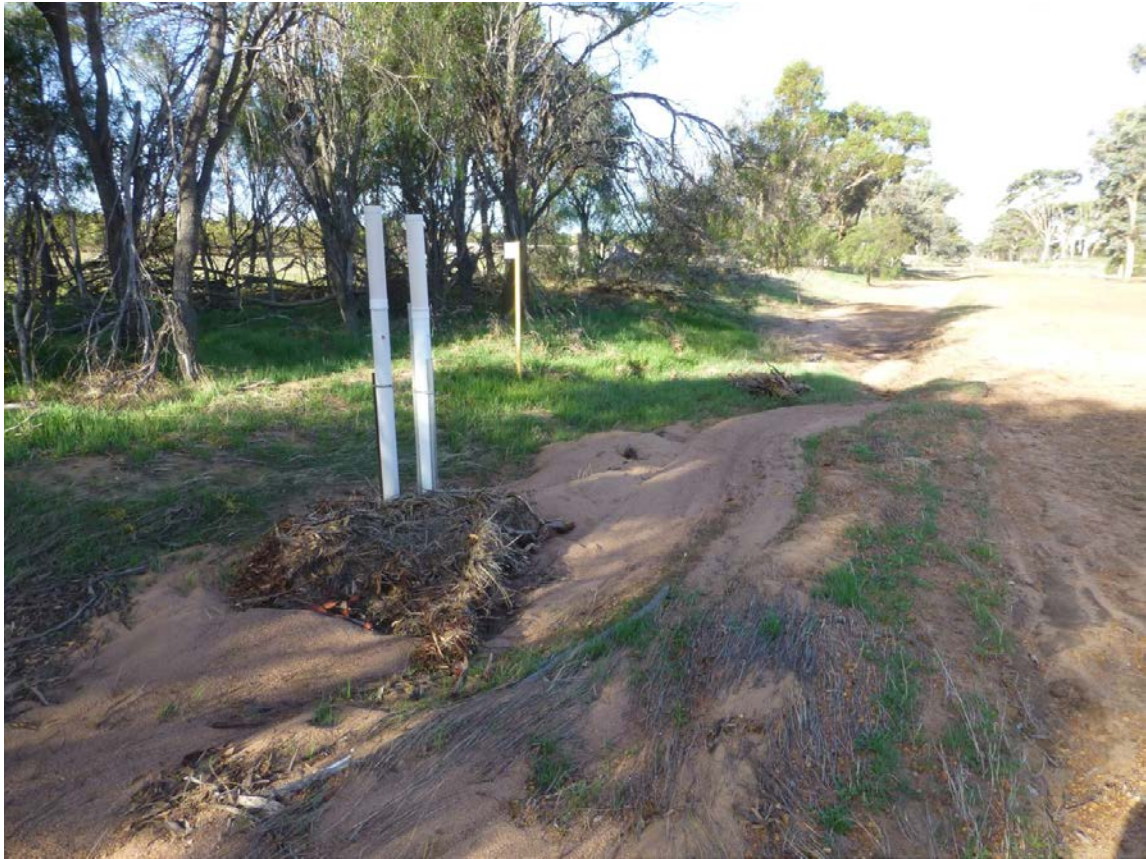
**Figure 4. Evidence of sedimentation and erosion occurring at site 11TAB001 resulting in changed channel dimensions.**

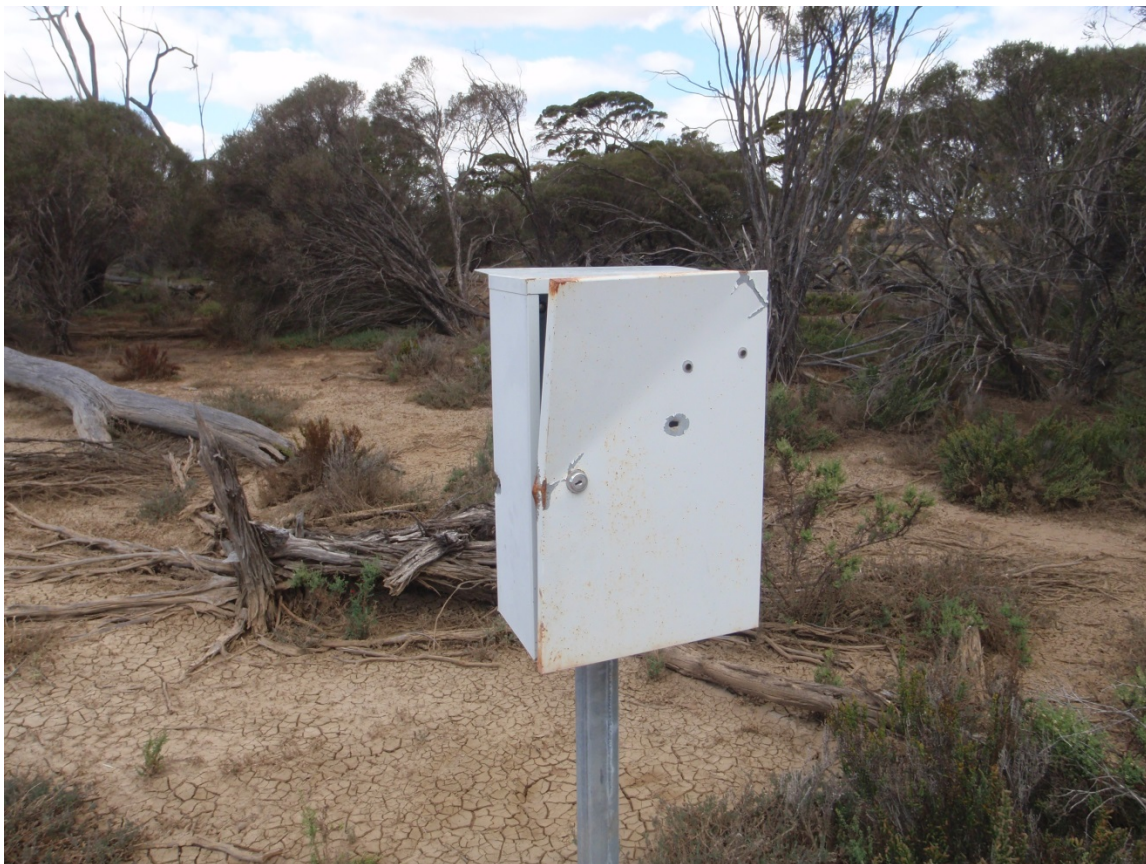
- Water level, temperature and salinity data was retrieved from two of the four AquaTroll data loggers deployed across the catchment.
- In all cases data was unable to be retrieved from Unidata data loggers due to flat batteries resulting in the loss of all data and in one case the data logger was found to be vandalized (gunshot holes in cabinet) (Figure 5).

**Figure 5. Data logger cabinet at site 03DUL06 located in the waterway east of Oval road. Note the small-calibre gunshot entry points on the door and evidence of forced entry.**

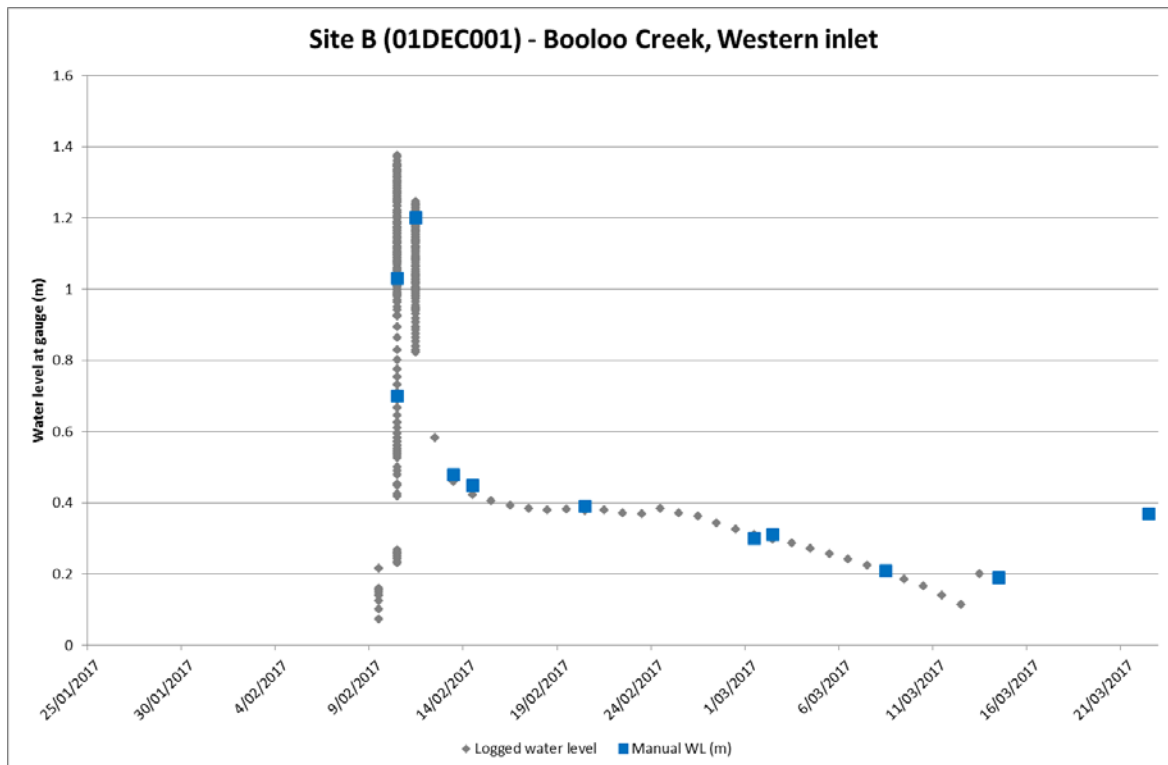
At Site B, a manual measurement observed at the gauge board taken at 09:00 hrs on 11 February 2017 was 1.20 m (Figure 6), whilst logged water levels captured with an AquaTroll logger at 09:14 was 1.24 m. A review of logged data over the previous 72-hours shows that a peak water level of 1.37 m occurred on 10 February at 15:59 hrs. A strong linear correlation ( $Y=0.9737 \cdot X+0.0195$ ,  $R^2$  0.9978) between all manual measurements and logged data provides a high level of confidence in the logged data. Inspection of trash lines on the adjoining fence indicated that a peak level of ~1.45 m occurred and therefore concurring with the peak level recorded by the automated logger on 10 February 2017.

**Figure 6. Manual measurements and logged surface water level data captured at Site B (01DEC001), located at Booloo Creek, the western inlet to the waterway at Toolibin Lake**

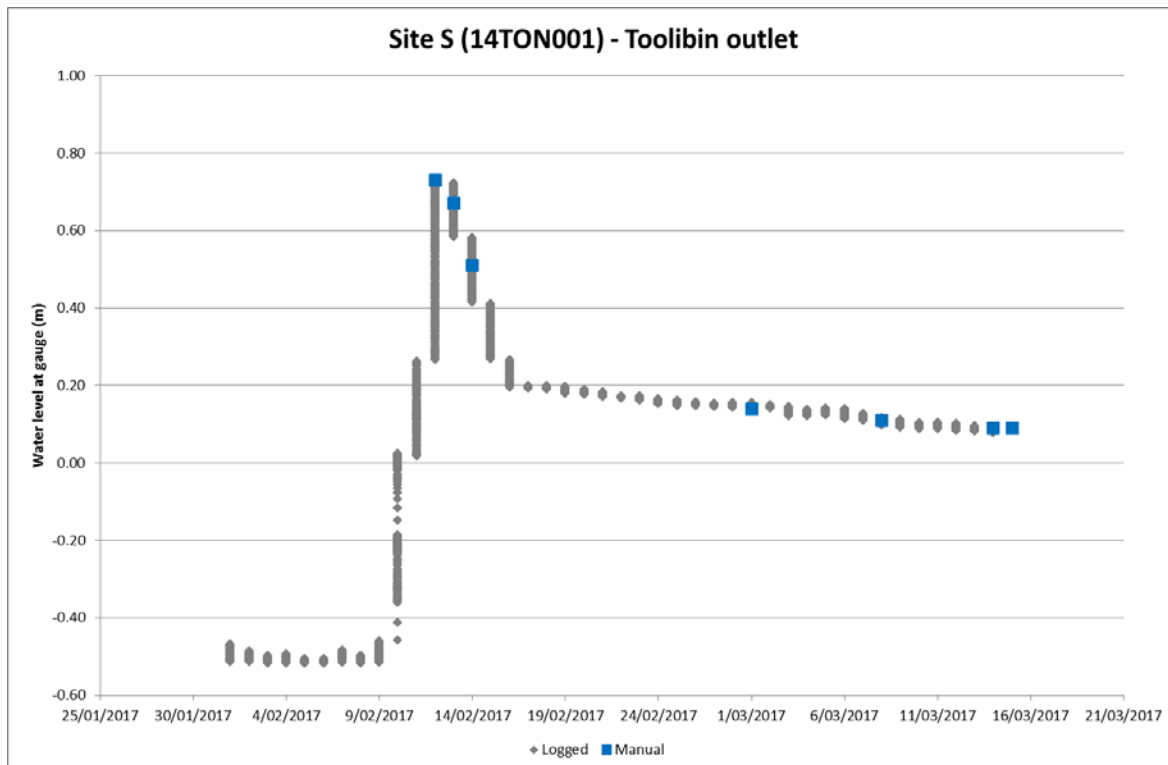
At Site S, a manual measurement observed at the gauge board taken at 13:51 hrs on 13 February 2017 was 0.67 m (Figure 8). The calibrated logged water levels captured with a Scott Parsons Electronics data logger at 13:55 was 0.66 m. A review of the logged data over the previous 72-hours shows that a peak water level of 0.73 m occurred at 21:55 hrs on 12 February. A strong linear correlation ( $Y=1.0959X-0.1349$ ,  $R^2$  0.9978) between manual measurements and logged data provides a high level of confidence in the logged data.

**Figure 8. Manual measurements and logged surface water level data captured at Site S (14TON001, DWER site 6091026), located at the outlet of Toolibin Lake.**

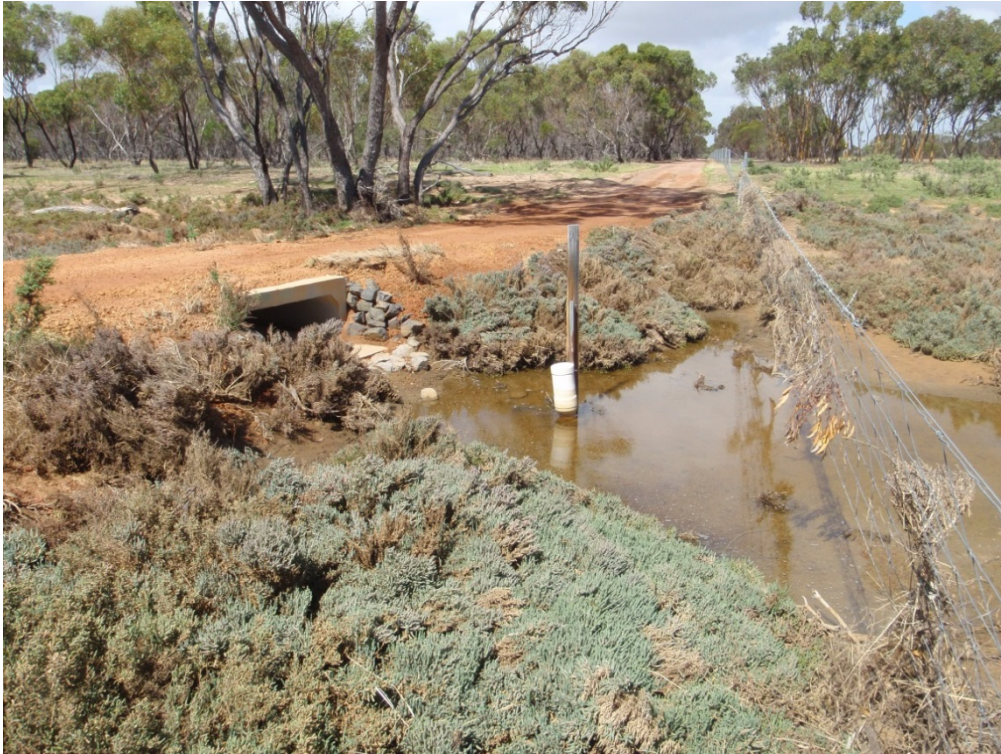
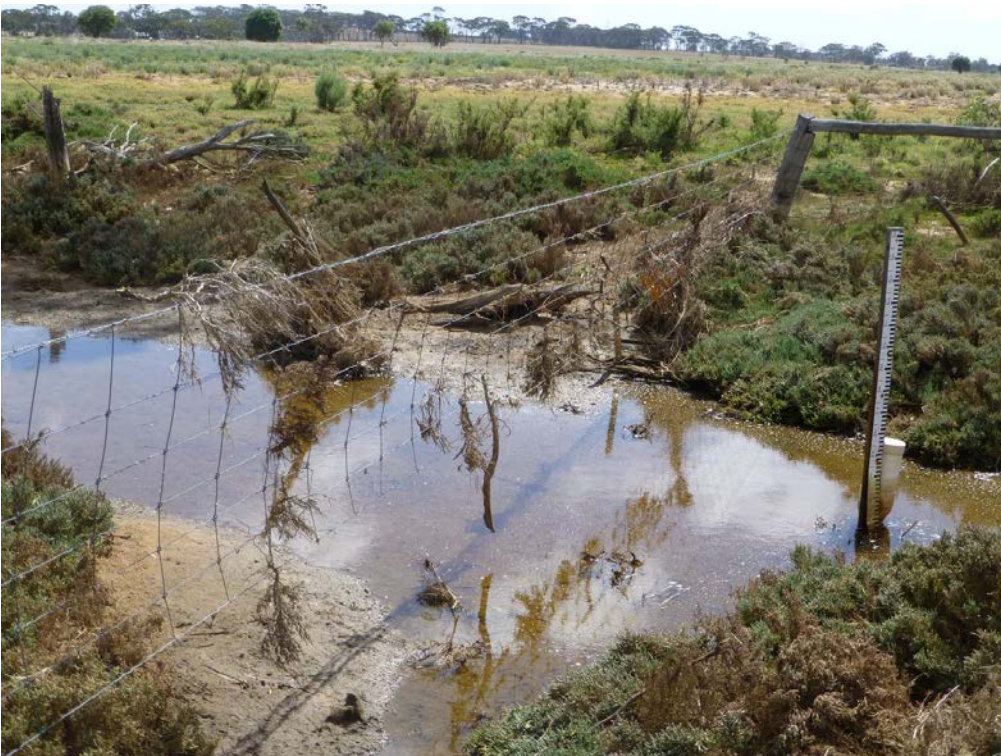
<b>SITE ID</b>	ASWTLB01DEC001
<b>SHORT ID</b>	01DEC001
<b>Site details</b>	MA1, Western Tributary, DEC Access Road upstream
<b>Sensor</b>	Water level, temp, EC
<b>TYPE</b>	AquaTroll
<b>Easting</b>	556041
<b>Northing</b>	6358016
<b>Comment:</b>

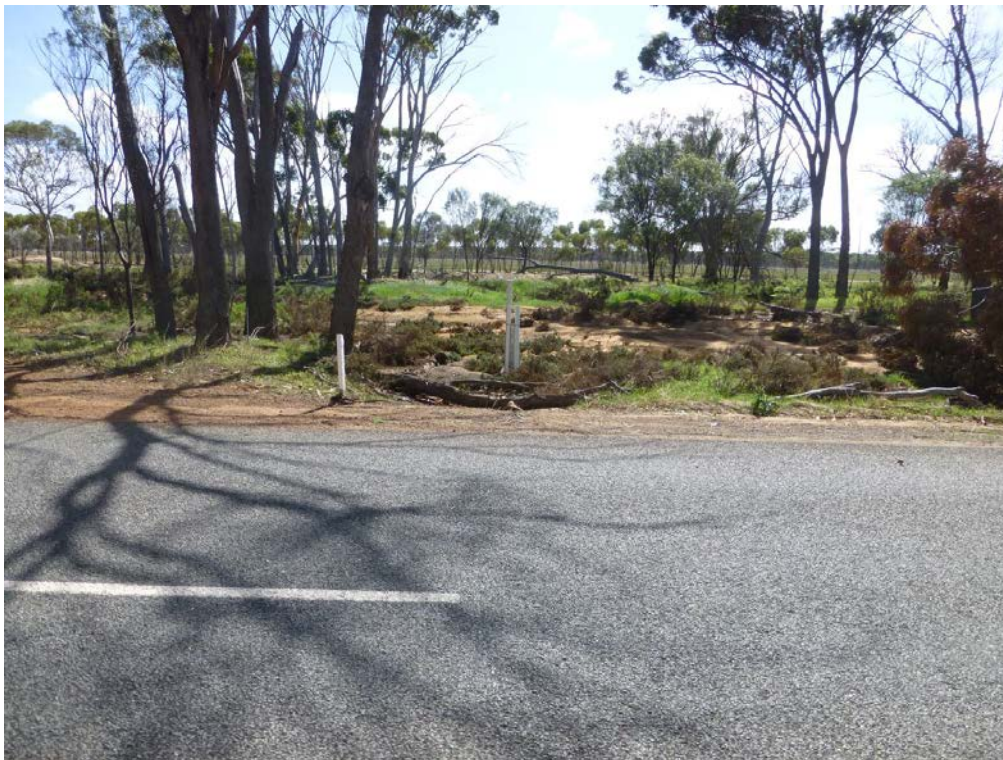
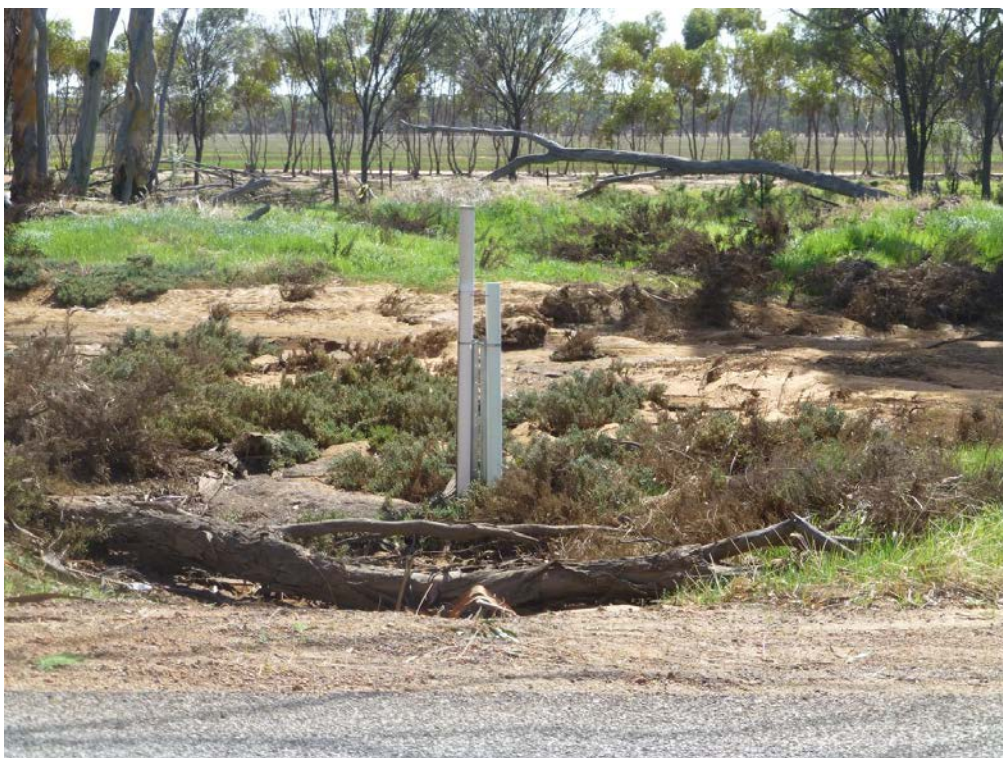
<b>SITE ID</b>	ASWTLB01HLC001
<b>SHORT ID</b>	01HLC001
<b>Site details</b>	MA1 Lower Harrismith Rd Upstream
<b>Sensor</b>	Water level
<b>TYPE</b>	SPE - USB
<b>Easting</b>	554090
<b>Northing</b>	6359568
<b>Comment:</b>

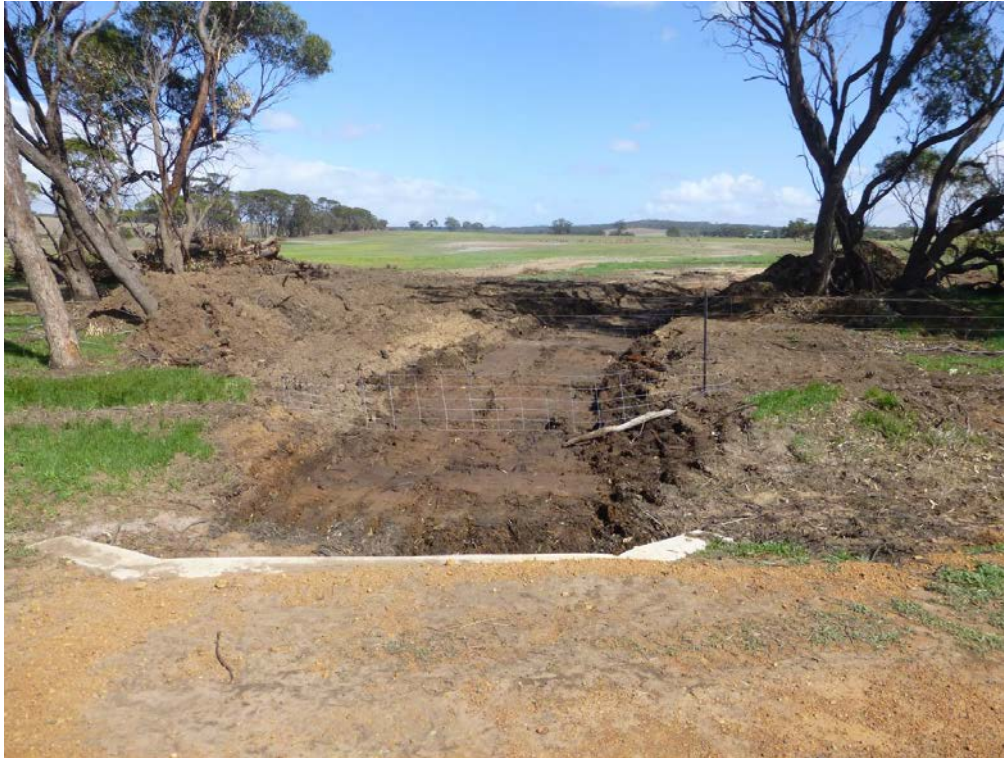
<b>SITE ID</b>	ASWTLB01HUC001
<b>SHORT ID</b>	01HUC001
<b>Site details</b>	MA1 Upper Harrismith Rd Upstream
<b>Sensor</b>	Water level
<b>TYPE</b>	SPE - USB
<b>Easting</b>	549656
<b>Northing</b>	6363147
<b>Comment:</b>

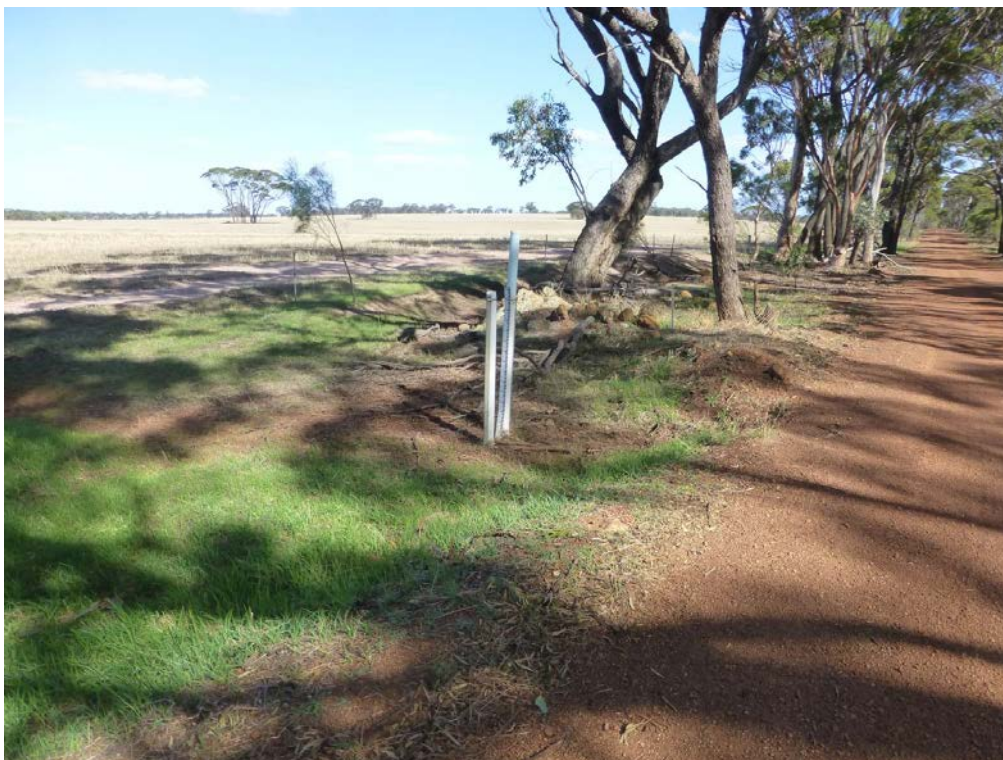
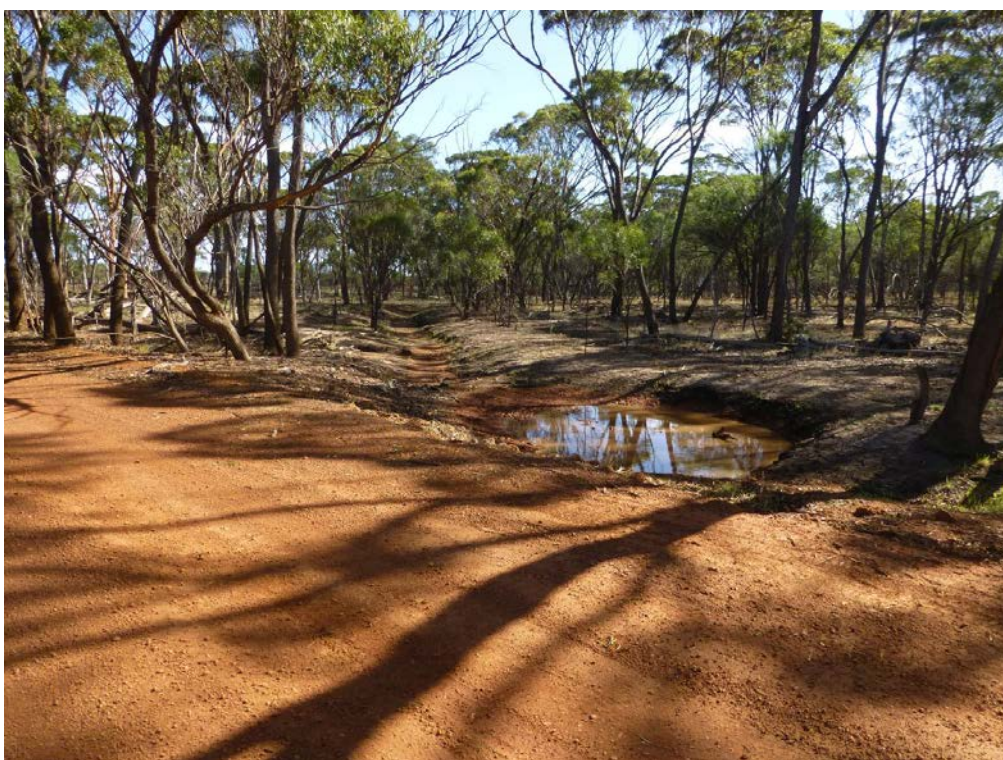
<b>SITE ID</b>	ASWTLB03BAK001
<b>SHORT ID</b>	03BAK001
<b>Site details</b>	MA3 Baker Road
<b>Sensor</b>	Water level
<b>TYPE</b>	SPE - USB
<b>Easting</b>	575424
<b>Northing</b>	6357984
<b>Comment:</b>

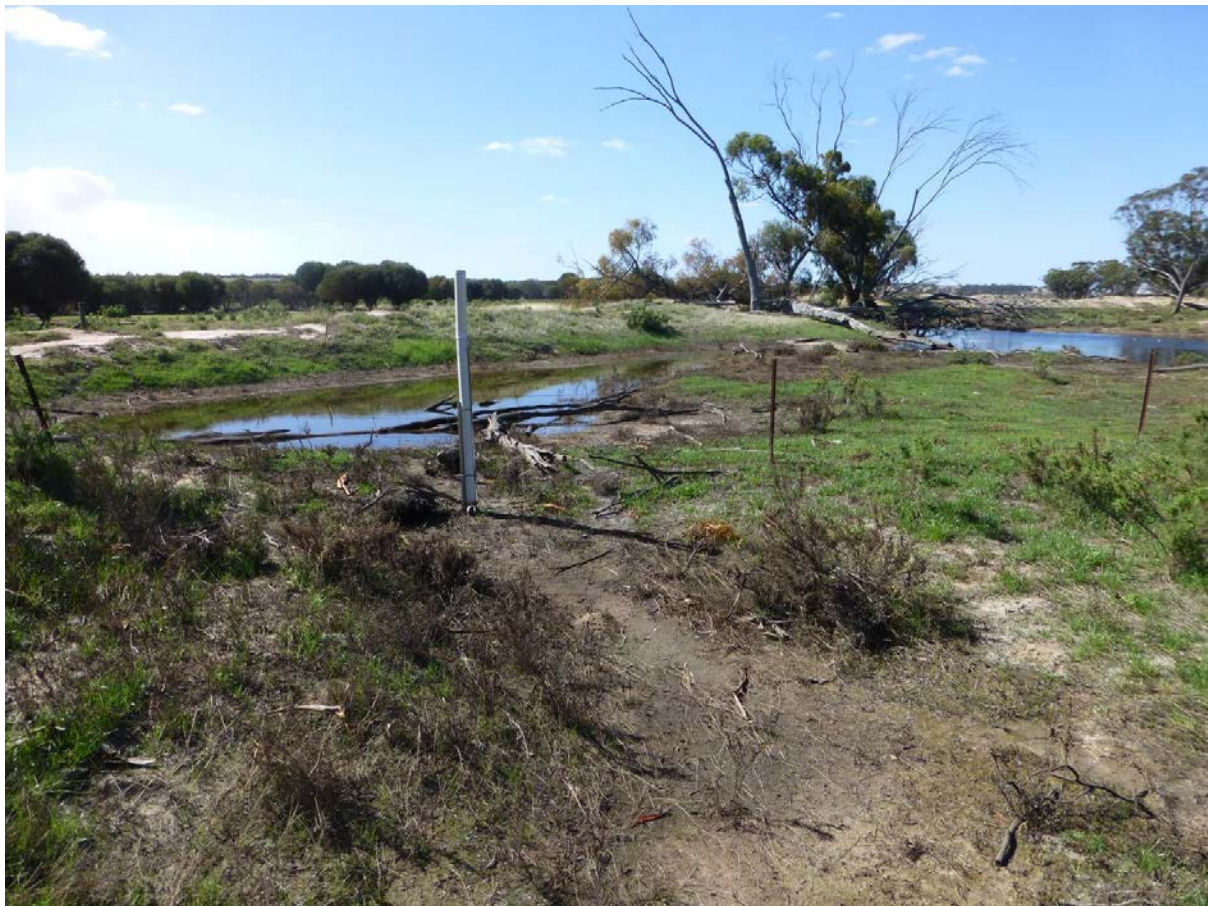
<b>SITE ID</b>	ASWTLB03BRO002
<b>SHORT ID</b>	03BRO002
<b>Site details</b>	MA3 Brown Rd Culvert
<b>Sensor</b>	Water level
<b>TYPE</b>	SPE – USB
<b>Easting</b>	562979
<b>Northing</b>	6360864
<b>Comment:</b>

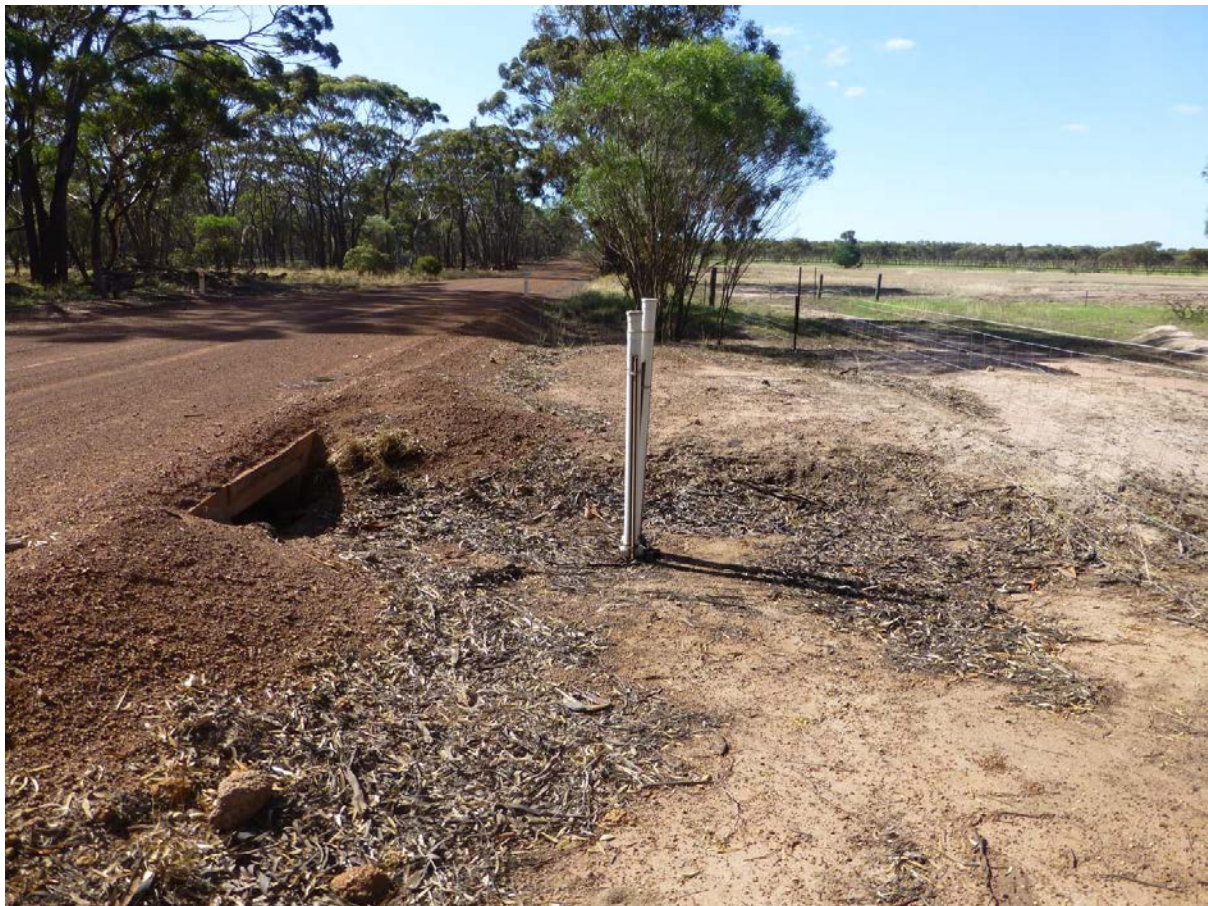
<b>SITE ID</b>	ASWTLB03TIN001
<b>SHORT ID</b>	03TIN001
<b>Site details</b>	MA3 Tincurrin Nth Rd Upstream
<b>Sensor</b>	Water level
<b>TYPE</b>	SPE – USB
<b>Easting</b>	571256
<b>Northing</b>	6359823
<b>Comment:</b>

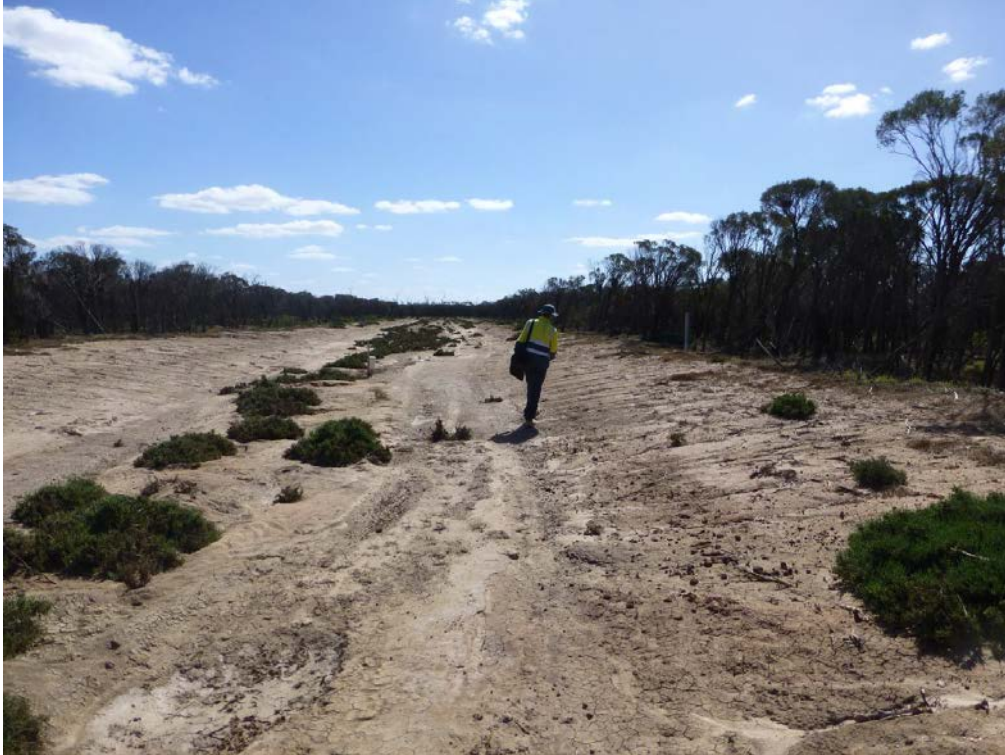
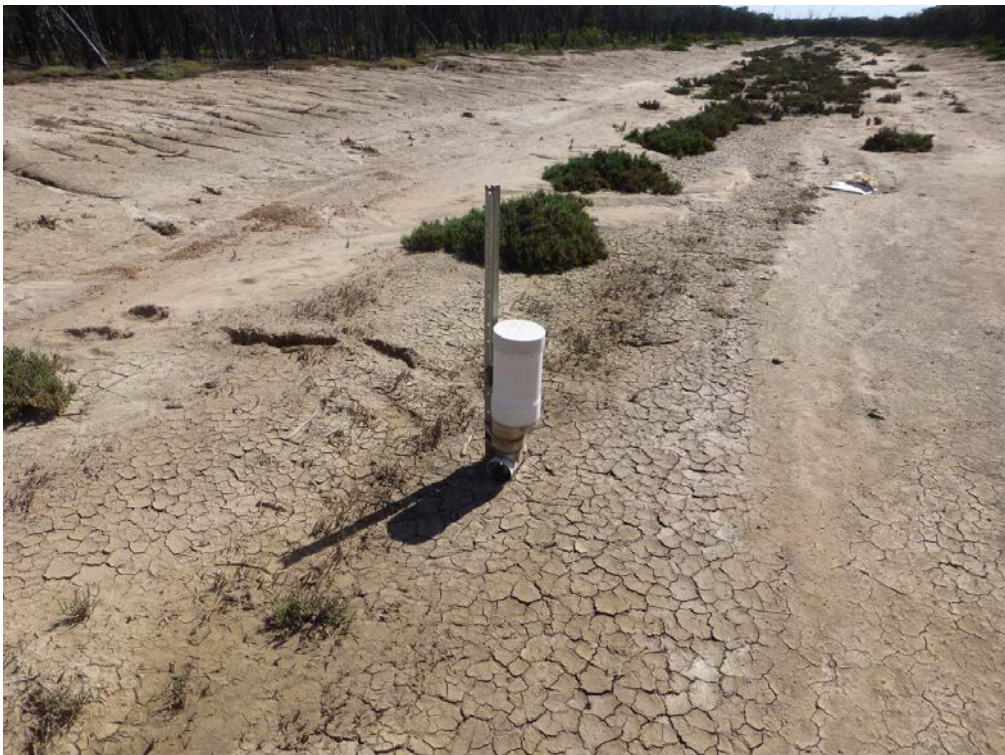
<b>SITE ID</b>	ASWTLB03TON002
<b>SHORT ID</b>	03TON002
<b>Site details</b>	MA3/5 Toolibin Nth Rd Downstream
<b>Sensor</b>	Water level, temp, EC
<b>TYPE</b>	AquaTroll
<b>Easting</b>	561509.434
<b>Northing</b>	6360275.4
<b>Comment:</b>

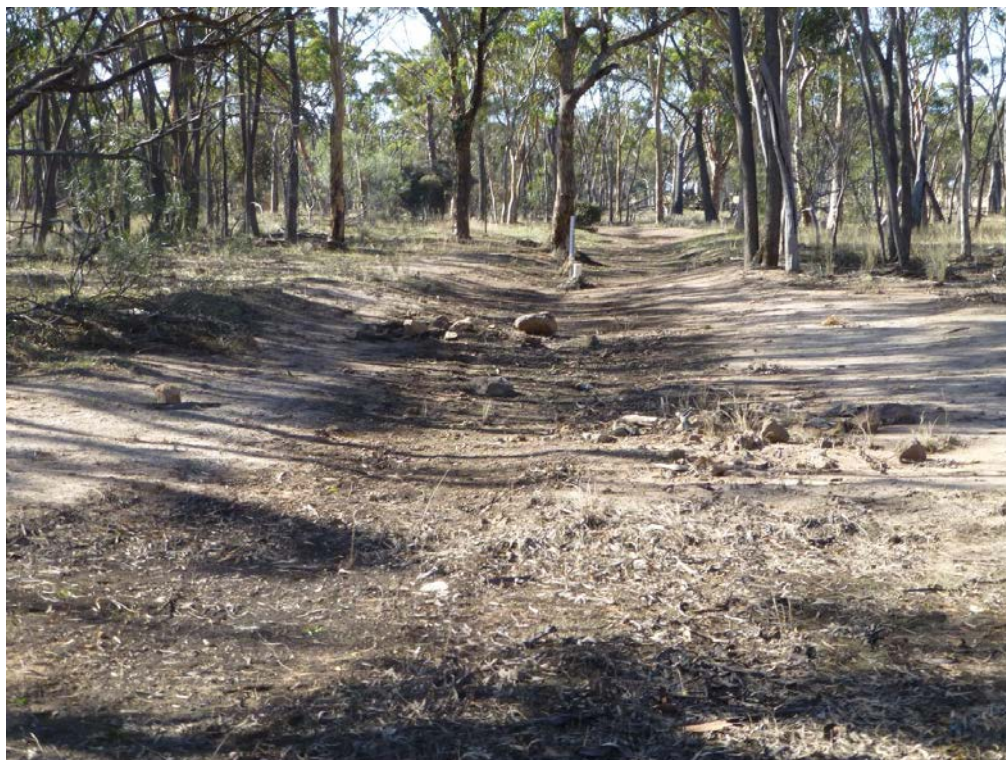
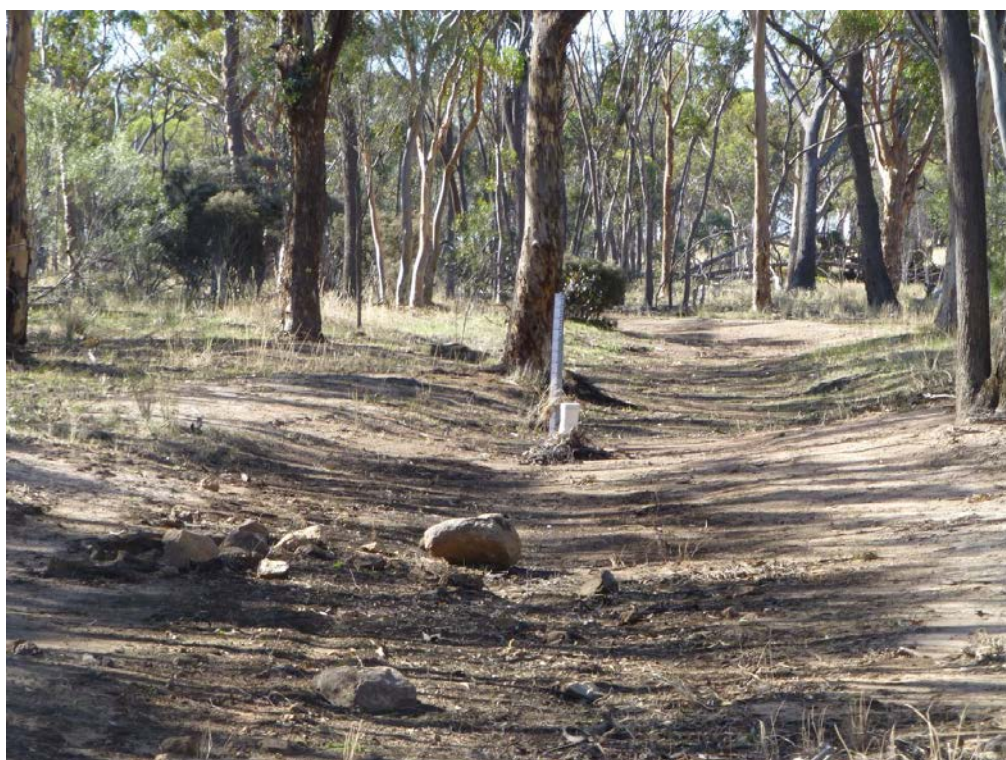
<b>SITE ID</b>	ASWTLB05HAR002
<b>SHORT ID</b>	05HAR002
<b>Site details</b>	MA5 Harrismith Rd Downstream
<b>Sensor</b>	Water level, temp, EC
<b>TYPE</b>	AquaTroll
<b>Easting</b>	565152.68
<b>Northing</b>	6357589.2
<b>Comment:</b>

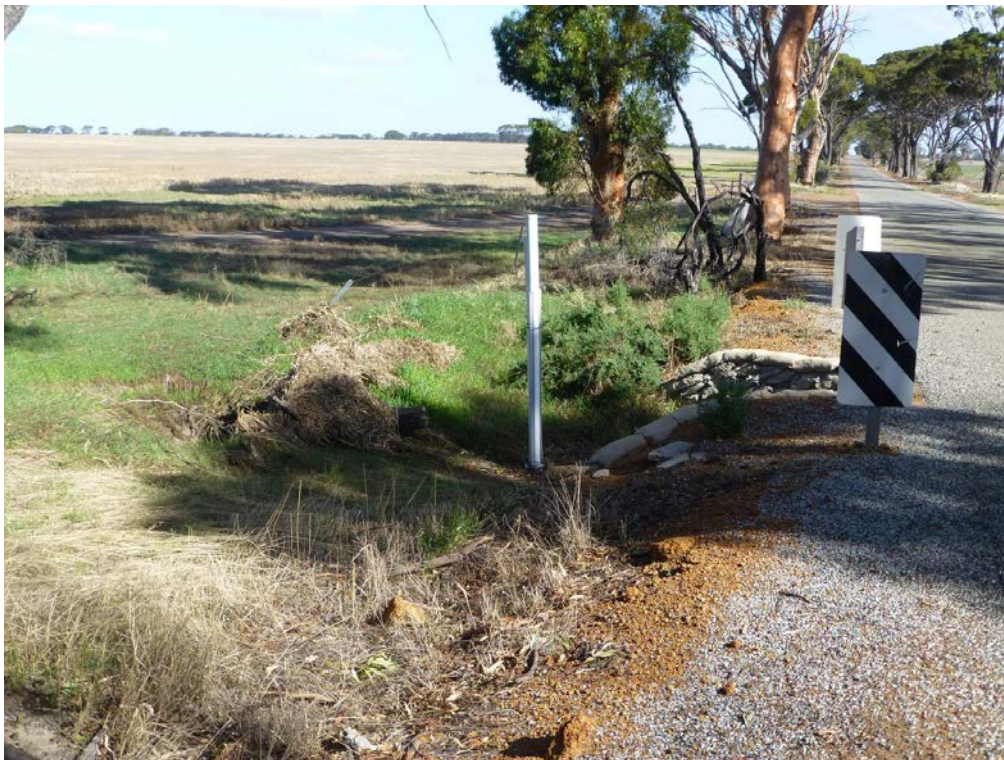
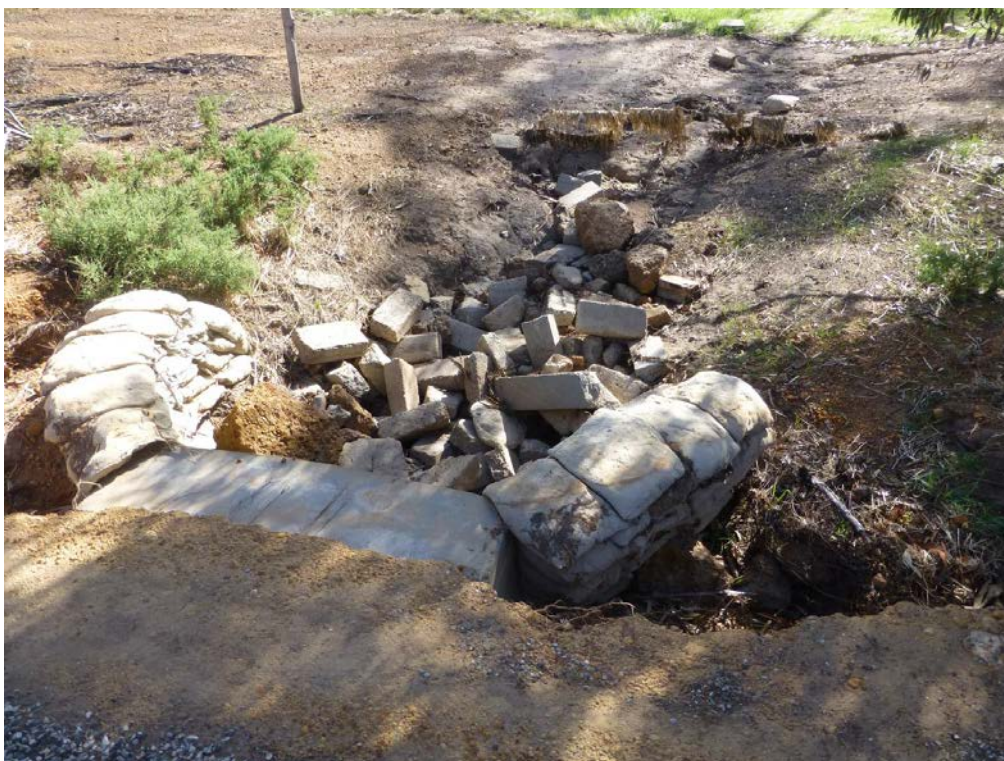
<b>SITE ID</b>	ASWTLB05TIN001
<b>SHORT ID</b>	05TIN001
<b>Site details</b>	MA5 Tincurrin Nth Rd
<b>Sensor</b>	Water level
<b>TYPE</b>	SPE – USB
<b>Easting</b>	571810
<b>Northing</b>	6353284.6
<b>Comment:</b>

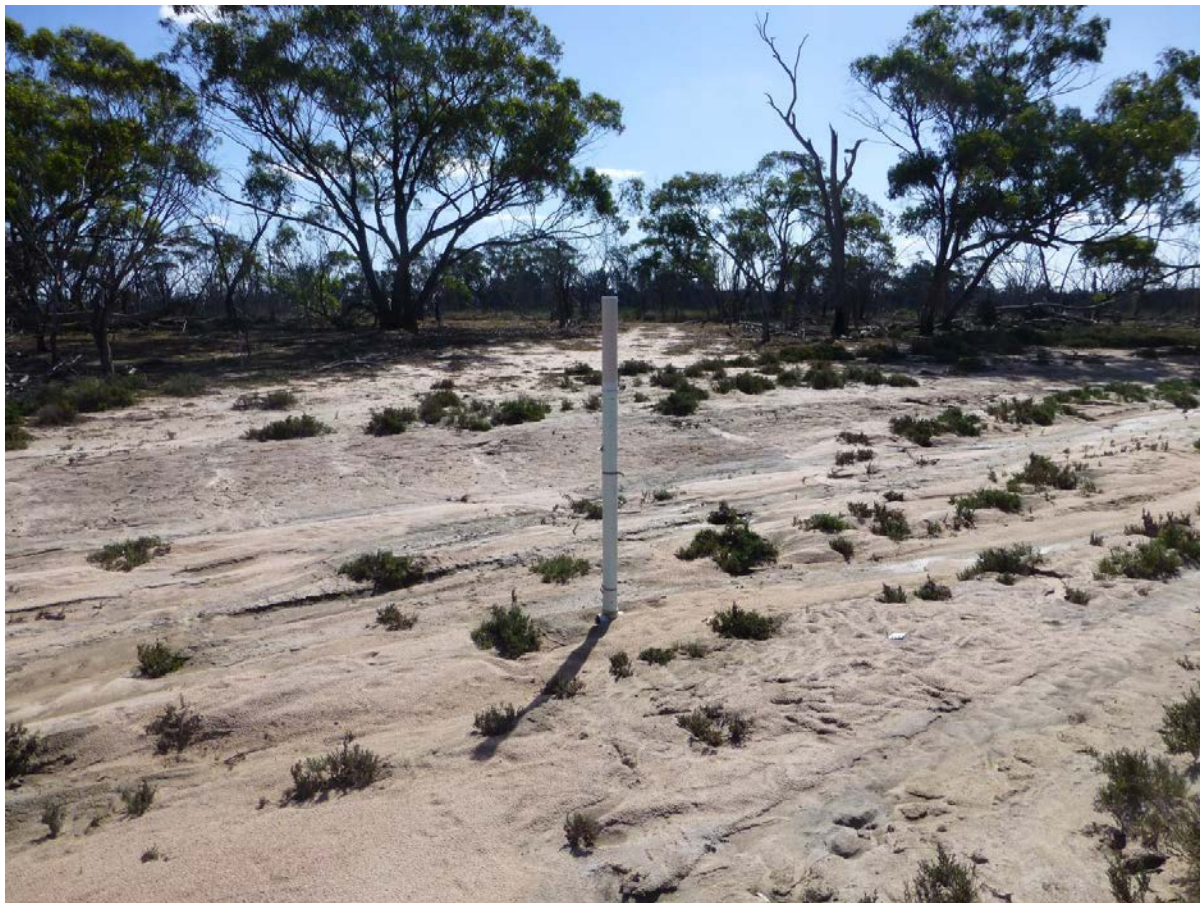
<b>SITE ID</b>	ASWTLB05TON001
<b>SHORT ID</b>	05TON001
<b>Site details</b>	MA5 Toolibin Nth Rd
<b>Sensor</b>	Water level
<b>TYPE</b>	SPE – USB
<b>Easting</b>	561409.94
<b>Northing</b>	6359998.48
<b>Comment:</b>

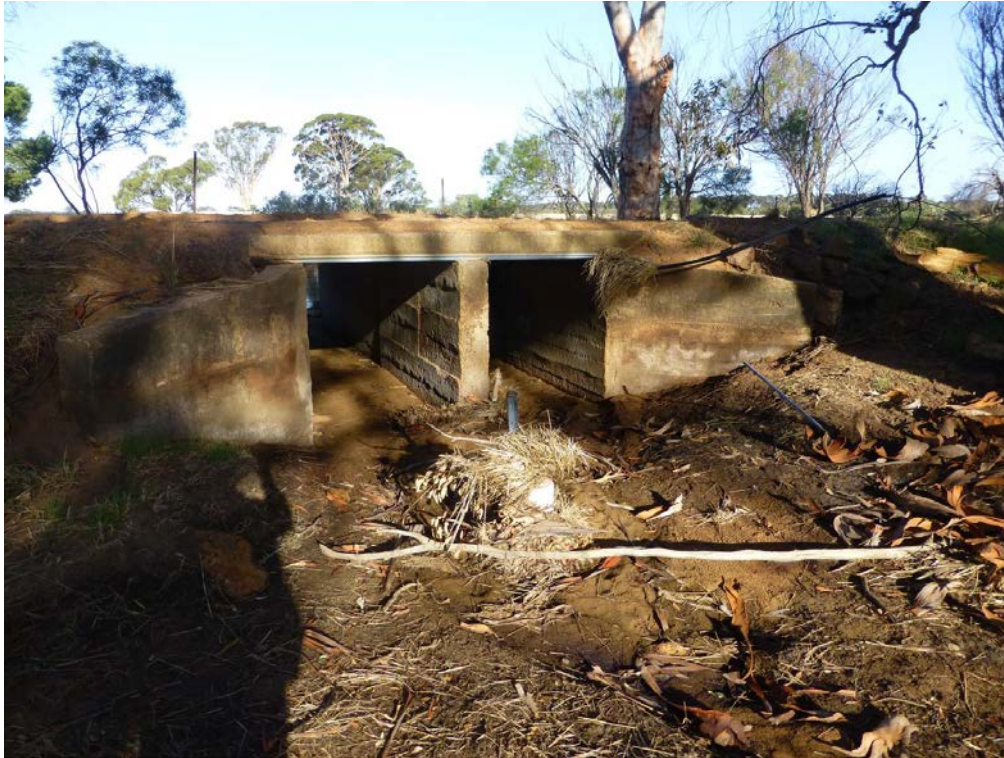
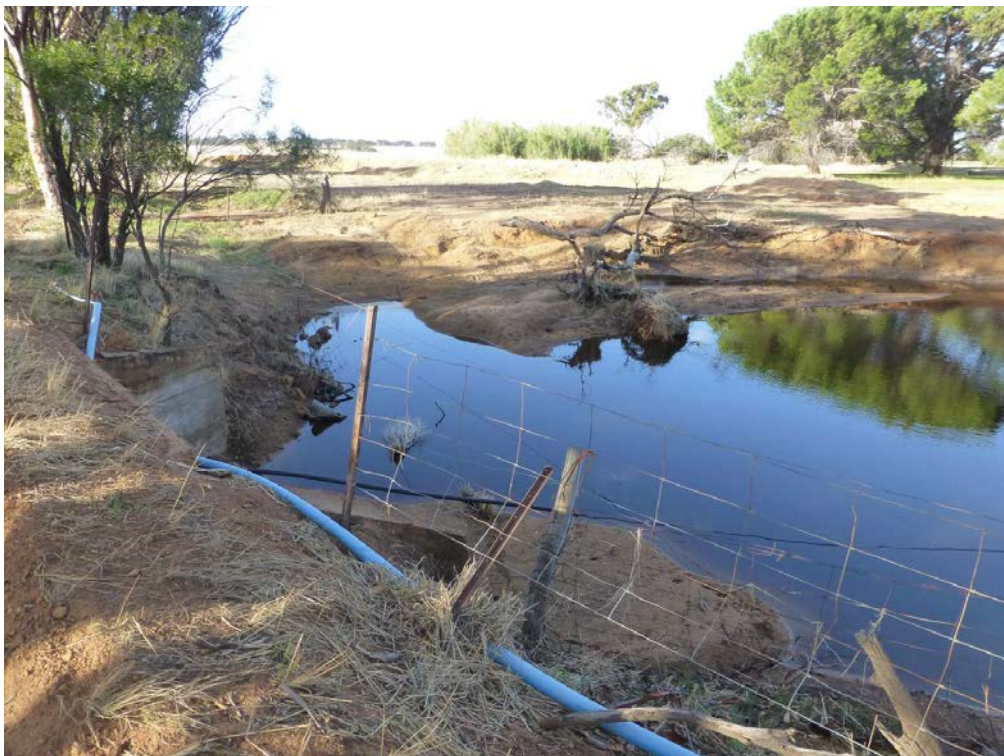
<b>SITE ID</b>	ASWTLB10HAL001
<b>SHORT ID</b>	10HAL001
<b>Site details</b>	MA10 Box Culvert Upstream
<b>Sensor</b>	Water level, temp, EC
<b>TYPE</b>	AquaTroll
<b>Easting</b>	553895
<b>Northing</b>	6366581
<b>Comment:</b>

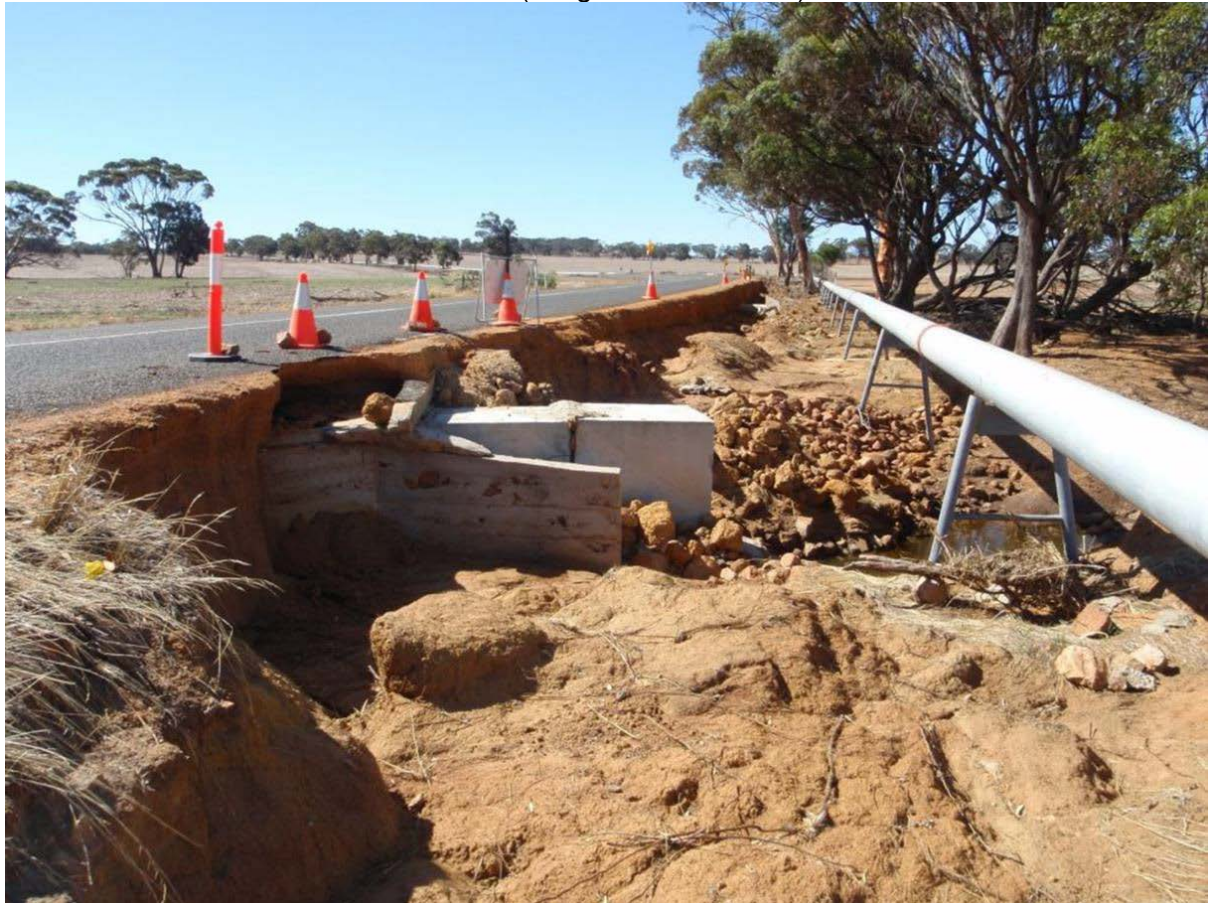
<b>SITE ID</b>	ASWTLB10HAR001
<b>SHORT ID</b>	10HAR001
<b>Site details</b>	MA10 Harrismith Rd Upstream
<b>Sensor</b>	Water level
<b>TYPE</b>	SPE – USB
<b>Easting</b>	548427.6
<b>Northing</b>	6366753.8
<b>Comment:</b>	Site destroyed following significant surface water flow event in December 2012 (image in 2012 below).
