## Site audit and decommissioning of surface water and climate monitoring data loggers – Toolibin Lake Catchment

Hydrology report series WCP-HR-2017-02  
September 2017

### **2017 surface water monitoring infrastructure site audit**

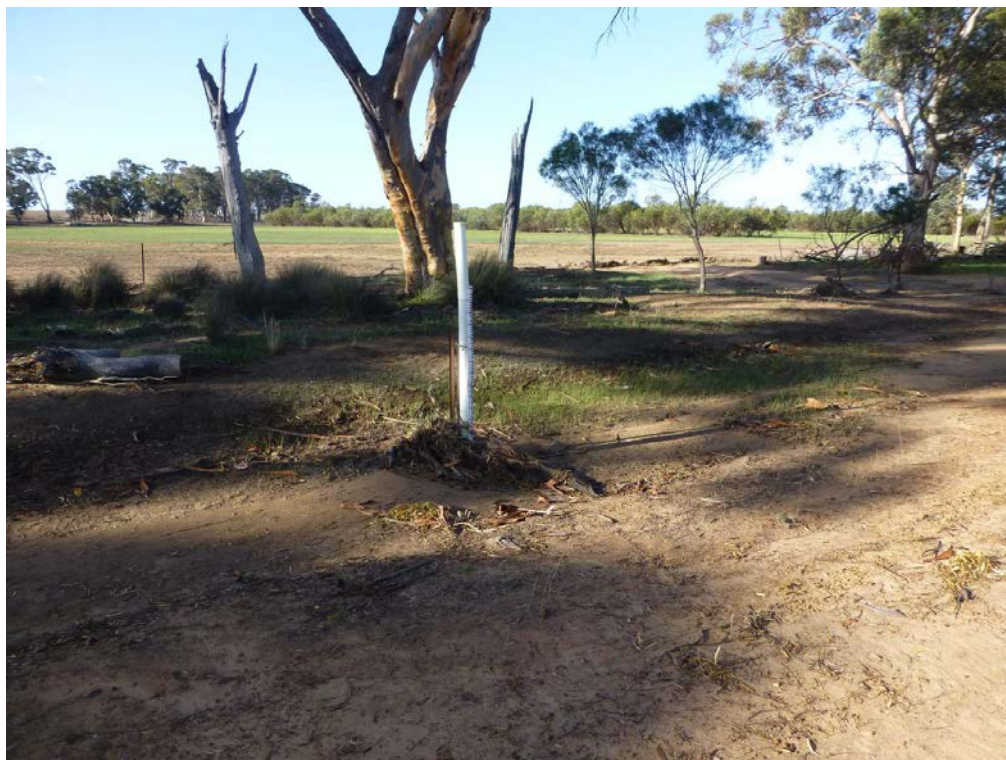
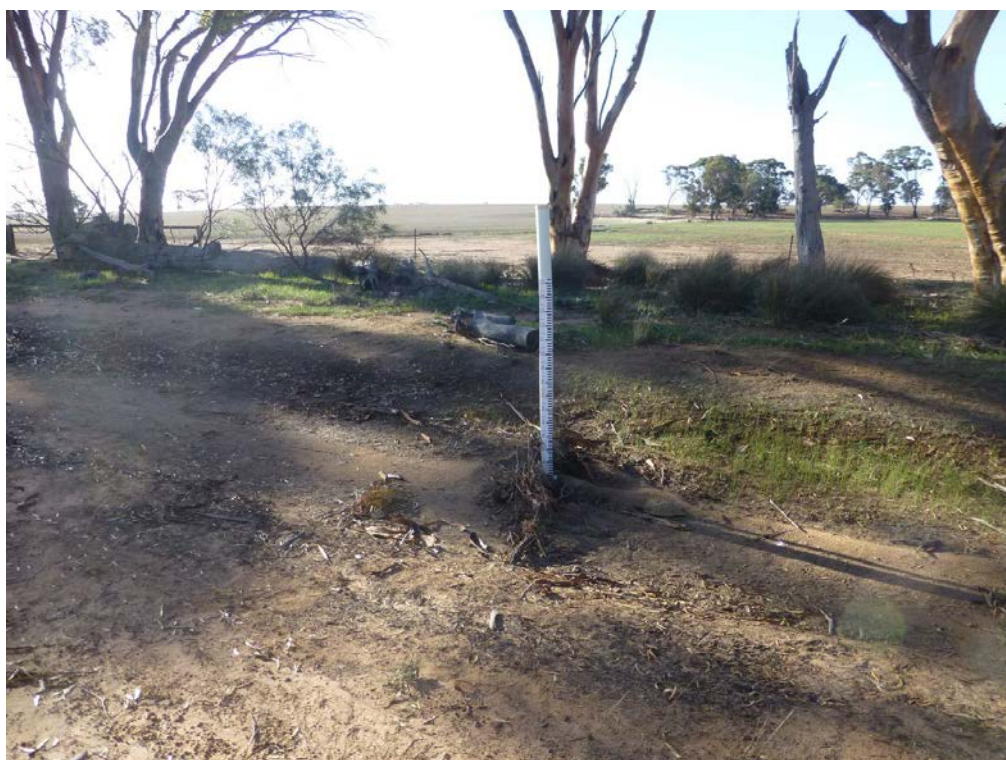
<b>SITE ID</b>	ASWTLB10WDR001
<b>SHORT ID</b>	10WDR001
<b>Site details</b>	MA10 West Drain Upstream
<b>Sensor</b>	Water level
<b>TYPE</b>	SPE – USB
<b>Easting</b>	557493.204
<b>Northing</b>	6365984.39
<b>Comment:</b>

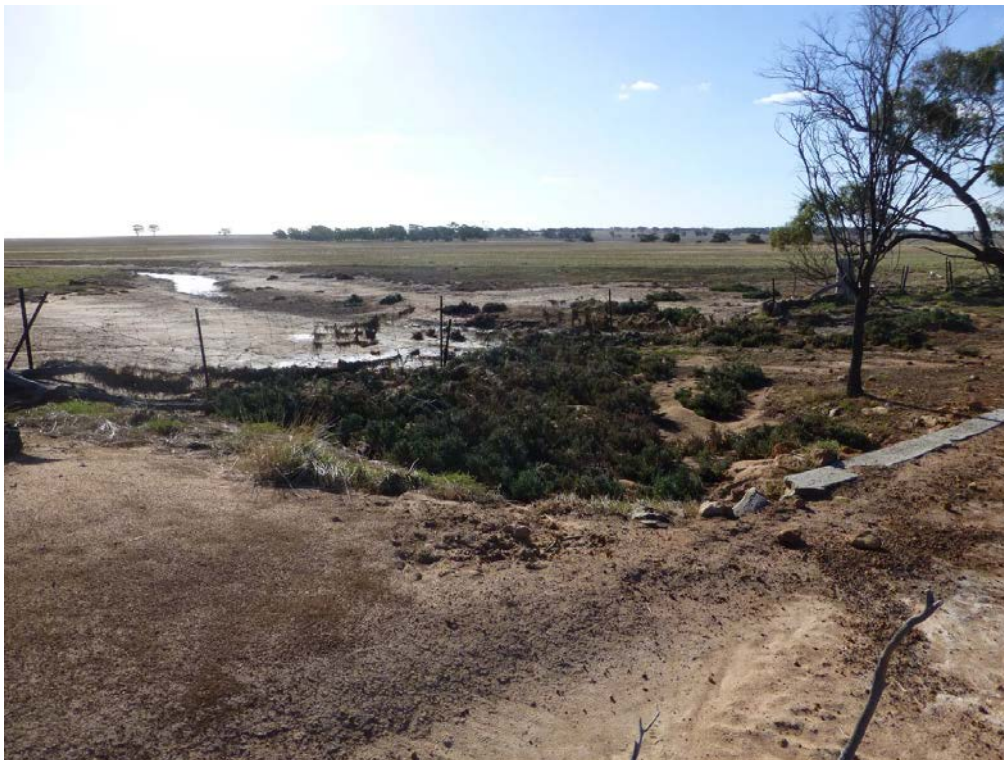
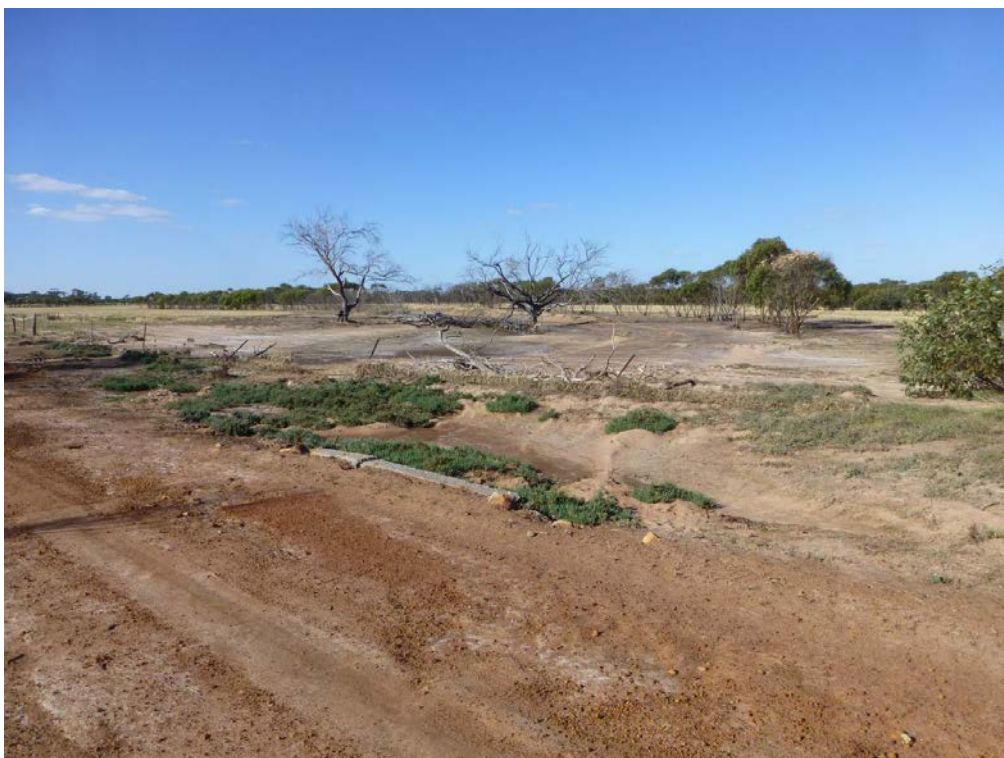
<b>SITE ID</b>	ASWTLB11DOR001
<b>SHORT ID</b>	11DOR001
<b>Site details</b>	MA11b Dorakin Road
<b>Sensor</b>	Water level
<b>TYPE</b>	SPE – USB
<b>Easting</b>	560233.7
<b>Northing</b>	6367722.28
<b>Comment:</b>

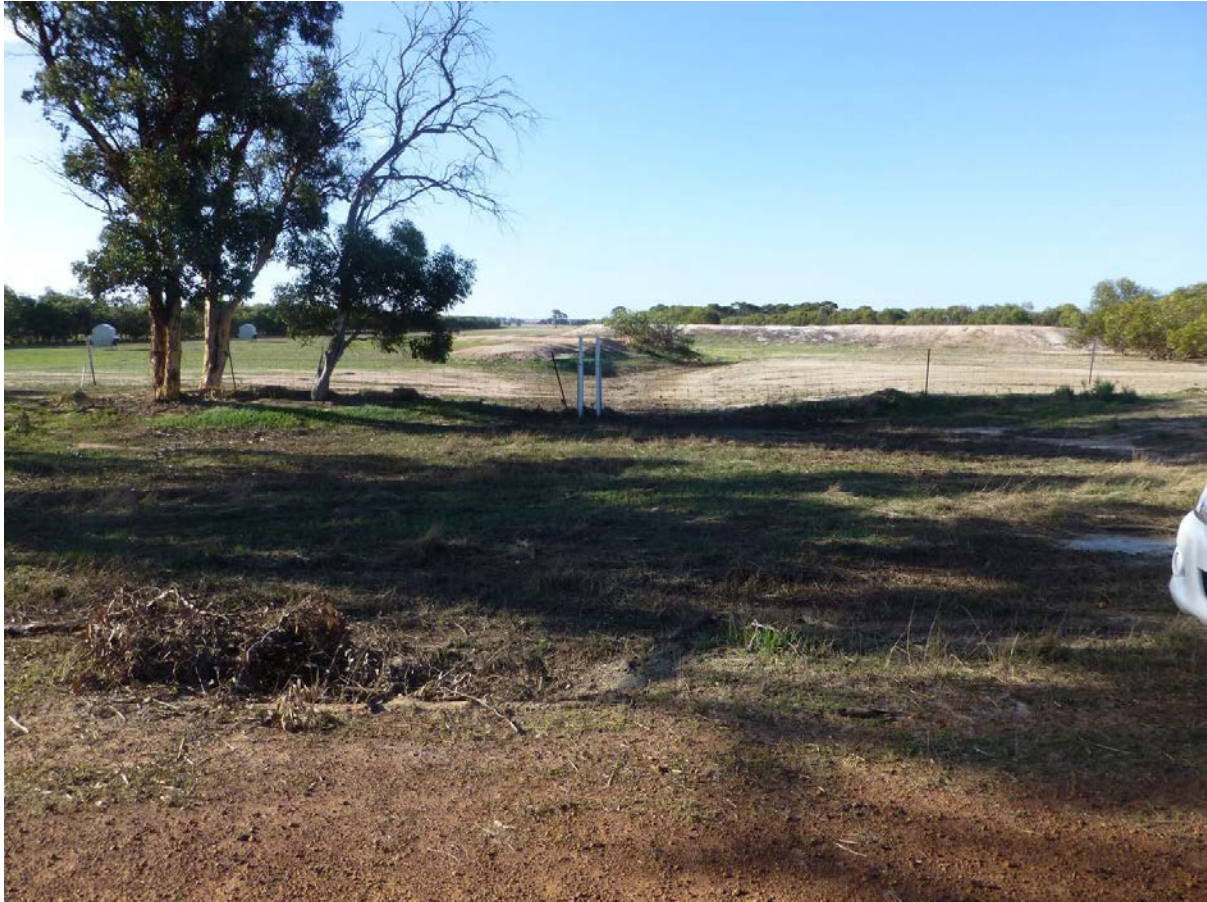
<b>SITE ID</b>	ASWTLB11EDR001
<b>SHORT ID</b>	11EDR001
<b>Site details</b>	MA11b East Drain Upstream
<b>Sensor</b>	Water level
<b>TYPE</b>	SPE – USB
<b>Easting</b>	559412.6
<b>Northing</b>	6365989
<b>Comment:</b>

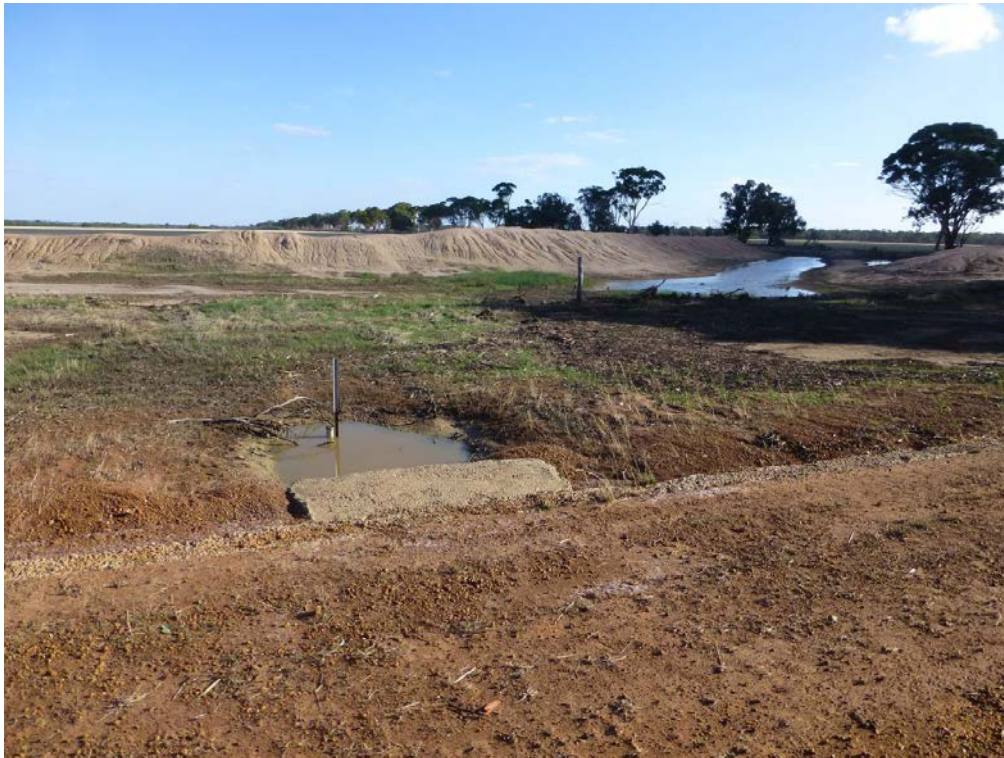
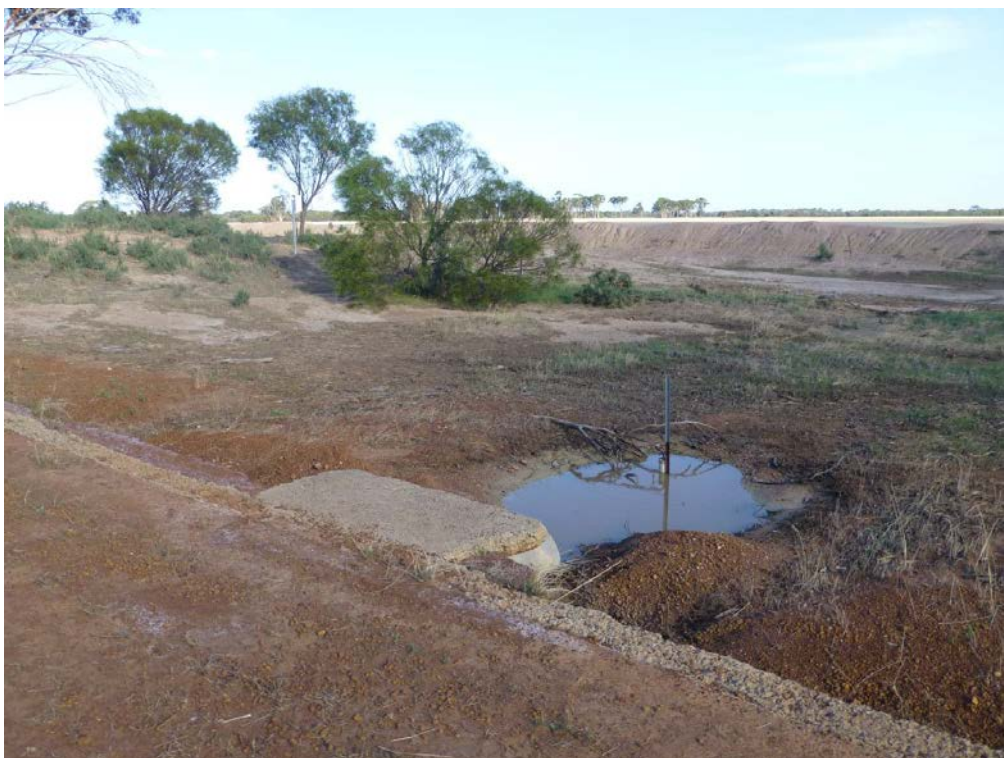
<b>SITE ID</b>	ASWTLB11EDR002
<b>SHORT ID</b>	11EDR002
<b>Site details</b>	MA11b East Drain Salinity
<b>Sensor</b>	EC and temp
<b>TYPE</b>	Unidata
<b>Easting</b>	559411
<b>Northing</b>	6365962
<b>Comment:</b>

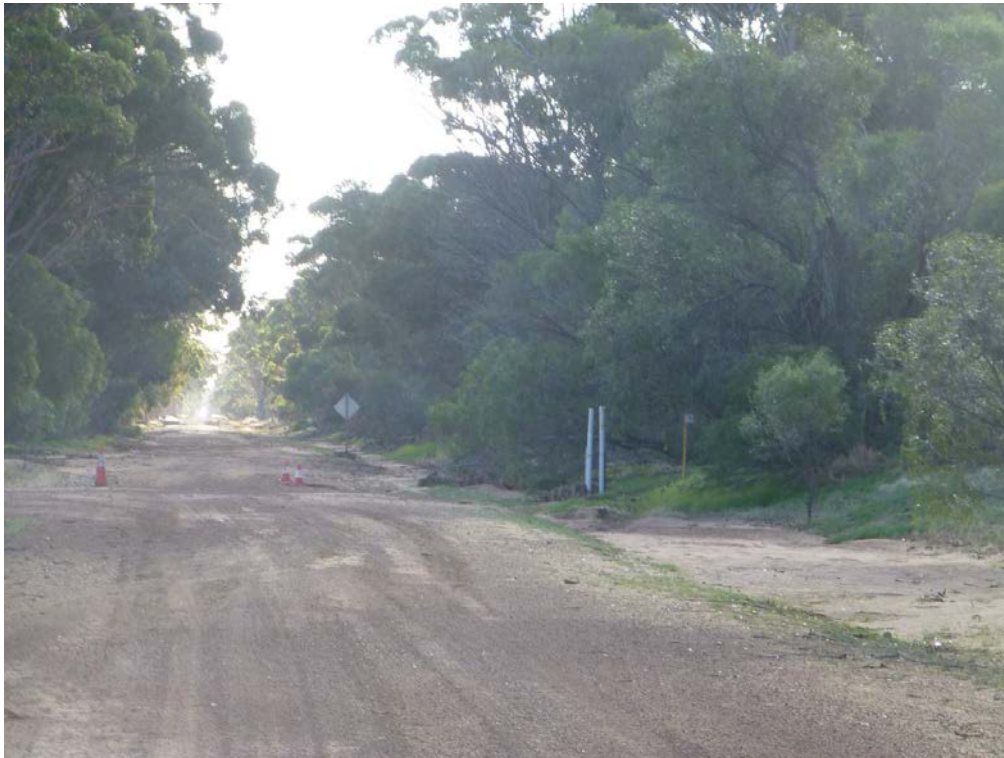
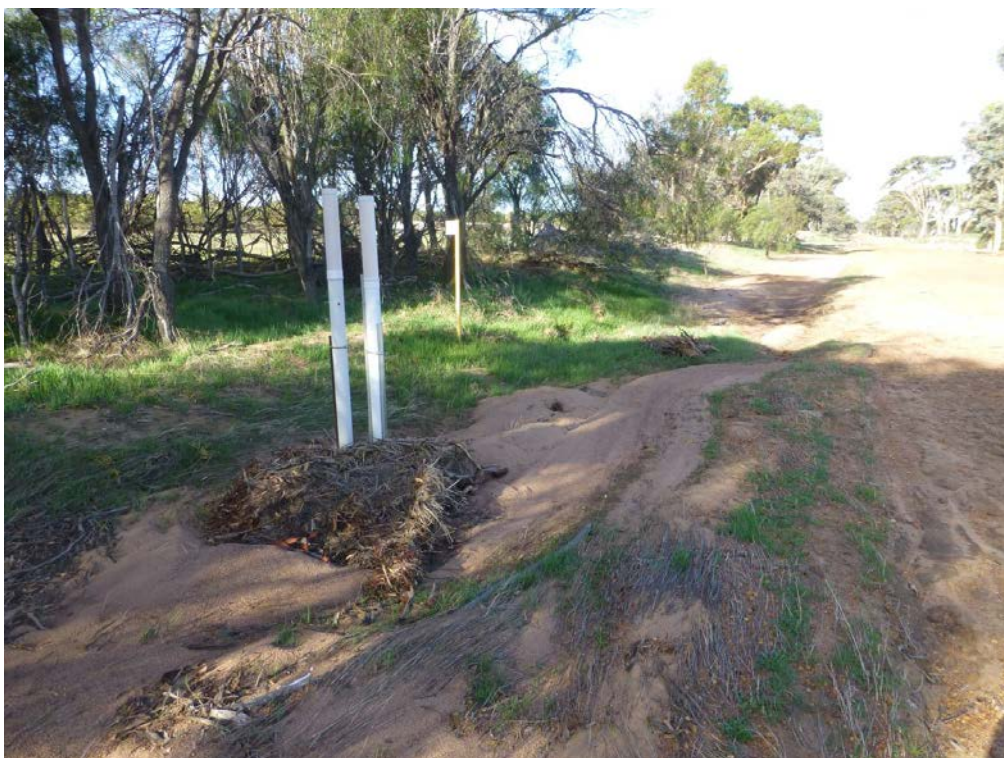
<b>SITE ID</b>	ASWTLB11TAB001
<b>SHORT ID</b>	11TAB001
<b>Site details</b>	MA11a Table Drain
<b>Sensor</b>	Water level
<b>TYPE</b>	SPE – USB
<b>Easting</b>	559291.5
<b>Northing</b>	6365976.8
<b>Comment:</b>

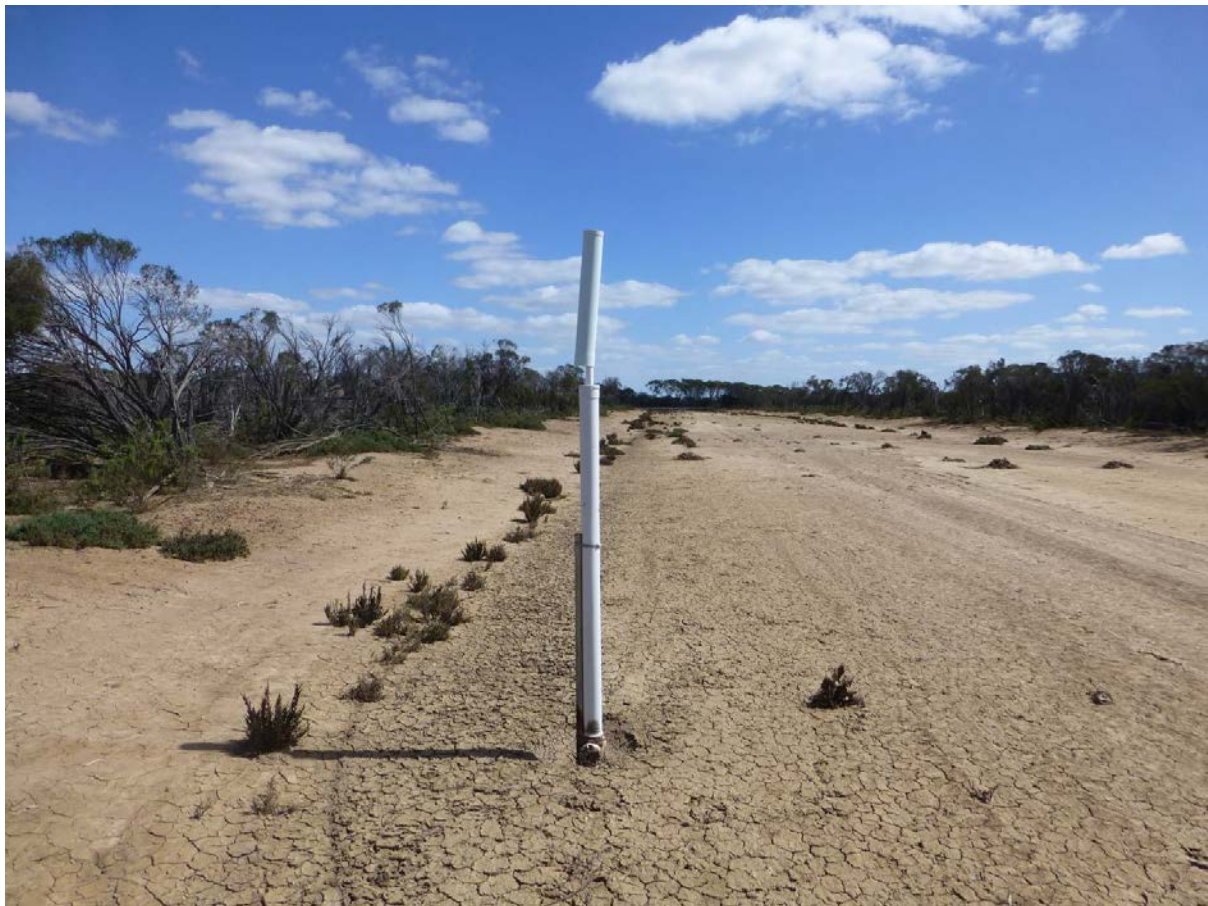
<b>SITE ID</b>	ASWTLB13DUL004
<b>SHORT ID</b>	13DUL004
<b>Site details</b>	Dulb&East Drains (Dul4)
<b>Sensor</b>	Water level
<b>TYPE</b>	SPE – Radio
<b>Easting</b>	560610
<b>Northing</b>	6359778
<b>Comment:</b>

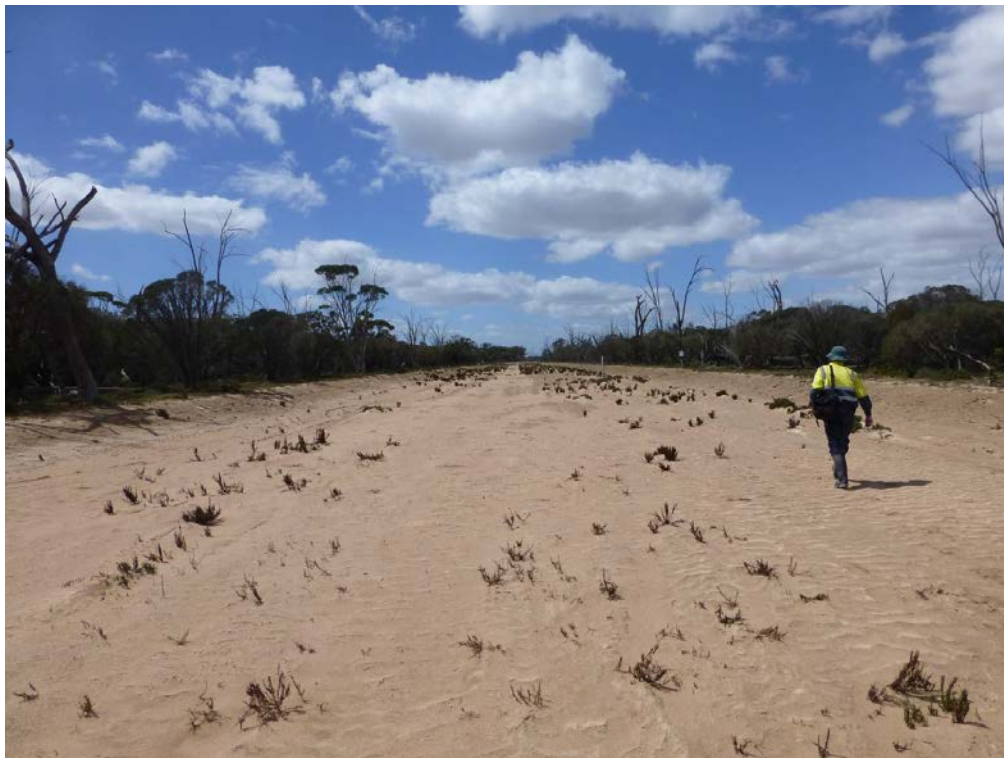
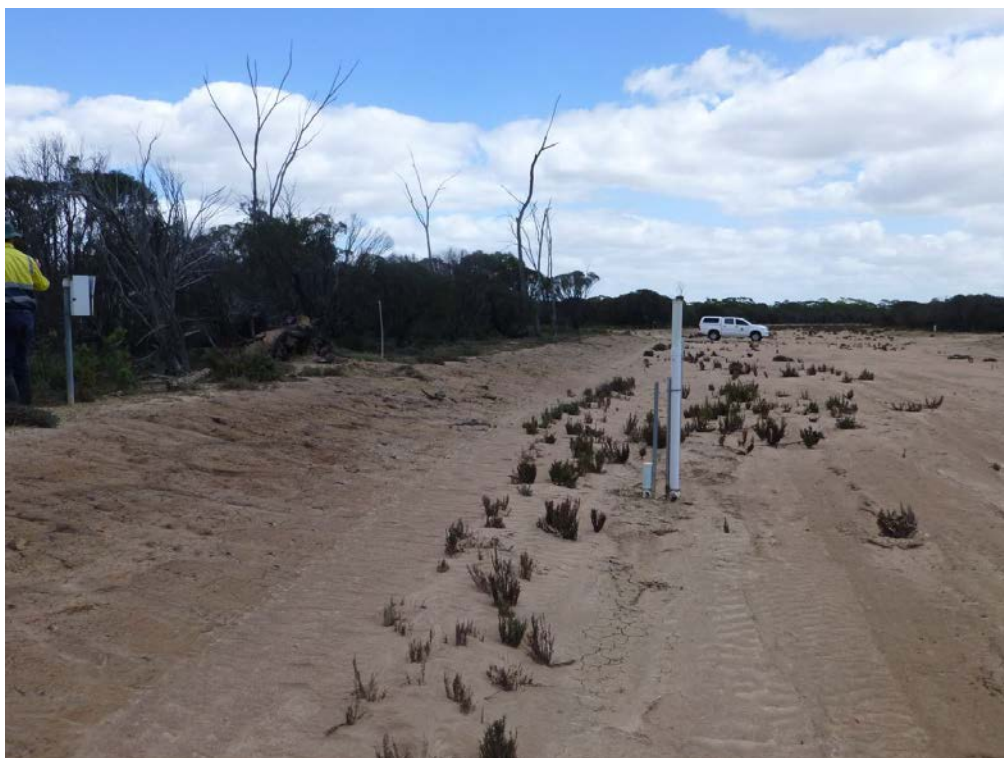
<b>SITE ID</b>	ASWTLB13DUL006
<b>SHORT ID</b>	13DUL006
<b>Site details</b>	Oval Road
<b>Sensor</b>	Water level/EC and temperature
<b>TYPE</b>	SPE – USB/Unidata
<b>Easting</b>	559061.165
<b>Northing</b>	6359391.95
<b>Comment:</b>

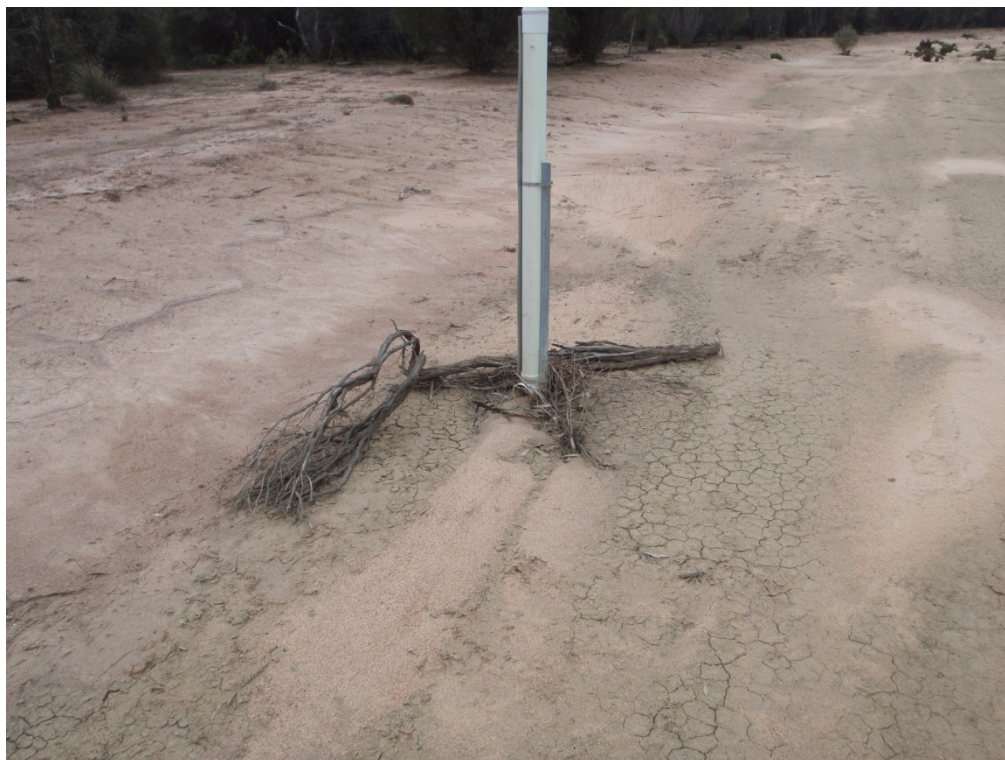
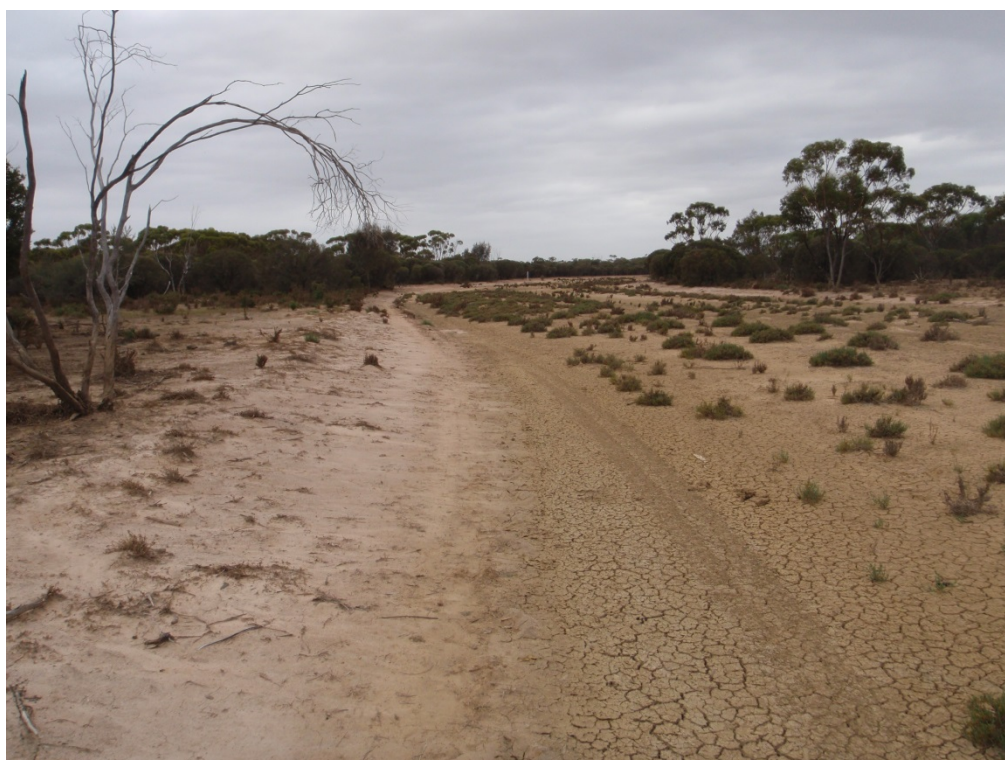
<b>SITE ID</b>	ASWTLB13DUL008
<b>SHORT ID</b>	13DUL008
<b>Site details</b>	Dulbining lake inlet
<b>Sensor</b>	Water level
<b>TYPE</b>	SPE – Radio
<b>Easting</b>	557783
<b>Northing</b>	6359493
<b>Comment:</b>

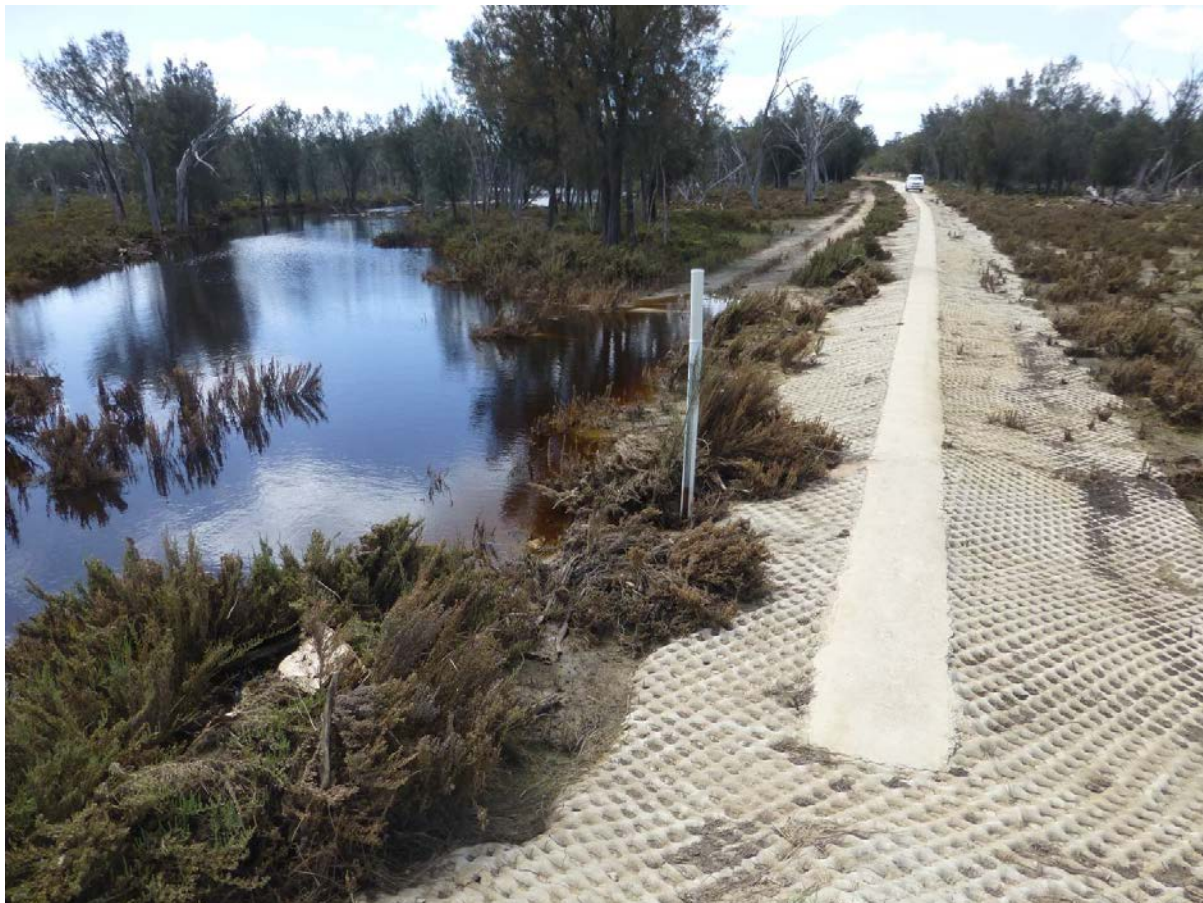
<b>SITE ID</b>	ASWTLB14TIN001
<b>SHORT ID</b>	14TIN001
<b>Site details</b>	Toolibin inflow Upstream
<b>Sensor</b>	Water level
<b>TYPE</b>	SPE – USB
<b>Easting</b>	556779.34
<b>Northing</b>	6358430.34
<b>Comment:</b>

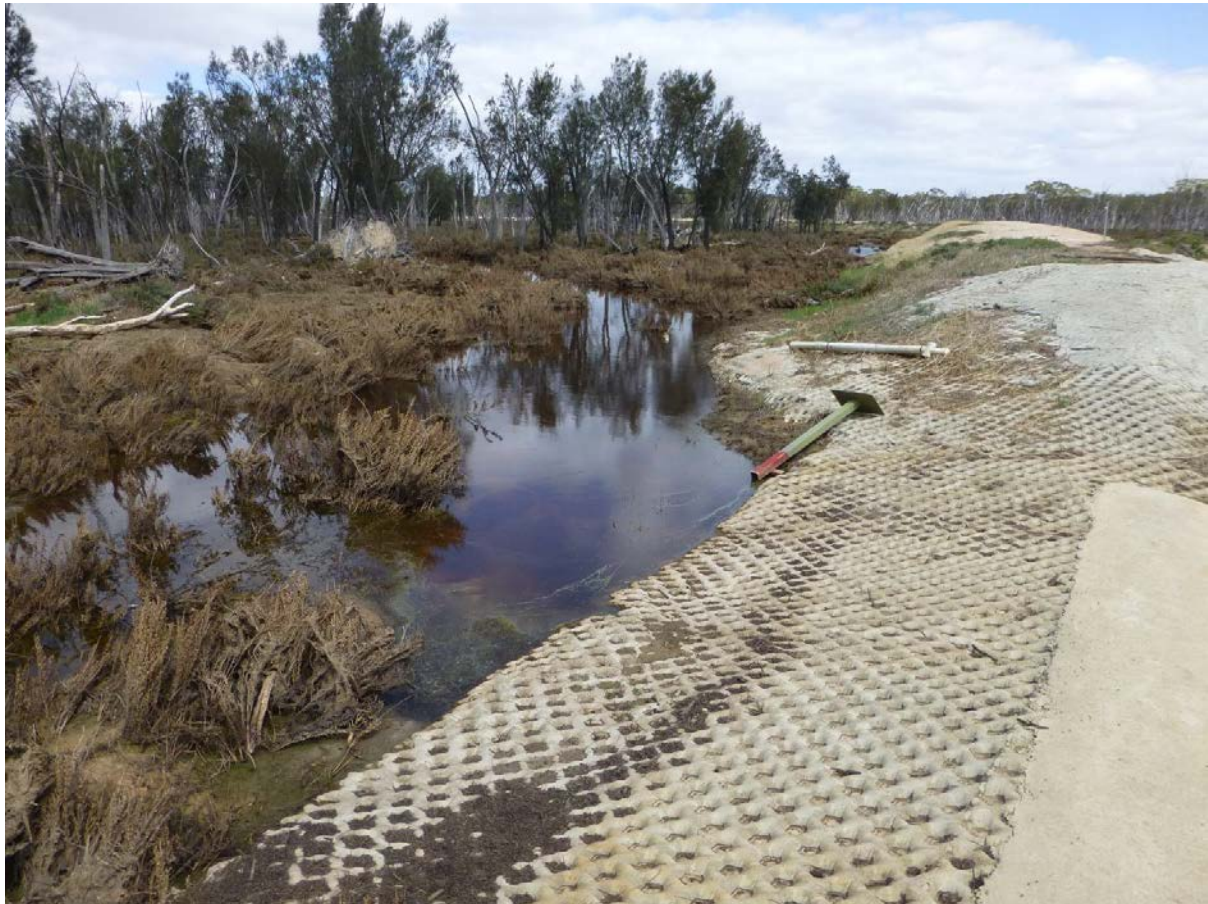
<b>SITE ID</b>	ASWTLB14TIN002
<b>SHORT ID</b>	14TIN002
<b>Site details</b>	Toolibin inflow Downstream
<b>Sensor</b>	Water level
<b>TYPE</b>	SPE – USB
<b>Easting</b>	556777.88
<b>Northing</b>	6358420.81
<b>Comment:</b>

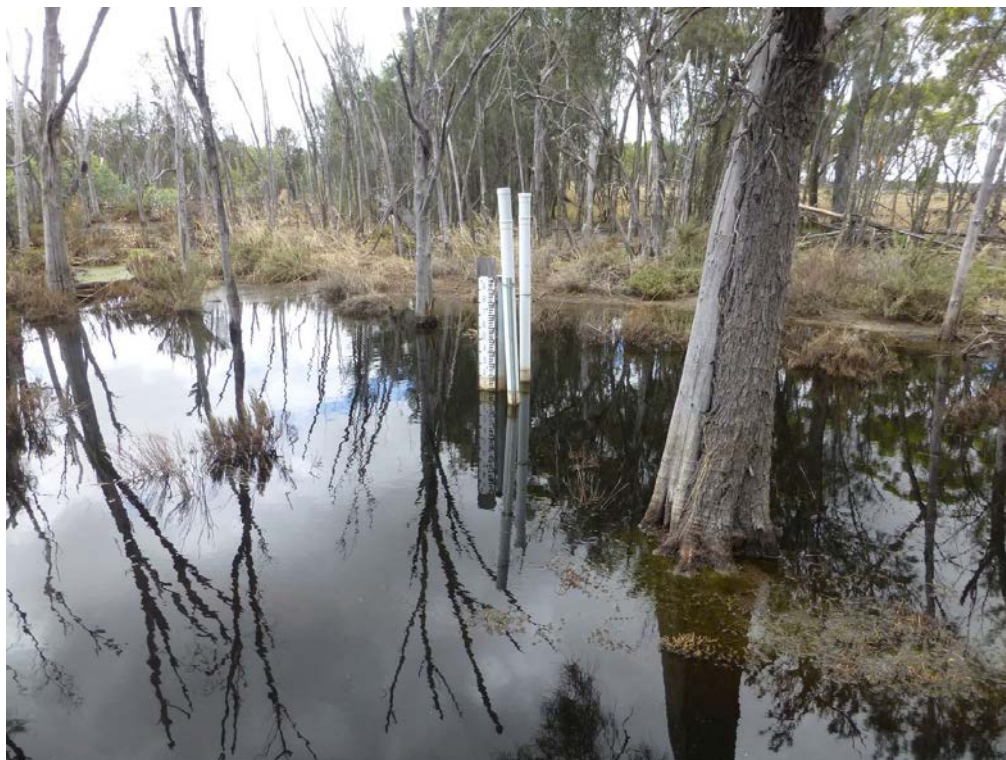
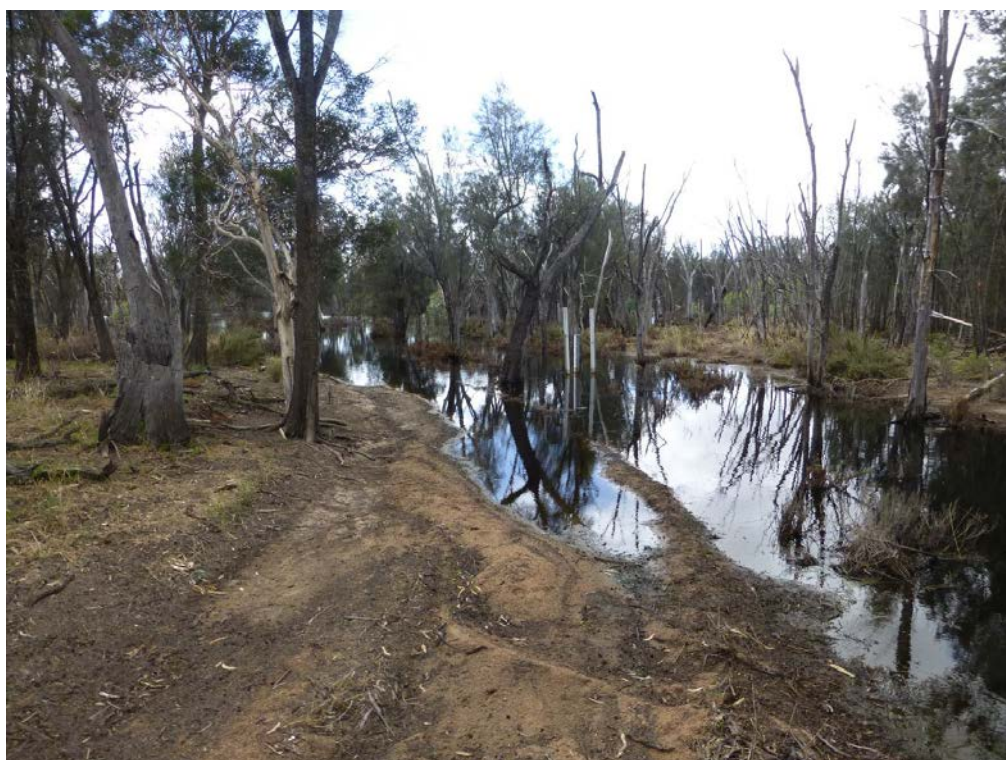
<b>SITE ID</b>	ASWTLB14TOT001
<b>SHORT ID</b>	14TOT001
<b>Site details</b>	Toolibin outlet
<b>Sensor</b>	Water level
<b>TYPE</b>	SPE – USB
<b>Easting</b>	556072
<b>Northing</b>	6356570
<b>Comment:</b>

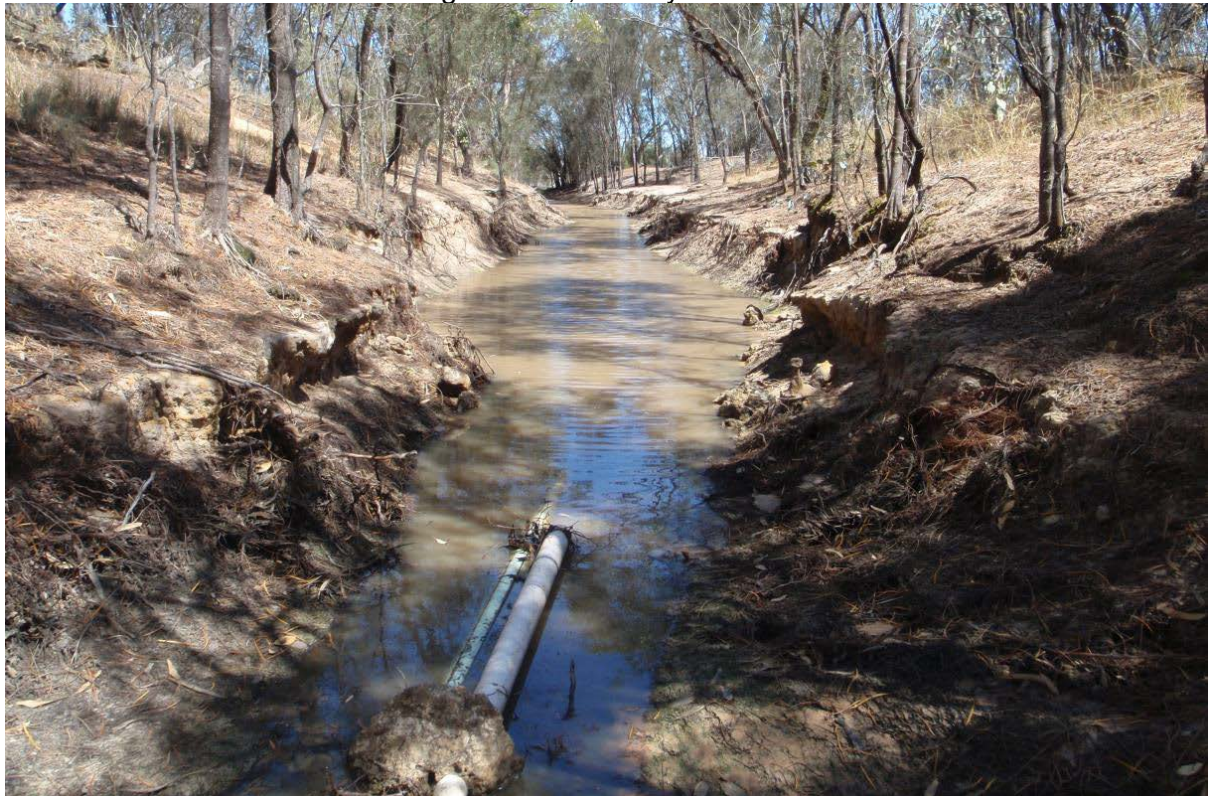
<b>SITE ID</b>	ASWTLB15WAL001
<b>SHORT ID</b>	15WAL001
<b>Site details</b>	Walbyring Inlet
<b>Sensor</b>	Water level
<b>TYPE</b>	SPE – USB
<b>Easting</b>	555745
<b>Northing</b>	6355497
<b>Comment:</b>	Site no longer active, destroyed in December 2012

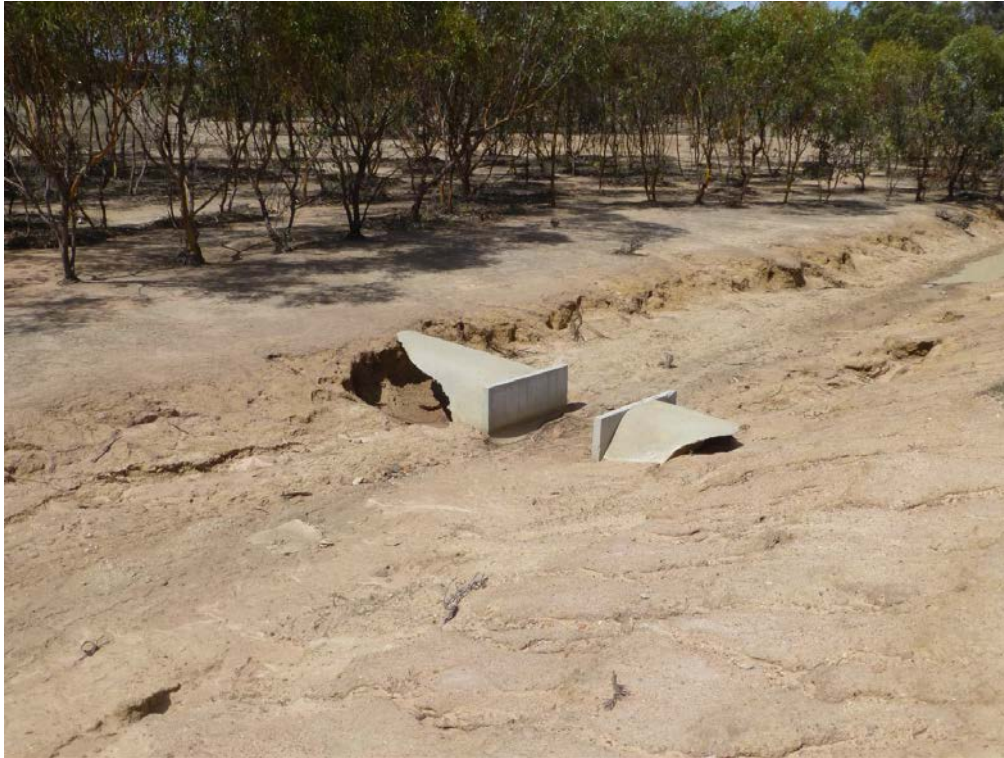
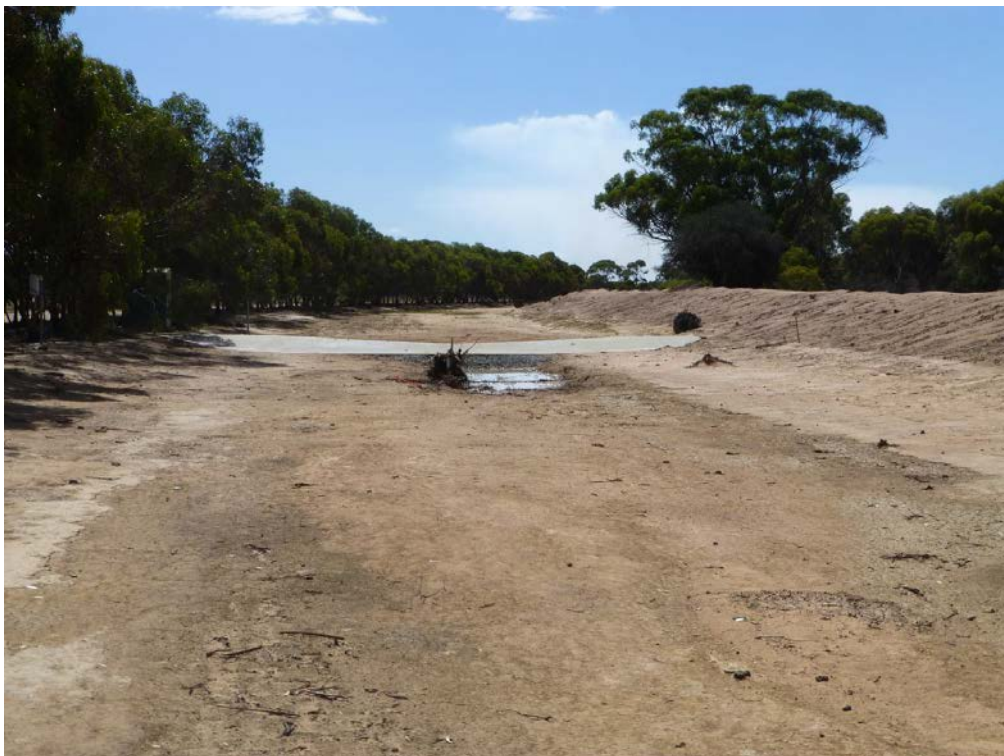
<b>SITE ID</b>	ASWTLB609037EC
<b>SHORT ID</b>	609037EC
<b>Site details</b>	DWER East Drain
<b>Sensor</b>	Water level/EC and temp
<b>TYPE</b>	SPE – USB/Unidata
<b>Easting</b>	559750
<b>Northing</b>	6361200
<b>Comment:</b>

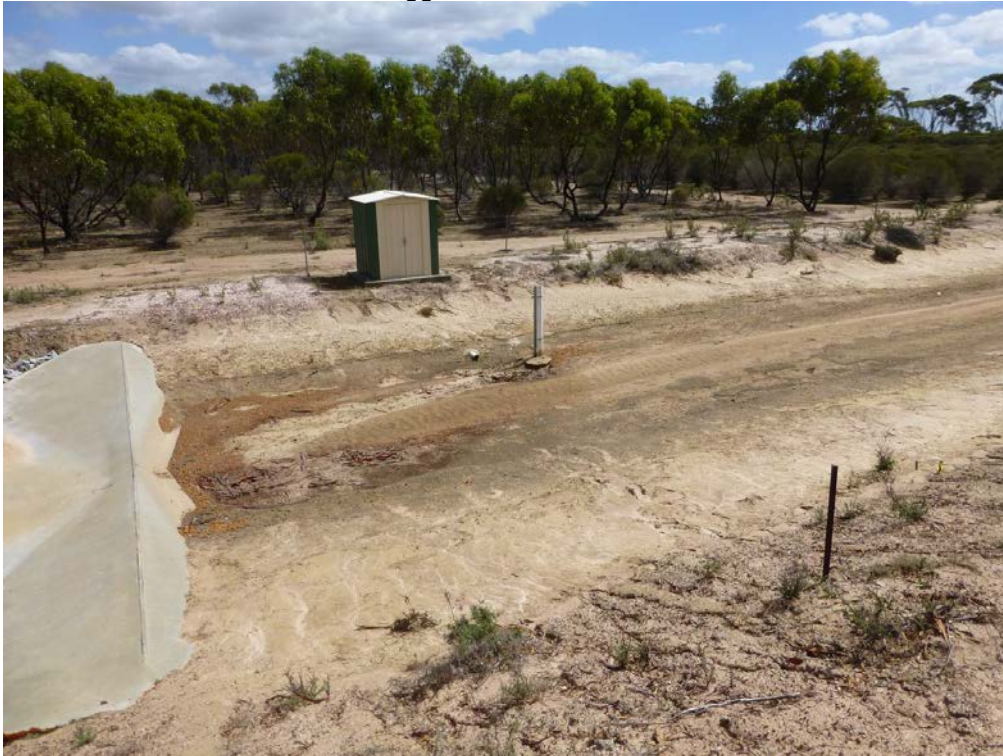
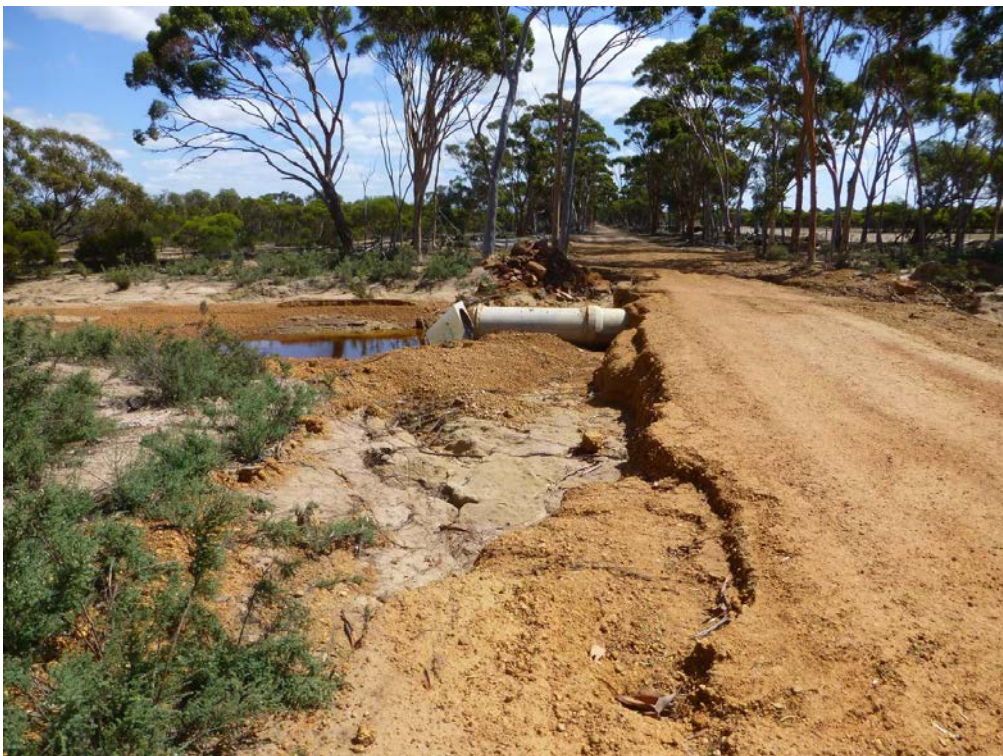
<b>SITE ID</b>	ASWTLB609038EC
<b>SHORT ID</b>	609038EC
<b>Site details</b>	DWER West Drain
<b>Sensor</b>	Water level/EC and temp/Water level
<b>TYPE</b>	SPE – USB/Unidata/Unidata
<b>Easting</b>	558980
<b>Northing</b>	6360670
<b>Comment:</b>	Three different loggers and sensors installed at site.

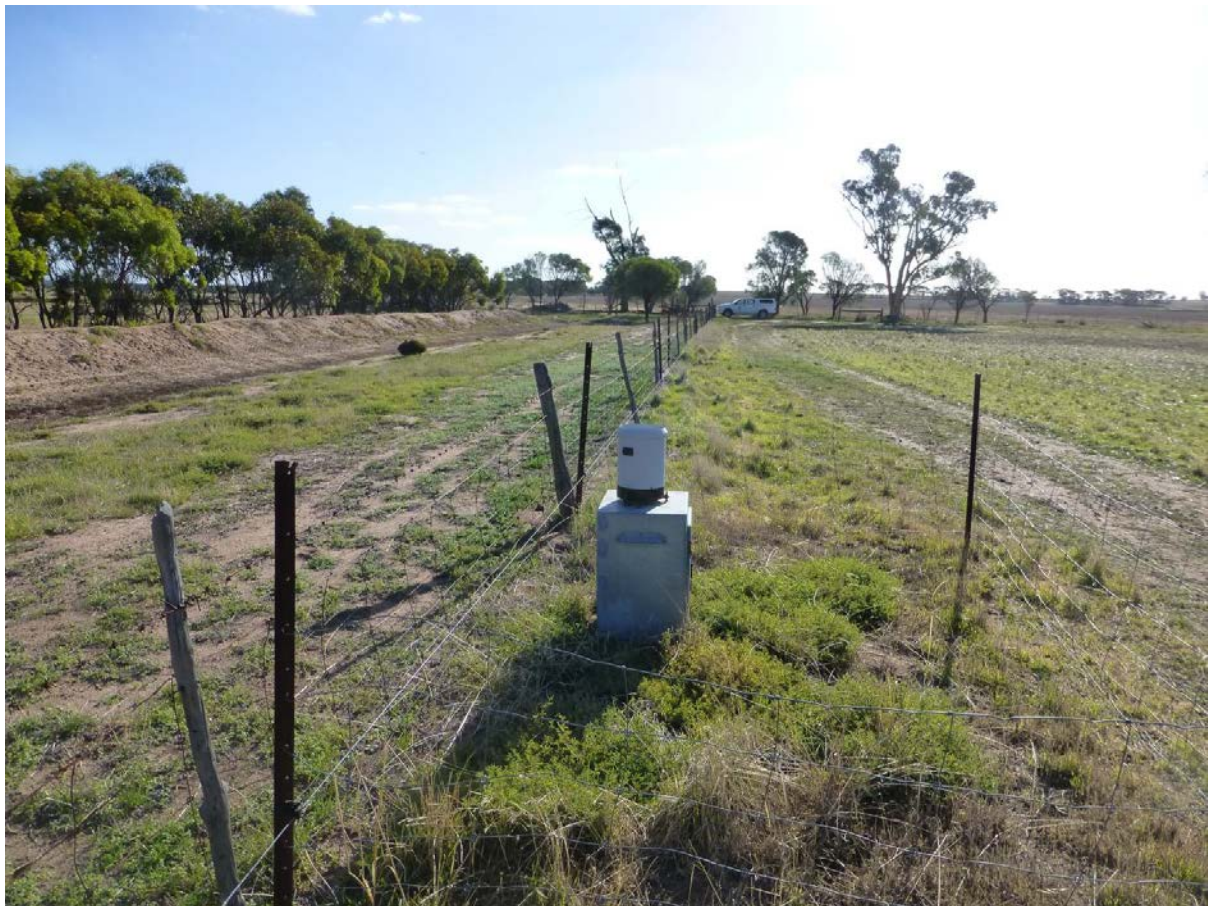
<b>SITE ID</b>	ASWTLBMAR101RG
<b>SHORT ID</b>	MAR101RG
<b>Site details</b>	Toolibin Rain Gauge East (Martins)
<b>Sensor</b>	Rainfall
<b>TYPE</b>	Hydrological Services
<b>Easting</b>	560422
<b>Northing</b>	6368919
<b>Comment:</b>

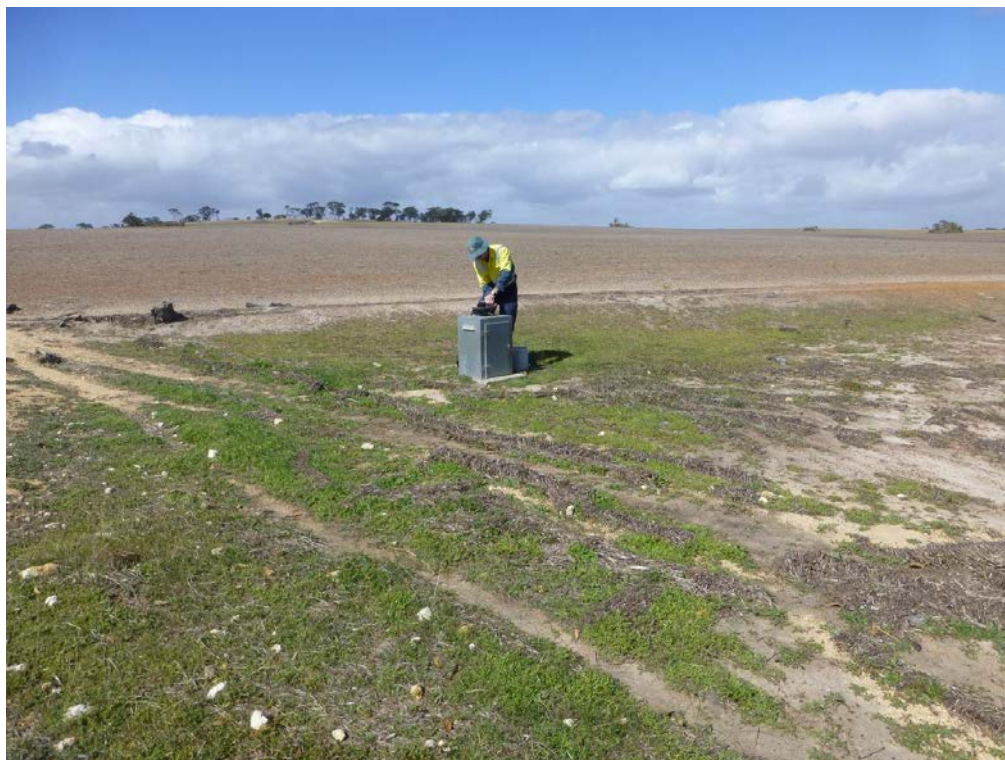
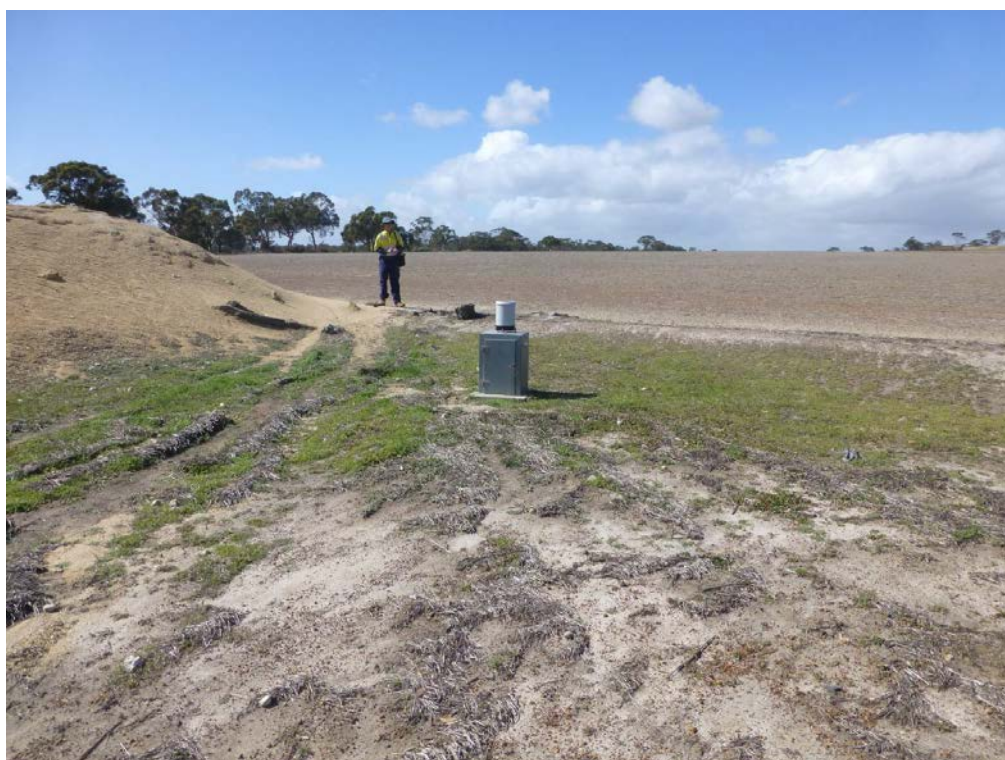
<b>SITE ID</b>	ASWTLBTIL102RG
<b>SHORT ID</b>	TIL102RG
<b>Site details</b>	Toolibin Rain Gauge West (Tilbrooks)
<b>Sensor</b>	Rainfall
<b>TYPE</b>	Hydrological Services
<b>Easting</b>	547778
<b>Northing</b>	6366835
<b>Comment:</b>
