**Penguin Island South Beach Rehabilitation  
Environmental Referral Document**

**November 2005**

Report No. 422/3

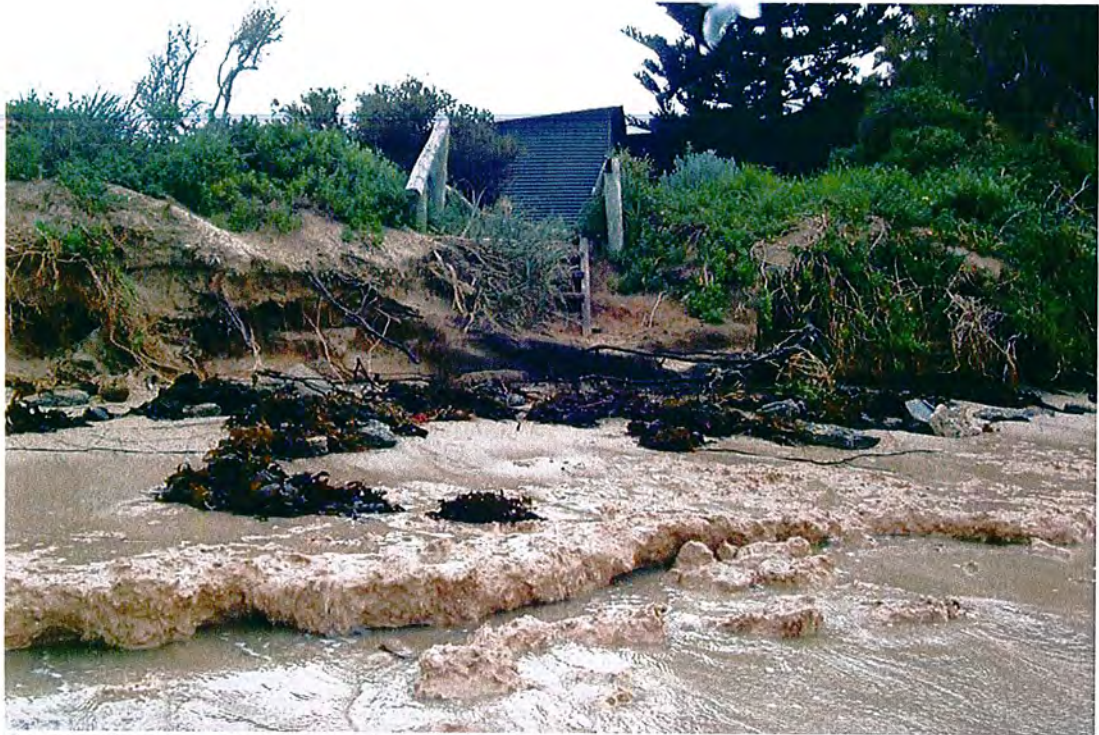
**Figure 1.4 Storm Damage to South Beach, winter 1996**

Progressive erosion on South Beach has been observed for decades. Observations by CALM personnel indicate that the erosion of South Beach is highly intermittent and is typically associated with severe winter storm events concurrent with high water levels. Recent storms, including 1996 and 2003, have caused considerable erosion of the shoreline and some damage to infrastructure (Figure 1.4). The current shoreline position is now such that any further erosion to South Beach could result in damage to the research and CALM rangers facilities (Figure 1.5).

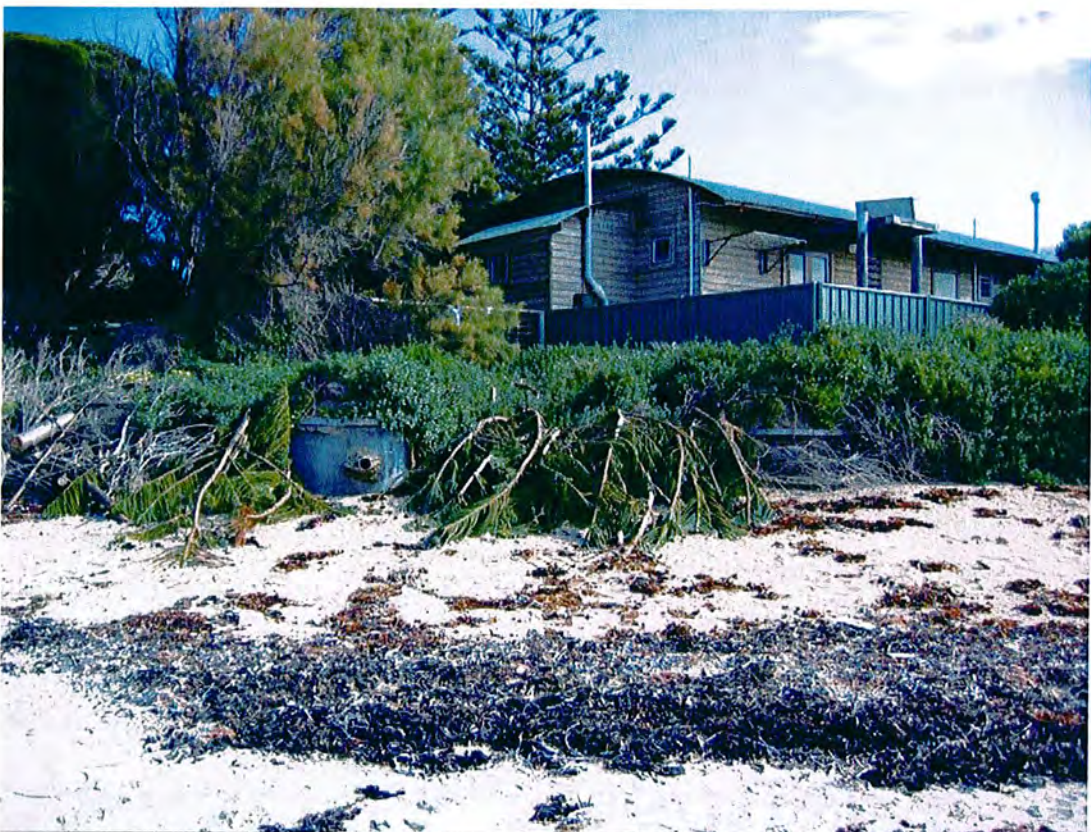
**Figure 1.5 CALM facilities on the shoreline of South Beach, September 2004**

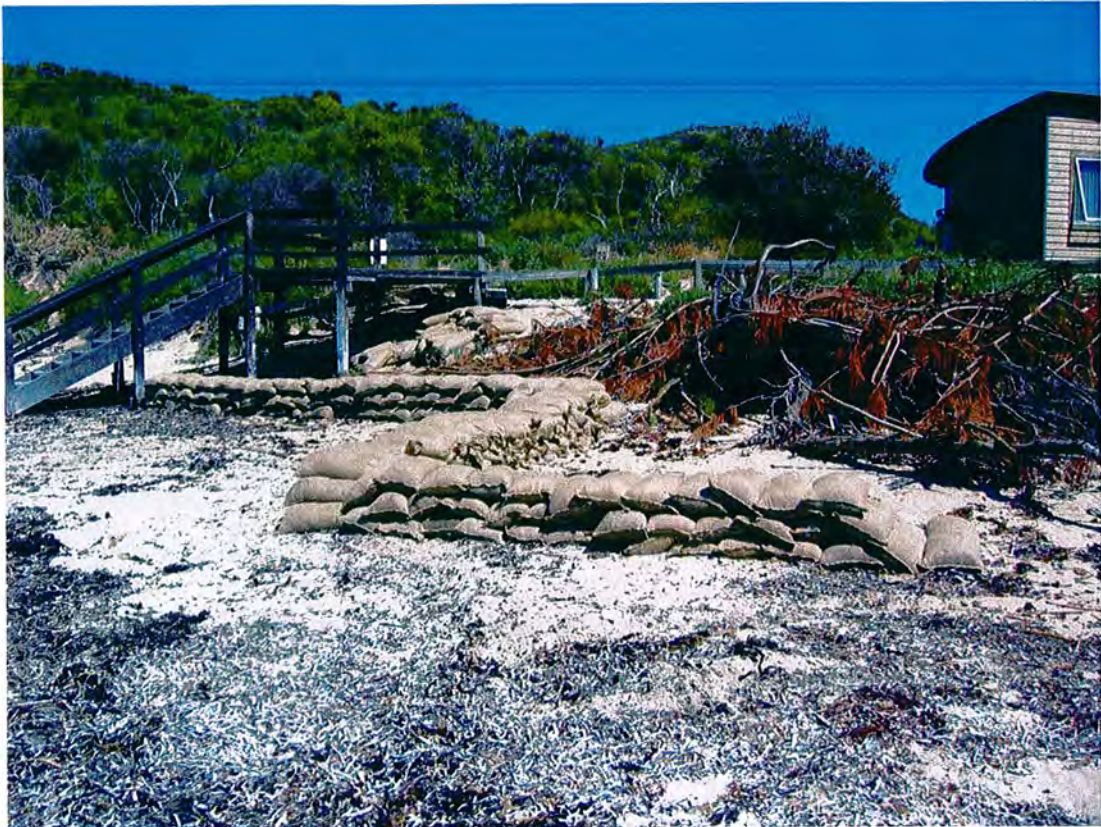
**Figure 1.6 Sandbagging and brushing on South Beach, September 2004**

Historically, shoreline erosion of South Beach has been managed through the construction of a small limestone groyne<sup>1</sup> at the eastern end of South Beach in 1968, but this became rapidly degraded and no longer provides effective protection to South Beach. More recently, CALM have deployed sand bags (Figure 1.6) and undertaken minor sediment redistribution operations to manage shoreline erosion of South Beach. In response to a request from CALM, comments on the current interim rehabilitation works (sandbagging and brushing) being used on South Beach are provided in Appendix A.

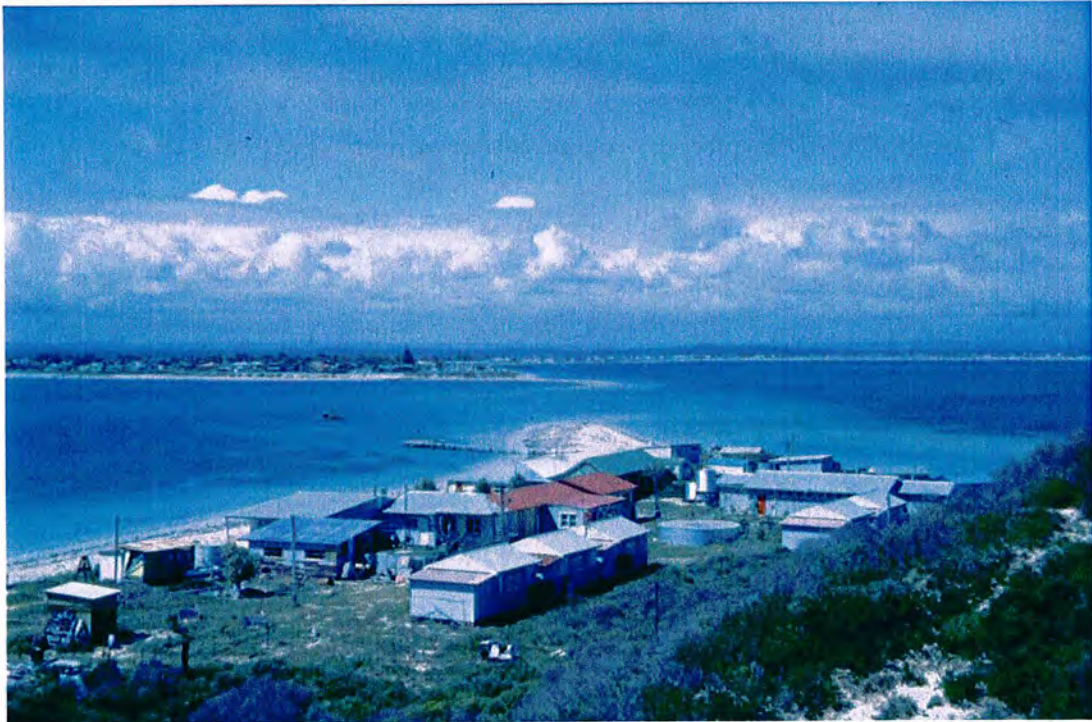
**Figure 2.2** Infrastructure on Penguin Island during the late 1980's

Source: Department of Conservation and Land Management 1988/1989

The series of old huts and buildings (Figure 2.2) were removed by CALM during 1989–1990, during which time several white goods (stoves, fridges etc) were found along the shoreline of South Beach and appeared to have been placed as shore protection works (Peter Dans, 01 November, 2004, pers. comm.). A new manager's residence, the WMC Research and Management Centre and the Penguin Island Discovery Centre were built in 1996 (Figure 2.3). November 1999 saw the completion of the new jetty which was the last stage of the six year development plan for Penguin Island.

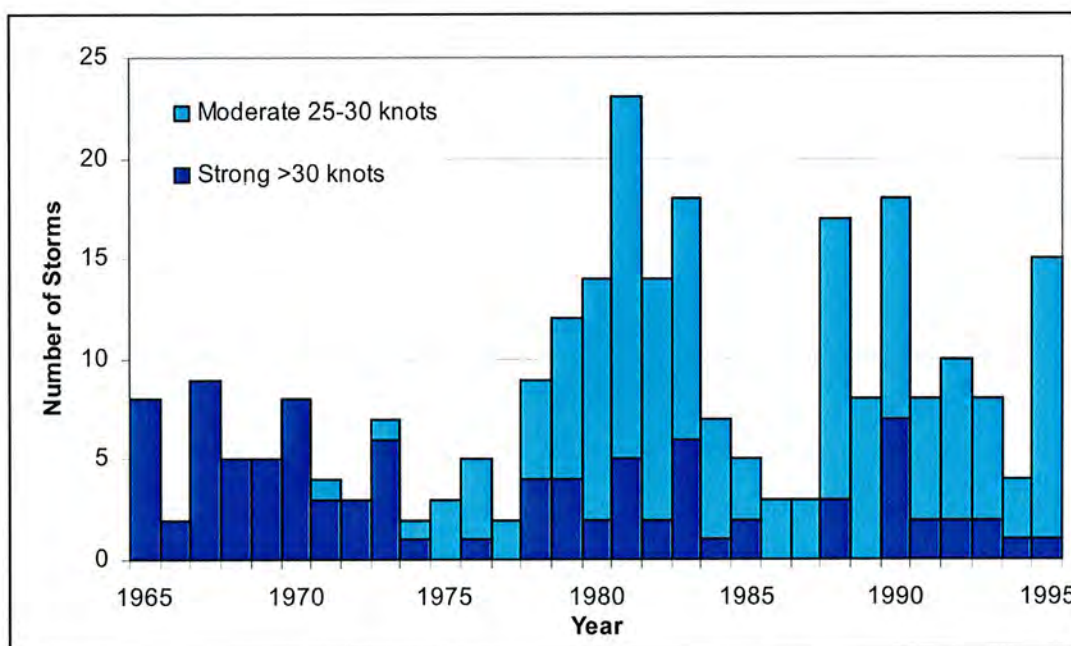
**Figure 3.8** Frequency count of moderate and strong 9 am winds recorded at Rottneest Island, 1965-1995

To identify periods of storm activity, wind databases from Rottneest and Fremantle were analysed (Figure 3.8). Historical wind records from Rottneest were observed at 9 am and 3 pm from 1965 to 1995, before installation of an automatic weather station. Dominance of the sea breeze at 3 pm prevents the meaningful use of this data for estimating storm events. The 9 am data provides a more clear distinction between storm and non-storm conditions, although it must be noted that a single daily observation is likely to miss the peak wind speed and can not be used for subtle comparison of wind speeds between events. The count of annual storm events is shown in Figure 3.8, indicating high levels of inter-annual variability.

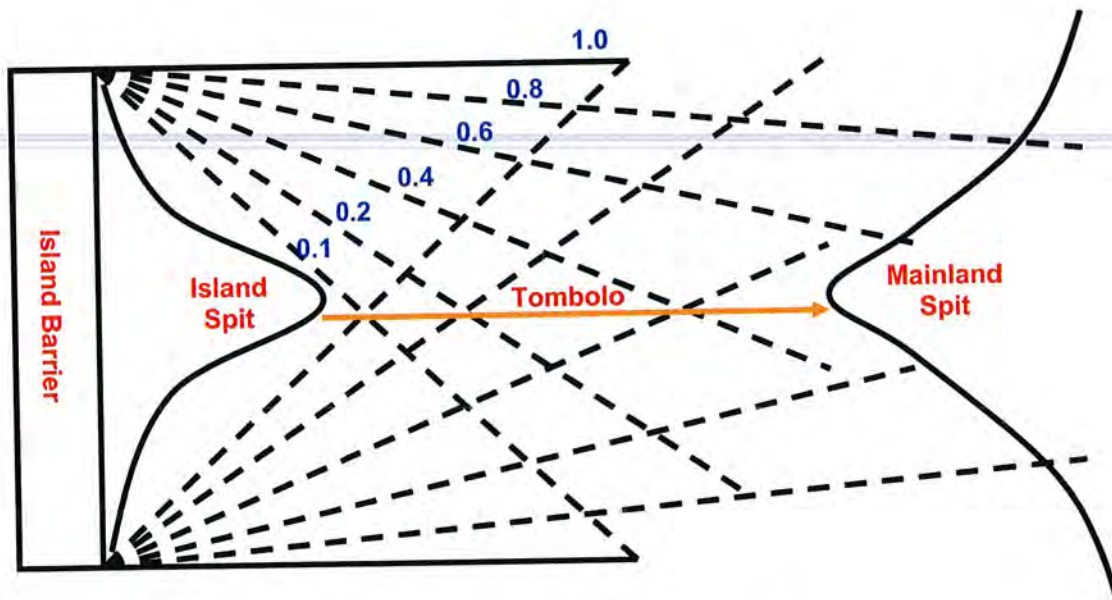
Figure 4.2 Changes in wave direction due to offshore barriers

An equilibrium model for salient formation is described by Hsu & Silvester (1996). Salients are lobate features occurring in the lee of islands or reefs. A tombolo is an 'advanced' salient, such that the shore feature connects with the island. The model of Hsu & Silvester (1996) is essentially driven by the refraction pattern of waves passing around either side of an island. In addition to damping, waves are bent, approximately in a radial pattern. The change in direction encourages shoreline curvature from either side, producing a characteristic lobate feature (Figure 4.2). In a similar manner, the wave damping pattern encourages deposition on the leeside shore of the island. For an island that is close to shore or sufficiently large, the 'shadow' may connect to the landmass, in which case a tombolo is formed, such as present at Penguin Island.

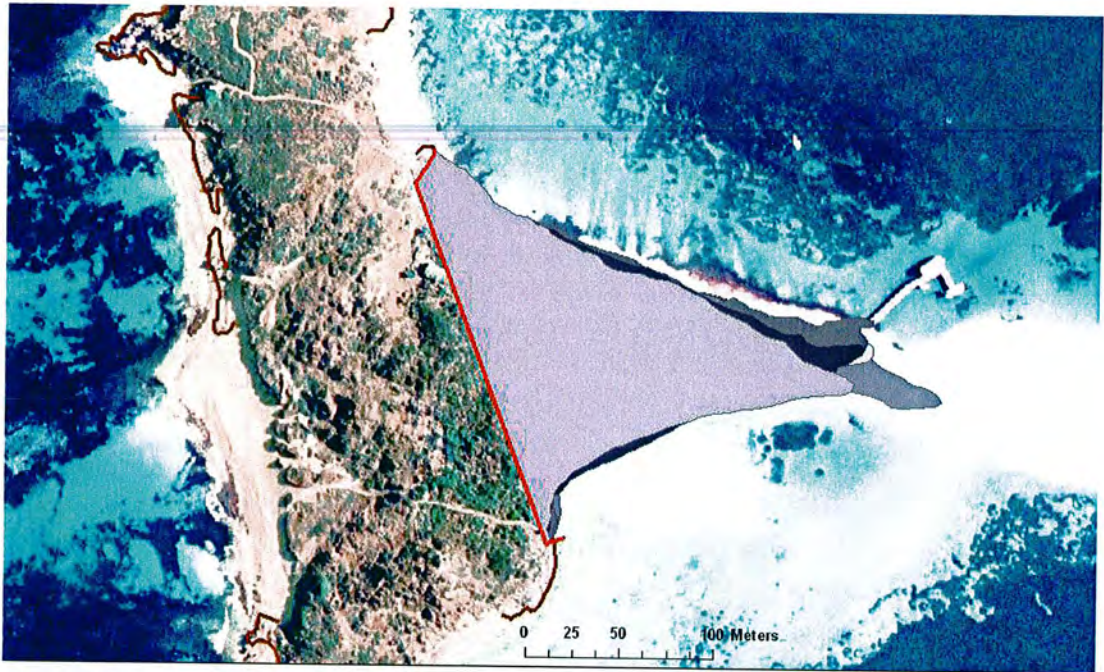
**Figure 5.2** Definition of spit area on Penguin Island

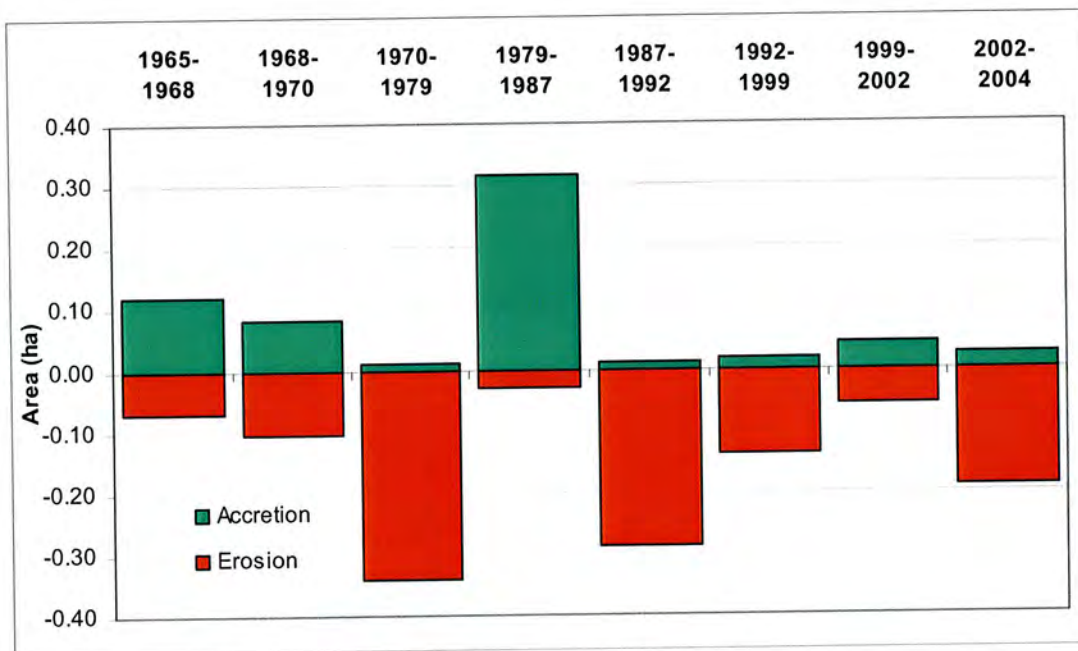
**Figure 5.5 Erosion and accretion between 1964 and 2004**

- An overall area loss of 0.59 ha between 1965 and 2004—corresponds to an average annual rate of area loss of 152 m<sup>2</sup>/year (Figure 5.3);
- An overall trend of decreasing area of the spit zone since 1965 (significant trend,  $r^2 = 0.78$ ) (Figure 5.4);
- The greatest periods of net erosion are from 1970 to 1979 (0.33 ha) and 1987 to 1992 (0.27 ha) (Figure 5.5).
- The only periods of net accretion noted in this data set are from 1965 to 1968 (0.05 ha) and 1979 to 1987 (0.29 ha) (Figure 5.5);

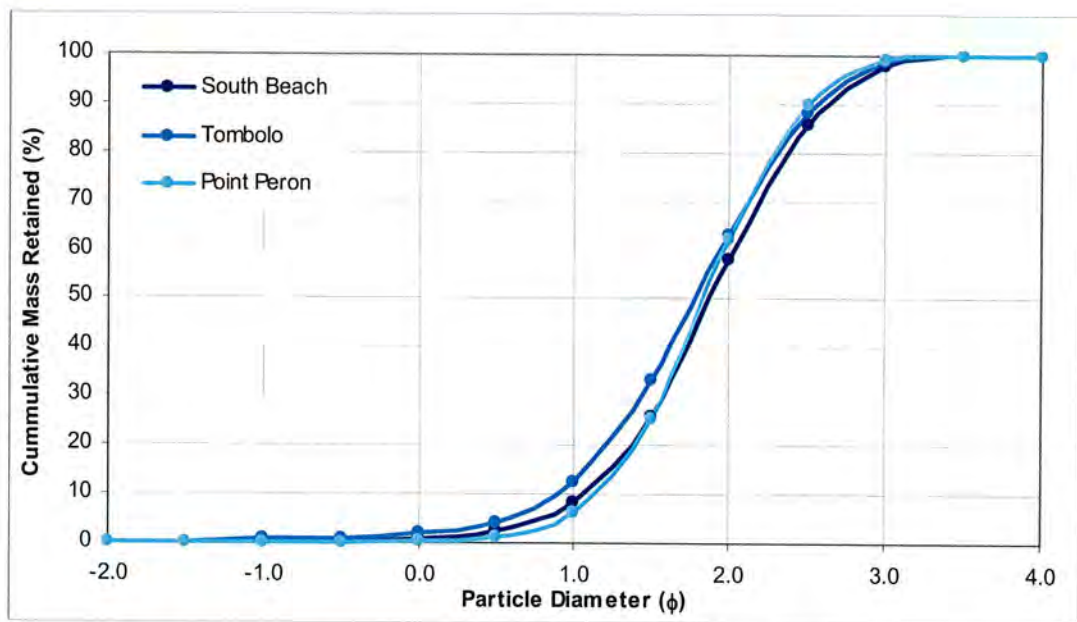
**Figure 9.2** Average particle size distribution of the sediment cores collected from South Beach, the tombolo and Point Peron

However, the average particle size distribution for each of the sites suggests that the sediment from the tombolo appears to be slightly coarser than that of either South Beach or Point Peron (Figure 9.2).

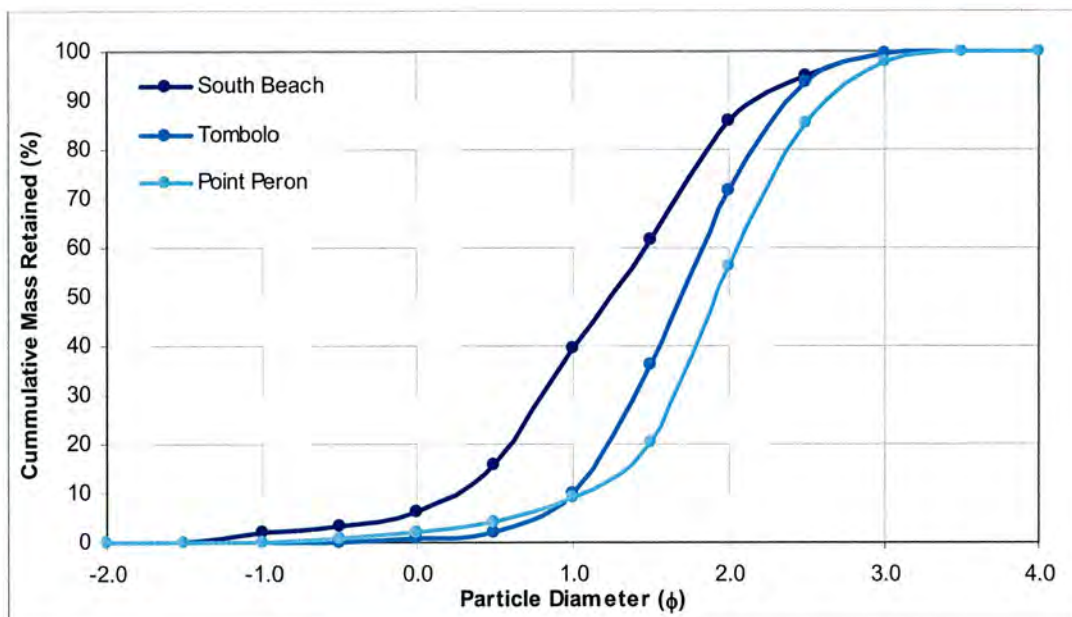
**Figure 3.1 Particle size distribution of grab samples taken at South Beach, tombolo and Point Peron**

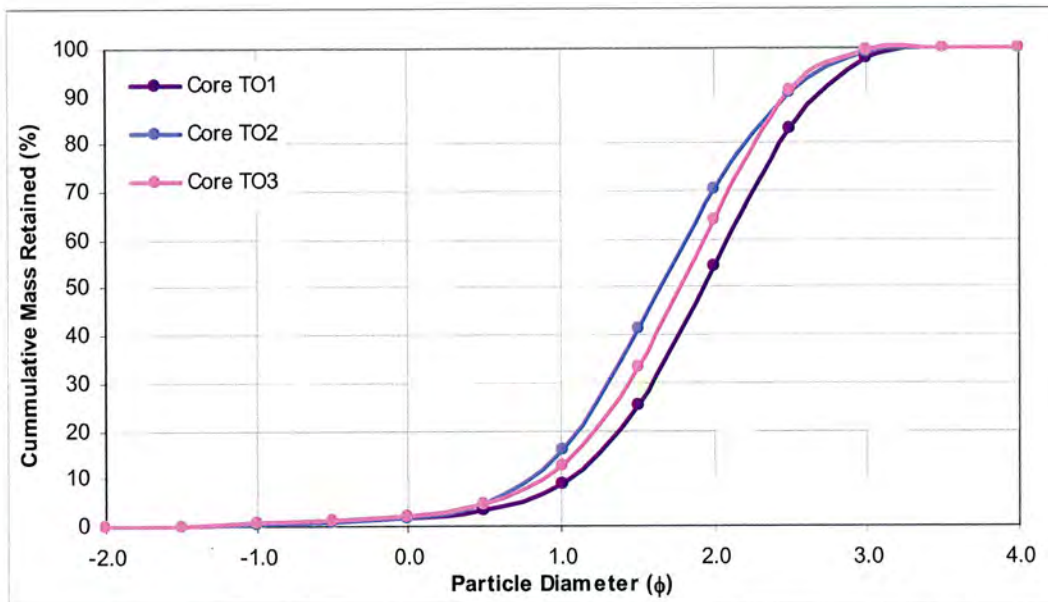
**Figure 3.3** Particle size distribution of the sediment samples taken across the tombolo joining Penguin Island to Mersey Point

There was a high natural variability in sediment grain size at each of the locations sampled (Figure 3.2 to Figure 3.4). At each site, the results from all three cores were averaged before overfill and renourishment factors were calculated (Section 3.4). The average particle size distribution of each of the sites shows that the sediment from the tombolo appears to be slightly coarser than the other two sites (Figure 3.5).

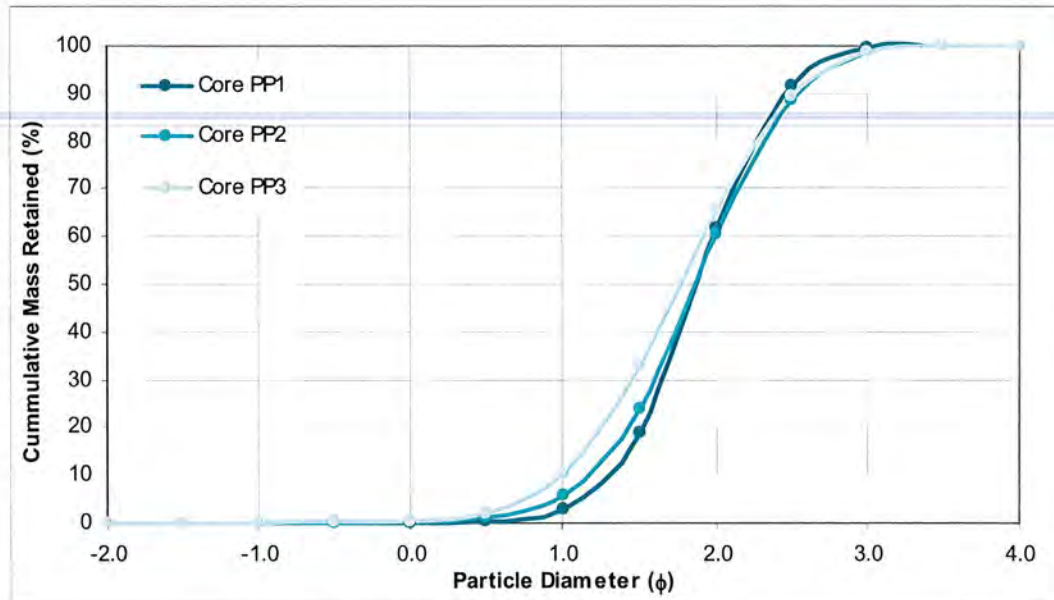
Figure 3.4 Particle size distribution of the sediment samples taken at Point Peron

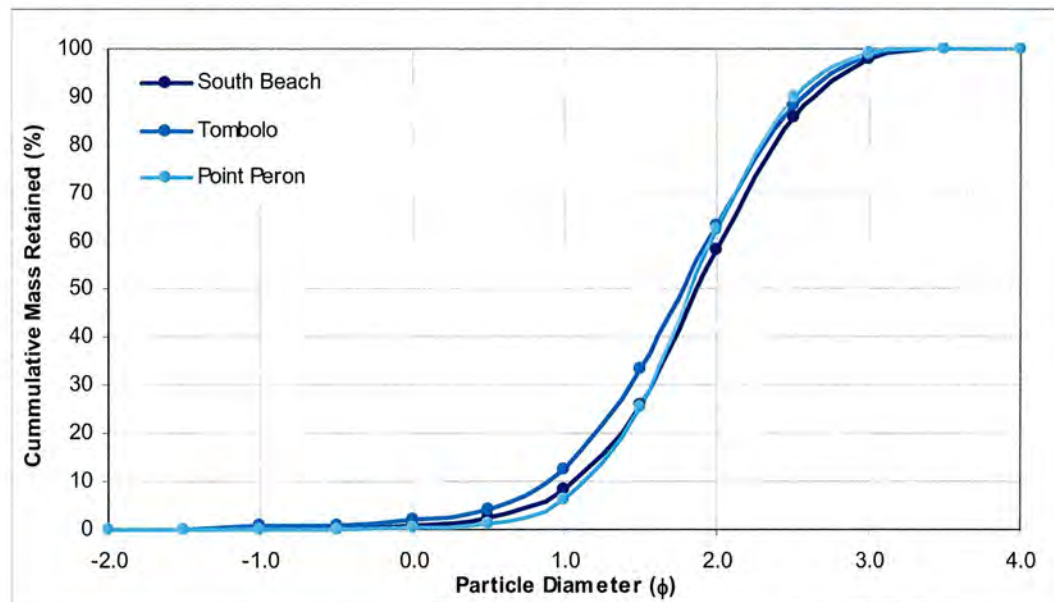
Figure 3.5 Particle size distribution of the average of core samples taken at South Beach, the tombolo and Point Peron
