# Swan Canning River Recovery Project Three

## Sediment Control at Cygnia Cove, Waterford Stakeholder Summary Report

**Bronwyn Scallan, Sediment Project Manager, Perth NRM**

March 2024

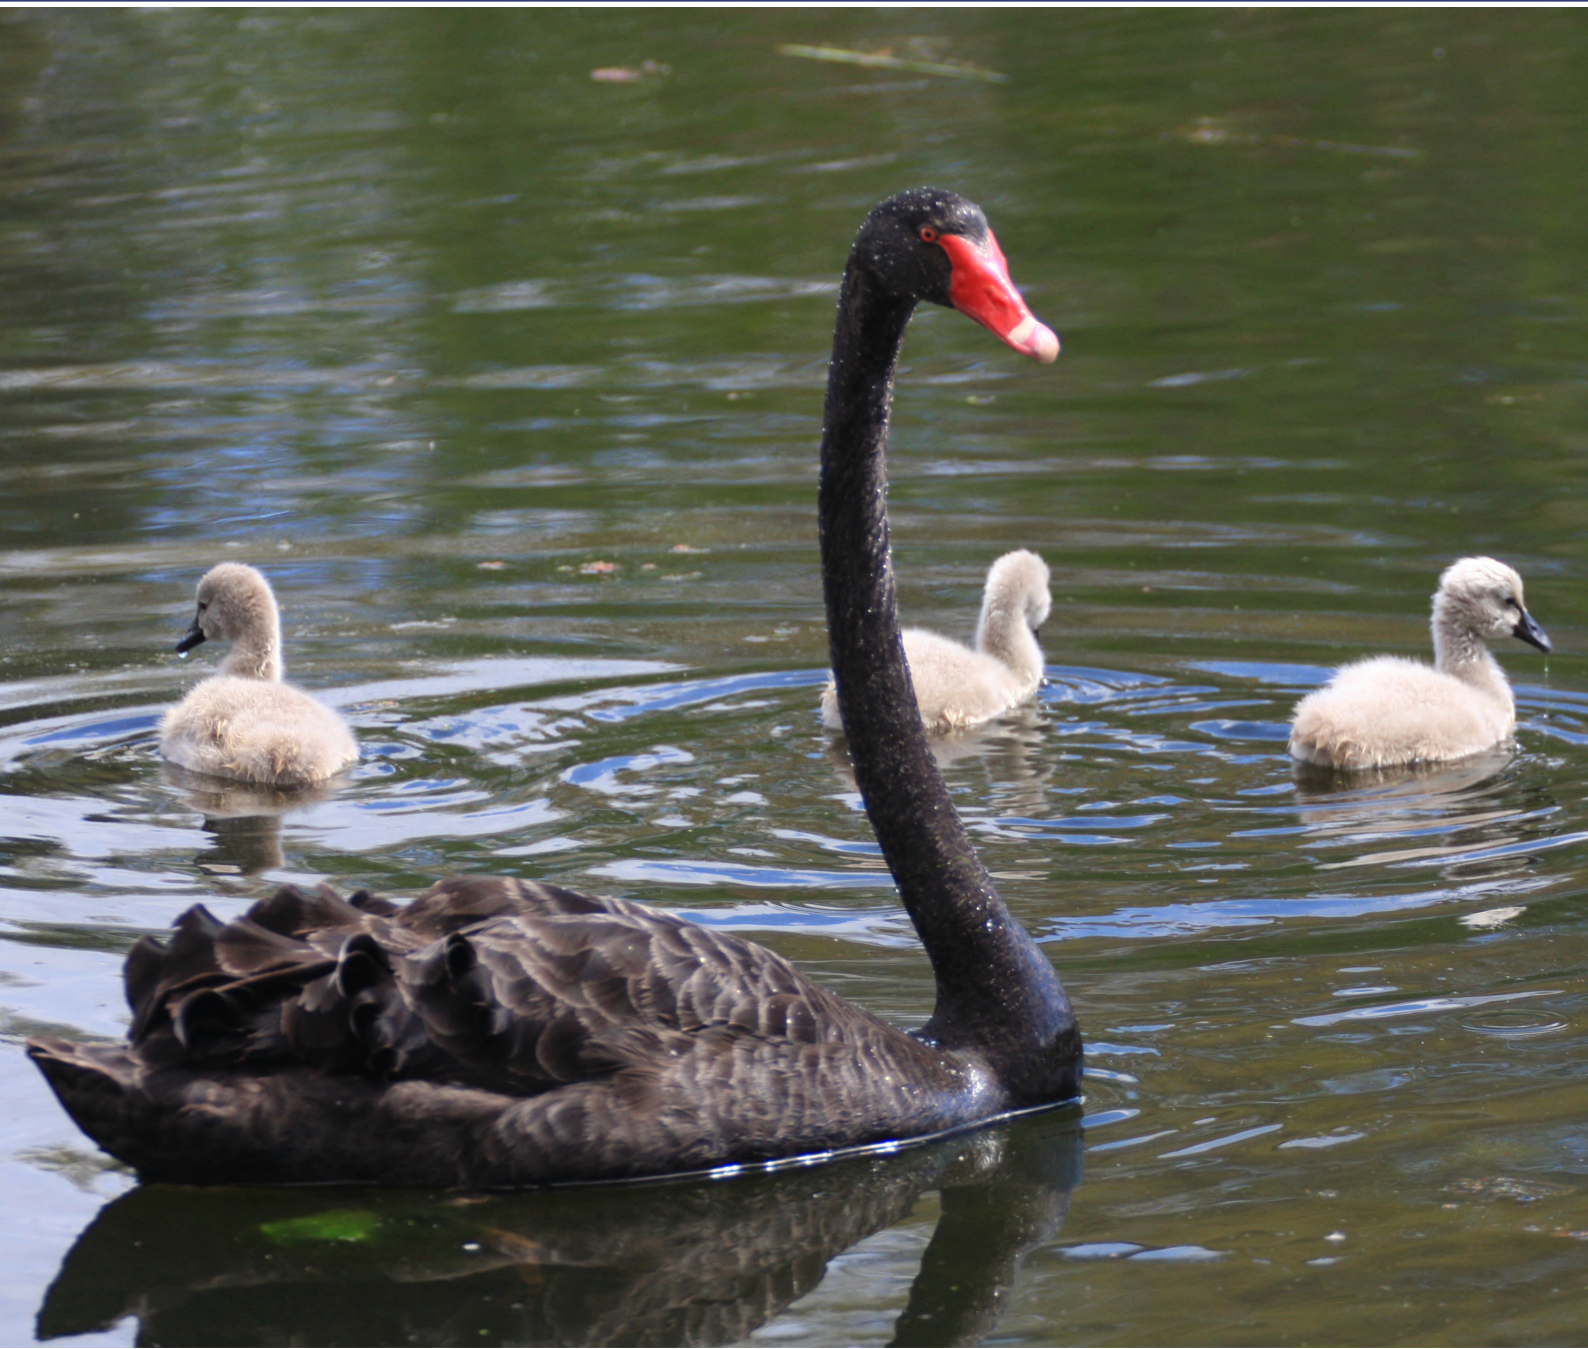
*Figure 1: Accumulation of builders sand in the Cygnia Cove constructed wetland (after passing through the Gross Pollutant Trap).*

*Figure 2: Sediment-laden water overflows a rock drain at Cygnia Cove estate after a storm event, discharging into Cygnia Cove wetland reserve.*

*Figure 3: Sedimentation upstream of the pedestrian bridge, where water flows from the retained wetland into the connecting channel.*

*Figure 4: Sedimentation downstream of the pedestrian bridge, where water flows from the retained wetland into the connecting channel.*

*Figures 5 & 6: Sedimentation of Cygnia Cove's connecting channel, prior to draining into the Canning River.*

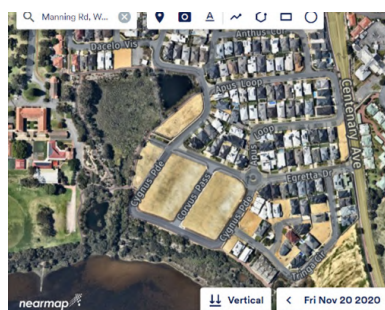
Figure 11: Cygnia Cove Project area at project commencement 20 November 2020  
Source: Nearmaps

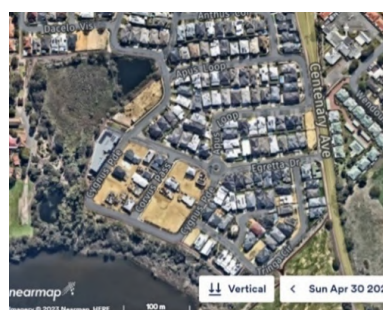
Figure 12: Cygnia Cove Project Area 30 April 2023 Source: Nearmaps

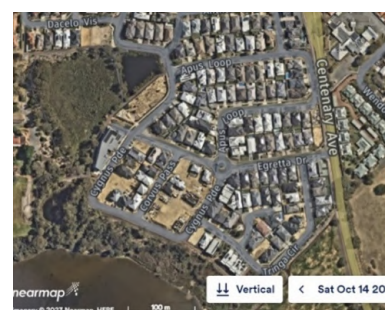
Figure 13: Cygnia Cove Project Area 14 October 2023 (post project).  
Source: Nearmaps

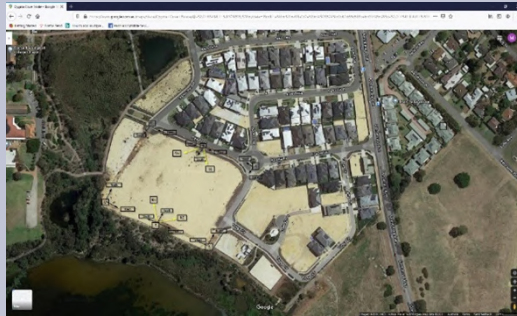
<p><i>Figure 23: DBCA Photopoint Monitoring Map 2021. (Also refer to Figure 81).</i></p>
Investigated use of corers to take sediment samples at wetland 'outlet drain/outfall' just before entering the Canning River to determine building sand composition.	DBCA	Nil	\$160	Sought university student to undertake this work in voluntary capacity. Due to time consuming sampling protocols and regulations to undertake sampling in the streambed, limited resourcing and no confirmed commitment by the student, no further action was possible.

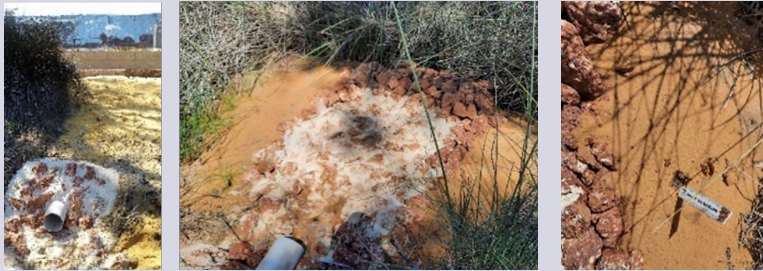
</div> <p><b>Figures 29-31:</b>  <i>LHS View of rock drain from the wetland (looking south) 17.03.2022.</i>  <i>Mid: Sediment evident around drain and dispersed within sedges.</i>  <i>RHS: 25 litres of imported builders sand covered sedges adjacent to right hand side of the rock drain. (Average depth of builders sand was 1cm).</i>  <i>(Note that some sediment present may be due to pipe construction).</i></p> <div data-bbox="1312 845 1720 1155">   </div> <p><b>Figure 32:</b> All sediment and builders sand had dispersed from the rock drain prior to 20.10.2022 (within six months).</p>

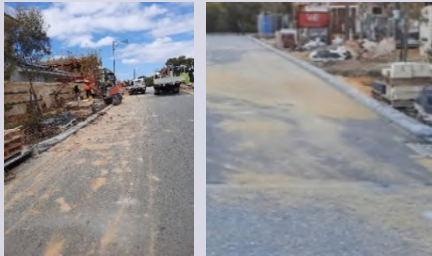
<p><b>Figures 42-43:</b> An example of poor sand management during garden landscaping at one site in Corvus Pass. 0.31m<sup>3</sup> (0.46 tonne of sand) measured during one random site visit.</p>
Provided Richard Noble & Company staff with Sediment Task Force Information Sheets targeted at land developers and the Summary of Economic Costs of Sediment Loss from Construction Sites report.	N/A	N/A	N/A	Positive feedback received and of interest to staff.

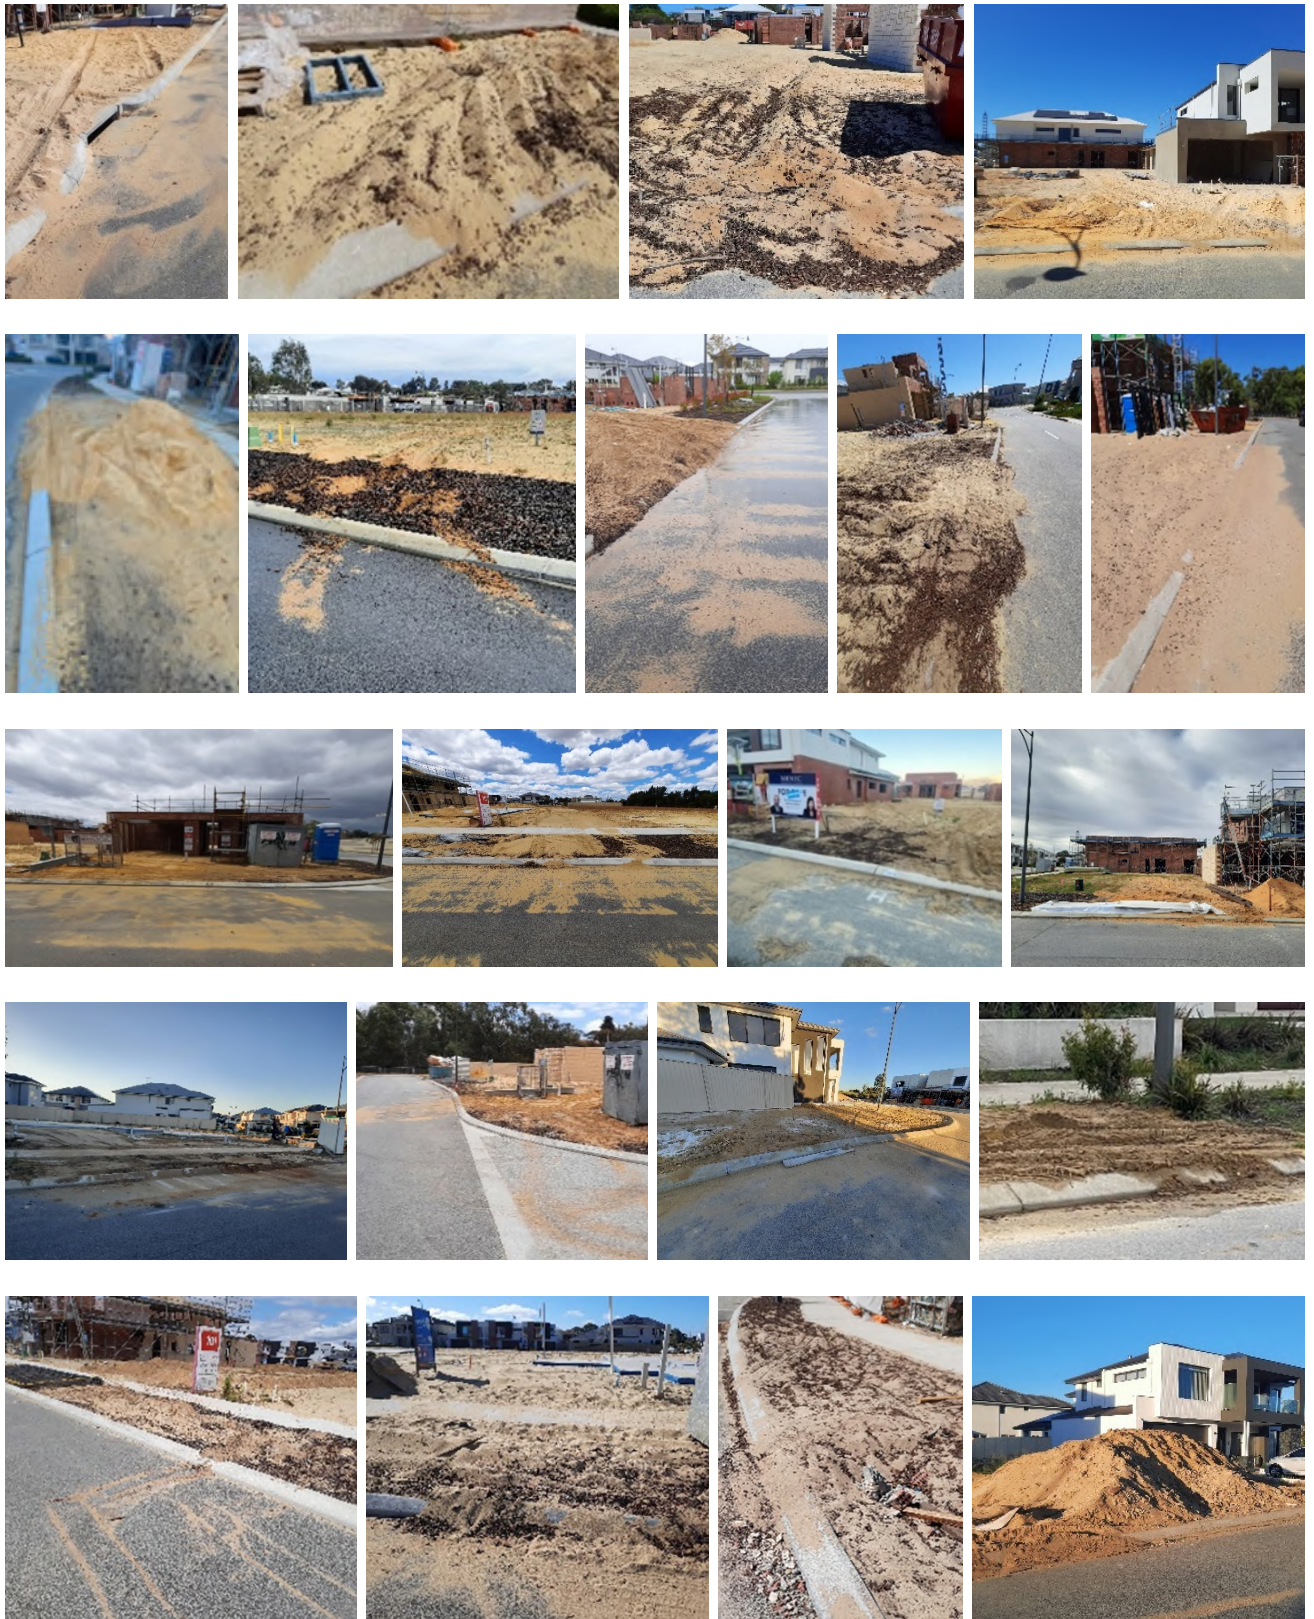
**Examples of vehicular tracking by earthmoving machinery and vehicles**

**Figures 49-78:** Additional photographs of poor sediment management practices commonly observed at the Cygnia Cove Land Development Project Site (various dates over the period early 2021-mid 2023).

Further recommended measures for builders/trades are to: restrict vehicular parking on verges and vacant lots; unload equipment onto the road; carry equipment onto site; park vehicle off vacant lots/sites; ensure earth moving machinery contractors visiting site are well informed of their requirement to clean sand up off road and replace it on site before leaving site; and to consider bulk bag sand delivery (with the Keeping Soil on Site stencil on every bag to raise awareness).

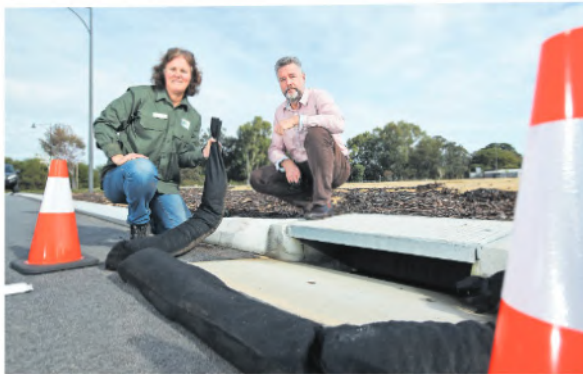
Perth NRM project officer Bronwyn Scallan and CEO Keith Pekin at one of the sites trialling silt control 'sausages'. Picture: David Baylis

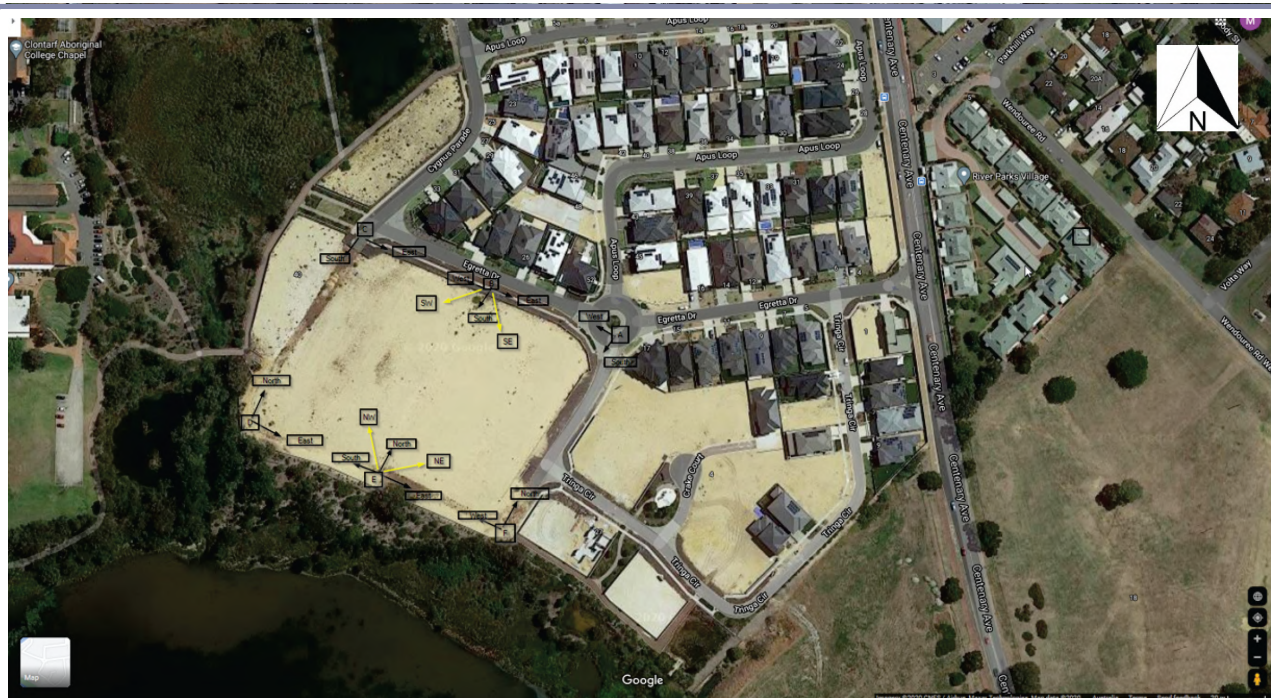
Figure 81: Cygnia Cove PhotoPoint Monitoring Program Map (DBCA 2020)

**SCRR3 Cygnia Cove Photo Monitoring Points.**  
(GoogleMaps).

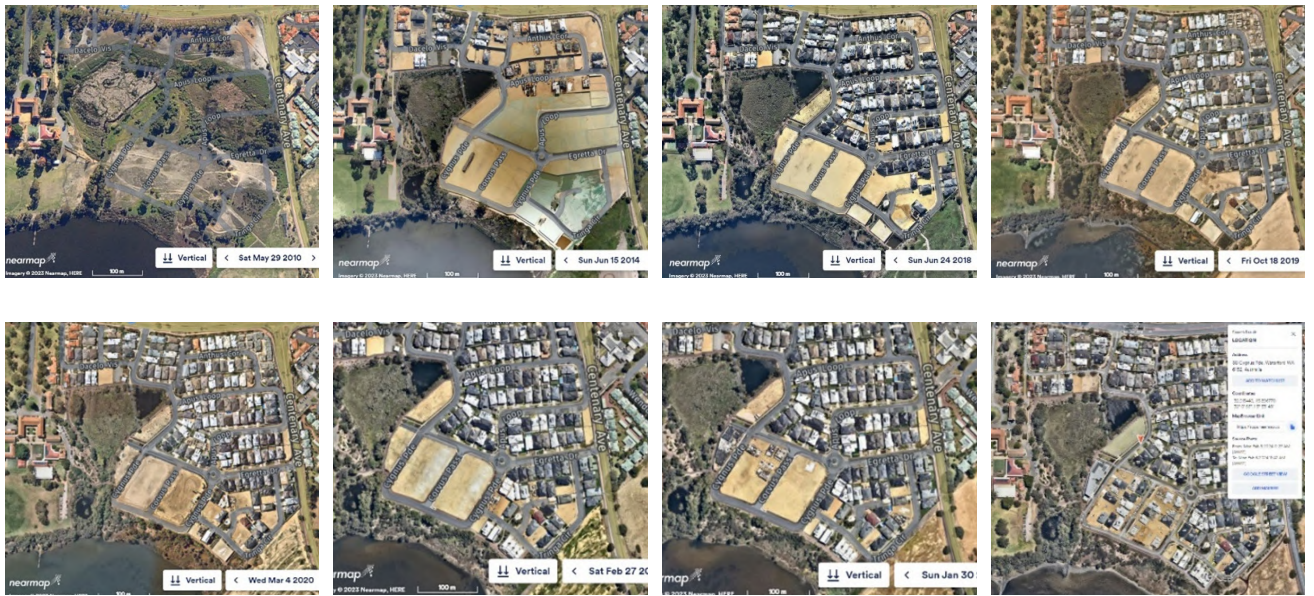
**Figures 89-96:** Photo montage of Cygnia Cove subdivision and lot development (pre, during and post study 02.05.2024) (Source: Nearmaps).
