Maylands

Maylands – facts and figures

Changes in nutrient concentrations over time in Maylands Main Drain

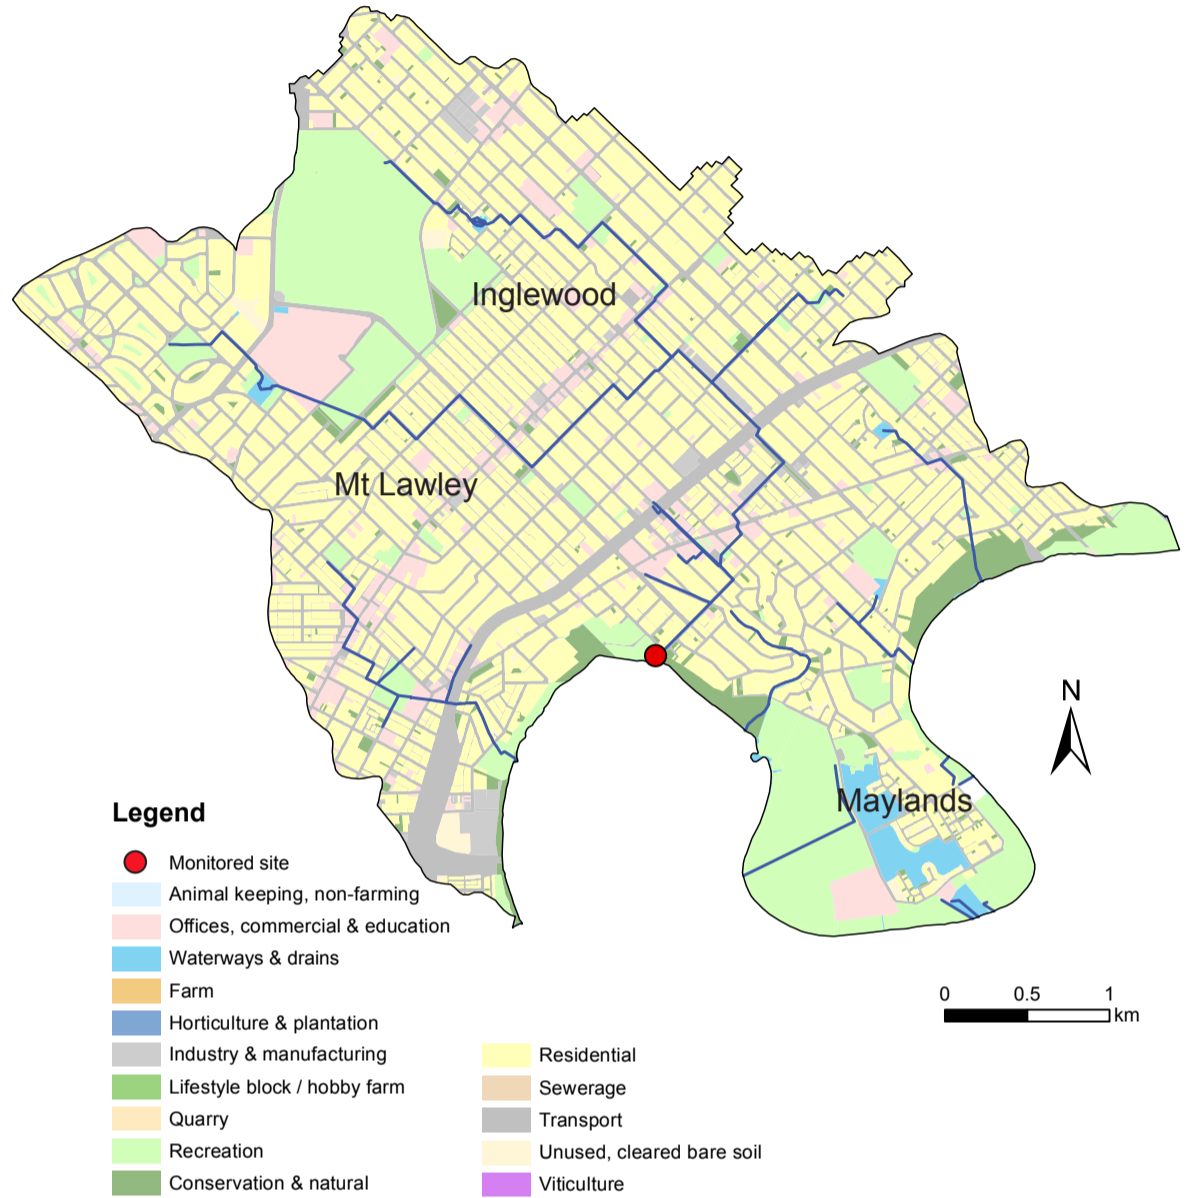
Water quality is monitored fortnightly at the outlet of the Maylands Main Drain to the Middle Swan Estuary near the Maylands Yacht Club. Because the sites is so close to the estuary it is only possible to sample when the flow from the drain is sufficient to remove any estuarine backflow. This means that while the drain appears to flow-year round it can only be sampled during winter, when drain flows are high. The site is positioned to indicate nutrient concentrations leaving the catchment and flowing into the Middle Swan Estuary, so the data may not represent nutrient concentrations in upstream areas, or in other drains in the catchment.

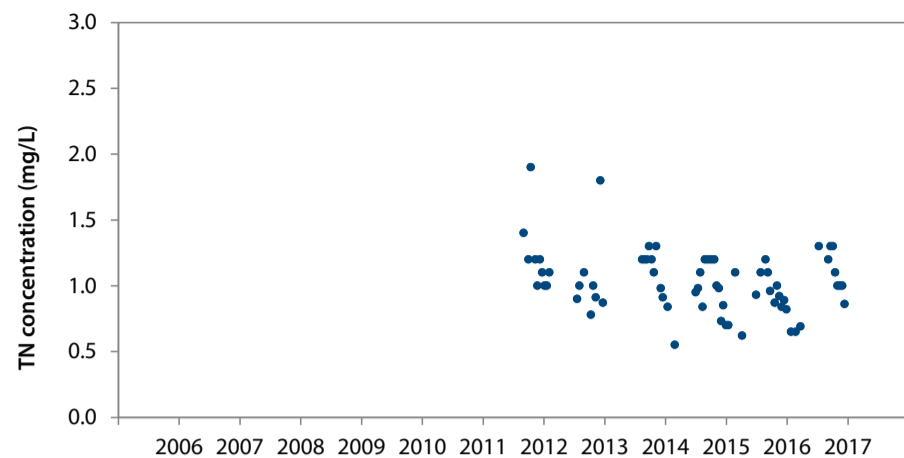
Total nitrogen concentrations over the 2006 to 2016 monitoring period

Total nitrogen (TN) concentrations appeared higher in 2011 than subsequent years. The exact reason for this is unclear but it may be linked to the higher than normal rainfall that year. No trends were detected.

Maylands Main Drain has been passing the short-term but failing the long-term TN target since monitoring commenced.

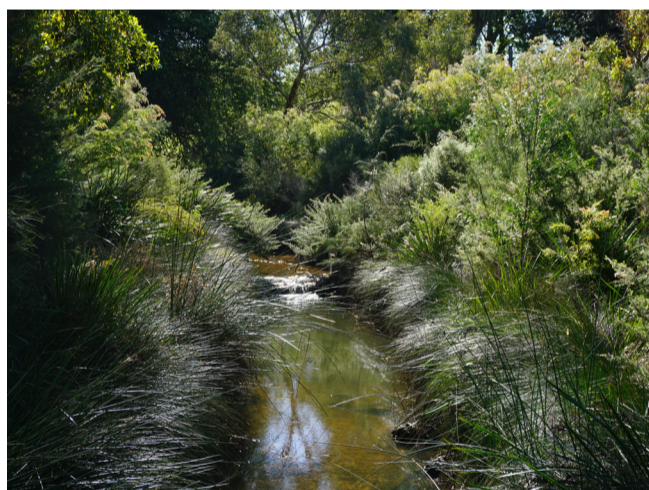
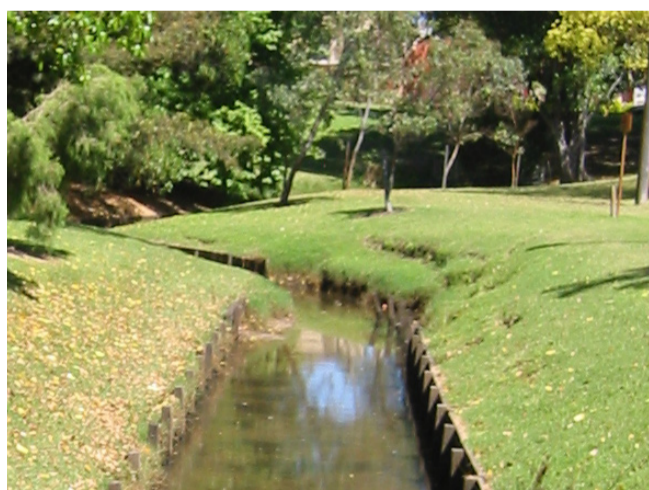
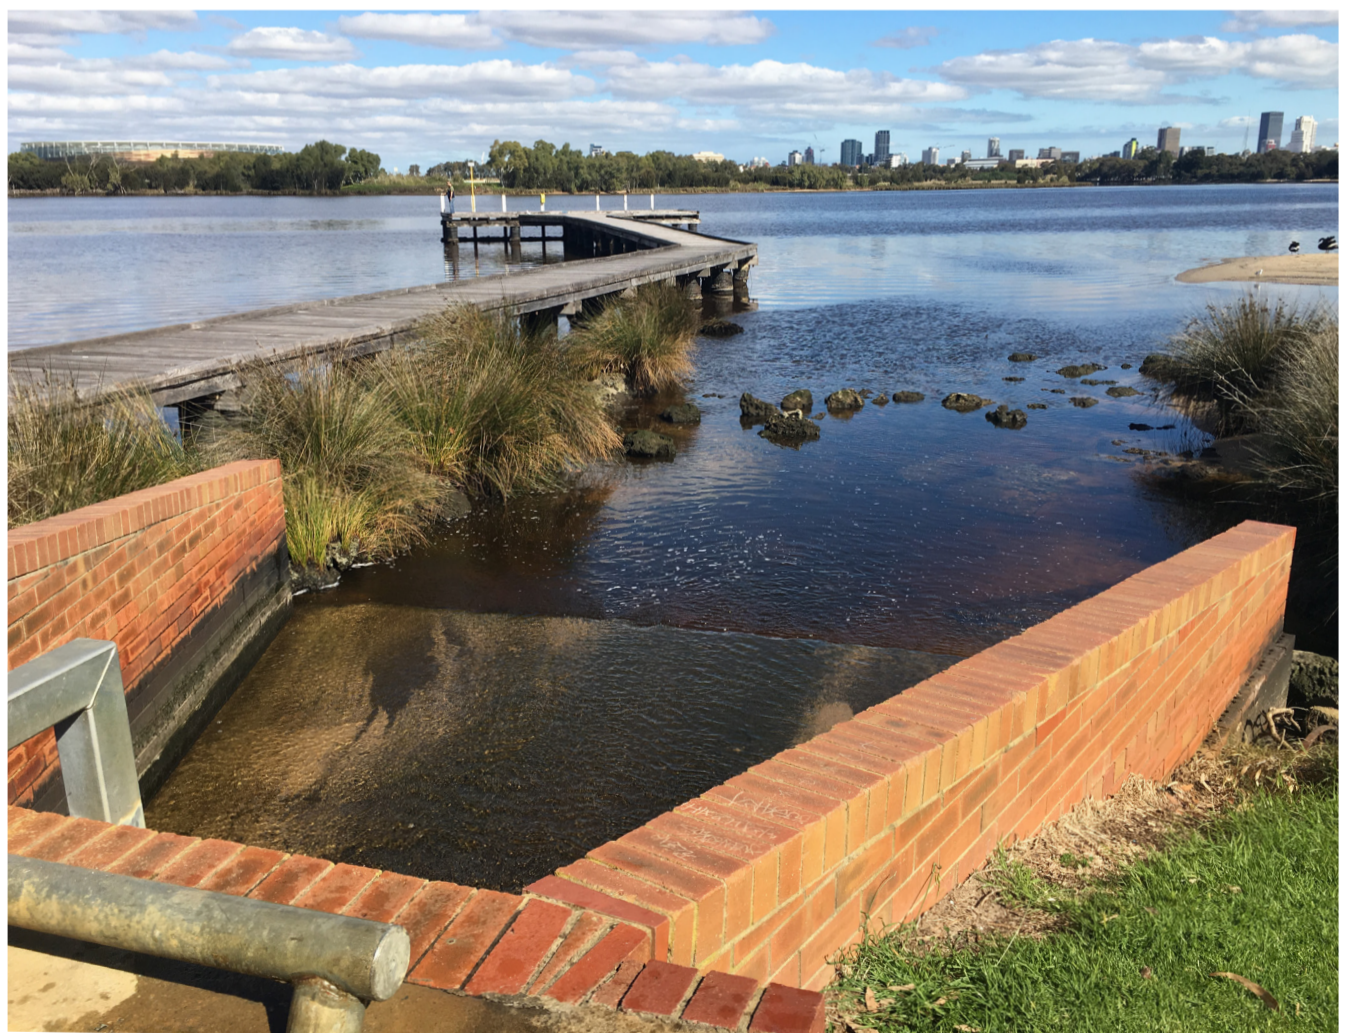
Photographs of Maylands catchment: (Top left) Walters Brook, photograph taken at the same point as the photograph below, post restoration, October 2017. (Bottom left) Walters Brook, shortly before it discharges to the Swan River, prior to restoration works. November 2005. (Right) Looking over the Maylands Main Drain sampling site, out to the Swan River, August 2017.

- The restoration of Walter's Brook located within Banks Reserve on the Swan River foreshore. The project was completed in May 2014 and included stabilisation of banks, reducing the turfed area and increasing native vegetation around the brook, aimed at improving the quality of water entering the river.

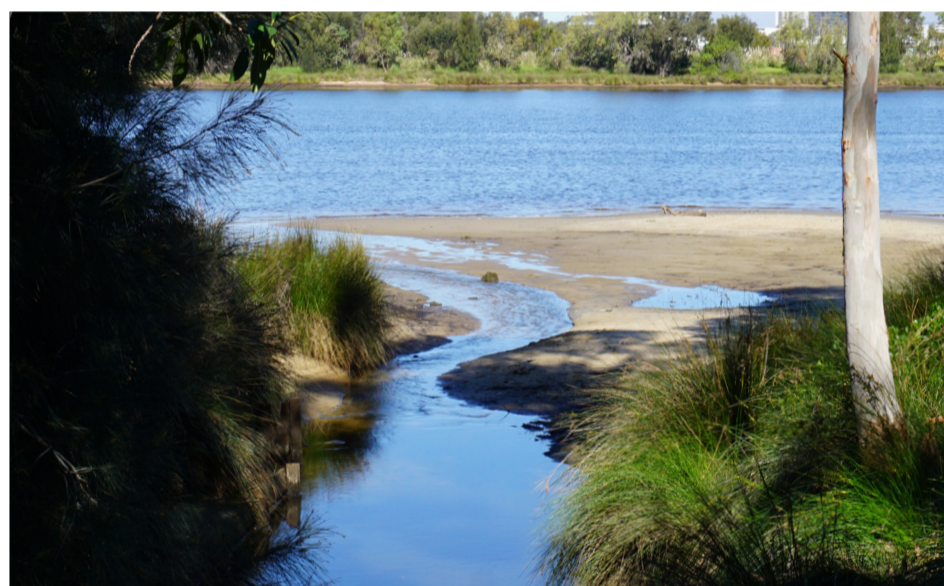
Walters Brook discharging to the Swan River, October 2017. Photo: Emma van Looij.
