Landslide Risk Case Studies in Forest Development Planning and Operations

Mike Wise, Glenn Moore, and Doug VanDine
Editors

Ministry of Forests Forest Science Program

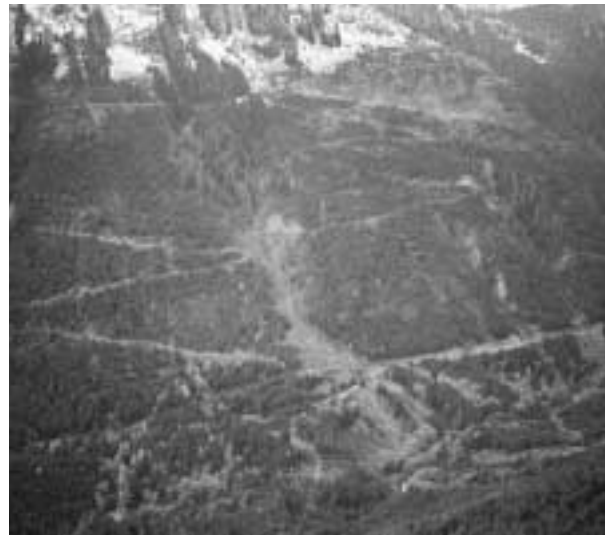
FIGURE 1 Steep slopes with branch roads, cutblocks, and gully areas above mainline forest road and utility corridors, coastal British Columbia (M. Leslie photo).

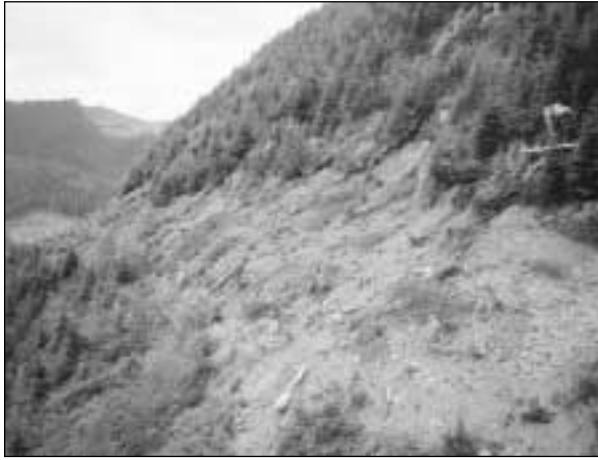
FIGURE 3 *Example of road deactivation to reduce probability (likelihood) of landslide occurrence (M. Wise photo).*

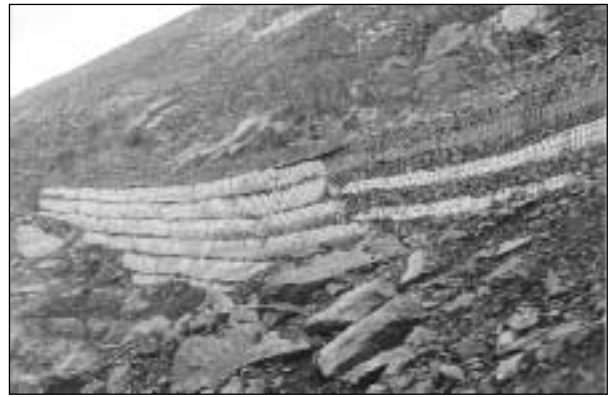
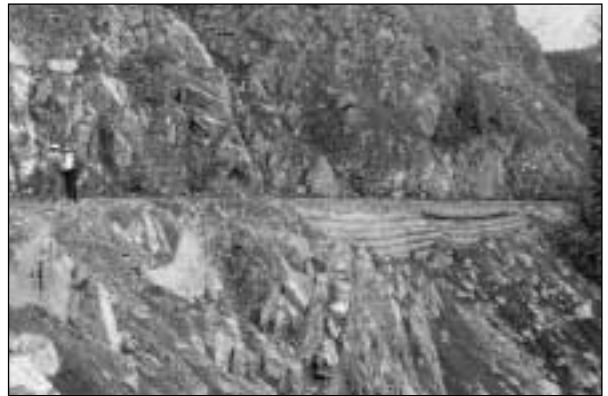
FIGURE 5 *Roadfill supported by retaining walls to reduce the amount of full bench / end-haul necessary for construction of a forest road (C. VanBuskirk photos).*

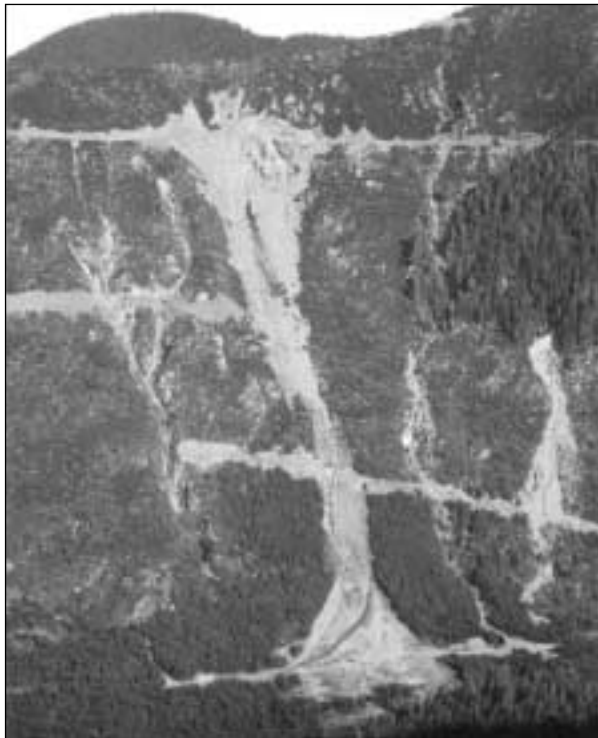
FIGURE 4 *Example of a debris flow control structure (a deflection berm) near the base of the slope to protect fish habitat (M. Wise photo).*

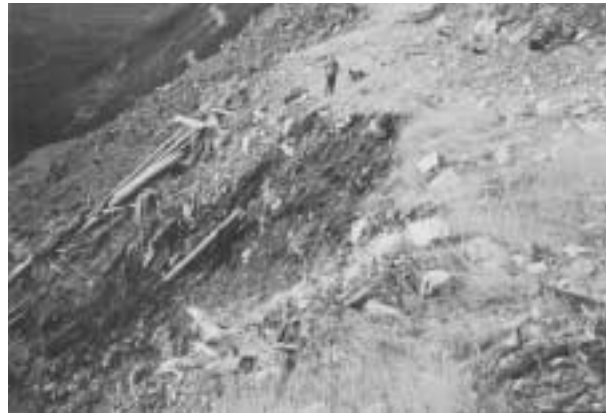
FIGURE 6 *Effectiveness monitoring can provide information on inadequate risk control, such as this section of road deactivation (M. Wise photo).*

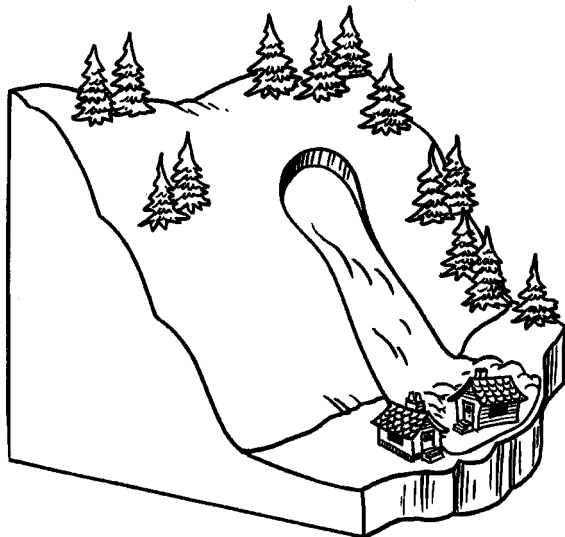
FIGURE 15 Upper and lower schematic drawings of $R(M)$, Multiple Risk.

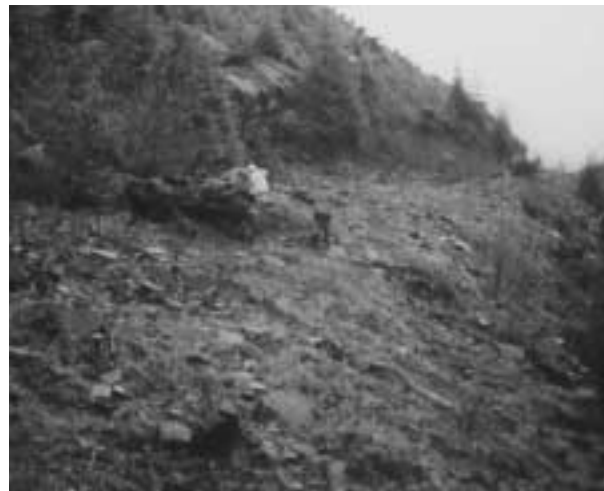
FIGURE 20 Permanently deactivated road in the Williams Creek sub-basin (A. Chatterton photo).

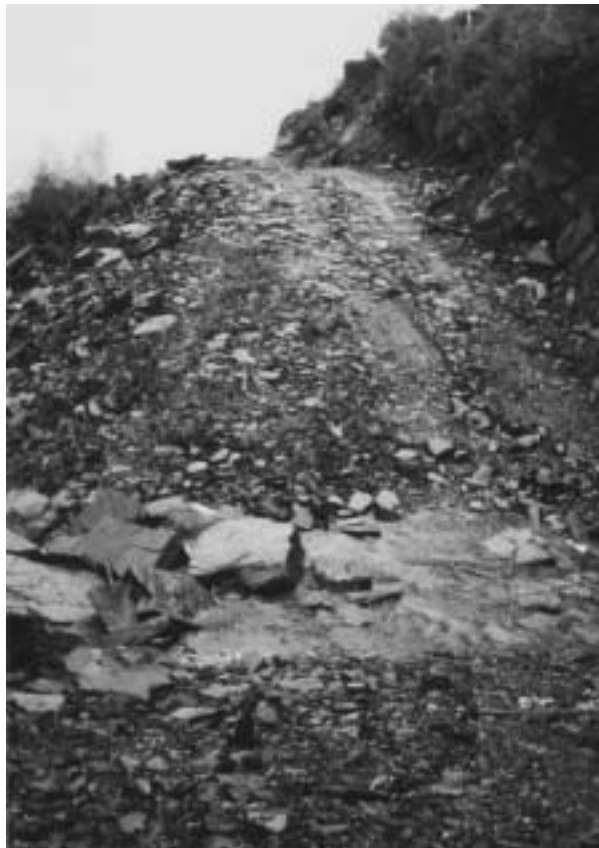
FIGURE 21 Armoured cross-drain on a semi-permanently deactivated road in the Three Arm Creek sub-basin (A. Hasanen photo).

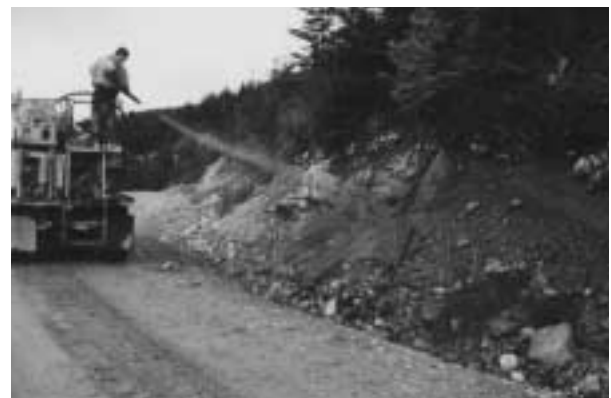
FIGURE 22 Hydroseeding exposed road cutslopes in the Lens Creek sub-basin (A. Hasanen photo).

On the basis of the specific project list, a series of detailed project plans for road deactivation, landslide stabilization, erosion control (Figure 22), and gully cleanout was developed by experienced consultants and contractors for the identified *high* and *very high* specific value of risk sites. In addition, some of the *moderate* specific value of risk sites that suggested an

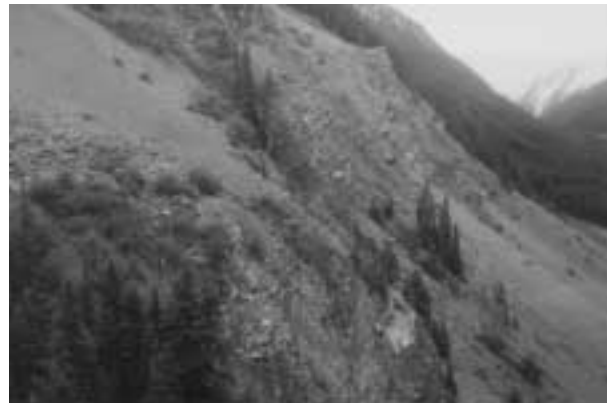
FIGURE 44 Looking south over the bedrock topple section of Option 4 (C. VanBuskirk photo).

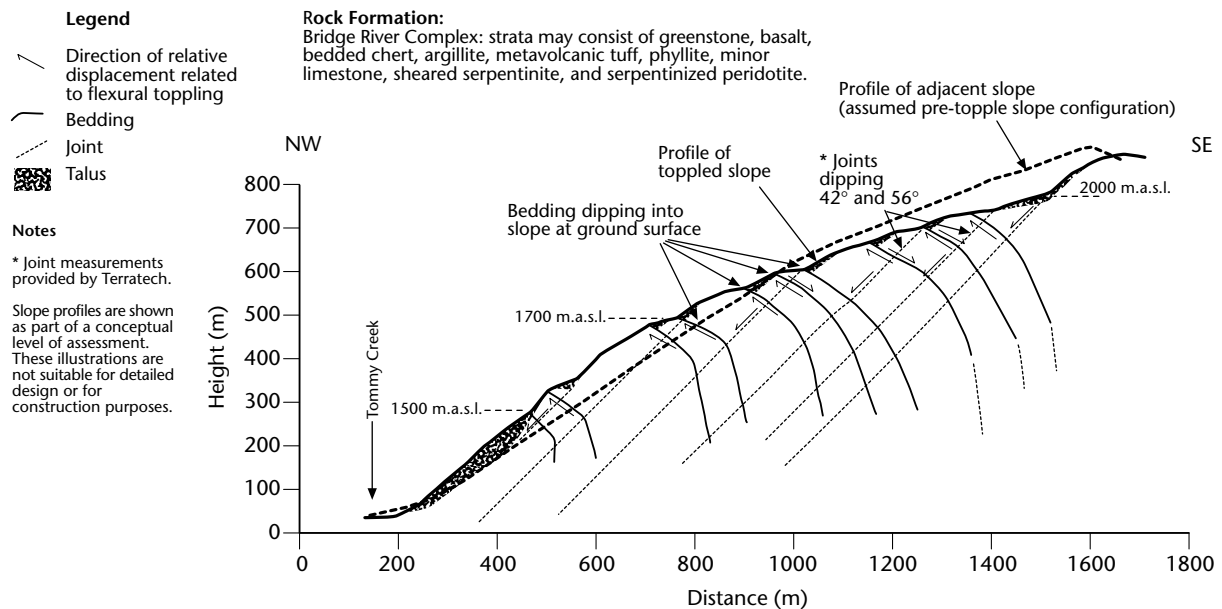
FIGURE 45 Illustrated cross-section sketch of bedrock-toppling (BGC 2001).

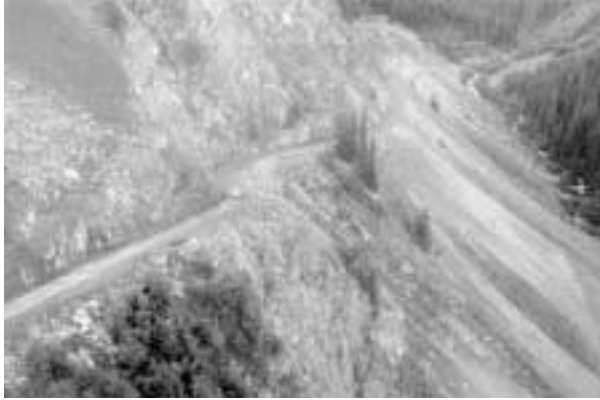
FIGURE 46 *Looking south at the critical section of Option 4 following construction (C. VanBuskirk photo).*

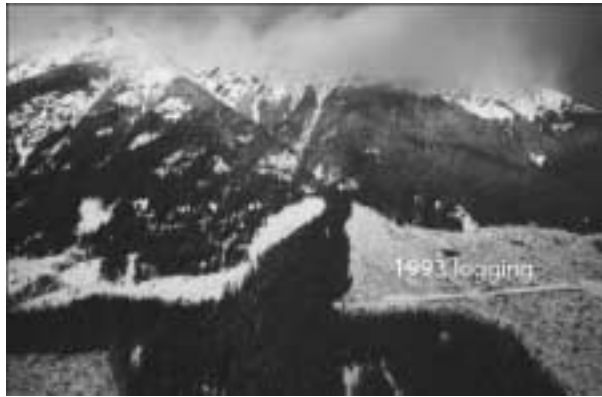
FIGURE 49a An oblique airphoto of the Kitsegucla fan looking in a northerly direction. The 1993 logging is shown on the right side (i.e., the east side) of the fan. The logging carried out in 2000–2001 based on the results of this risk analysis is shown on the left side of the fan. The forested reserve is the debris flow runout zone (D. Wilford photo).

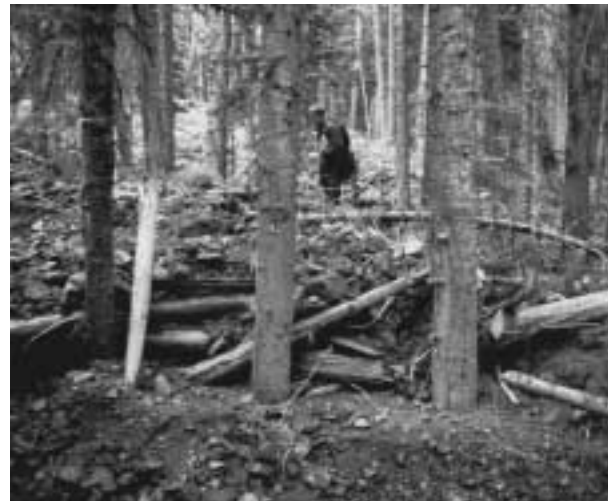
FIGURE 50 An example of a 1.5 m high wedge of debris flow (D. Wilford photo).

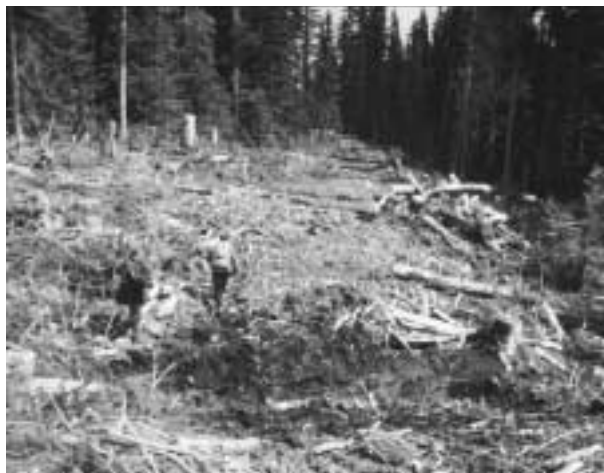
FIGURE 51 A view of the spur road following 2001–2002 logging. Note the narrow width of the road and right-of-way (D. Wilford photo).

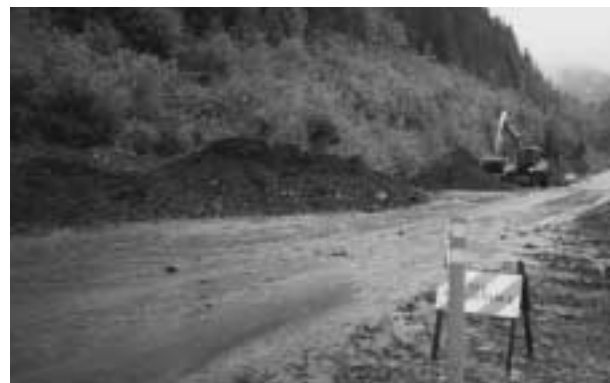
FIGURE 52 Debris being cleared from Highway 6, following June 4, 1999 debris flow (B. Ewings photo).

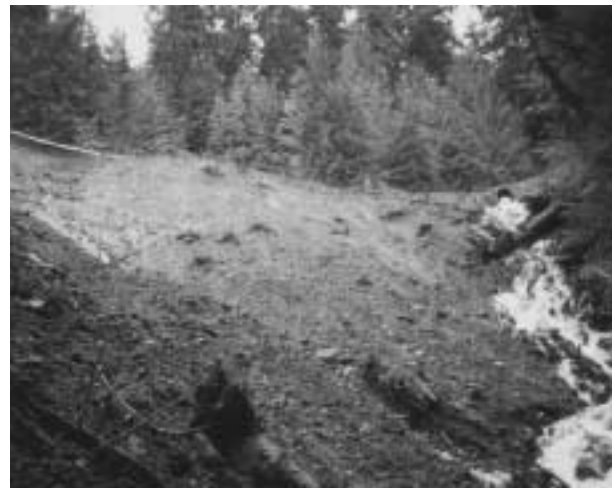
FIGURE 55 Debris slide scarp (D. Nicol photo).

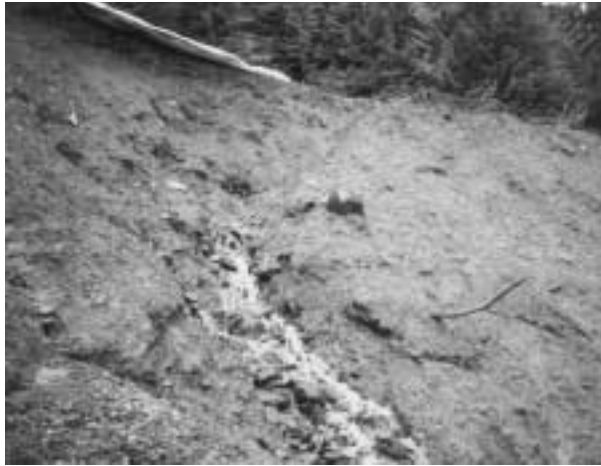
FIGURE 56 Seepage zone on headscarp of debris slide (D. Nicol photo).

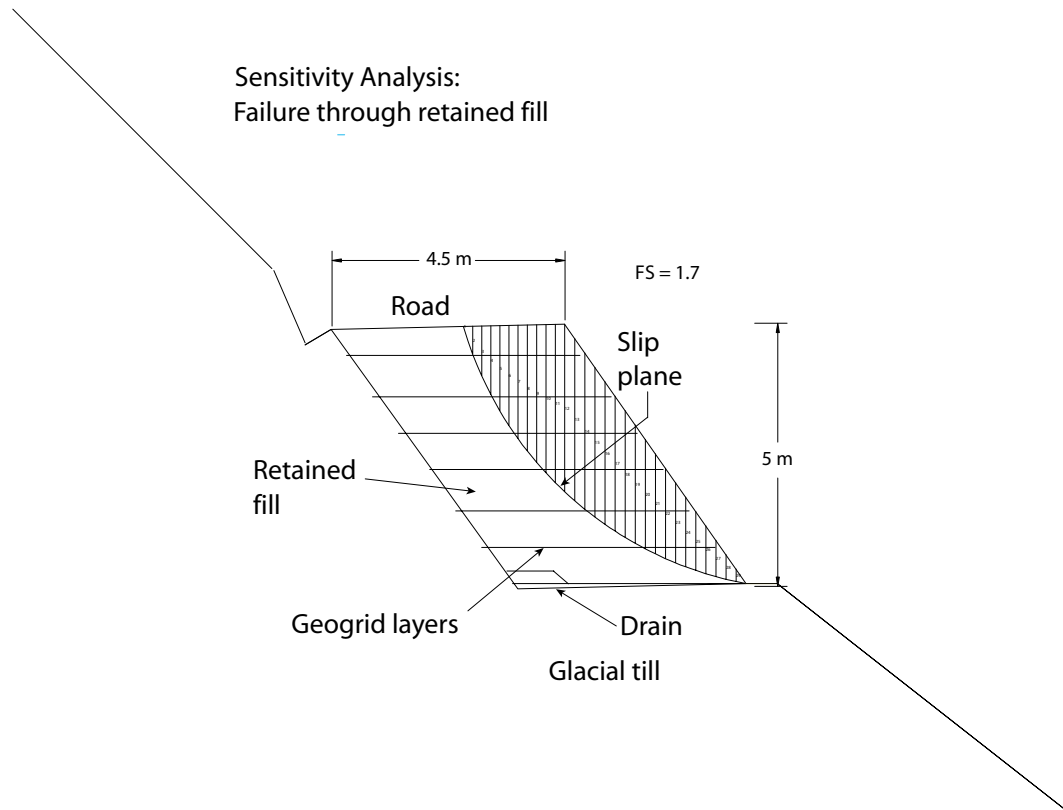
FIGURE 58 Limit Equilibrium Analysis for retained fill.

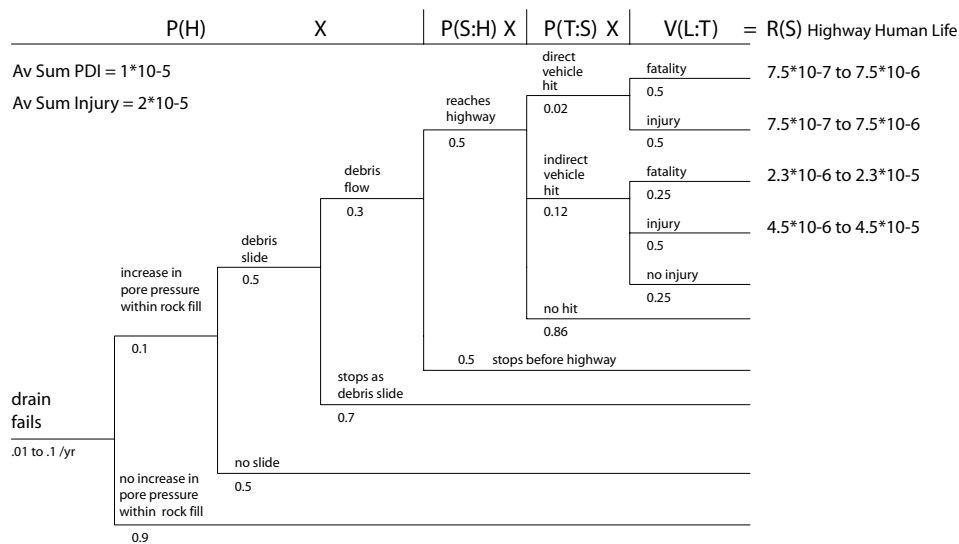
FIGURE 60 Simplified event tree for Specific Risk to Human Life (PDI).

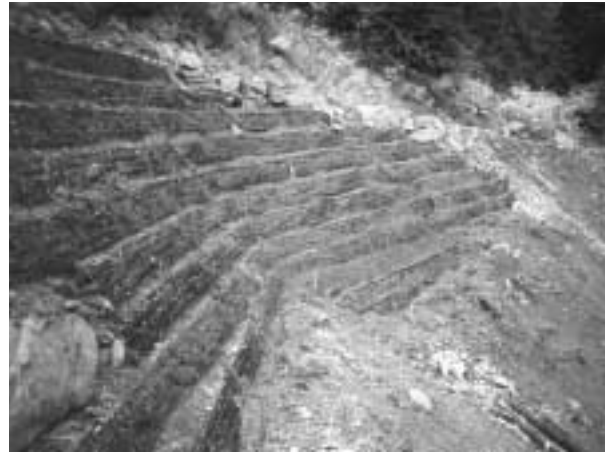
FIGURE 62 *Repaired Summit Lake FSR (D. Nicol photo).*
