# Lower Warren River Action Plan

# **Lower Warren River Action Plan**

Prepared for Warren Catchments Council- Southern Forests Landcare  
and  
the Manjimup Land Conservation District Committee

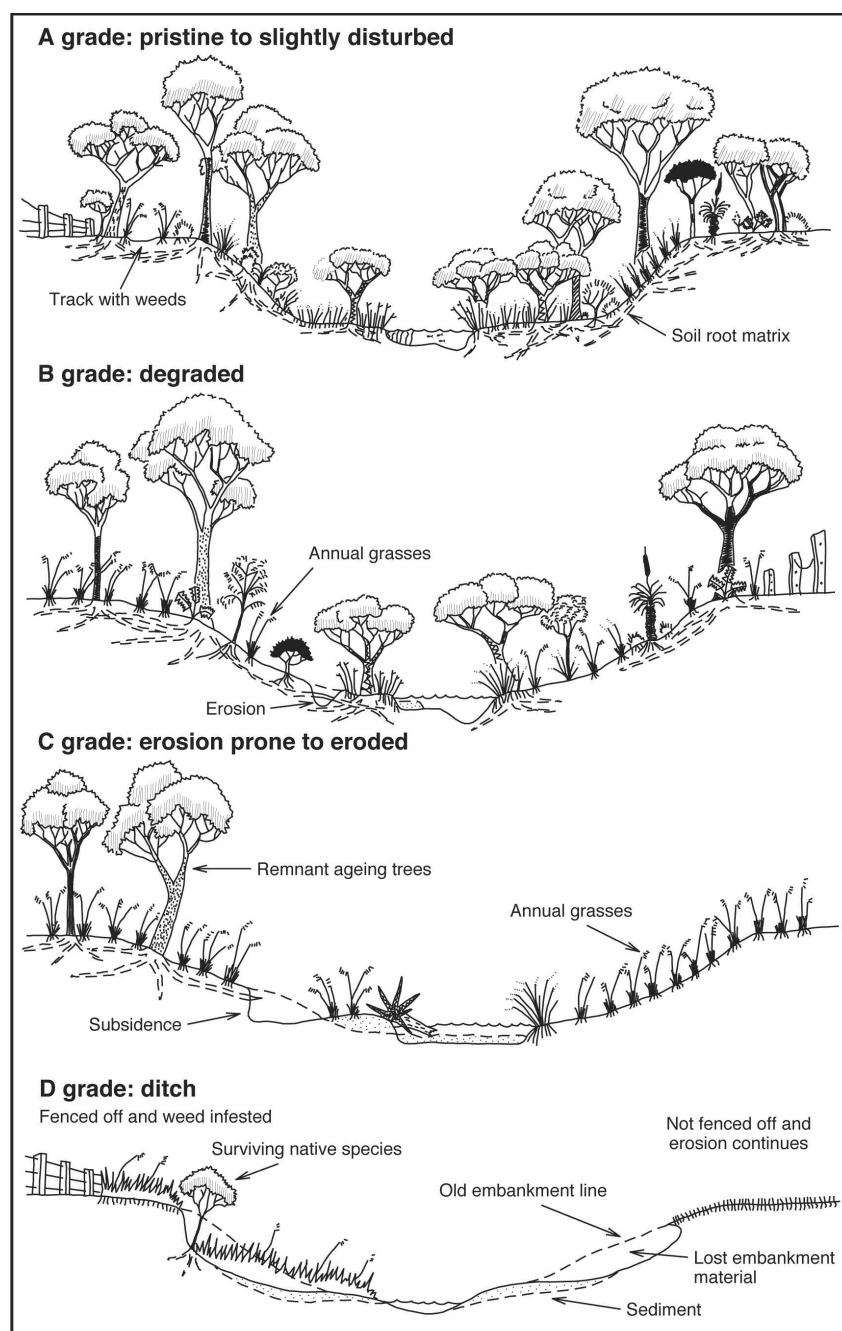
Figure 2: The four grades of river foreshore condition: A (pristine) to D (ditch) (after Pen & Scott, 1995)

The Pen-Scott method of riparian zone foreshore assessment was used to evaluate the condition of the lower Warren River foreshore. The Pen-Scott method is a standardised rating technique for classifying foreshore areas along a gradient from pristine (A grade) through to D grade, connoting a ditch. The four grades are further divided into three sub-categories per grade, i.e. A1, A2 and A3. A description of these grades follows and they are represented pictorially in Figure 2 (Pen & Scott, 1995). Indicative sites representing each grade along the Warren River are also included in the following pages (Figure 3).

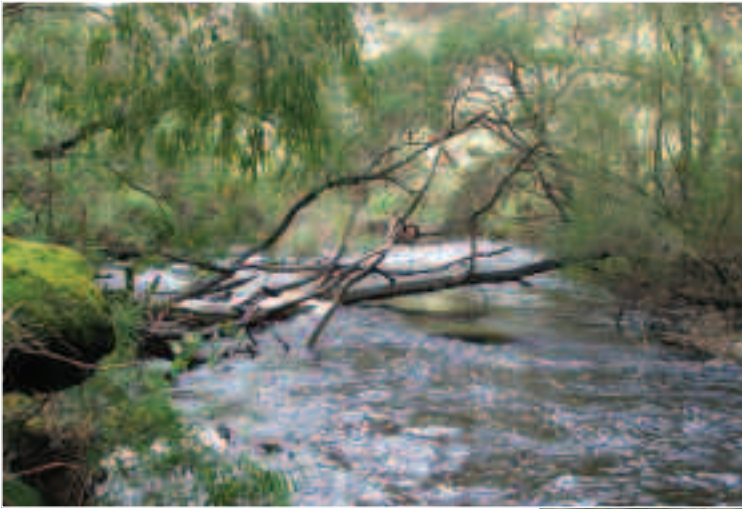
*A grade section*

*Figure 3: Foreshore condition of the lower Warren River (photos- Jenni Munro)*

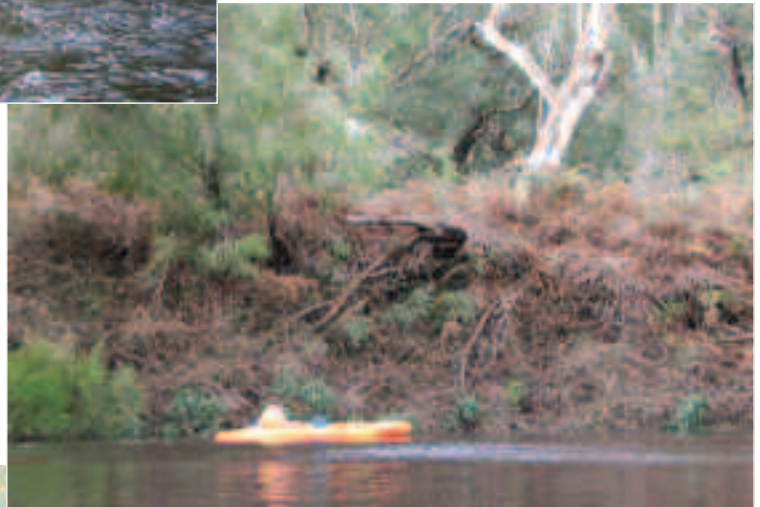
*B grade section*

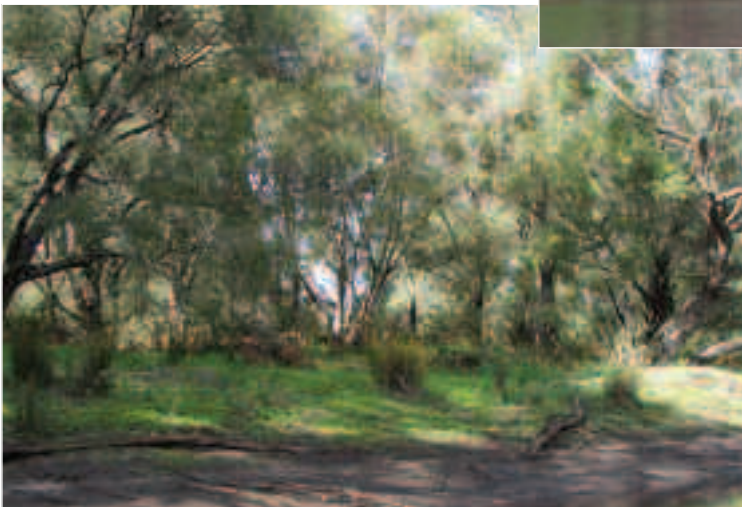
*C grade section*

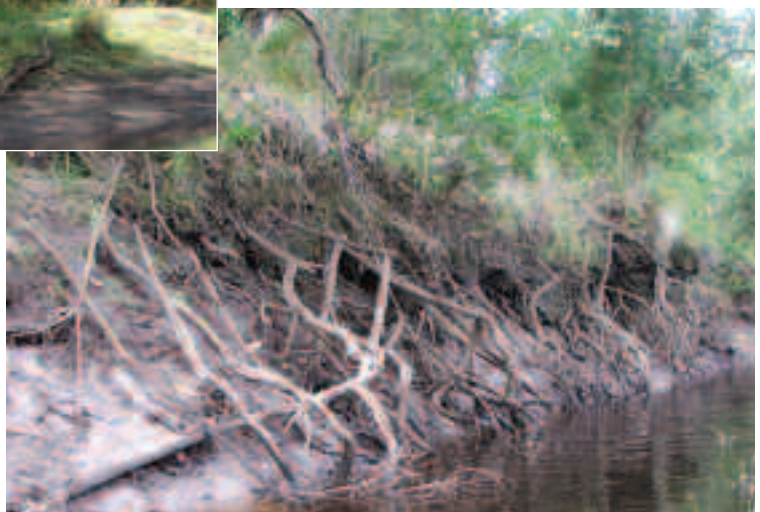
*Natural bank cutting exposing underlying root systems*

Natural, dynamic bank erosion processes occur freely on rivers and are evident along the length of the lower Warren River, where soils are sandy. The erosion process becomes exacerbated and cause for management

concern when supporting riparian vegetation is cleared and banks become further destabilised, leading to erosion and sedimentation downstream. As most of the erosion is a natural occurrence, bank cutting along the lower Warren River is not cause for significant concern, apart from areas where unrestricted stock access is compounding the erosion problem. Stock access to riparian zones also affects bank stability, vegetation cover and weed infestations and can enhance erosion concerns. For much of the section assessed, bank cutting is occurring on one side of the channel and deposition on the other, with the actual river channel being in a constant state of flux. Issues associated with erosion and subsequent siltation include loss of soil fertility, poor water quality, infilling of summer pools, increased channel width, further loss of native riparian vegetation, alteration of in-stream vegetation and flow dynamics, macroinvertebrate communities and the potential effects of reduced photosynthesis (WRC, 2000g).

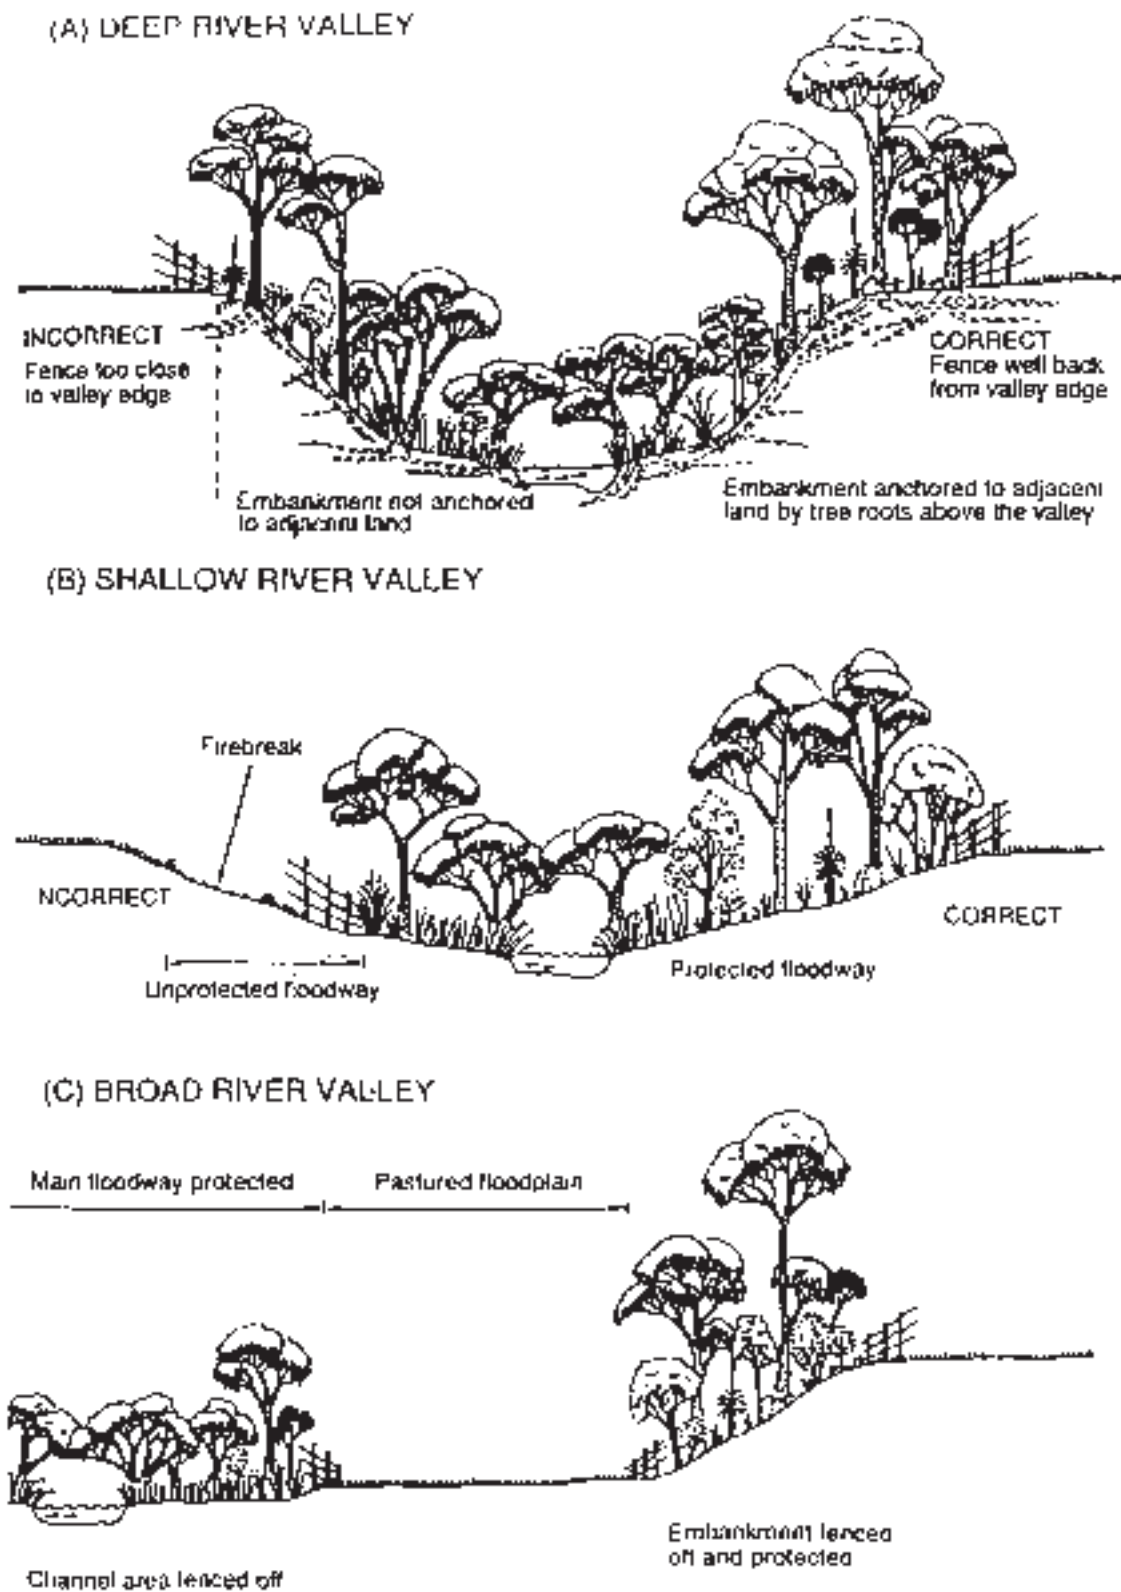
Figure 4: Placement of fences in relation to the river valley

Fencing off the riparian zone does not have to be absolute; the quantity of land from which stock are excluded will depend on management objectives. If the aim of fencing is to protect high quality riparian vegetation to maintain habitat, landscape and ecological corridors, all stock should be excluded. However, if the riparian zone has a history of grazing and stock exclusion could lead to the proliferation of weeds and a fire hazard, allowing access for seasonal grazing is beneficial. Fences in this instance are used to control the level of grazing so that the dominant native vegetation is able to regenerate. Considerations when planning fence location include the form of the river, presence of riparian vegetation and frequent flood levels, in addition to land tenure and cadastral boundaries. Correct fence placement in relation to river valleys is illustrated in Figure 4.

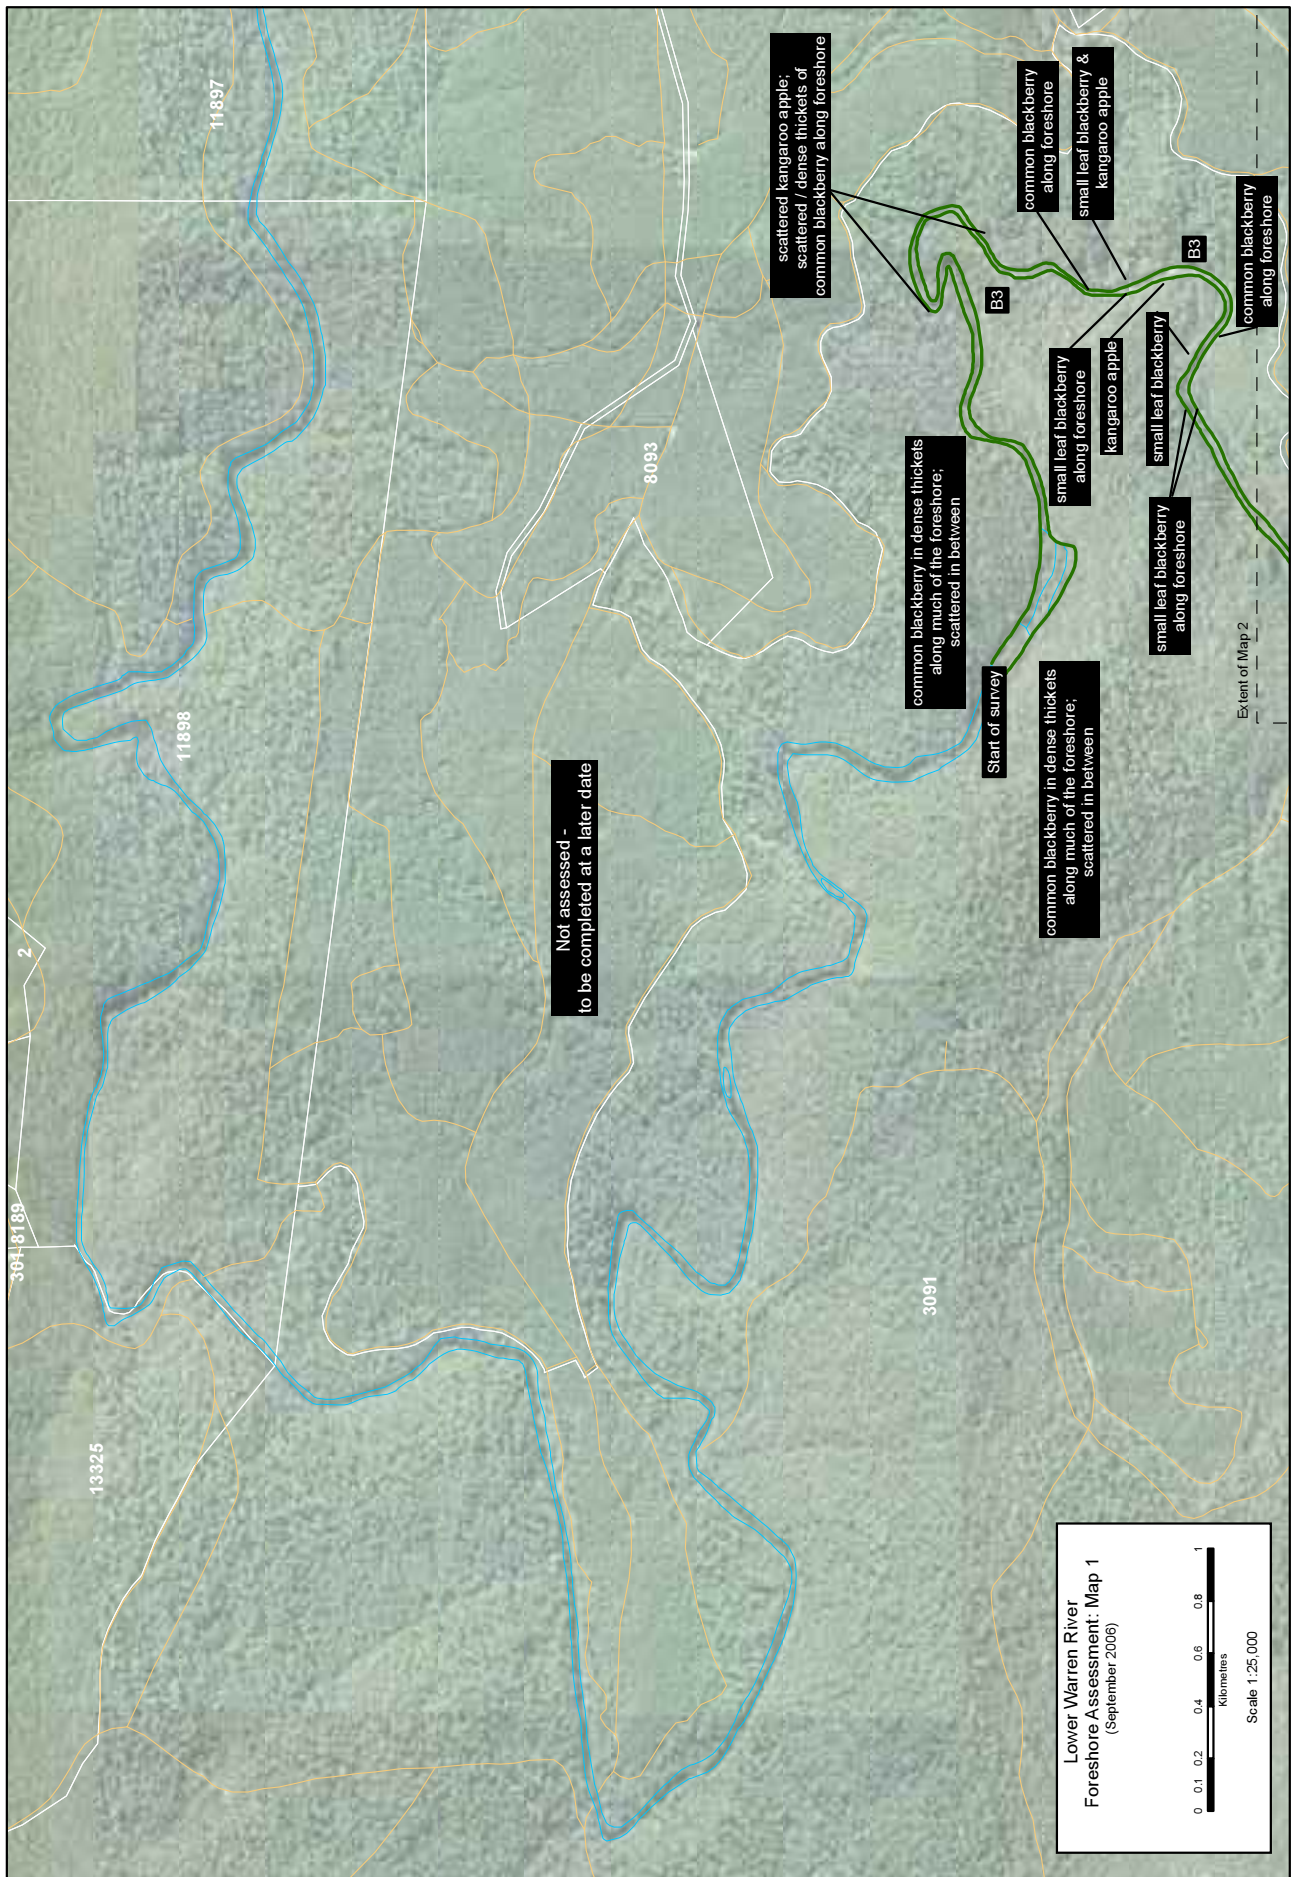
Lower Warren River Map 1

| Summary Information | |
|---|---|
| Foreshore condition rating (as at Oct 2006) | B3      100% |

| Prioritised management actions recommended |
|---|
| 1. Monitor effect of blackberry biocontrol rust and further spread of common and small leaf blackberry |
| 2. Monitor emergence and spread of other weed species |

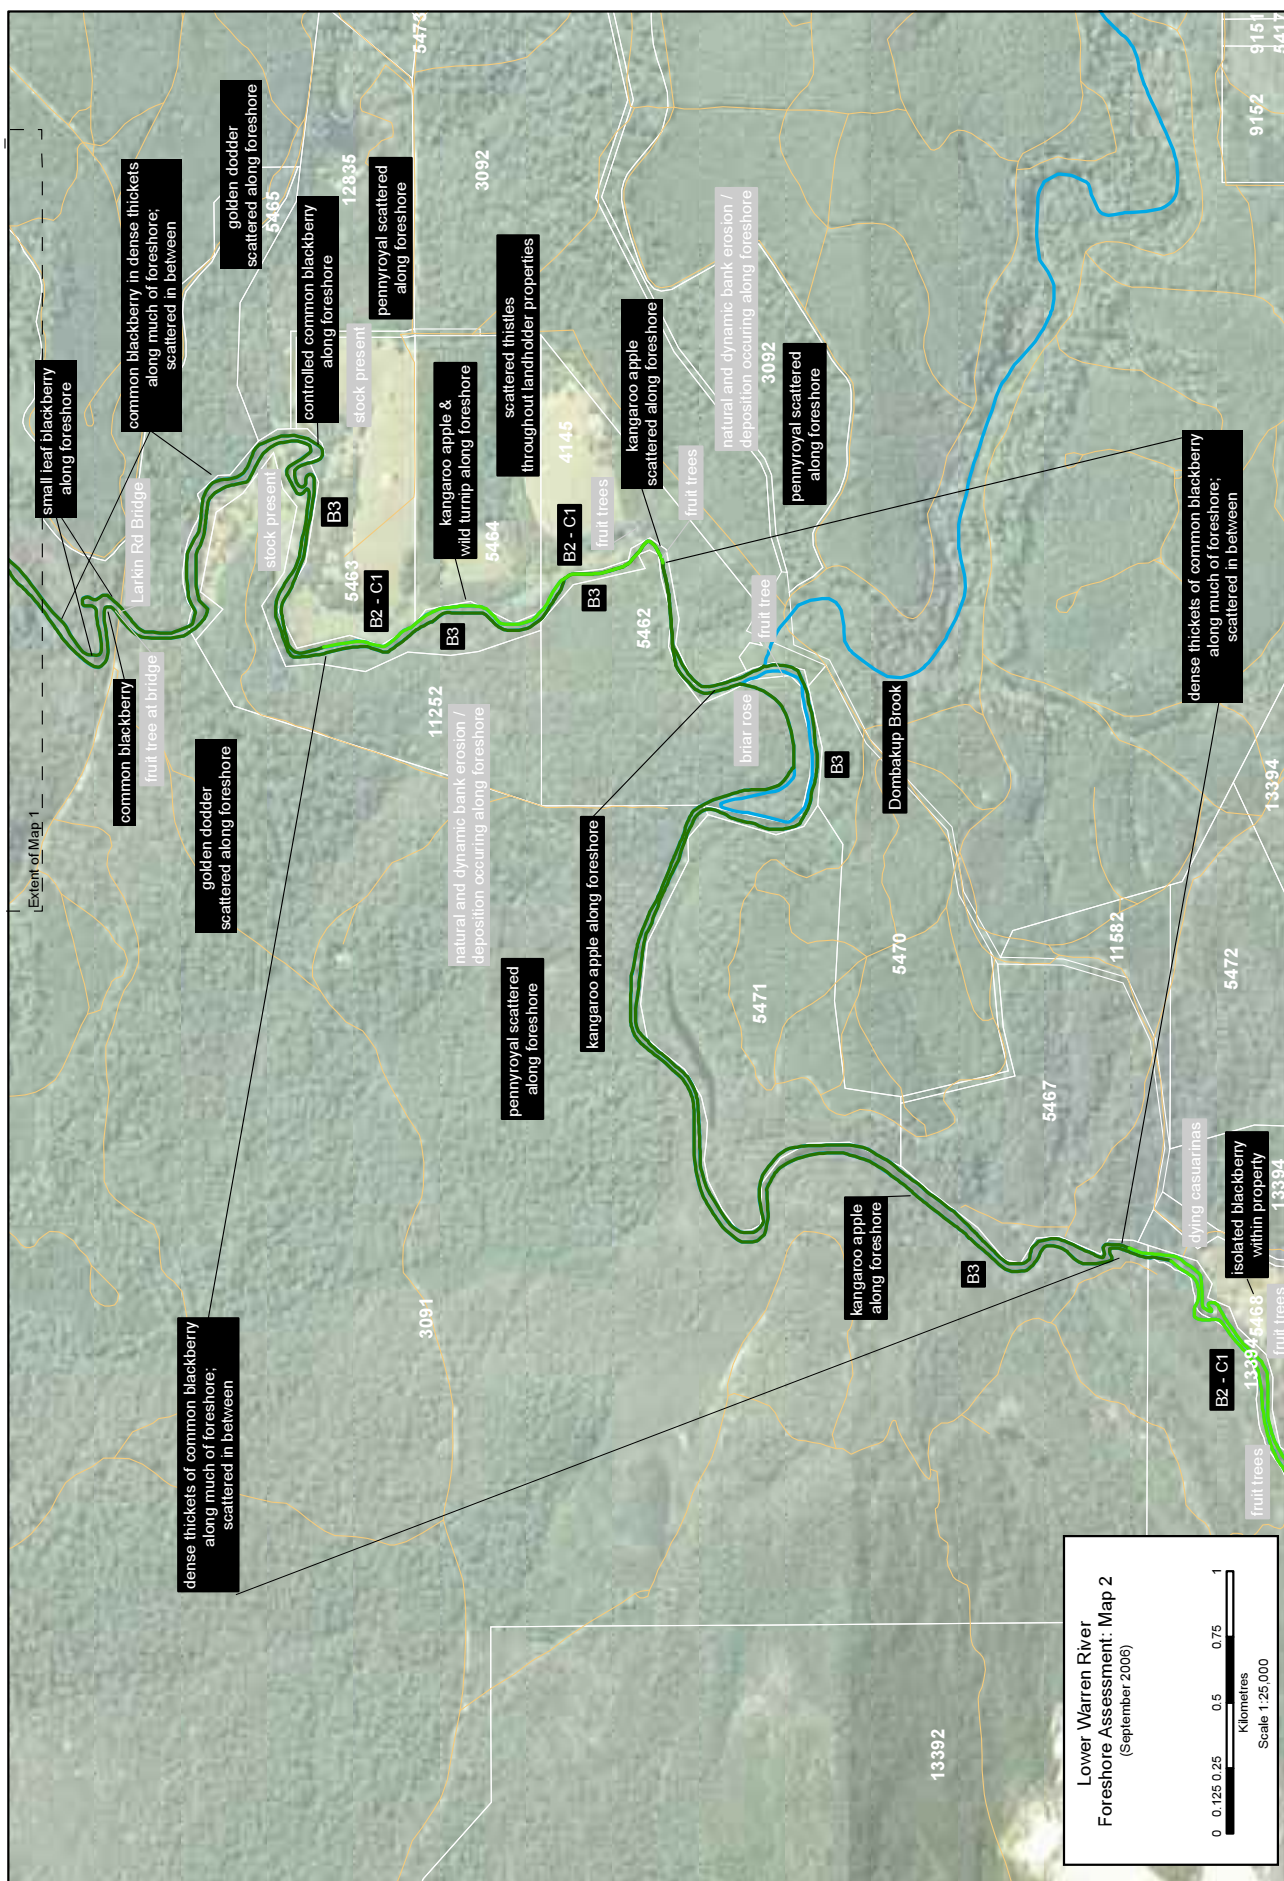
Lower Warren River Map 2

| Summary Information | |
|---|---|
| Vegetation cover & health | Aside from common blackberry thickets and golden dodder growths, generally a very healthy and predominantly natural assemblage of plants. Foreshore vegetation has been removed in some parts of landholder properties |
| Land use | Private property, stock grazing, Greater Hawke/<br>D'Entrecasteaux National Park |
