LOWER ORD RAMSAR SITE, KUNUNURRA –
SURVEY OF NON-ABORIGINAL CULTURAL
HERITAGE SITES.

Prepared by
Gaye Nayton BSc (Hons), AACAI

Department of Contract and Management Services

Department of Conservation and Land Management
February 1998

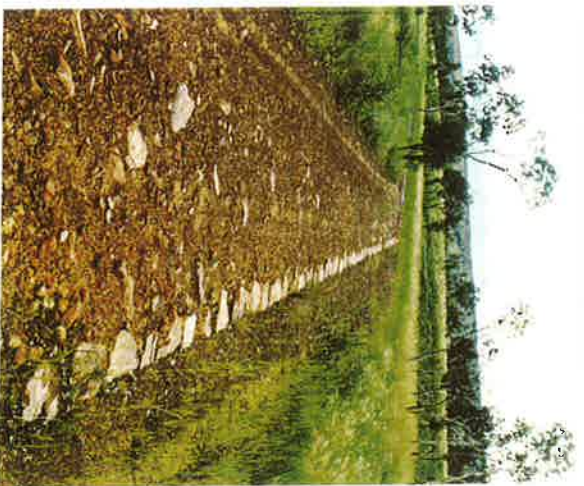
PLATE 1. COBBLESTONE EDGES OF 2ND
HALL'S CREEK ROAD

The road was constructed using cobblestones to line the edges of the 4 metre wide road (421456E, 8263600N). Stone rubble was used to fill between the cobblestone edges forming the road surface (Plate 1). The condition along the traversed section of the road varied, ranging from excellent preservation through to extensive deterioration where no trace of cobbling could be discerned. CALM officers reported that there were other sections where the roads' surface had been entirely cobbled, and that these areas were in good condition. They were not inspected as ground conditions prohibited access.

The use of cobblestones in the construction of this road is quite rare. Likewise, that the road is in similar condition as to when it was first constructed is also rare, this being one of only two known examples in WA. The preservation of examples of this road surface then should be of high priority.

It is recommended that in areas where the cobblestone road surface is present any planned works that may affect examples of this construction (realigning or upgrading, resurfacing, installation of drainage) be aligned around these areas.

It is recommended that a survey of the entire road course through the study area be undertaken to further determine the road's condition and to plot associated artefacts or features.

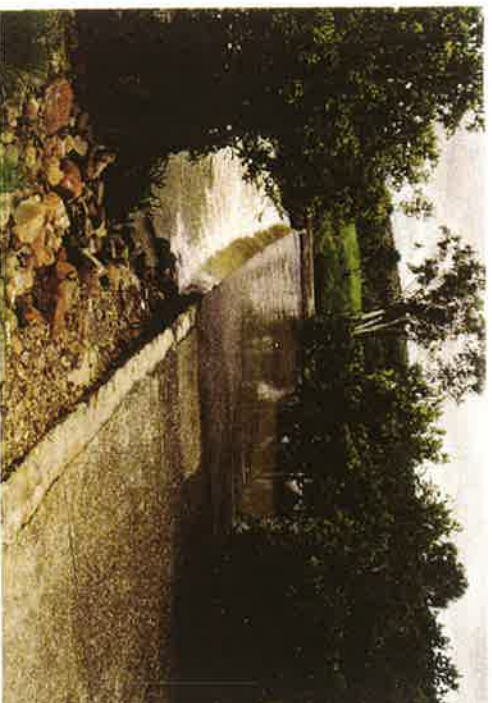
PLATE 2. CAUSEWAY ON 2ND
HALL'S CREEK ROAD

Causeways have been constructed across the many creeks that the road crosses. Some causeways are in excellent condition whilst others were seen to be badly eroded. One causeway in good condition (422274E, 8265971N) was approximately 5 metres wide and was constructed using cobblestones that had been cemented into place (Plate 2). The causeway had then been filled with rubble. Cement blocks measuring 5 metres long by 3 metres wide had then been placed side by side over the causeway. It is suggested that the cement blocks are a modern addition aimed at stopping the causeway from deteriorating.

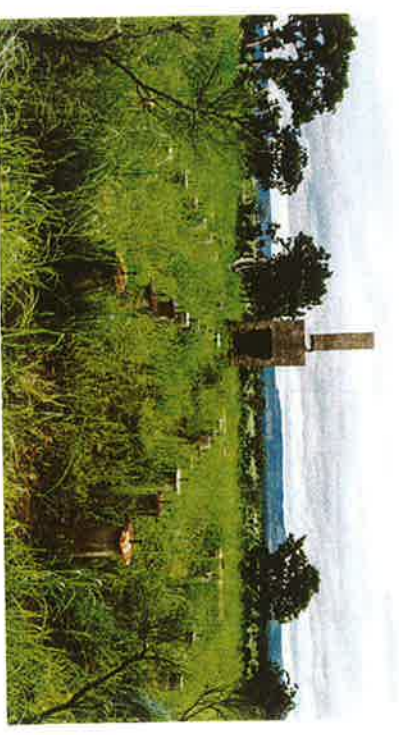
PLATE 3. TELEGRAPH HILL #1

Of the two large residences that appear to have been at the site, this is the better preserved. Although the building is no longer present the pillars on which the building was located, the concrete tank stands and a chimney at the western end all remain. The building sat on 48 concrete posts, all with retaining rods protruding (Fig. 10). The posts are approximately 70 cm high and 20cm in diameter. Forty of the posts are in a 8 x 5 grid pattern, whilst the remaining eight posts are in a 2 x 4 grid pattern leading up to the chimney (Plate 3). Two pairs of smaller posts (\approx 30cm high) are located on the NW corner and northern side of the site and may indicate the location of steps leading up to the building.

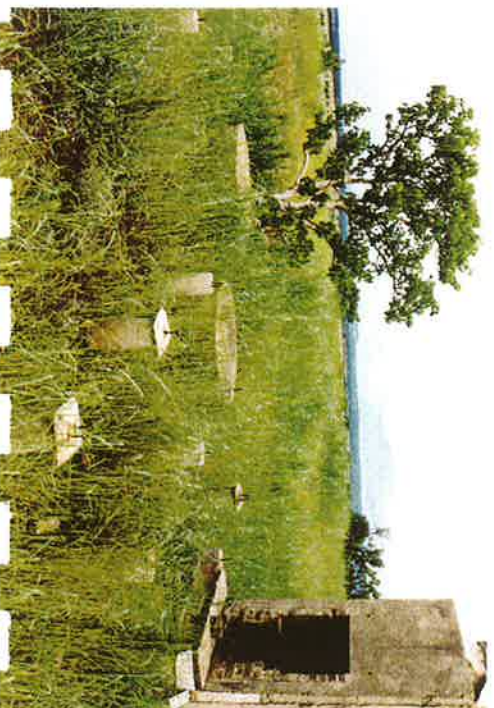
PLATE 4. CONCRETE TANK STANDS,
TELEGRAPH HILL #1

The pillars are surrounded by six concrete tank stands, each measuring \approx 2m in diameter and of variable height (Plate 4). One tank stand is located at each of the corners of the 8 x 5 grid, whilst the remaining two are located either side of the chimney. The chimney constructed of brick, cement render and tin and is approximately 4m high.

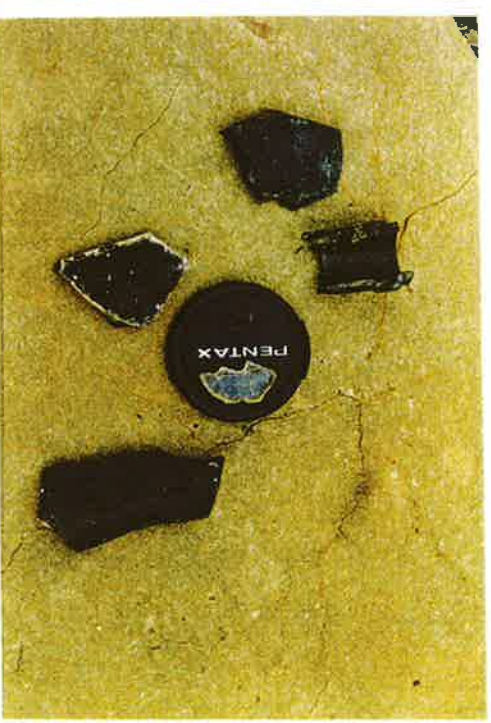
PLATE 6. GLASS ARTEFACTS,
TELEGRAPH HILL #2

A cluster of broken glass was identified at the southern end of the pad (Plate 6). The glass is from broken automatically made beer and wine bottles. One beer bottle has the large barrel trademark used by the Perth and Fremantle Bottle Exchange from 1907 to ca 1925.

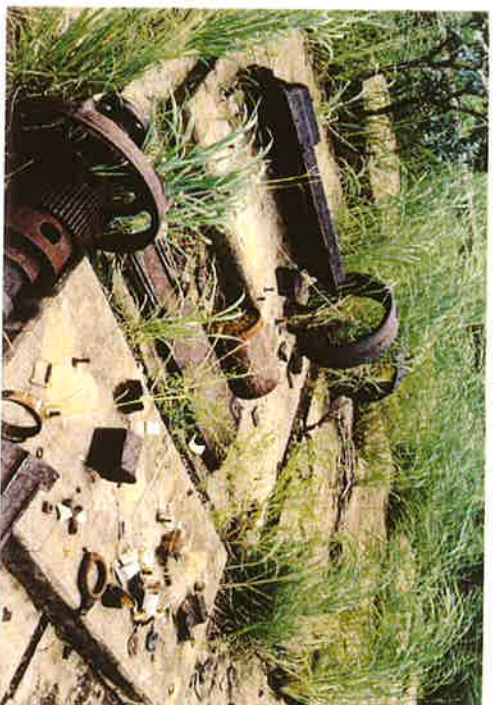
PLATE 11. MACHINERY PARTS, TELEGRAPH HILL #4

In the centre of the pad are two raised platforms. In the western third of the pad there is a third raised platform. It is suggested that these are machinery pads, on which generators used to power the site were located. This is supported by the presence of machinery parts on the central pads (Plate 11). No other machinery parts were located in the complex. Several broken insulators, battery packs, carbon rods, copper wire, ceramics, automatically made bottle glass, and smaller construction materials (bolts, nails etc) were also found around the platforms.

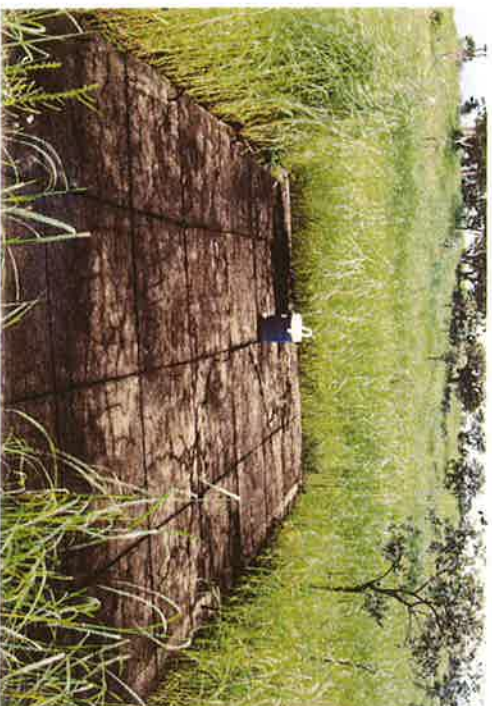
PLATE 14. TELEGRAPH HILL #7A

TH#7a is 4m wide by 7m long. Grooves have been marked into the cement forming metre squares (Plate 14). Sixteen of these squares have retaining rods protruding from their surface. TH#7b is smaller, being 3m wide and 4m long (Plate 15). The surface of the pad is flat and three railway tracks that have been placed vertically into the cement are found on one side. The tracks obviously formed part of the frame of the original structure. With the exception of three railway tracks on TH#7b no building material was observed.

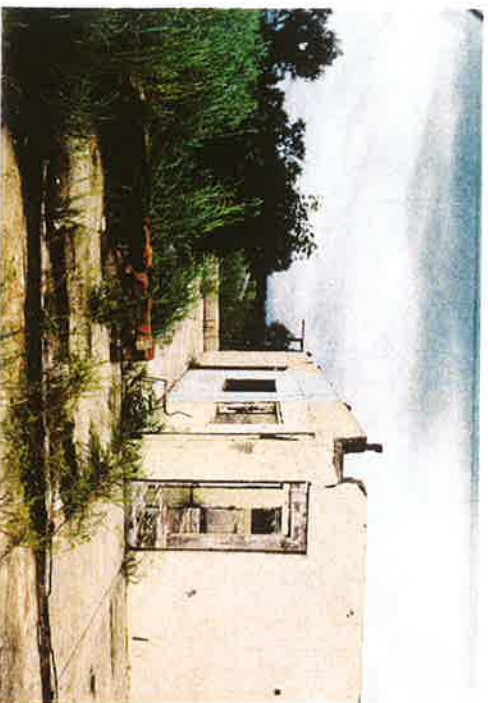
PLATE 16. GOOSE HILL STATION
(FORMERLY ASCOT HOMESTEAD)

The homestead is located on a large concrete pad. The building itself consists of five rooms and is adjoined by a toilet, shower and laundry (Fig. 16). The building has lost its roof, but the walls appear to be in a stable condition. The walls are constructed of cement bricks, render, and wooden beams. Electrical cables hang from wall fittings and are likely to have serviced light fittings. The walls have been painted a variety of colours, mainly cream, blue and pink (Plate 16).

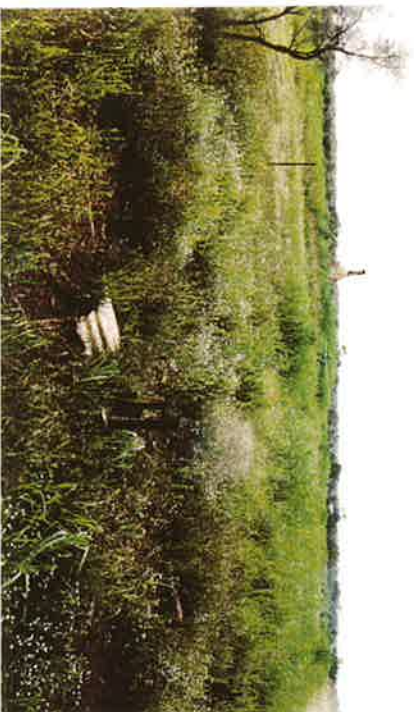
PLATE 19. MAST FOOTING AND GUY
WIRE SUPPORT POLES

Approximately 100 metres behind the Kitchen(?) are the foundations of a radio mast. Whilst the mast is not present, the mast foot and guy wire supports are clearly discernable (Plate 19).

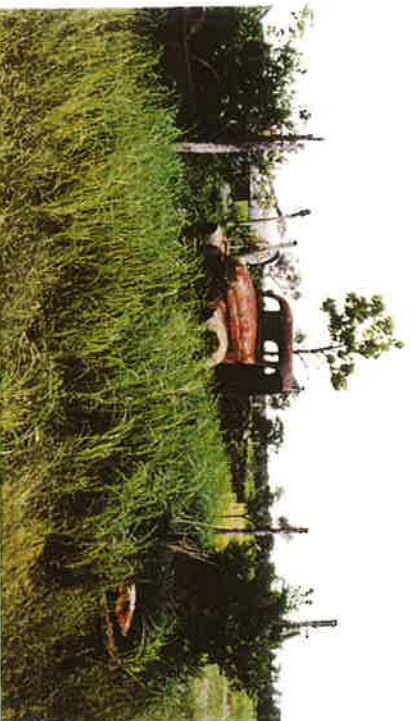
PLATE 22. FLAT BED "INTERNATIONAL"
TRUCK

garage. The body of a flat bed "International" truck is located within the boundary of the shelter (Plate 22). Machinery parts can be seen around the floor of the shelter.

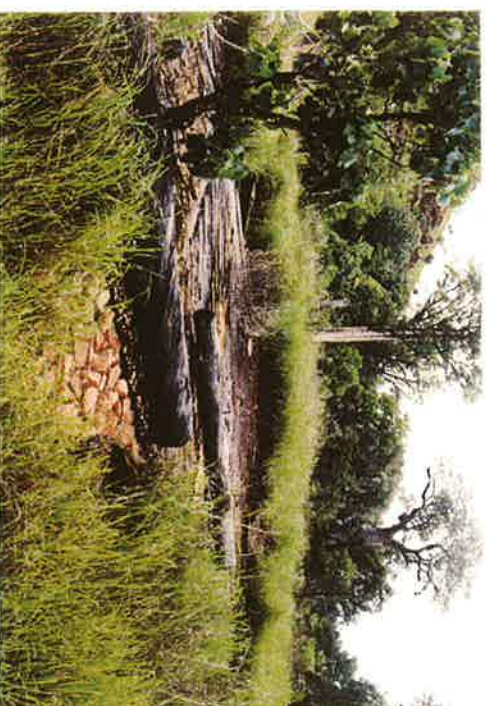
PLATE 29. CONCRETE PAD OF DIPPING
YARD, GOOSE HILL

Approximately 200 metres behind (south of) the chimney are the remains of a dipping yard (Fig. 19), used to dip cattle to remove parasites. All that visibly remains of the dipping yard is a concrete slab and the dipping trough (Plate 29 & 30). An overturned square storage tank is located at the end of the trough away from the slab. Two fence posts were identified nearby, with two larger wooden beams lying across the pad.
