**REPORT ON SAMPLING AND ANALYSIS UNDERTAKEN IN  
MAGELLAN SHIPPING CONTAINERS STORAGE AREA,  
FREMANTLE PORT**

**18 January 2011**

**Department of Environment and Conservation**  
Pollution Response Unit  
Environmental Regulation Division

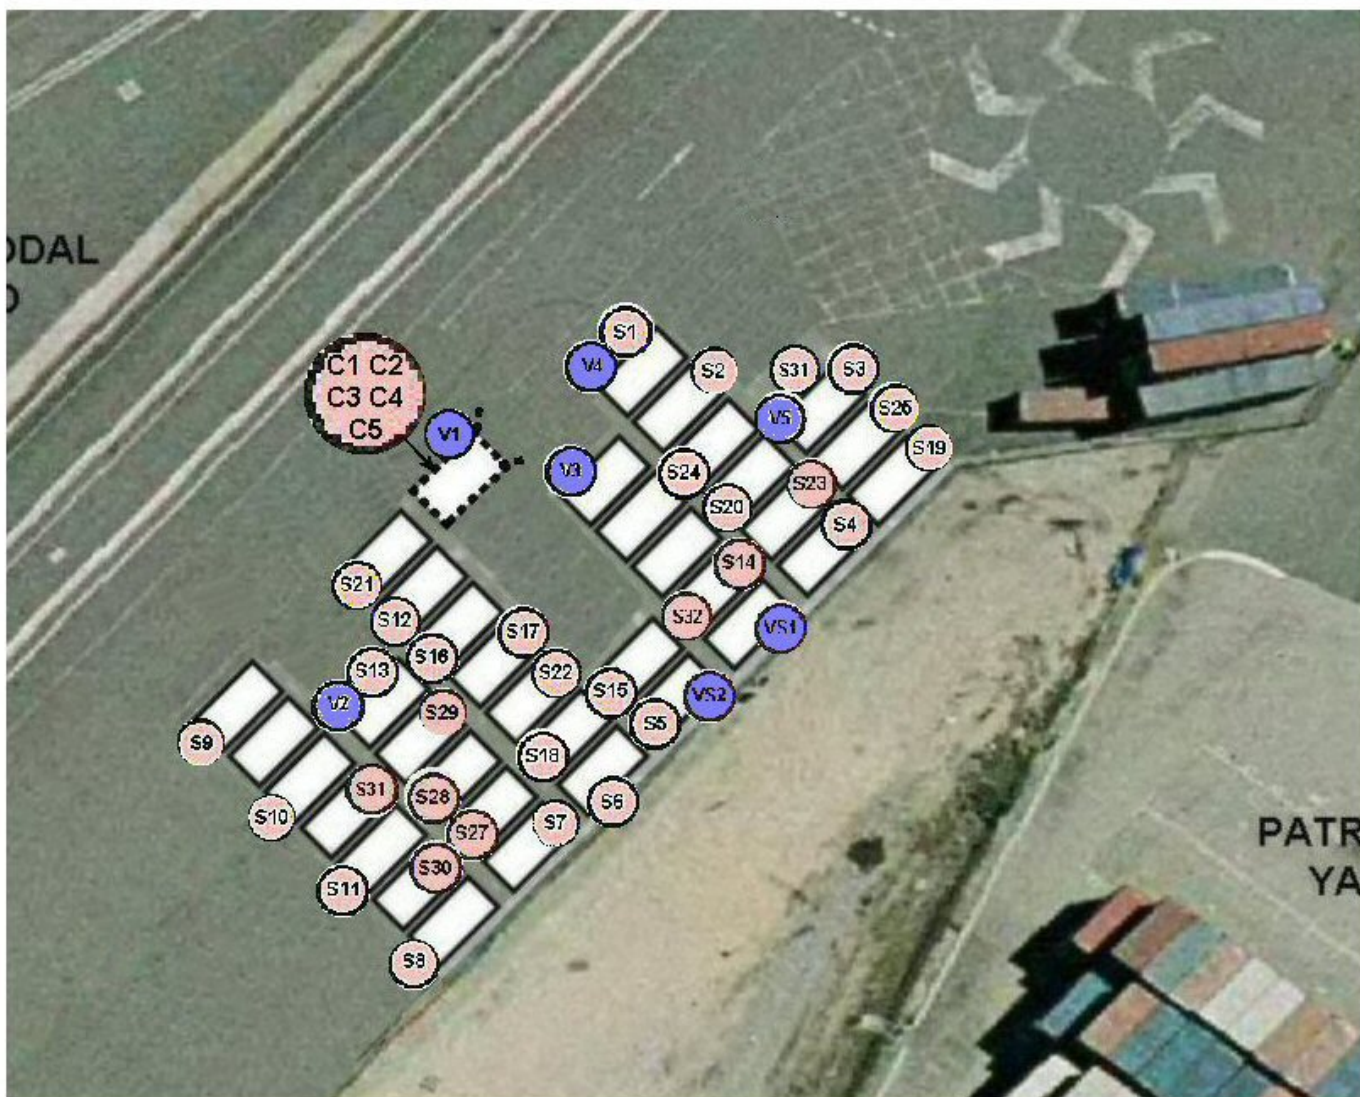
**Figure 2: Magellan shipping containers – swab sample locations**

On 4 January 2011 swabs were taken from external surfaces of 20 Magellan containers (marked S1 – S20). An additional 12 swabs from Magellan containers (S21 – S32) were taken on 5 January 2011. Figure 2 shows the surface swab sampling locations.

swabs (VS-1 and VS-2) were obtained from vents on 5 January 2011. Figure 2 shows the vent sampling locations. Photograph 4 shows a plastic ventilation point.

During sampling procedures on 4 January 2011, personnel from Inspectorate Cox (engaged by Magellan Metals) opened a Magellan container in order to collect air monitoring equipment from inside. Although unplanned, DEC officers took the opportunity to obtain swab samples from both internal and external surfaces on this container. Figure 2 shows the surface swab sampling locations.

**Note:** Dotted line indicates the shipping container that was temporarily opened to retrieve an air monitoring device.

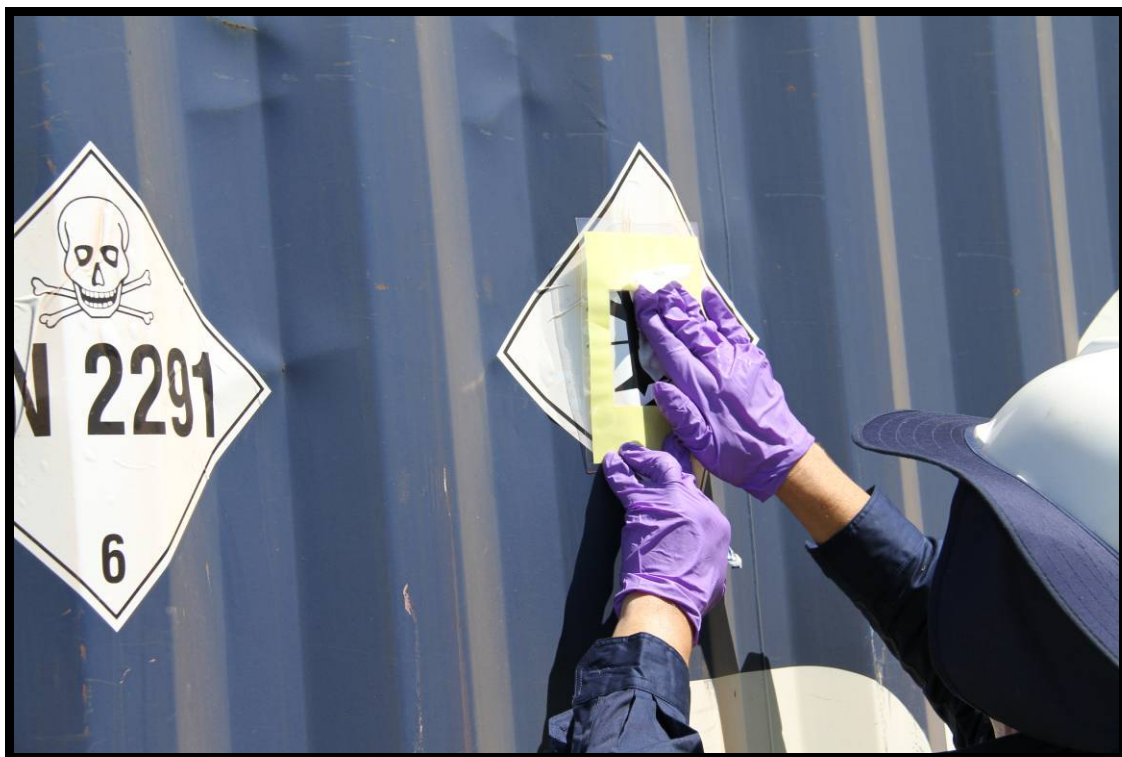
1. Remove a *GhostWipe* from its package and unfold it.
2. Next fold the *GhostWipe* in half and wipe a measured 10cm by 10cm area, starting at the outside edge of the surface. Applying firm pressure, wipe the surface, progressing towards the centre by making concentric squares of decreasing size.
3. Fold wipe in half, with the used side in, and wipe the surface again by making concentric squares of decreasing size.
4. Fold the wipe in half again, used side in, and wipe surface a third time.

Photograph 2 shows a surface swab sample being collected, and Photograph 3 shows a Dangerous Goods placard sticker after sampling.

**Photograph 2: A DEC inspector collecting a swab sample**

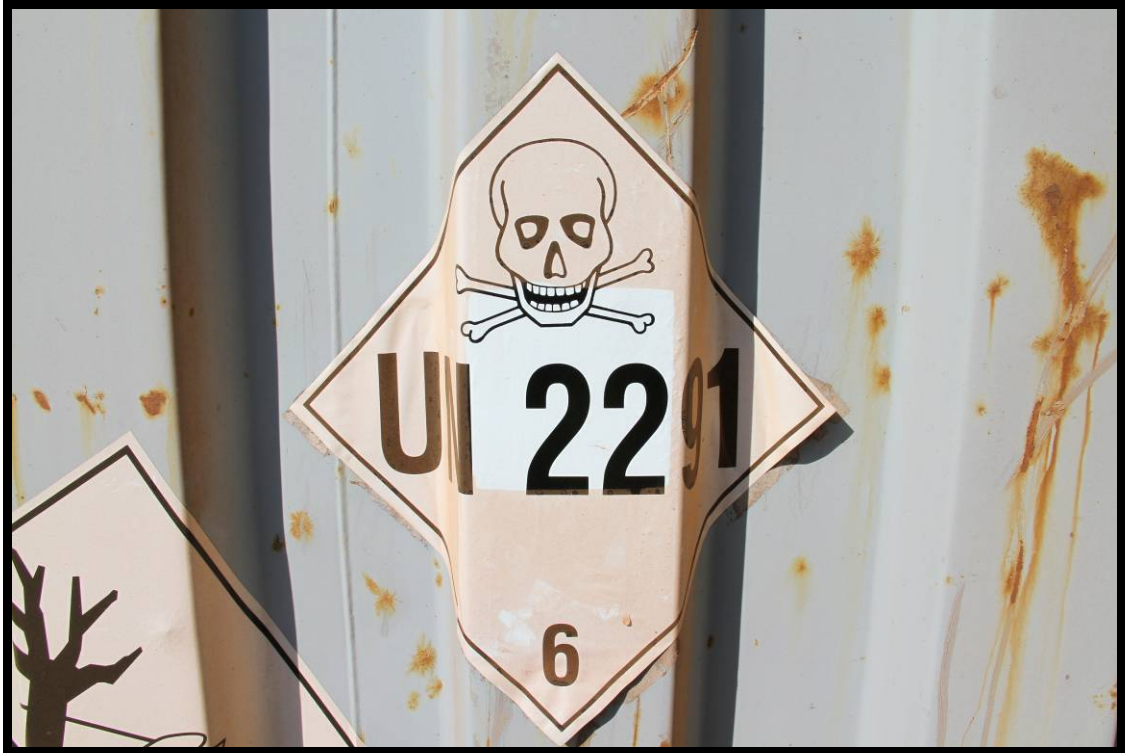
Swab samples were taken from the surface of the Dangerous Goods placard stickers applied to external surfaces of the Magellan containers. DEC understands that these stickers were applied to the shipping containers by Magellan Metals before the containers left the mine site. The stickers were chosen as the sampling point because initial X-ray fluorescence (XRF) screening by DEC found that lead was incorporated into the material of the walls of a large proportion of containers tested (both Magellan containers and non-Magellan containers).

**Photograph 3: A dangerous goods placard sticker on a Magellan shipping (sea) container**

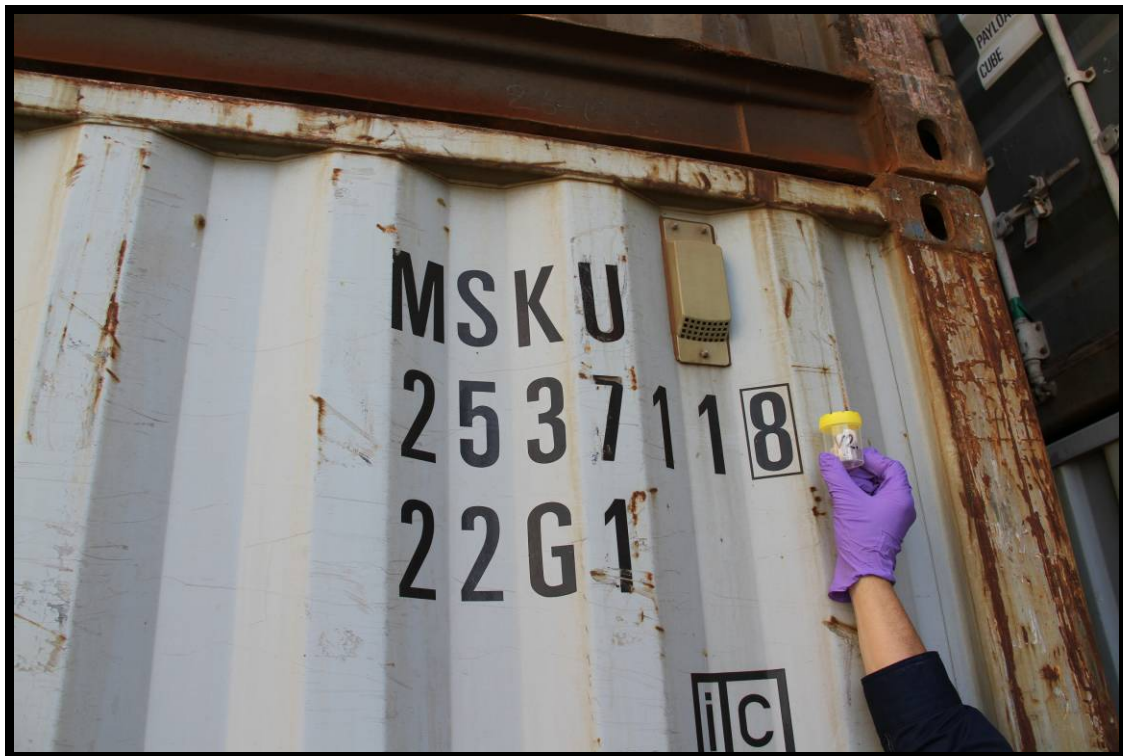
Five vent samples (marked V1 - V5) were obtained by swabbing the plastic ventilation points located on the top walls of the shipping containers on 4 January 2011. An additional two

**Photograph 4: Swab sample V2 collected from a plastic vent**

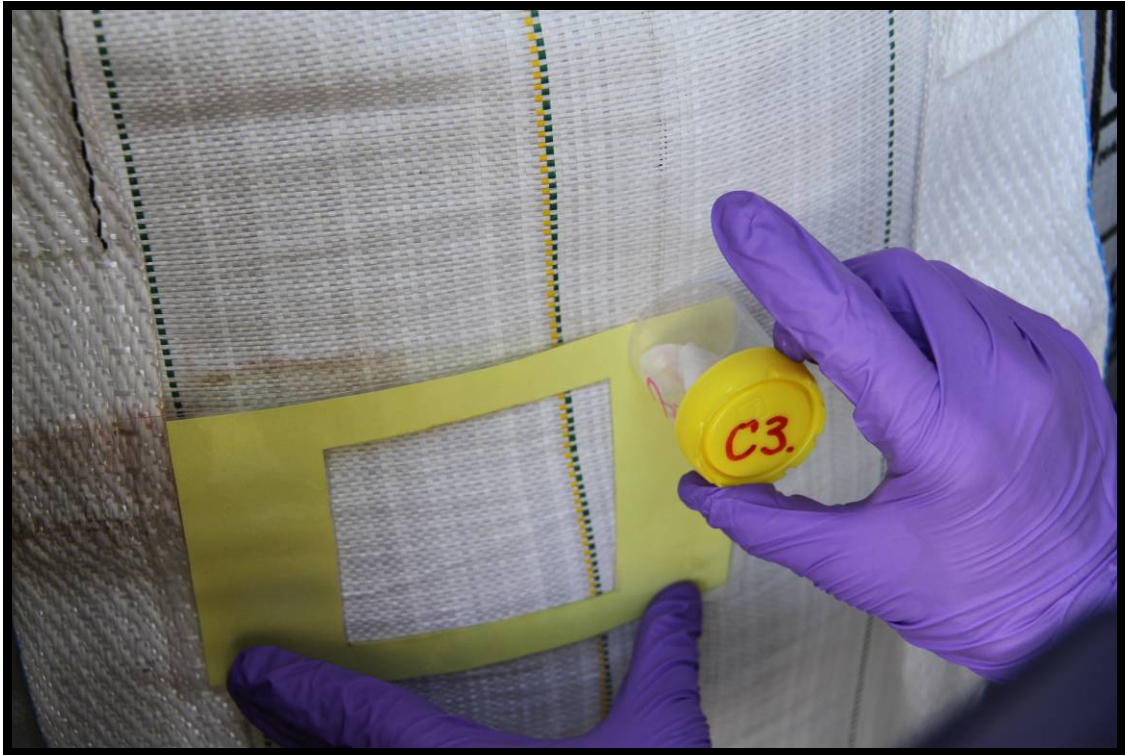
- C1 Interior of container, inside door next to air monitor.
- C2 Interior of container, wooden floor.
- C3 Outside surface of a product transportation bag containing lead carbonate, which had visible staining, and which was inside the container (Photograph 5).
- C4 Interior of container, from a sticker.
- C5 External surface of container, from an accumulation of red dust located on the bottom ledge (Photograph 6).

**Photograph 5: Swab sample C3 as collected from the outermost bag which was inside the Magellan shipping (sea) container**

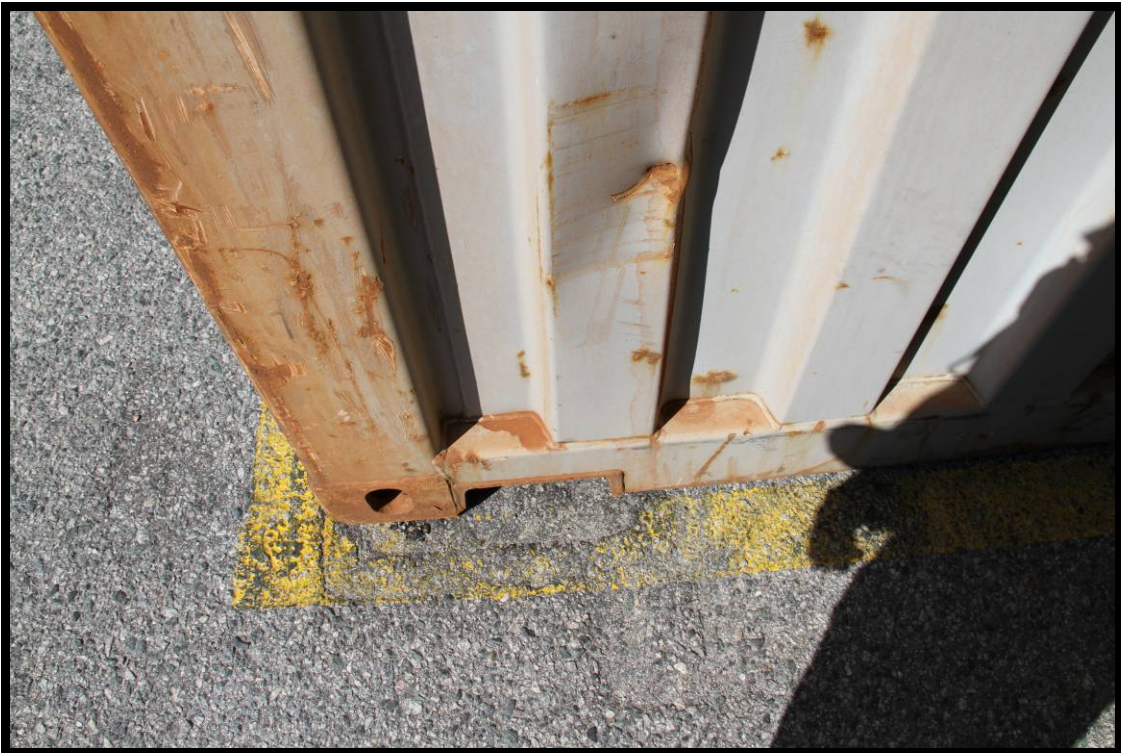
Isotopic ratio analysis of dust samples from the plastic vents on Magellan containers showed that Magellan was not a major source of the lead identified in three of the samples. Another two samples were found to have a possible slight contribution of Magellan lead when compared with the background reference samples. Analysis of the sixth sample found that Magellan lead was likely to be the primary source of the lead present. Magellan lead was also found to be the primary source of lead in a small accumulation of dust on the external ledge of a container, although there was some indication of a mixture of sources.

**Photograph 6: A small dust deposit on the outside of the Magellan shipping (sea) container, swab sample C5 was collected from this location.**

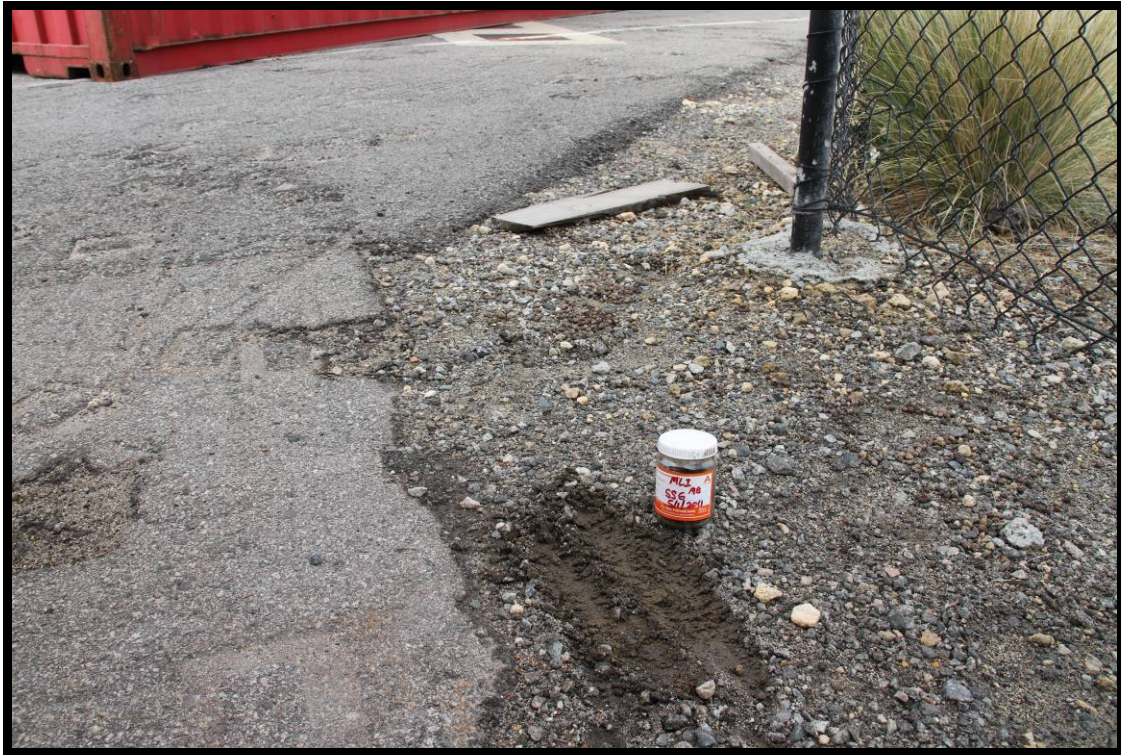
then placed in a secured evidence bag before being transported to the ChemCentre for lead analysis. Photograph 7 shows one of the soil sampling locations.

Soil samples SS1 to SS6, collected adjacent to ILS' Magellan container storage area indicated lead concentrations between  $29\text{mg}/\text{kg}$  and  $52\text{mg}/\text{kg}$ . Isotopic ratio analysis provided indications of a possible contribution from Magellan lead when compared with background reference sample BGS-1. However, ChemCentre noted that further analysis including a larger number of reference samples (BGS-2 was very different to all other samples) would be required to confirm whether Magellan lead was present in the soil samples (and not another lead source such as Broken Hill lead).

**Photograph 7: A soil sample collected along the boundary of the container storage facility.**

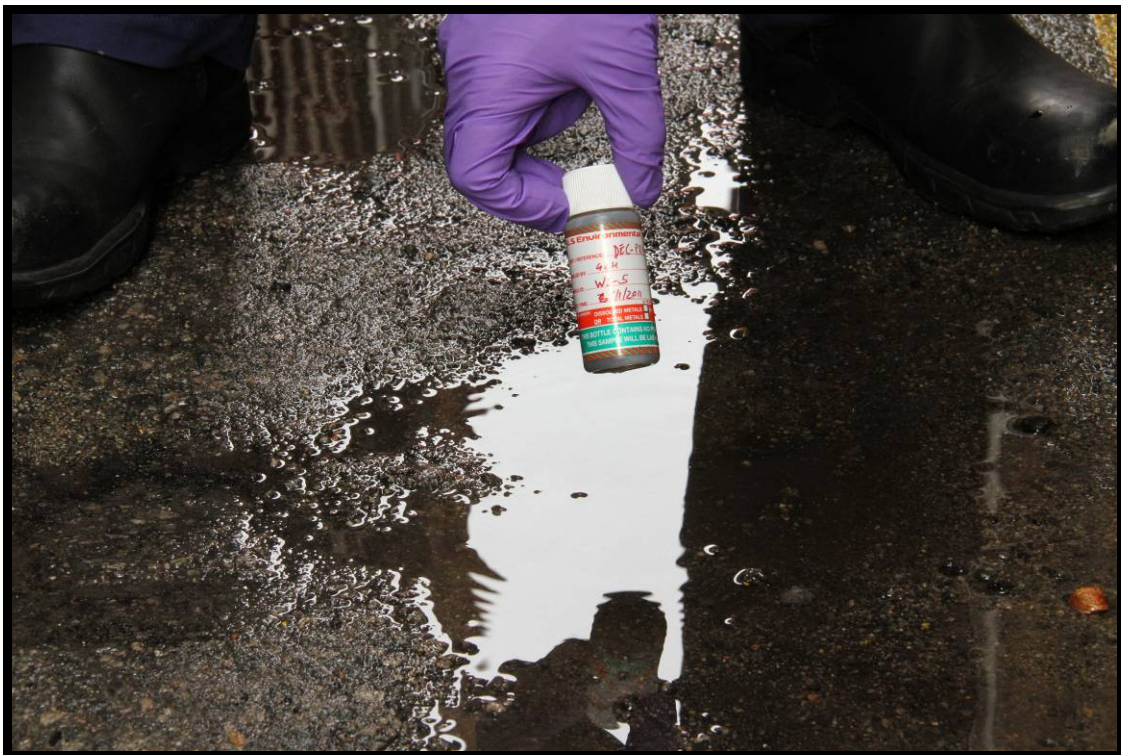
The water samples were extracted from the puddles using a new syringe for each sample. Each sample was then transferred into a laboratory-supplied sample container for metals analysis. The samples were not filtered in the field, to ensure that analysis would determine the total lead present (both dissolved and solid particles). Photograph 8 shows one of the water puddles.

Samples from rainwater puddles at the Magellan container storage area (WS-1 to WS-5) indicated lead concentrations between 0.03mg/L and 0.66mg/L. Isotopic ratio analysis found that all samples (and in particular WS-3 and WS-4) show indications of a possible contribution from Magellan lead when compared with the background reference samples, however, ChemCentre noted that further analysis would be required to confirm this.

**Photograph 8: A water sample collected after rainfall occurred at the container storage facility.**
