SURVEY OF FORESHORES OF THE FRANKLAND AND GORDON RIVERS

A REPORT BY APACE GREEN SKILLS AND DR LUKE PEN
FOR THE FRANKLAND GORDON CATCHMENT MANAGEMENT GROUP
JANUARY 1998

A Report Prepared For The
Frankland Gordon Catchment Management Group

by
APACE Green Skills and Dr Luke Pen (Water and Rivers
Commission)

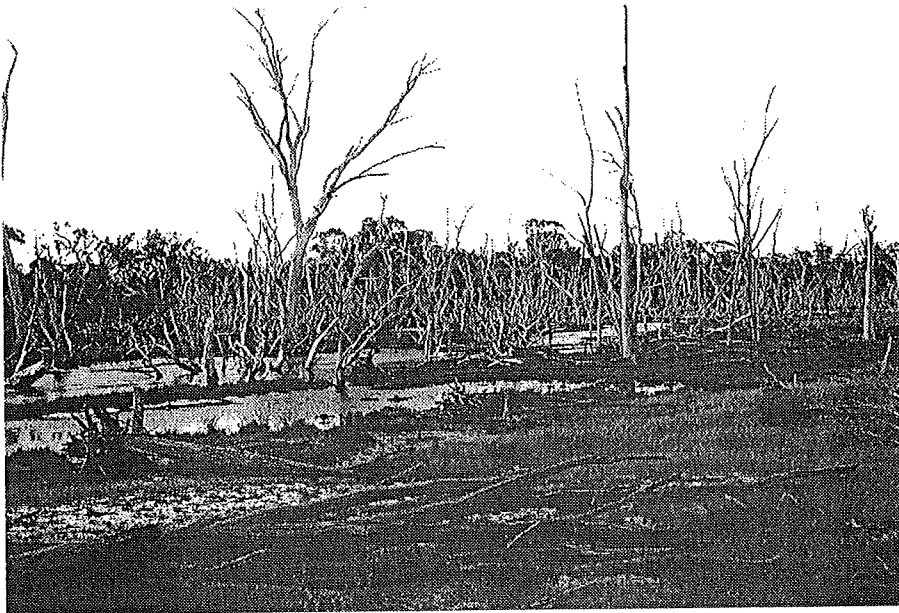
Extensive areas of foreshore show riparian vegetation affected by salinisation.

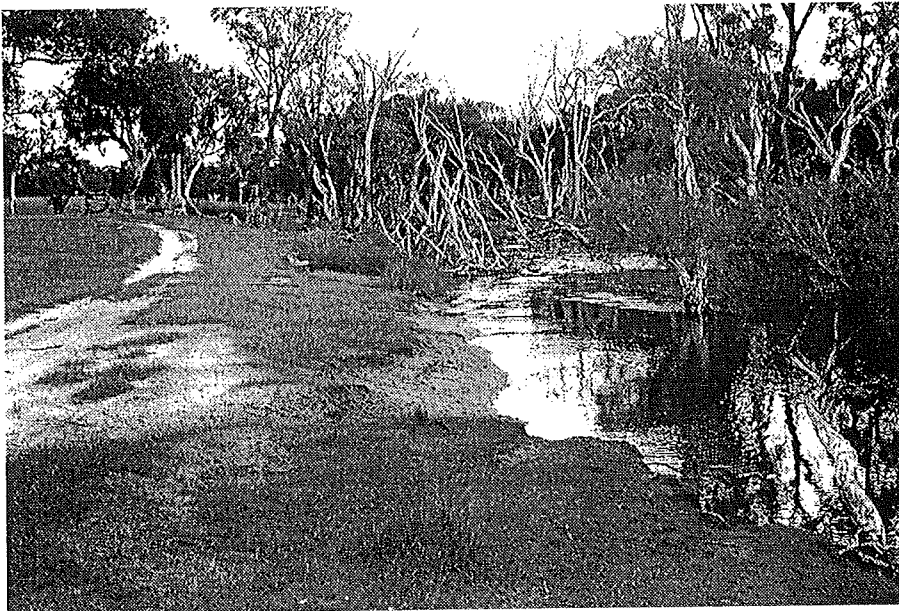
Erosion occurring on an access point to the Gordon River.

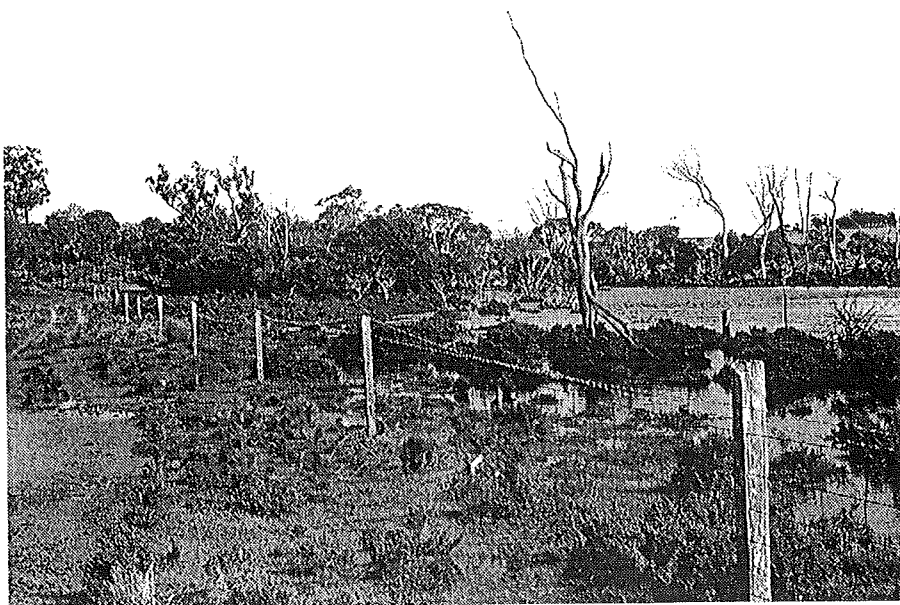
Samphire flats on fenced foreshore of Gordon River.

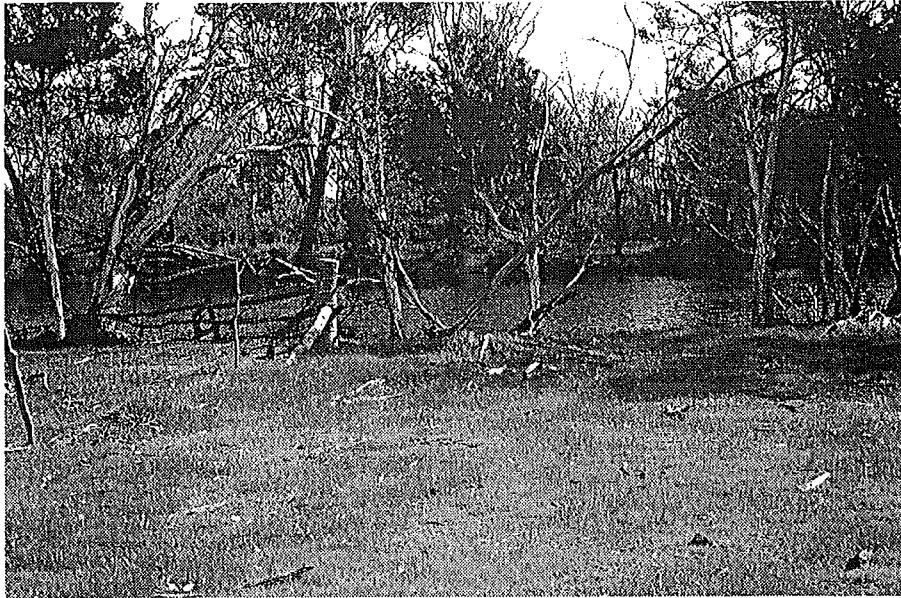
*View of Gordon River foreshores:
B3 Grade on opposite bank.
C2 Grade on near foreshore.*

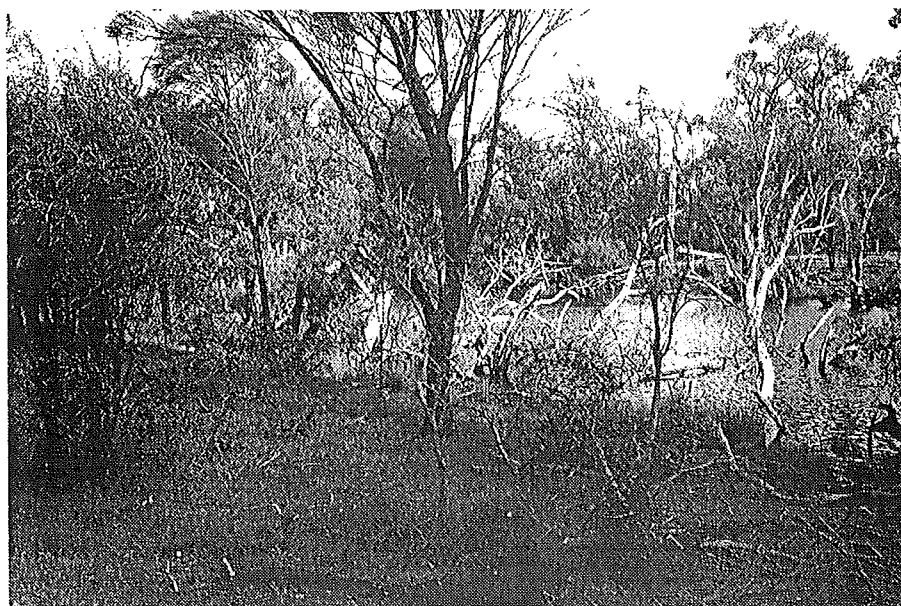
*Golden wattle, Acacia saligna,
regenerating
along the Gordon River foreshore.*
