**LAND WATERLOGGING  
NORTH OF LAKE TOOLIBIN**

**K. McIntosh  
A. Harris  
June 1990**

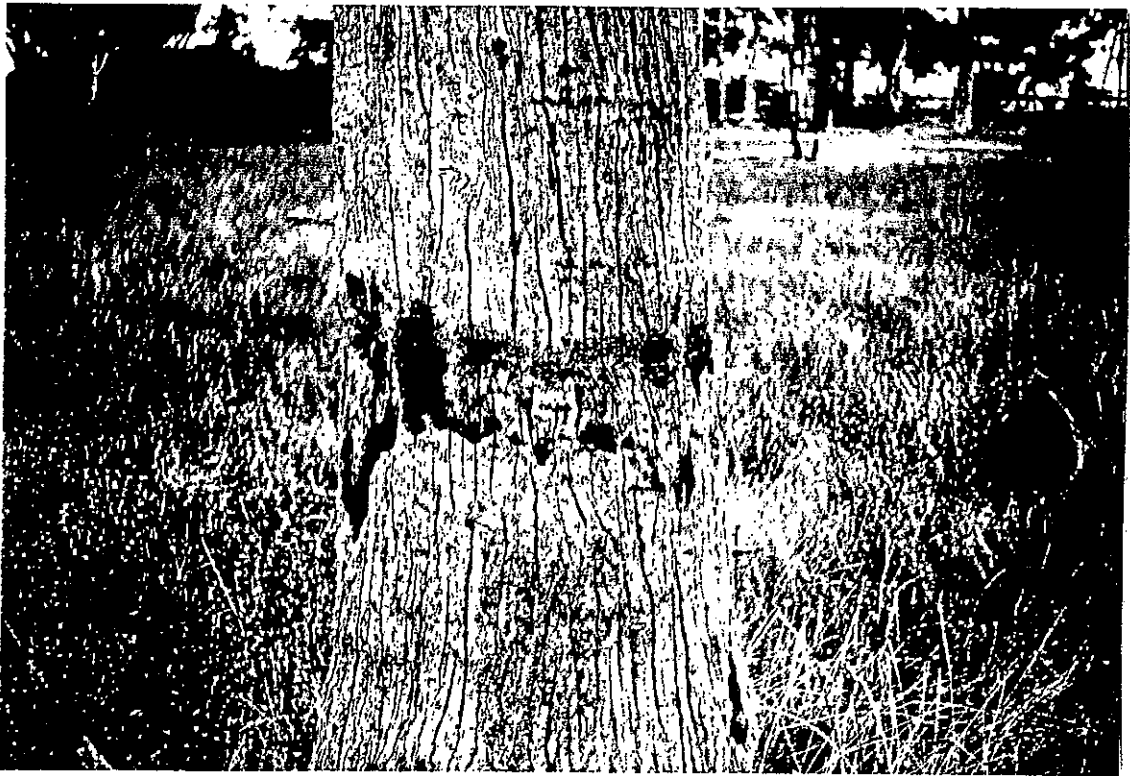
urceolaris and M. lateriflora are the dominant understorey species, with admixtures of Cyperaceae and Halophytic species. Health of the vegetation within low lying areas of the reserve is in decline. A large number of overstorey deaths are attributed in part to ringbarked trees, (Photo 1) a legacy from when grazing was the main land use of the reserve. This practice ceased a number of years ago.

Photograph 1: Eucalyptus wandoo stag ringbarked to allow grazing within the reserve (refer Map 1 for location).

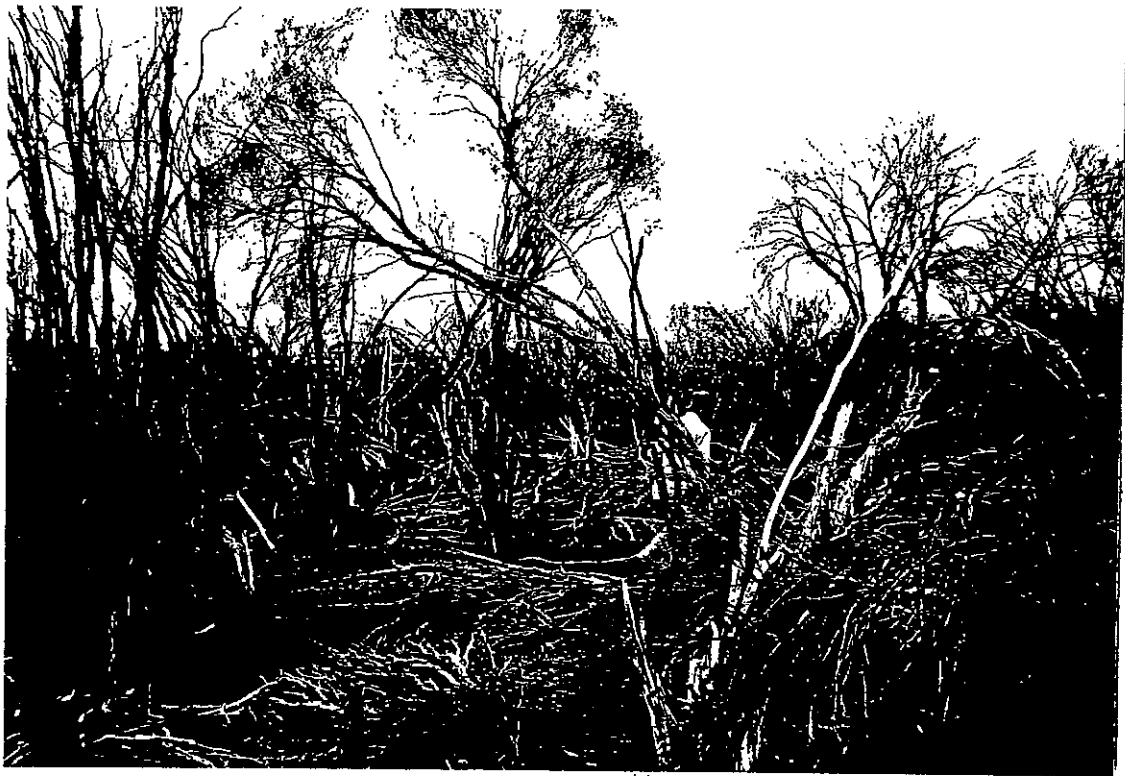
With the clearing of surrounding areas for agriculture, surface water run off into the reserve has increased. Water samples of bores, established by the Department of Agriculture, have also shown an increase in groundwater salinity levels. Affects on vegetation of the increased drainage from cleared farmland is evident. Recent deaths of Salmon Gum were noted within the reserve. Also a significant number of Melaleuca deaths have occurred within areas of inundation (Photo 2). (Chadwick pers Comm.)

Photograph 2: Melaleuca sp. deaths caused by inundation and increasing salinity (refer Map 1 for location).

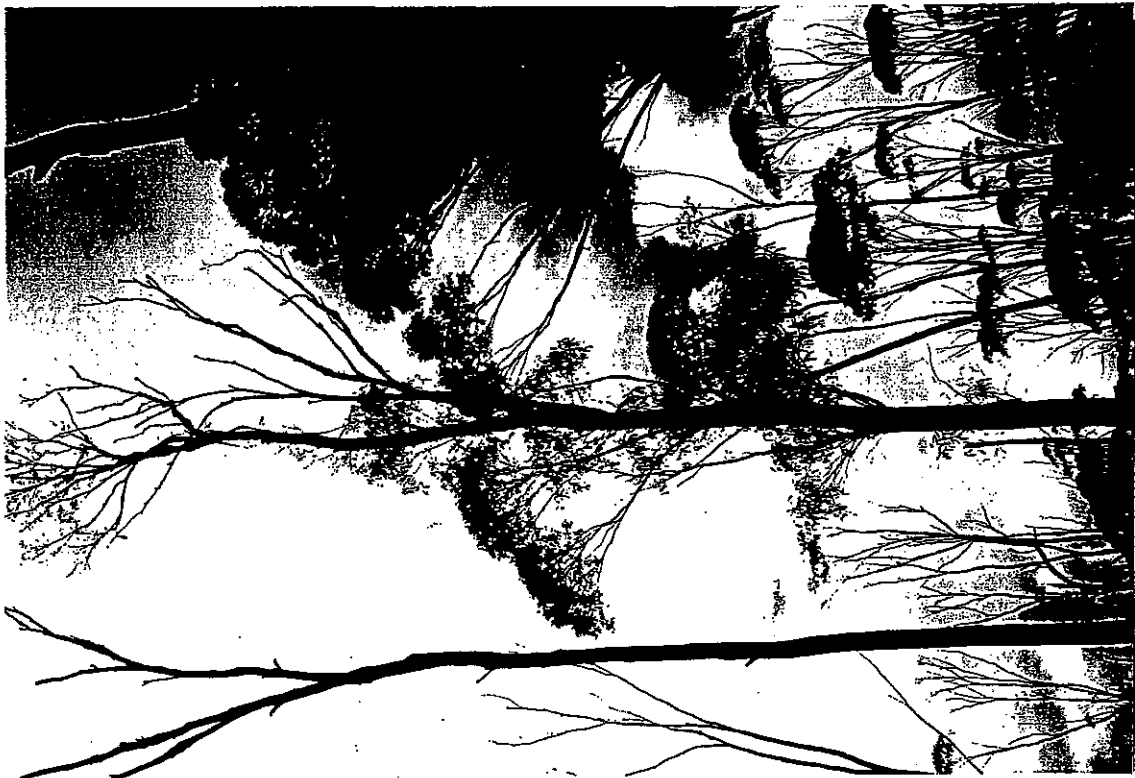
Photographs 3 & 4 show Salmon Gum and Melaleuca respectively in a state of decline. This was typical along drainage routes through the reserve. Studies on the vegetation of Lake Toolibin in 1987 have indicated that the York Gum is not able to withstand even low soil salinities and has a lack of tolerance to soil saturation. Melaleuca sp. is also susceptible to increasing levels of salinity.

Photograph 3: Eucalyptus salmonophloia under stress (refer Map 1 for location).

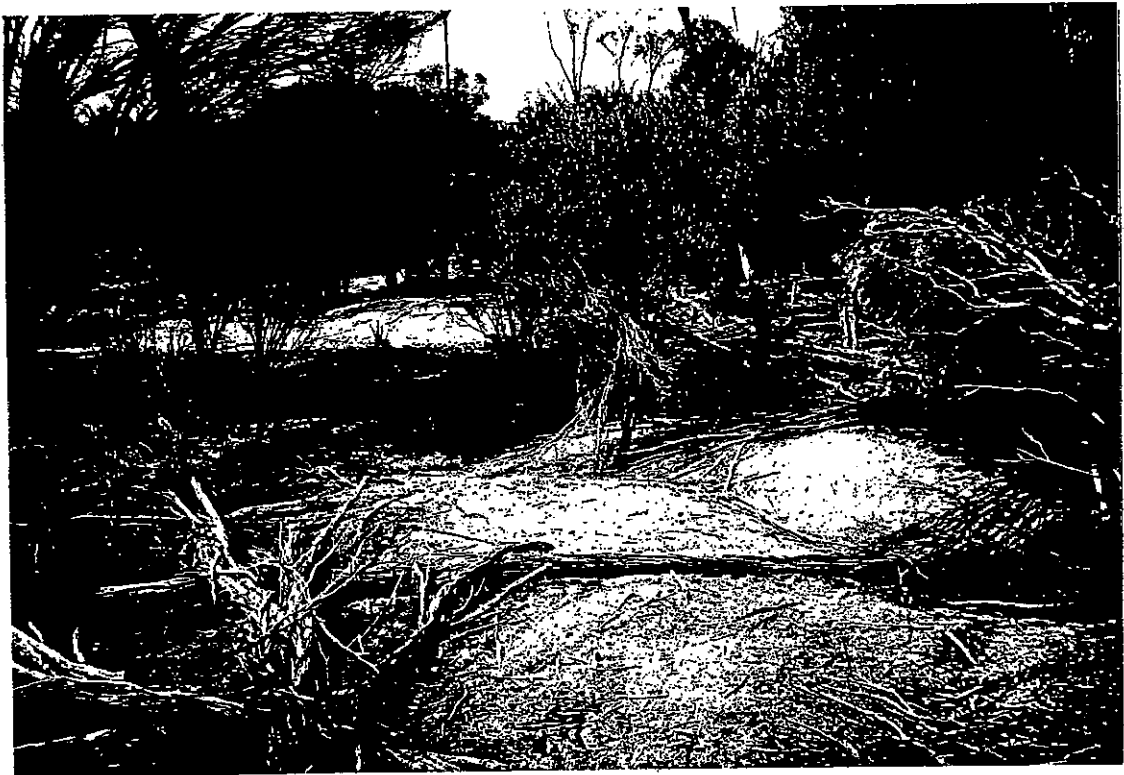
Cyperaceae and Halophytic species (Schoenus and Samphire) were the major components of ground dwelling species within wetter areas of the reserve. The presence of this understorey type reflects the underlying soil and moisture conditions. The presence of Samphire became more frequent as inundation increased (Photo 5). The formation of soil mounds (Photo 6) is evident through the effects of grazing, winter waterlogging and summer drying. In some areas salt crusting of the surface of bare soil patches and cracking of the surface suggests that soil structure has been damaged. Plant germination and growth in these areas is severely restricted.

Photograph 6: Shows mounding of soil surface in an area of drainage and seasonal water ponding (refer Map 1 for location).

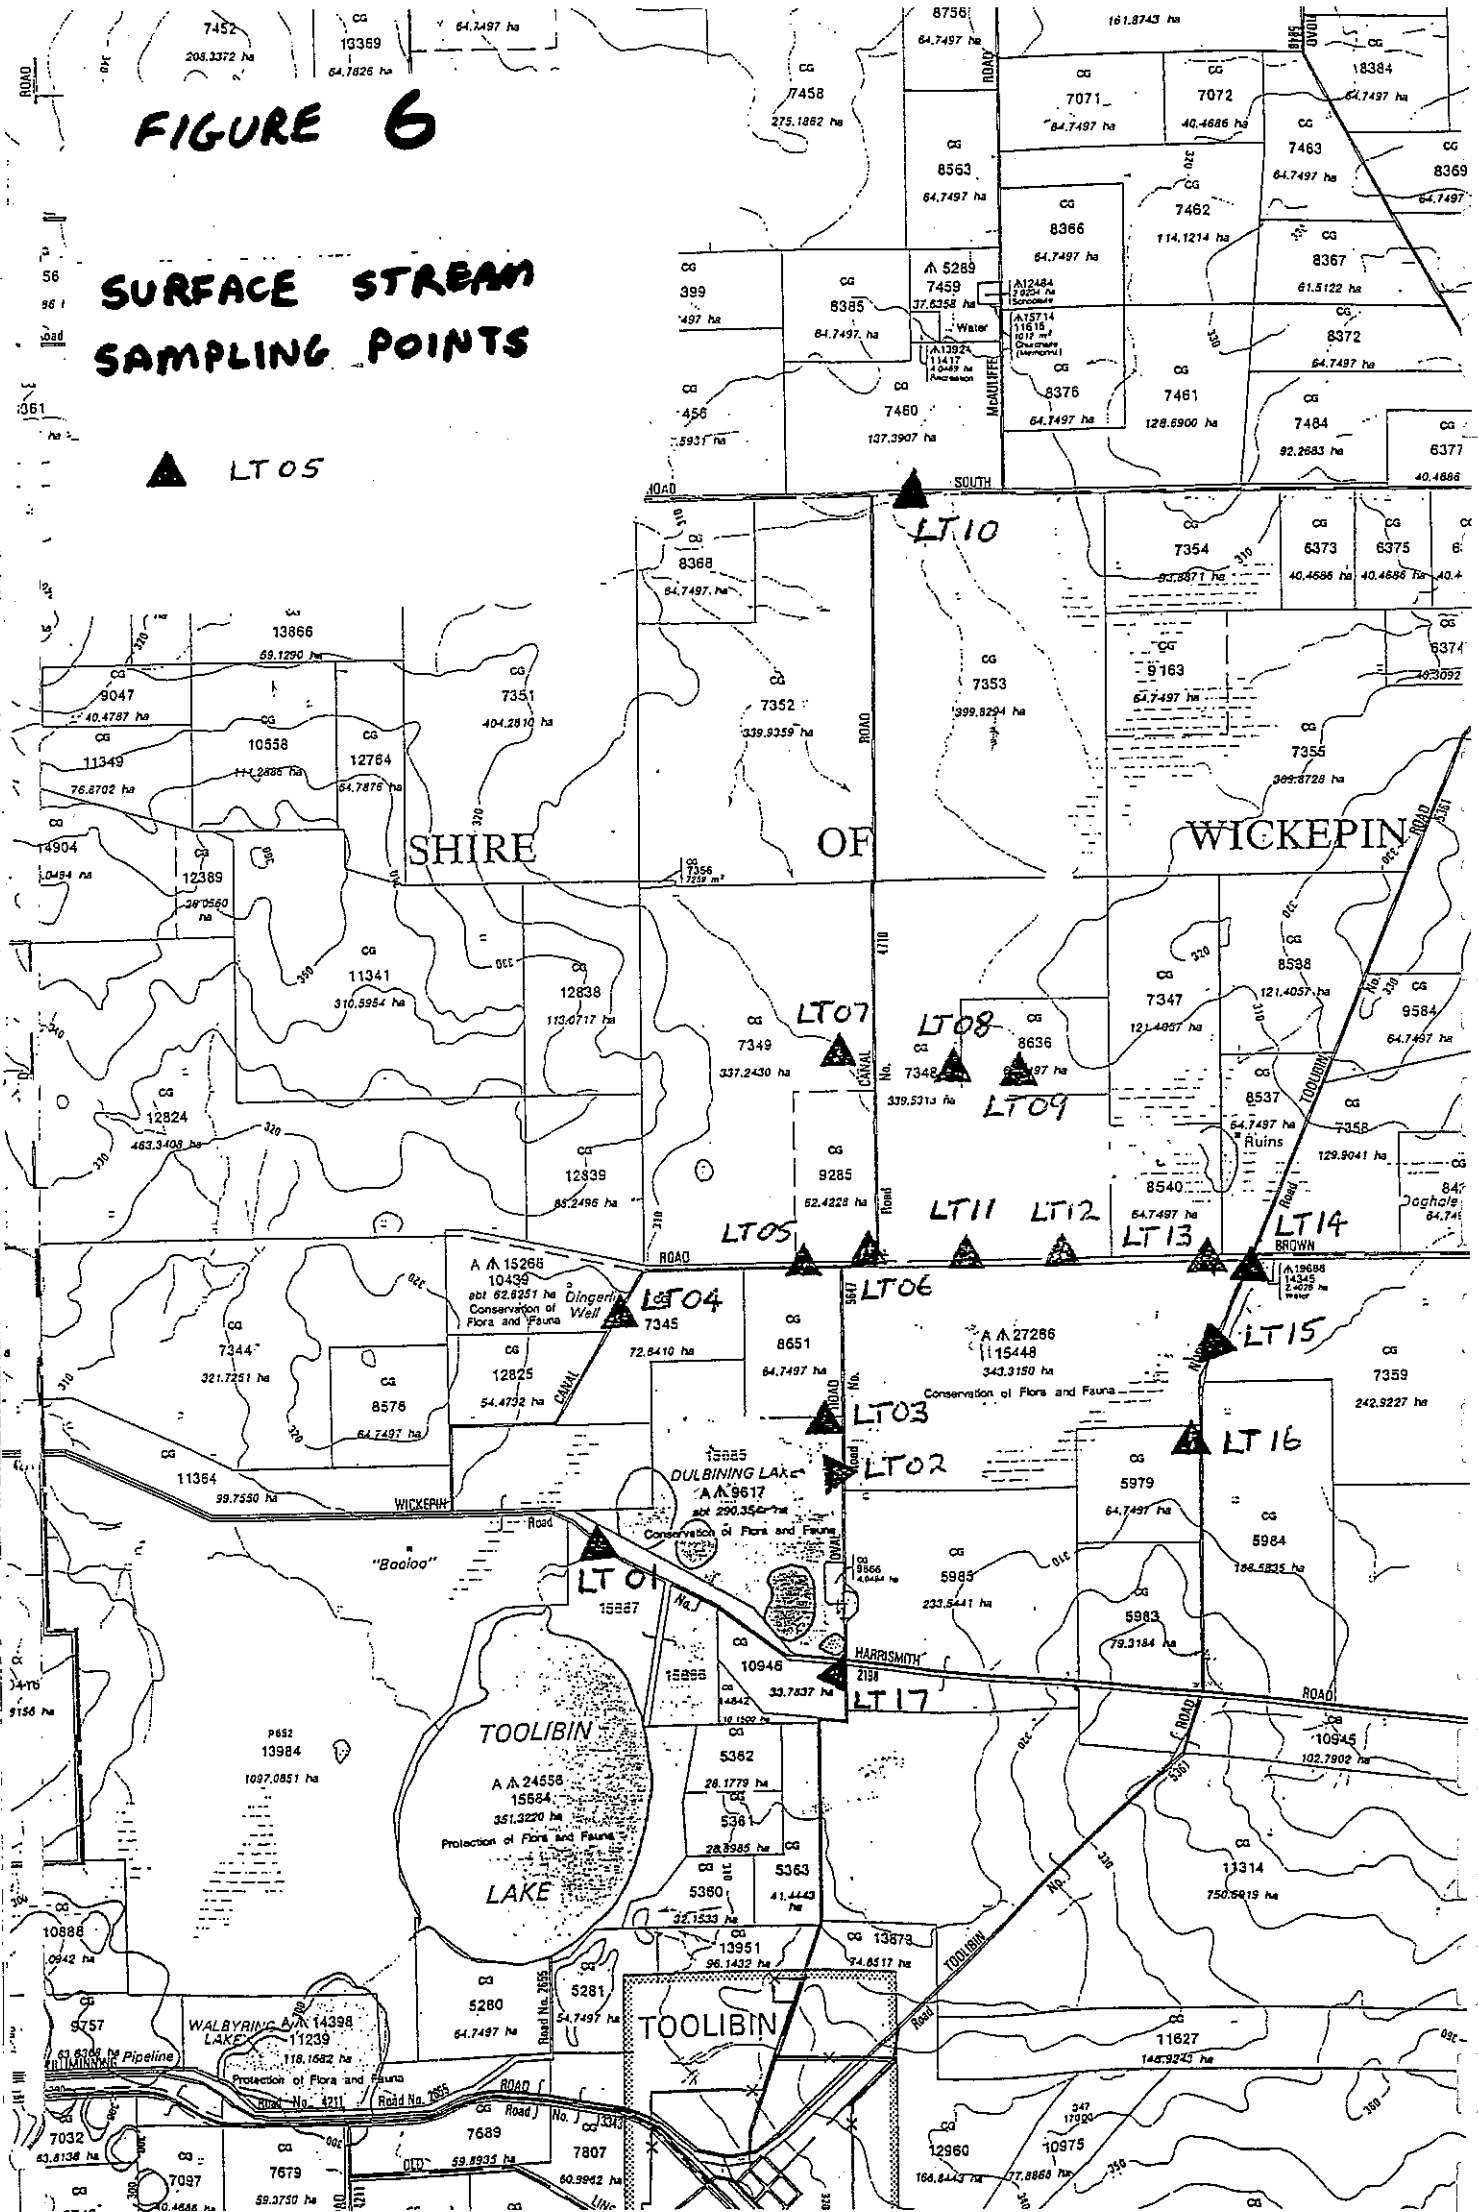
# FIGURE 6

## SURFACE STREAM SAMPLING POINTS

- o Operation of WAWA monitoring stations be maintained
- o 1990 vegetation survey should proceed
- o a surface water monitoring programme for streams surrounding Reserve A27286 be carried out during the 1990 winter (K. McIntosh, P. Hawker and M. Elliott established this in June 1990 Figure 6). Data on stream salinity and "order of flowrate" to be recorded.
