# LEALHOLM EAST ROCKINGHAM

## ASSESSMENT OF SIGNIFICANCE

COMMISSIONED BY  
DEPARTMENT OF CONSERVATION AND LAND MANAGEMENT (CALM)

MAY 1998

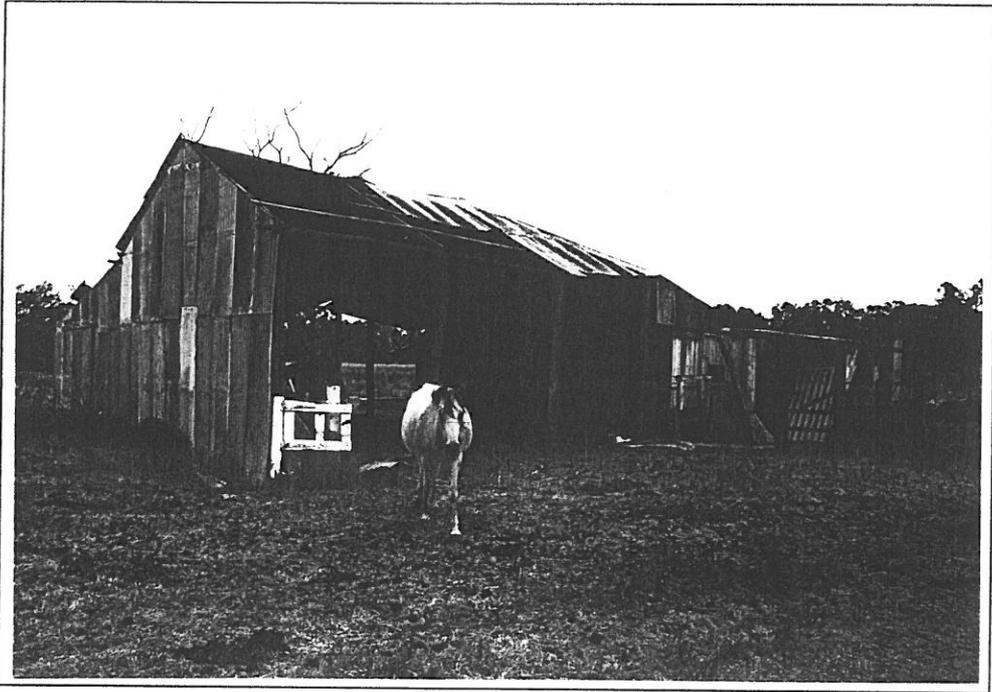
The barn, view looking north-west. Note the sheeting missing from the roof.

- repair of the roof and west facing wall of the barn;
- apply preservative oil treatment to exposed joinery of the dwelling and adjacent structures as an interim measure to prevent further deterioration;
- carry out an inspection / treatment for termites to the dwelling, outbuildings and barn (although no termites were identified, older buildings are highly susceptible to termite attack).

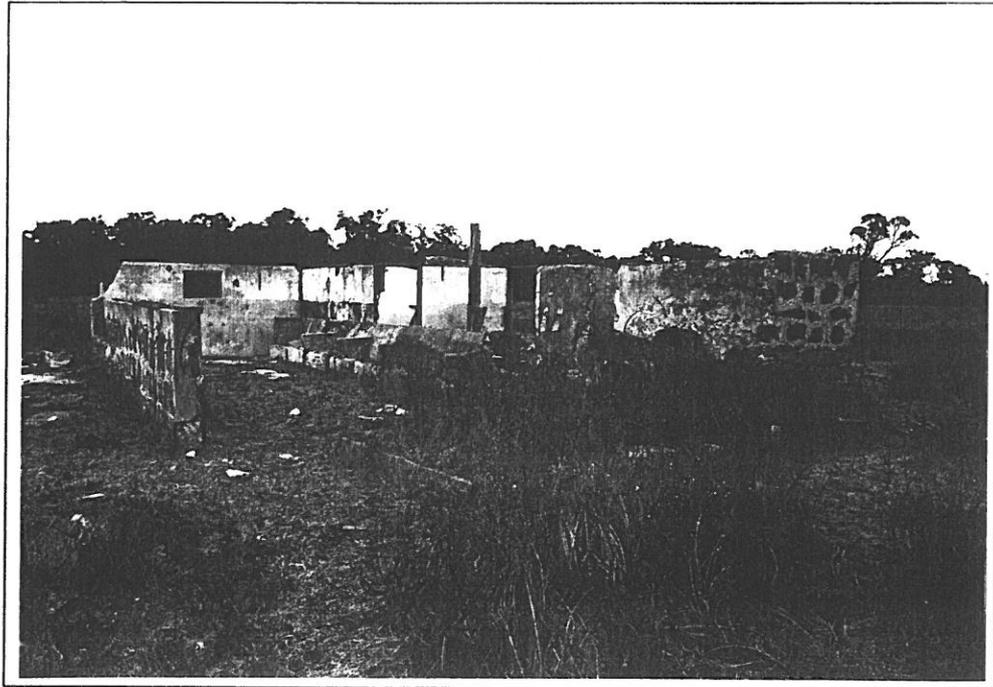
Although in ruinous condition, all roof fabric is missing but most masonry walling of the dairy remains intact and appears to be in a relatively stable condition. The structure is composed of several different materials including vuggy lacustrine limestone blocks, limestone rubble, and brick walls, and a concrete floor. Some areas of wall have been rendered. The layout of the dairy may be described as follows: the main area is a rectangle oriented north-south, with a brick and mortar feed trough extending through its centre. A small room is located off to the west from this area, and the southern end of the building contains two small rooms divided by a narrow passage.

Dairy ruin, view looking south.

- (subject to the initial preparation of a conservation plan) clear soil and debris from dairy ruin and ensure that the structure is well drained to prevent damage from damp;

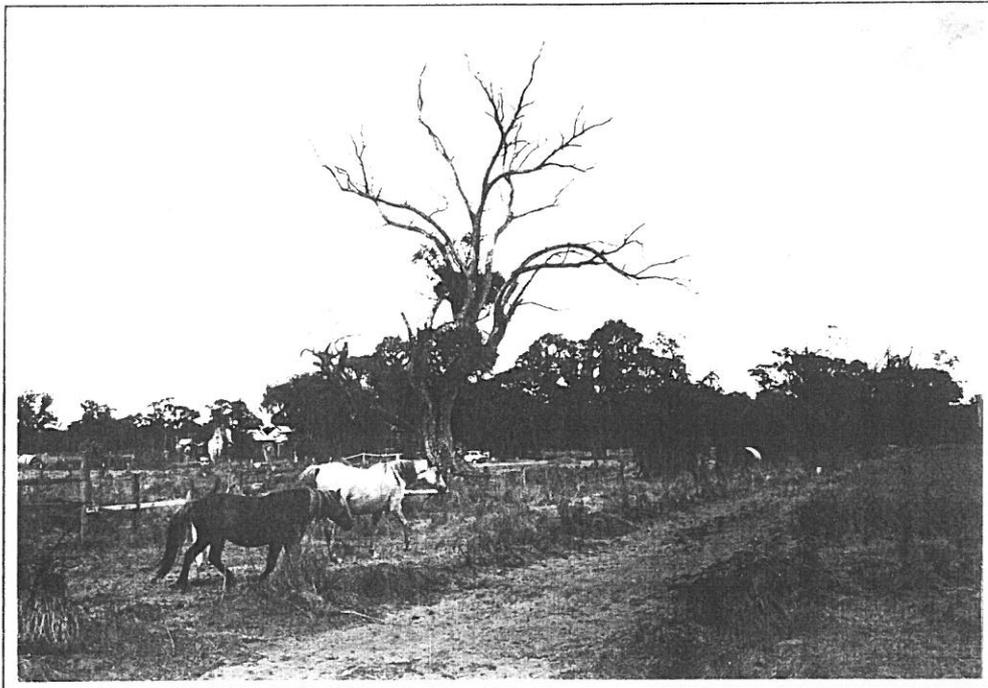
The "killing tree" immediately west of the barn, with the homestead and outbuildings in the background.
