Waterway assessment for the Lockhart River: Lake Kurrencutten to the Camm River confluence

Report no. WRM 55
December 2008

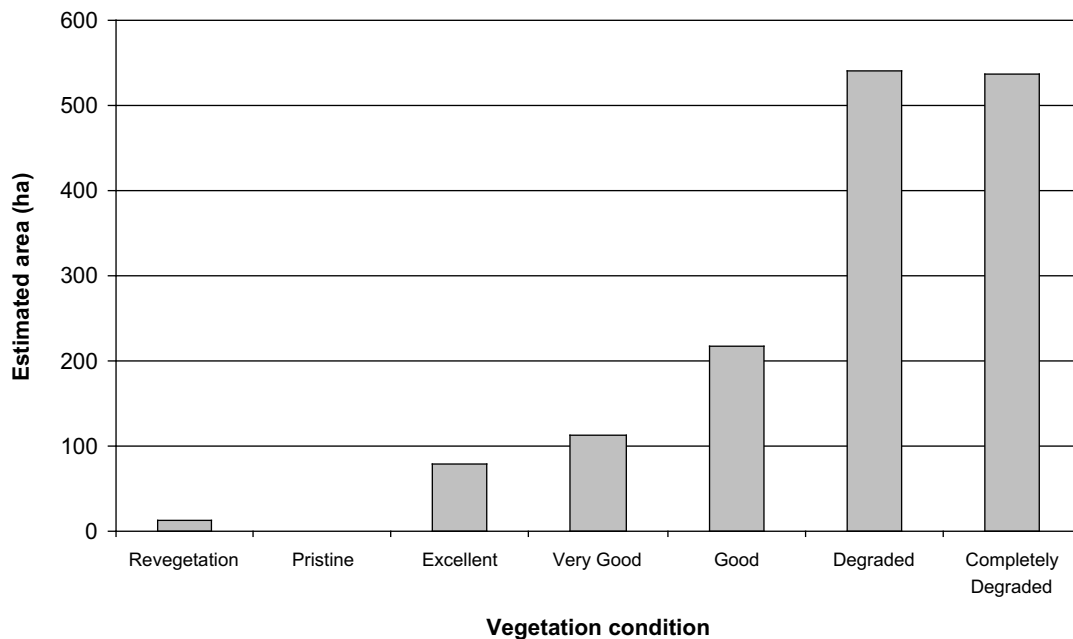
Figure 1 Estimated area of vegetation surveyed within each vegetation condition rating.

of percentage of each condition in each remnant and an estimate of the proportion of vegetated area in each remnant, it clearly shows that most of the vegetation surveyed in the study area is in degraded or completely degraded condition. In most cases, the vegetation has been assessed as degraded or completely degraded because of the loss of native species, which have either not been replaced by anything (largely bare areas formerly supporting vegetation), or have been replaced by salt-tolerant species (where they probably would not have been present or only at low densities) or weeds.

The amount of *degraded* and *completely degraded* vegetation present in the lower part of the landscapes indicates that significant changes affecting vegetation condition have occurred within the Lockhart River system. Increases in salinity, changes to the watertable and changes to period of inundation, all a result of widespread clearing for agriculture, are the most obvious causes of change.

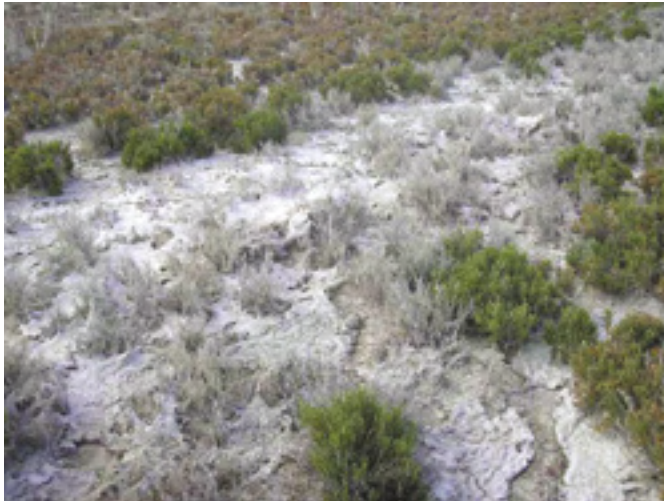
Many areas surveyed were grazed by livestock for part of the year, particularly summer and autumn to fill the feed gap at that time. Damage to the soil surface, which leads to erosion, was observed, which compounds the soil structural decline that has resulted from increased salinity. Natural regeneration is also likely to be affected by livestock grazing. Faeces and urine are likely to be adding to the nutrient loads in the waterways. An example of this was seen in LR03 (Larke's), where samphire appears to have been killed as a result of being smothered by an algal bloom after the last floods (Photo 1).

Photo 1
Samphire killed after being smothered by an algal bloom (Larke's LR03)

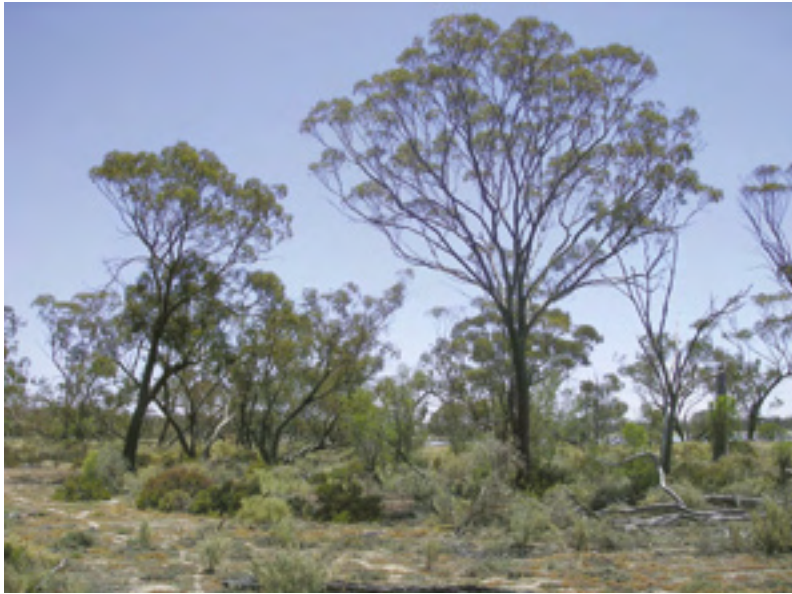
Photo A1.1: LR01
Good condition vegetation association 1: Eucalyptus salmonophloia, E. salubris and E. loxophleba very open woodland.

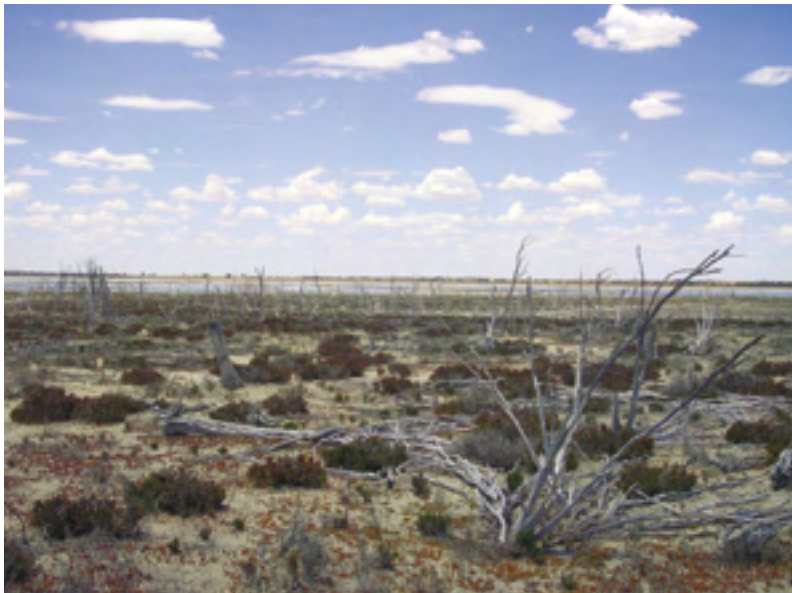
Photo A1.2: LR01
Degraded condition vegetation association 2: Halosarcia spp. sparse shrubland.

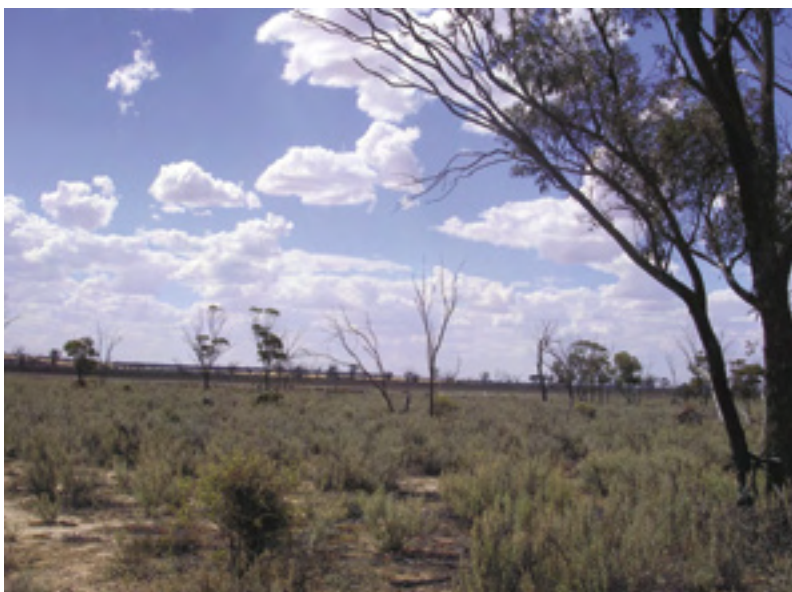
Photo A1.3: LR01
Very good condition vegetation association 3: Eucalyptus myriadena very open woodland.

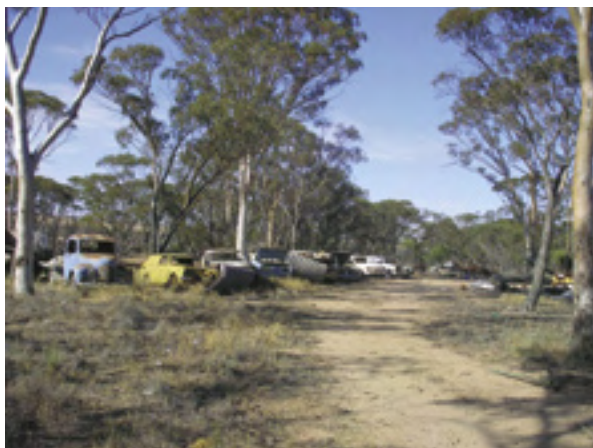
Photo A1.4: LR02

Apart from a vehicle dump, this site is good condition vegetation association 1: *Eucalyptus salmonophloia* and *E. loxophleba* subsp. *loxophleba* very sparse woodland on lower valley slope..

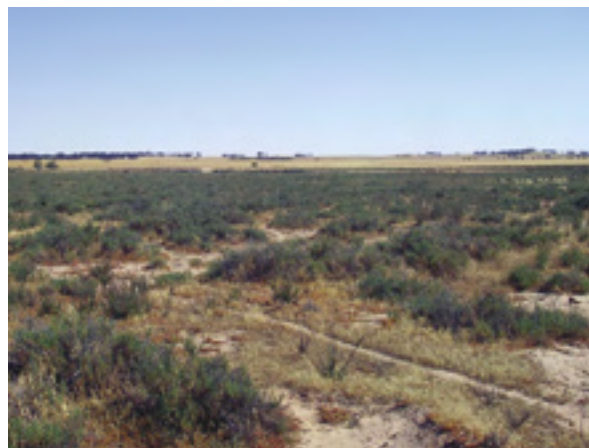
Photo A1.5: LR02

Completely degraded vegetation association 2: *Halosarcia* spp. open shrubland on floodplain. This would have been woodland prior to clearing

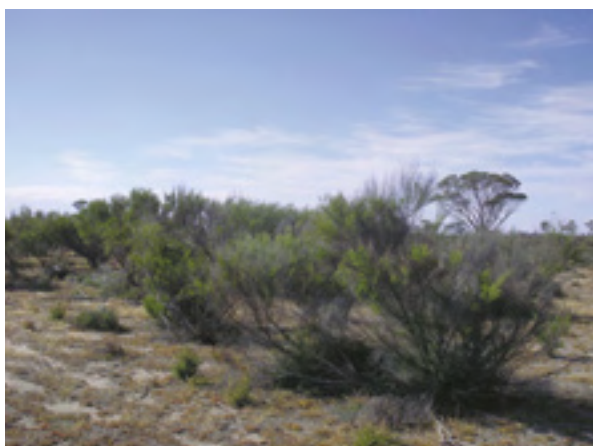
Photo A1.6: LR02

Small degraded patch within Vegetation 2, showing part of former composition prior to clearing.

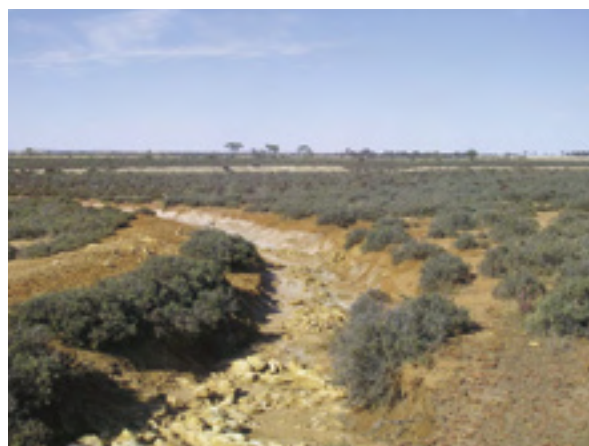
Photo A1.7: LR02

Surface drain on floodplain.

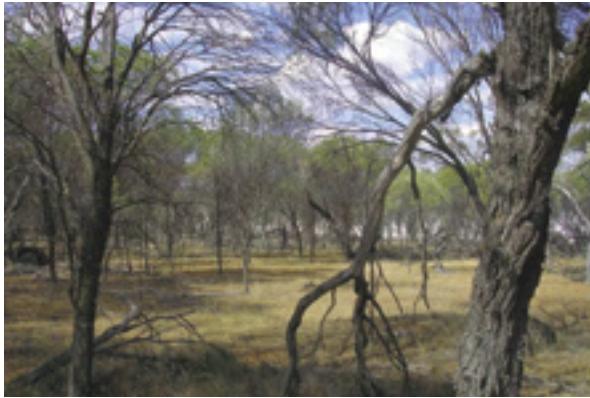
Photo A1.8: LR03
Excellent condition vegetation association 1: Eucalyptus loxophleba subsp. loxophleba very sparse woodland on lower valley slope.

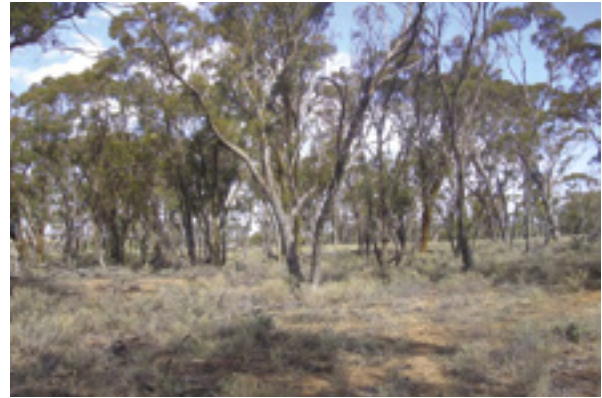
Photo A1.9: LR03
Excellent condition vegetation association 2: Eucalyptus longicornis and E. salubris sparse woodland on lower valley slope.

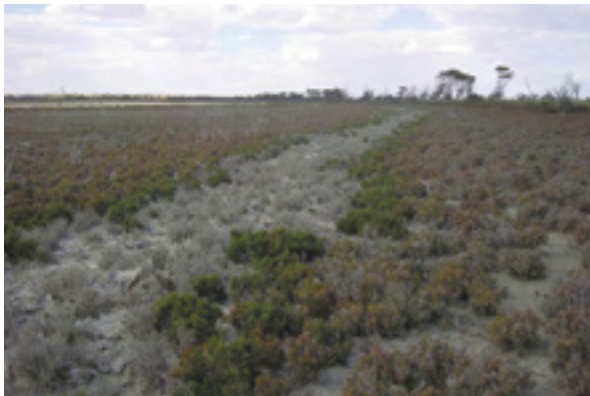
- Lichen was common in the woodland, indicating good soil condition and lack of salinity.
- There was a band of dead samphire around the main lake bed, which appears to have been smothered by a mat of algae resulting from the last flood event (2006).
- Gilgai were observed in the morrell / gimlet woodland.
- There has been some fencing and revegetation along the streamline flowing into the western side of the lake.
- Although there was water in the lake, there were no waterbirds.

Photo A1.10: LR03
Degraded condition vegetation association 3: Halosarcia open shrubland on floodplain. Note the line of dead samphire smothered by an algal mat and regeneration alongside.

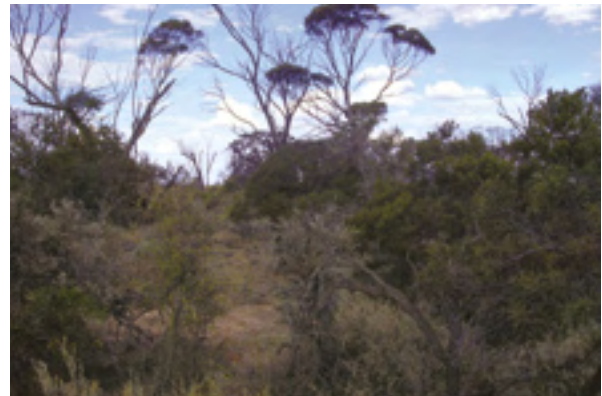
Photo A1.11: LR03
Good condition vegetation association 4: Eucalyptus myriadena very sparse woodland on lunette.

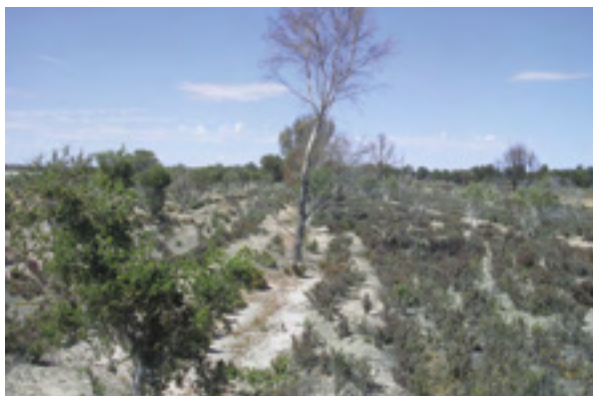
Photo A1.13: LR04
Revegetation: mixed species vegetation association 1. Note that there have been several recent deaths of planted species.

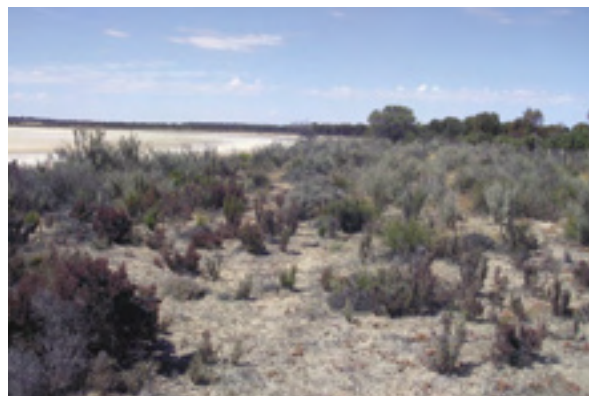
Photo A1.14: LR04
Good condition vegetation association 2: Halosarcia spp. very sparse shrubland. This stream edge vegetation was unusual for its high diversity of species.

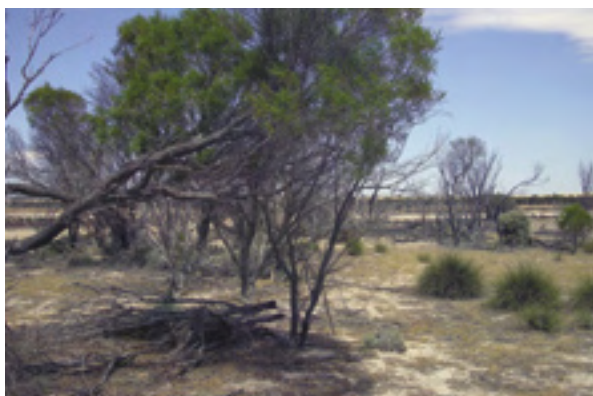
Photo A1.15: LR04
Good condition vegetation association 3: Acacia acuminata very sparse woodland on lunette.

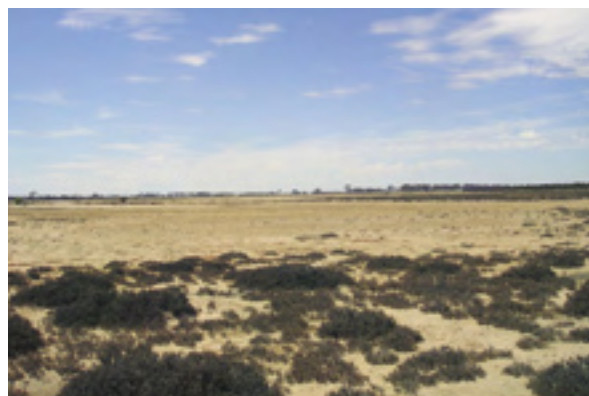
Photo A1.16: LR04
Completely degraded area on floodplain.

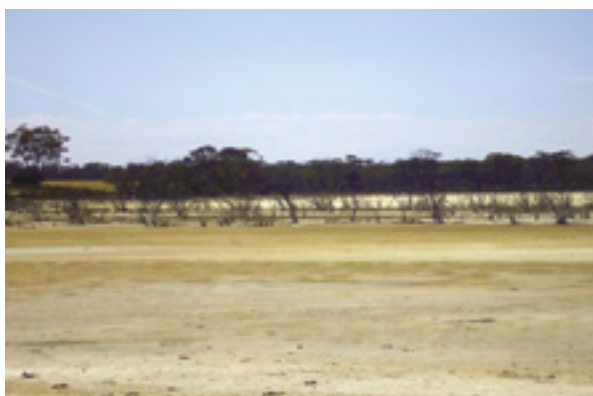
Photo A1.17: LR04
Completely degraded vegetation on floodplain.

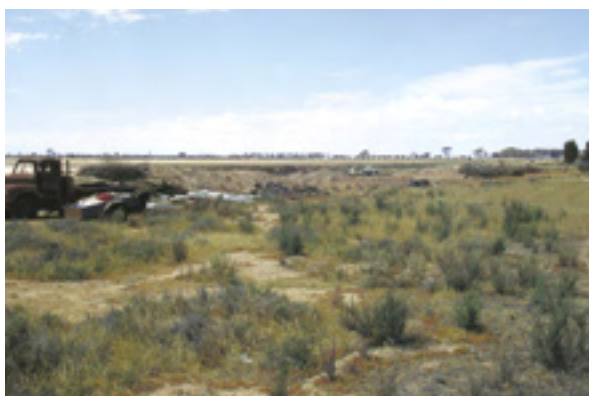
Photo A1.18: LR04
Rubbish dump on edge of waterway.

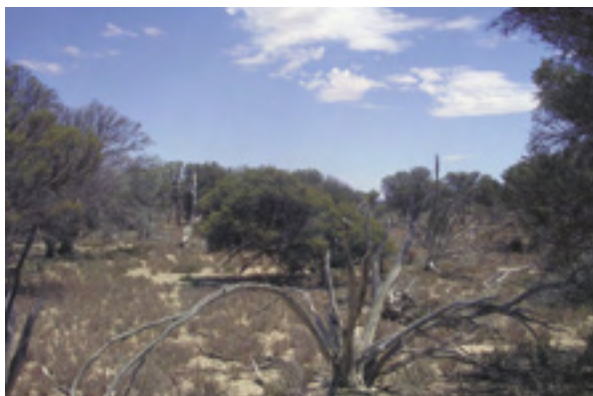
Photo A1.19: LR05

Very good condition vegetation association 1: Melaleuca brevifolia very sparse shrubland. This site was unusual in having living Melaleuca over samphire.

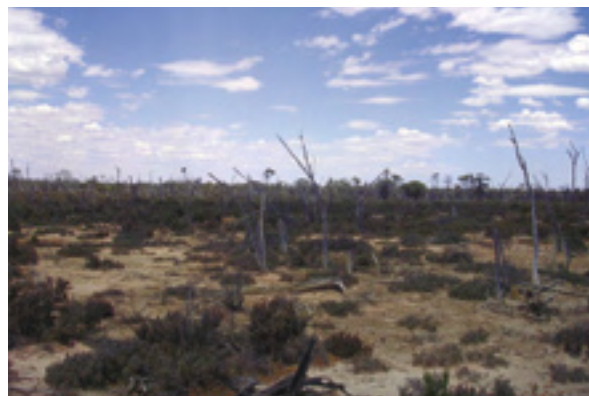
Photo A1.20: LR05

Degraded condition vegetation association 2: Halosarcia sparse shrubland. This vegetation would have been similar to Vegetation 1 but is now degraded.

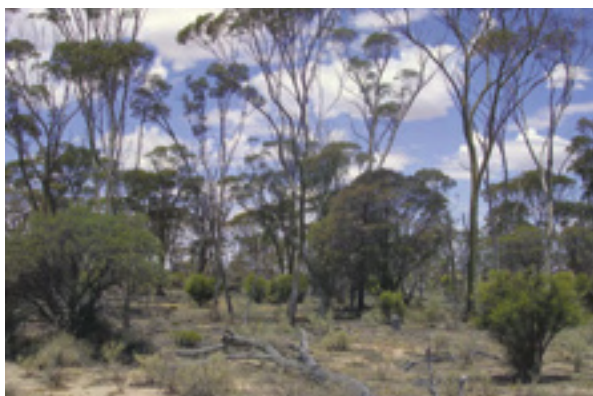
Photo A1.21: LR05

Excellent condition vegetation association 3: Eucalyptus salubris and E. salmonophloia very sparse woodland on lower valley slope.

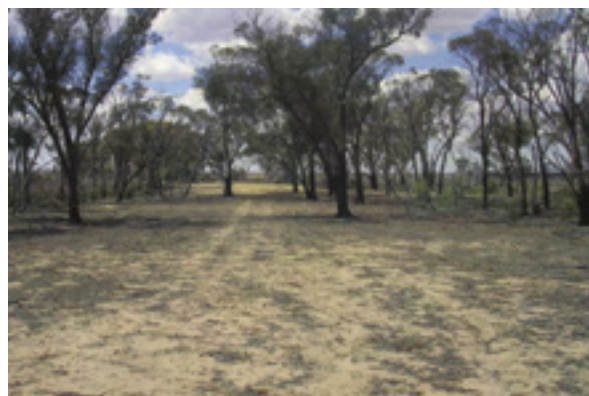
Photo A1.22: LR05

Good condition vegetation association 4: Eucalyptus kondininensis very sparse woodland on lunettes.

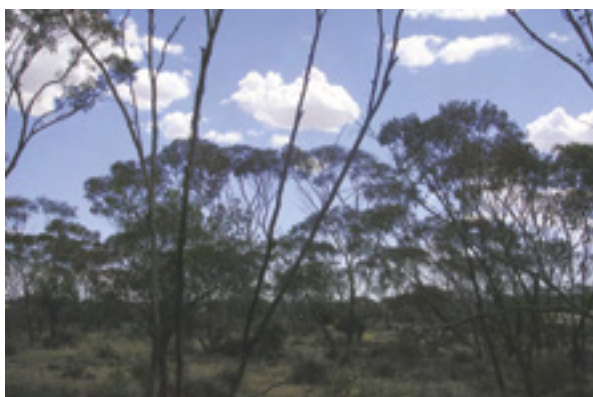
Photo A1.23: LR05

Good condition vegetation association 5: Eucalyptus loxophleba subsp. gratiae and E. horistes very sparse mallee on lunettes.

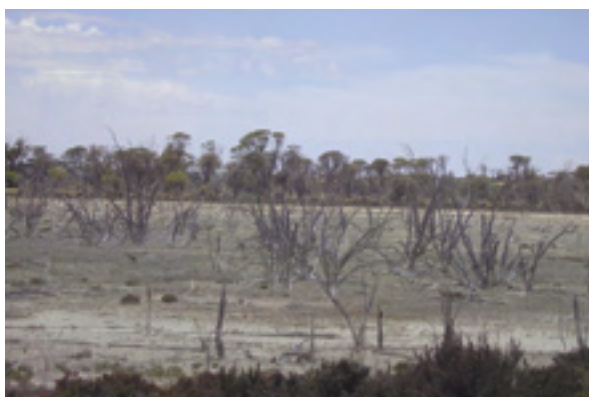
Photo A1.24: LR05

Completely degraded condition lake.

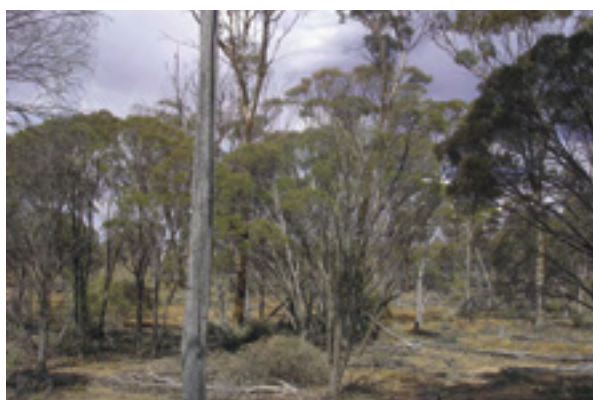
Photo A1.25: LR06
 Very good condition vegetation association 1:
 Eucalyptus salubris very sparse woodland on
 lower valley slope.

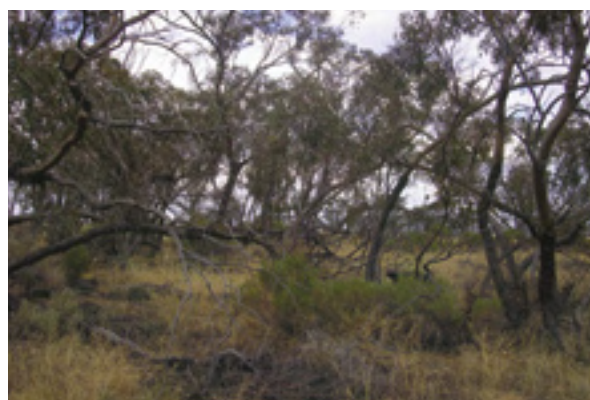
Photo A1.26: LR06
 Good condition vegetation association 2:
 Eucalyptus loxophleba subsp. gratiae very sparse
 woodland on lunette.

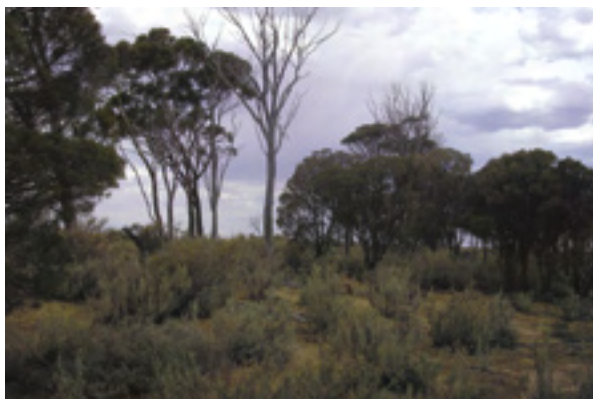
Photo A1.27: LR06
Very good condition vegetation association 3: Eucalyptus longicornis very sparse woodland on lunettes.

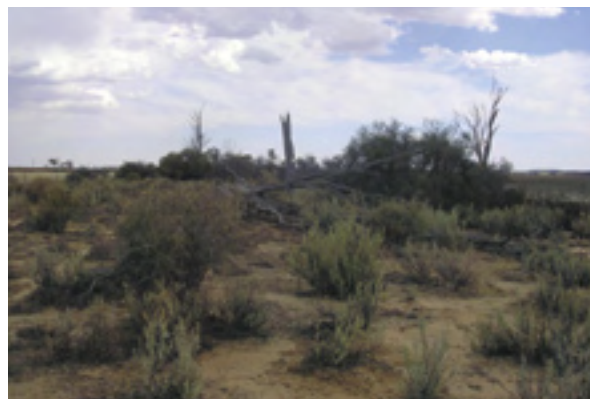
Photo A1.28: LR06
Good condition vegetation association 4: Acacia nyssophylla very sparse shrubland on lunette within lake bed. Note dead tree trunks, indicating this was formerly woodland.

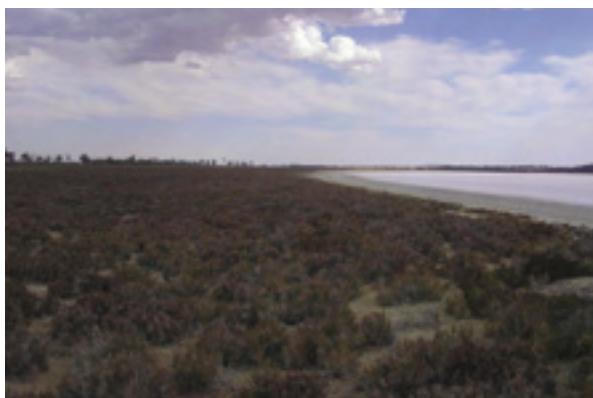
Photo A1.29: LR06
Degraded condition vegetation association 5: Halosarcia spp. open shrubland on lake edge.

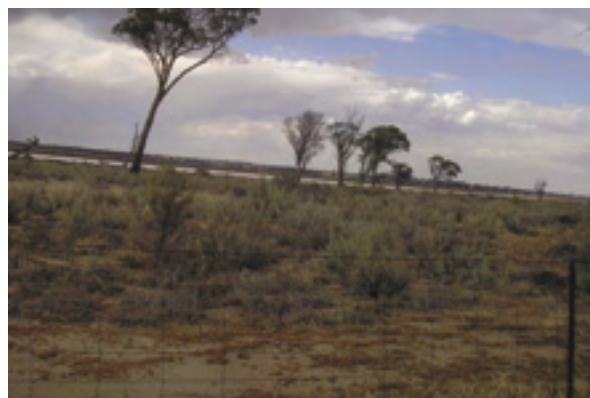
Photo A1.30: LR06
Good condition vegetation on lunette.

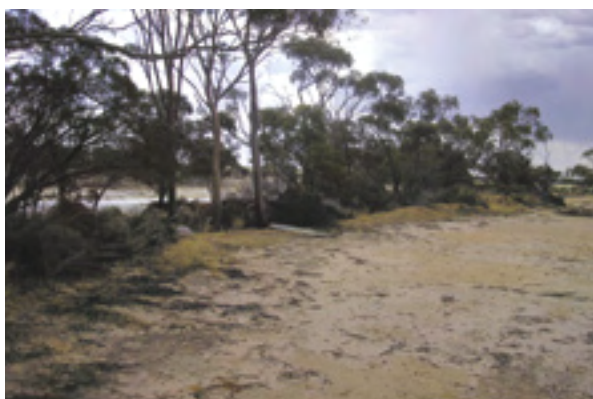
Photo A1.31: LR06
Area of sand extraction and rubbish dumping near north-east corner of site.

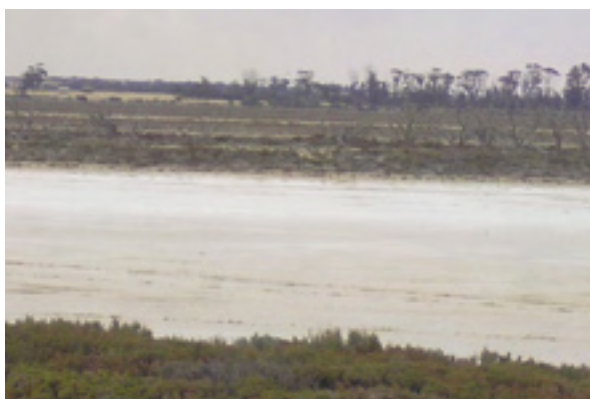
Photo A1.32: LR06
Degraded condition vegetation on lake (background).

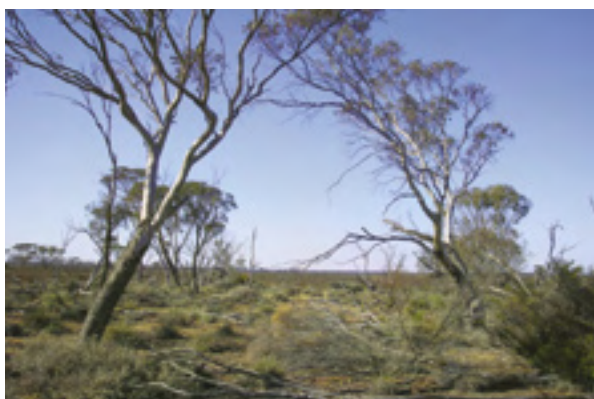
Photo A1.33: LR07

Very good condition vegetation association 1: Eucalyptus loxophleba subsp. loxophleba very sparse woodland on slightly raised area on floodplain.

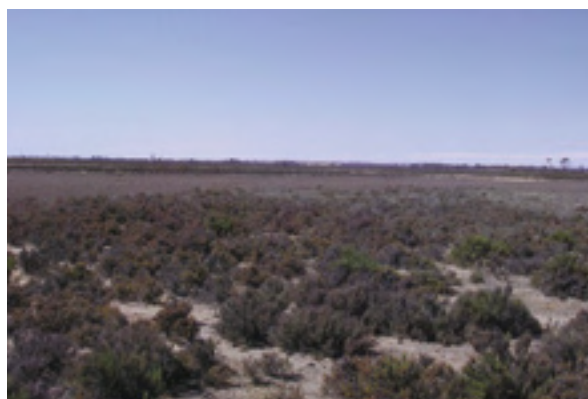
Photo A1.34: LR07

Degraded condition vegetation association 2: Halosarcia spp. sparse shrubland on floodplain.

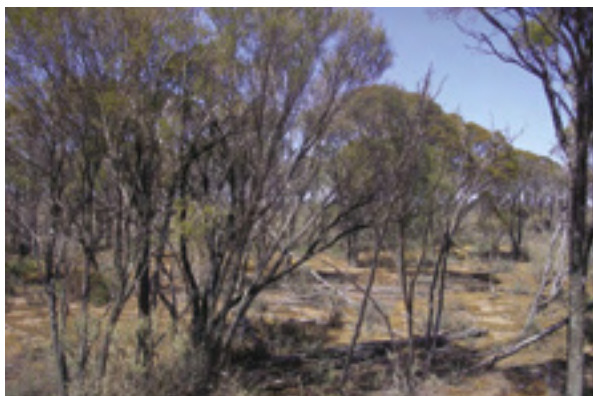
Photo A1.35: LR07
Very good condition vegetation association 3: Melaleuca pauperiflora, M. acuminata and M. lateriflora sparse shrubland on raised area of floodplain.

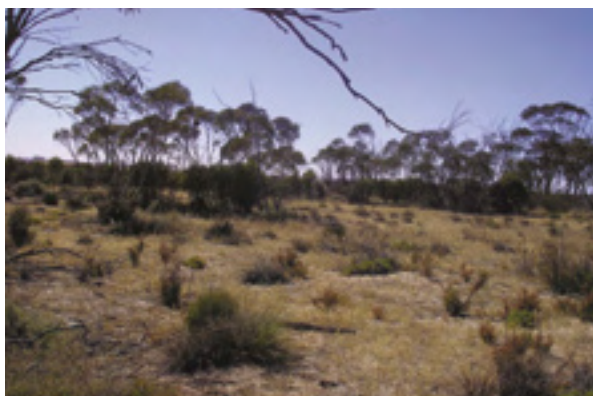
Photo A1.37: LR07
Degraded condition Eucalyptus loxophleba subsp. loxophleba woodland on lower valley slope.

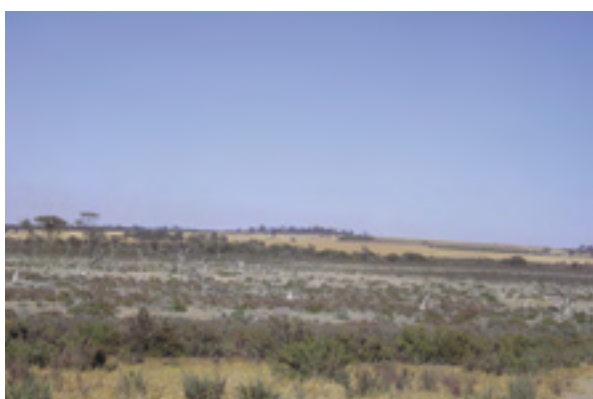
Photo A1.39: LR07
General view of floodplain with cleared area in foreground.

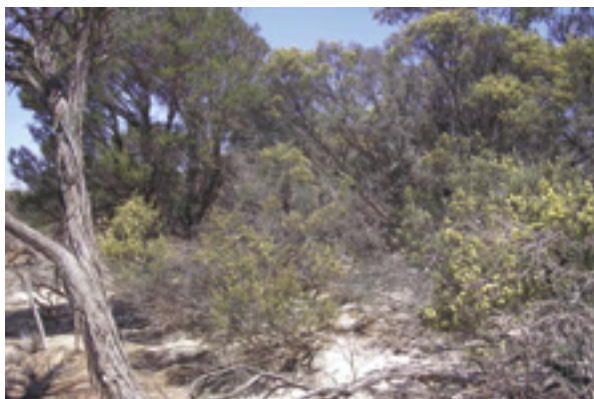
Photo A1.40: LR08
Very good condition vegetation association 1: Melaleuca spp. sparse shrubland on lunette of south lake.

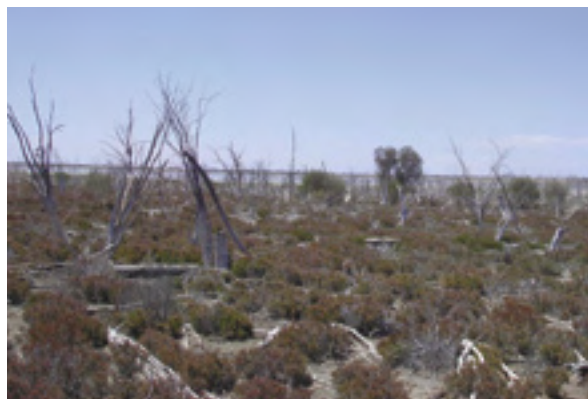
Photo A1.41: LR08
Degraded condition vegetation association 2: Halosarcia spp. sparse shrubland with rare emergent Melaleuca spp. shrubs on lake edge.

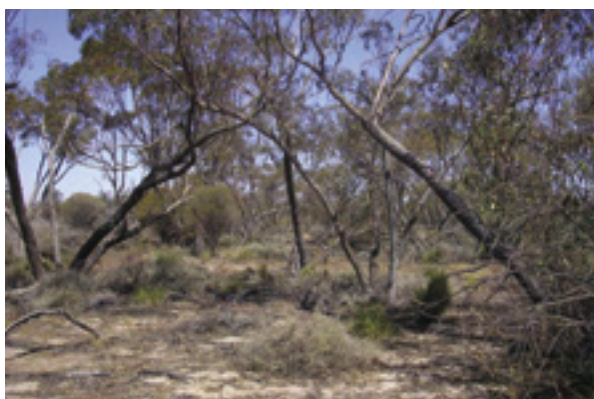
Photo A1.42: LR08
Very good condition vegetation association 3: Eucalyptus loxophleba subsp. loxophleba, E. yilgarnensis and E. spathulata sparse woodland on lunette. This woodland has been cleared or degraded in most areas due to sand extraction.

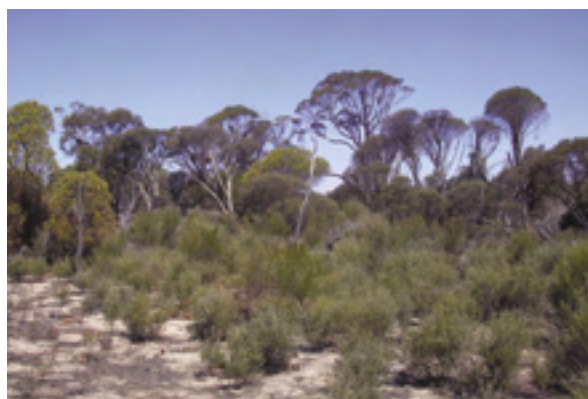
Photo A1.43: LR08
Very good condition vegetation association 4: Eucalyptus spathulata very sparse woodland on lunette at lake edge. Note regenerating Melaleuca spp. shrubs.

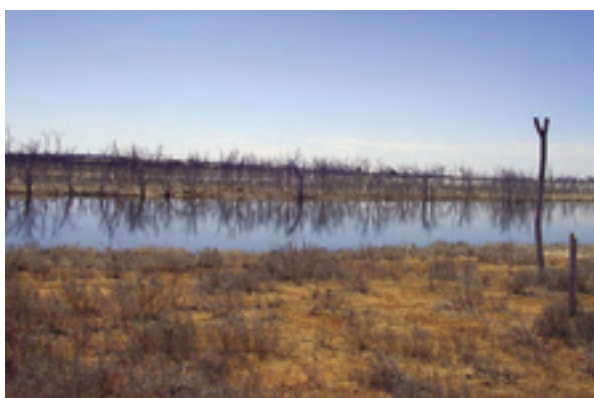
Photo A1.44: LR08
Tributary into the south-west corner of the north (main) lake. Note completely degraded condition of vegetation. This is near the site of water quality sample.

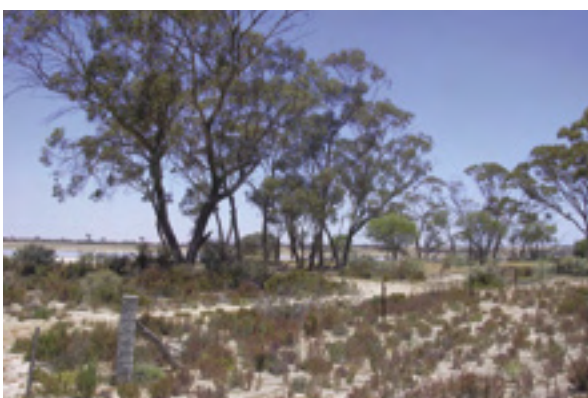
Photo A1.45: LR08
Good condition Eucalyptus spp. woodland on lunette of southern lake.

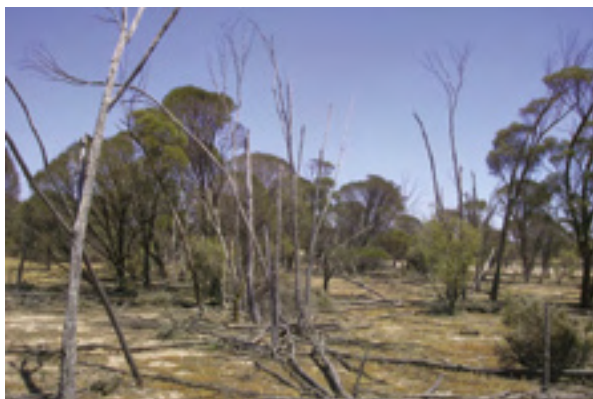
Photo A1.50: LR09
*Good condition vegetation association 1:
Eucalyptus spathulata very sparse woodland on
lunette.*

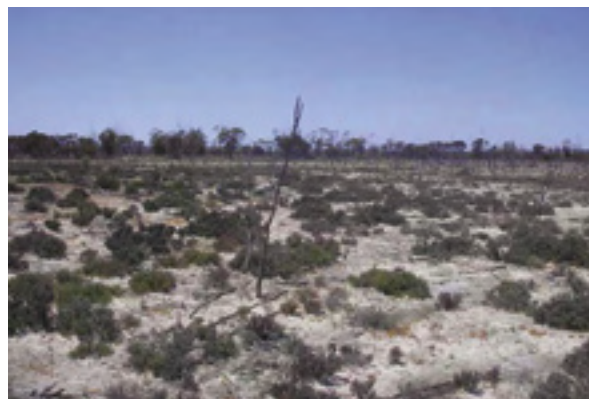
Photo A1.51: LR09
*Degraded condition vegetation association
2: Halosarcia spp. very sparse shrubland on
floodplain.*

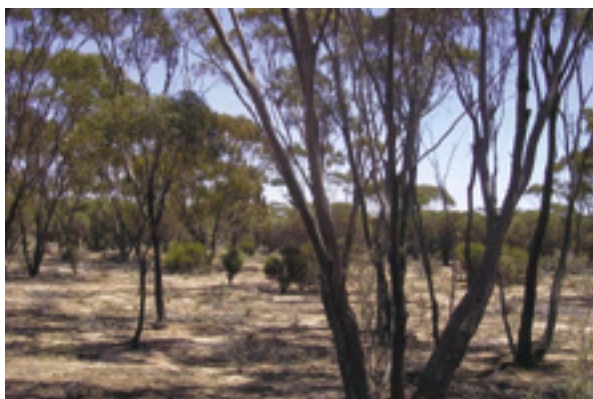
Photo A1.52: LR09
*Good condition vegetation association 3:
Eucalyptus yilgarnensis sparse mallee on lower
valley slope between lakes.*

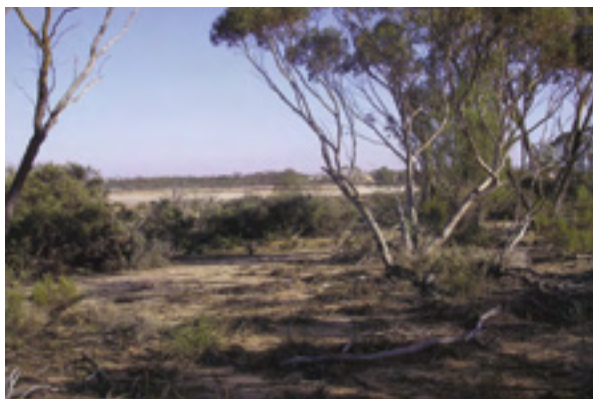
Photo A1.53: LR10
Very good condition vegetation association 1: Eucalyptus horistes very sparse mallee on lunette between river confluences.

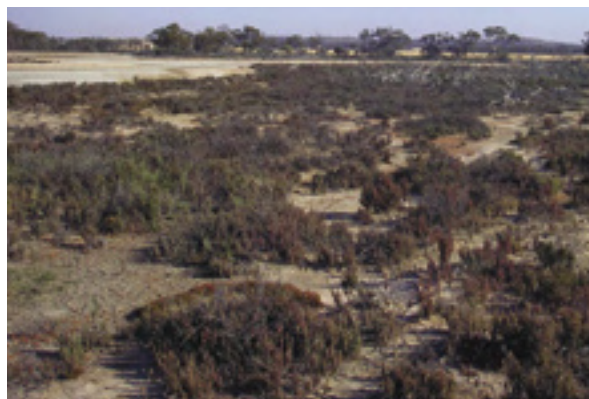
Photo A1.54: LR10
Good condition vegetation association 2: Halosarcia spp. sparse shrubland on floodplain. The samphire on the floodplain varied from good to completely degraded condition.

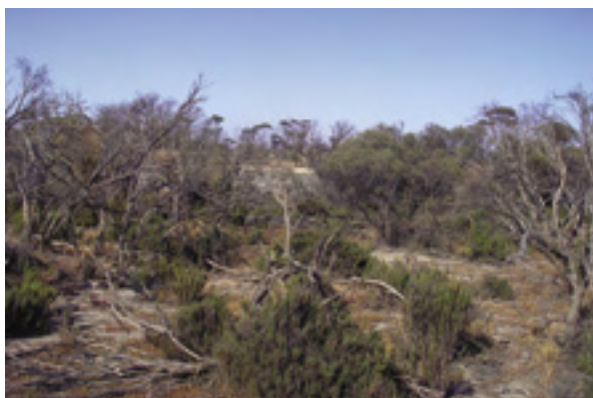
The lower lying (floodplain) areas amongst the lunettes, which were *Melaleuca* spp. shrublands, had high proportions of recently deceased shrubs and have now been colonised by samphire, probably as a result of the 2006 floods.

Photo A1.55: LR10
Degraded condition vegetation association 3: Melaleuca brevifolia and M. lateriflora very sparse shrubland on low-lying area adjacent to floodplain. Note recent shrub deaths.

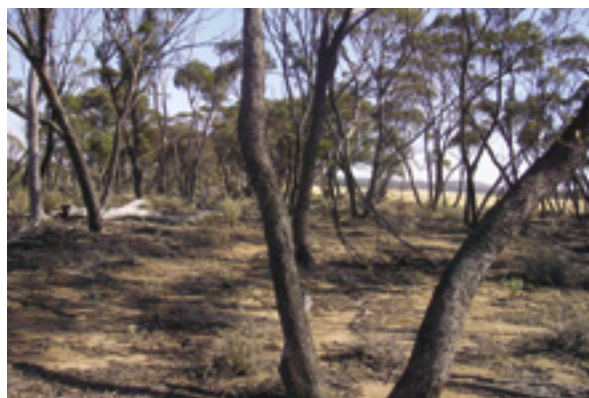
Photo A1.56: LR10
Very good condition Eucalyptus yilgarnensis and E. kondininensis sparse woodland on lower valley slope.

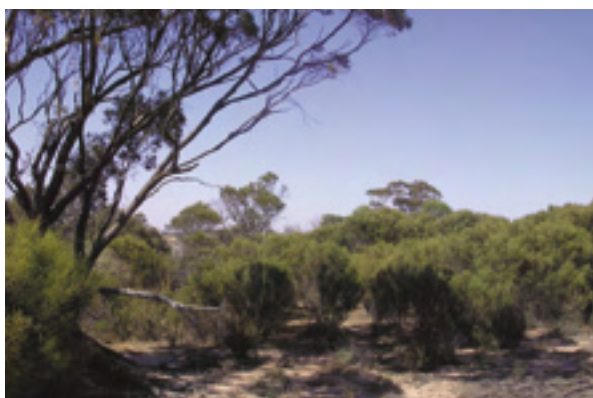
Photo A1.57: LR10
Good condition vegetation association 5: Eucalyptus yilgarnensis very sparse woodland on lower valley slope adjacent to lake edge.

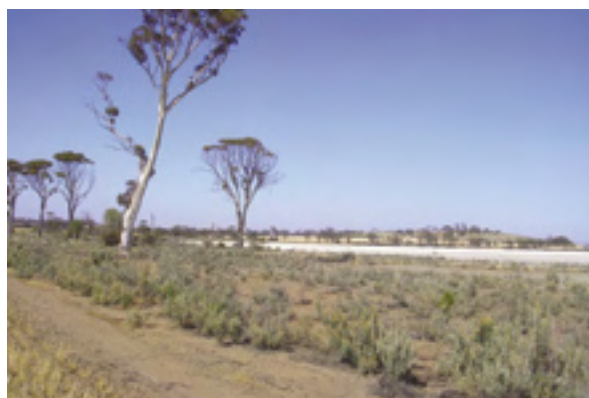
Photo A1.58: LR10
Degraded condition woodland on southern edge of the lake.

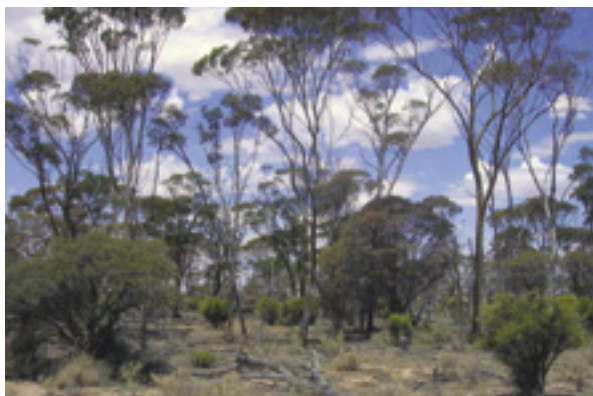
Photo A3.1
Excellent condition woodland, Dickinson's (LR05 Vegetation Association 3).

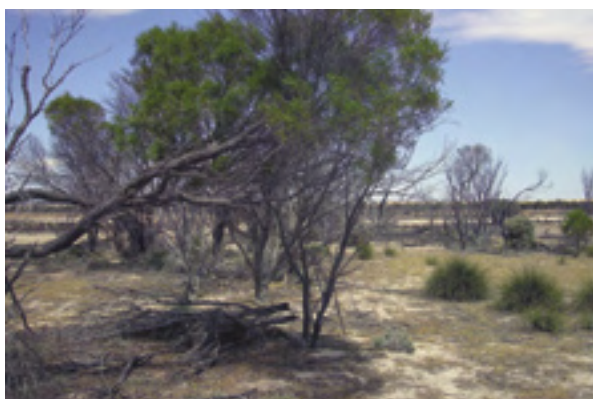
Photo A3.3
Good condition vegetation, Crossland (LR04 Vegetation Association 2)

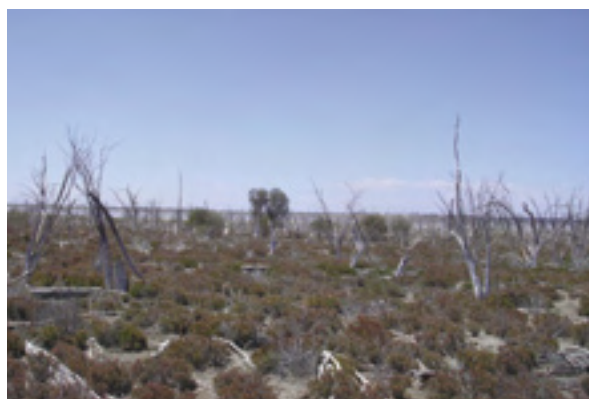
Photo A3.4
Degraded condition vegetation, Kondinin Lake Nature Reserve (LR08 Vegetation Association 3).

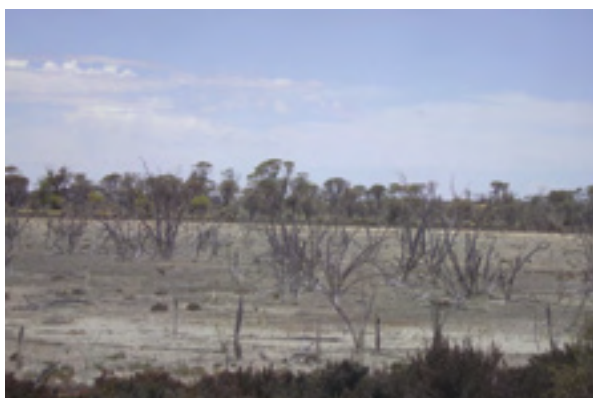
Photo A3.5
Completely degraded vegetation, Dickinson's (LR05)

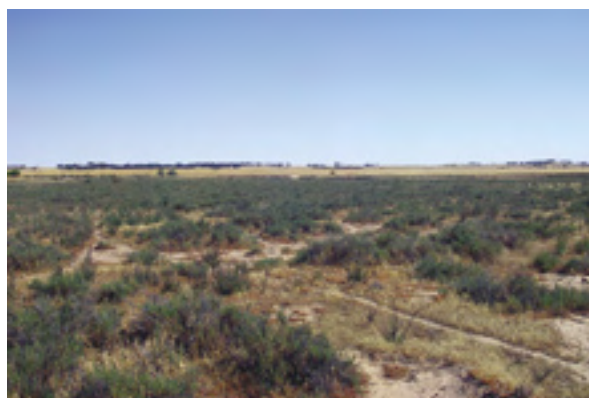
Photo A3.6
Completely degraded vegetation (formerly woodland), Silvergate (LR02 Vegetation Association 2).
