# Waterway assessment of the Camm River: Lockhart River confluence to Hyden

Water resource management series  
*Looking after all our water needs*

Report no. WRM 57  
December 2009

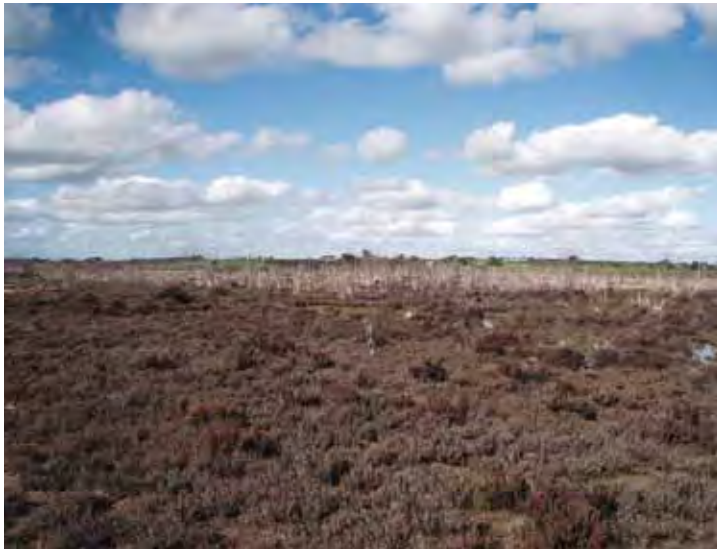
*Photo A1.5: CR02*

*Degraded condition vegetation association 1: Tecticornia spp. Low Heath (dead stems indicate different vegetation in the past).*

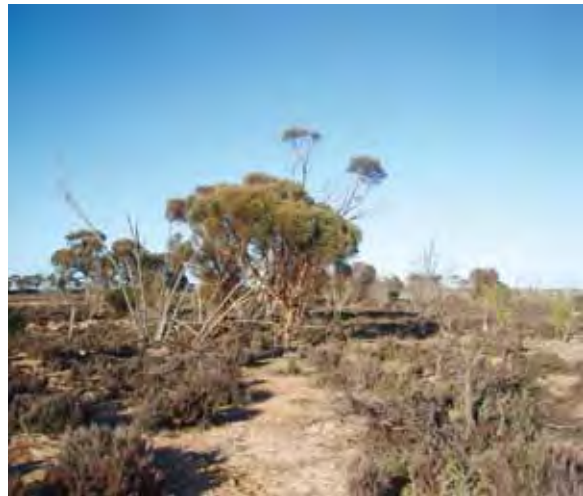
**Photo A1.9: CR03**  
Good condition vegetation association 2: *Melaleuca pauperiflora* Open Scrub with scattered *Eucalyptus spathulata* over *Lycium australe* Open Low Scrub over *Tecticornia* spp. Dwarf Scrub over Open Herbs.

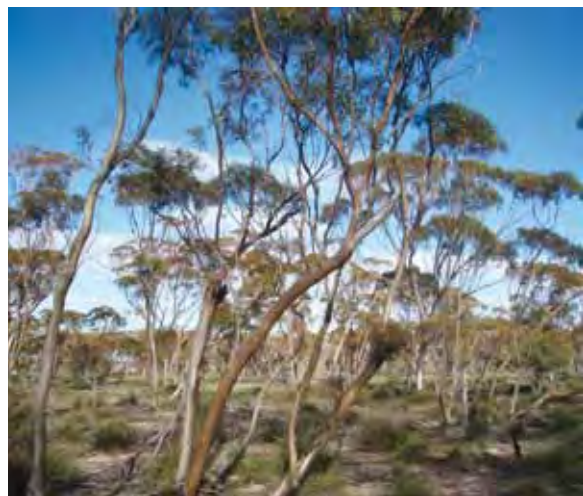
**Photo A1.11: CR03**  
Very good condition vegetation association 4: *Eucalyptus horistes* Very Open Tree Mallee over *Lomandra effusa* and mixed annual Very Open Herbs and *Neurachne alopecuroidea* Very Open Low Grass.

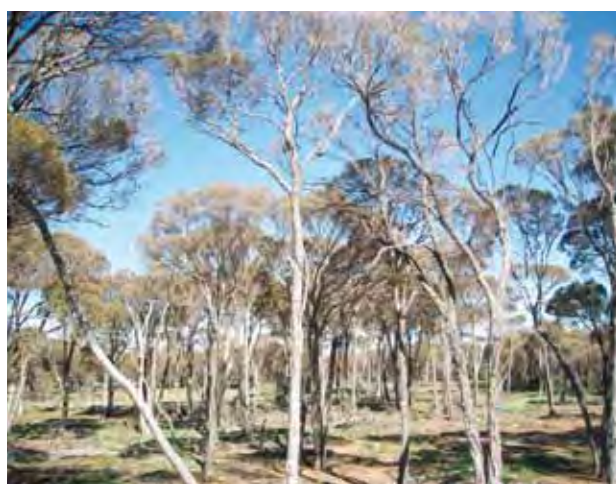
*Photo A1.12: CR04*  
 Very good condition vegetation  
 association 1: *Melaleuca pauperiflora*  
 Open Scrub over Open Herbs.

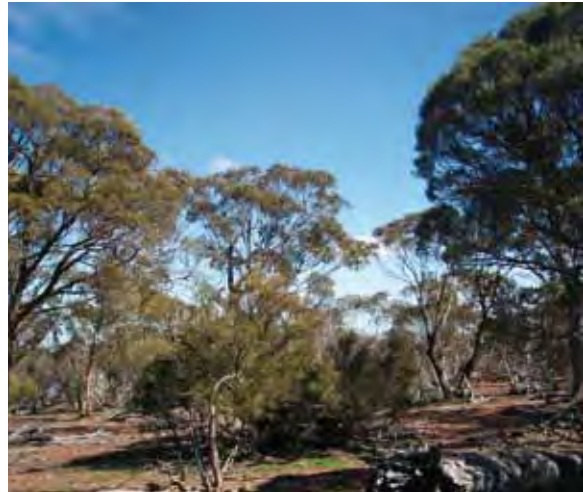
**Photo A1.14: CR04**

*Very good* condition vegetation association 3: *Eucalyptus myriadena* and *E. longicornis* Open Woodland over *Melaleuca pauperiflora* and *Exocarpos aphyllus* Open Low Woodland over Very Open Herbs (mostly introduced).

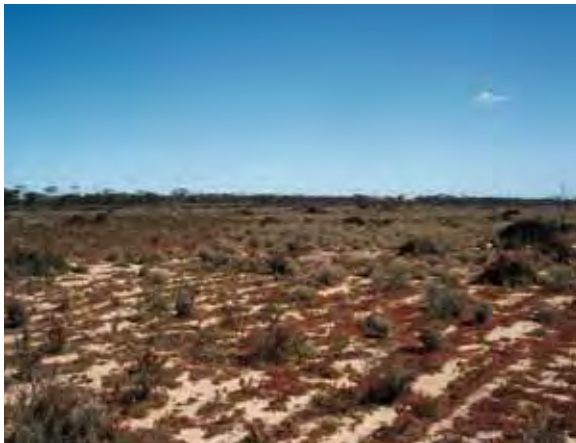
Photo A1.17: CR05

Completely degraded vegetation association 1: *Tecticornia* sp., *Maireana brevifolia*, *Atriplex paludosa* Open Dwarf Scrub over *Mesembryanthemum nodiflorum* Open Herbs on a previously cleared area.

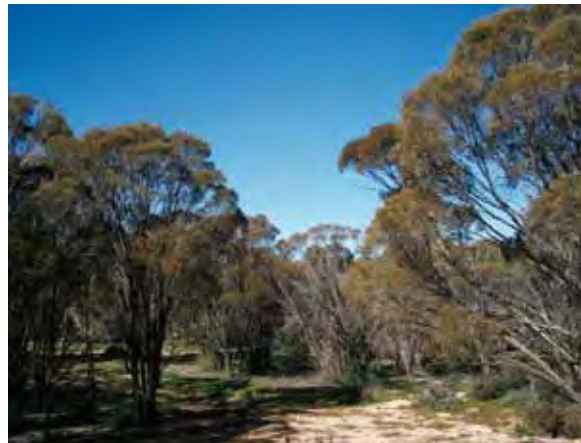
Photo A1.18: CR05

Very good condition vegetation association 2: *Melaleuca pauperiflora* and *M. lateriflora* Scrub over mixed annual Open Herbs.

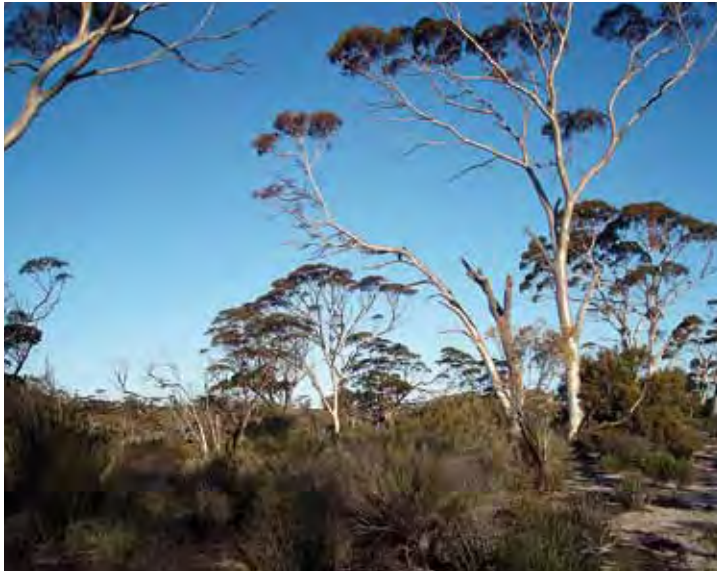
**Photo A1.27: CR06**

*Excellent condition vegetation association 7: Eucalyptus salicola* Open Low Woodland over *Dodonaea viscosa* subsp. *angustissima*, *Alyxia buxifolia* and *Hakea kippistiana* Scrub over *Rhagodia preissii* Open Dwarf Scrub over *Lomandra effusa* Very Open Herbs.

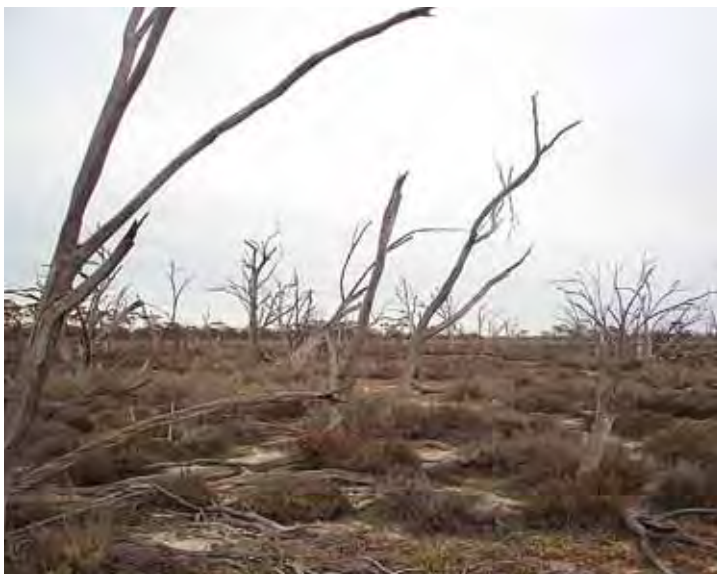
**Photo A1.28: CR06**

*Degraded condition vegetation association 8: Tecticornia* spp. and *Atriplex* sp Open Dwarf Scrub over *Disphyma crassifolium* Open Herbs (many dead tree stumps, possibly *E. myriadena*).

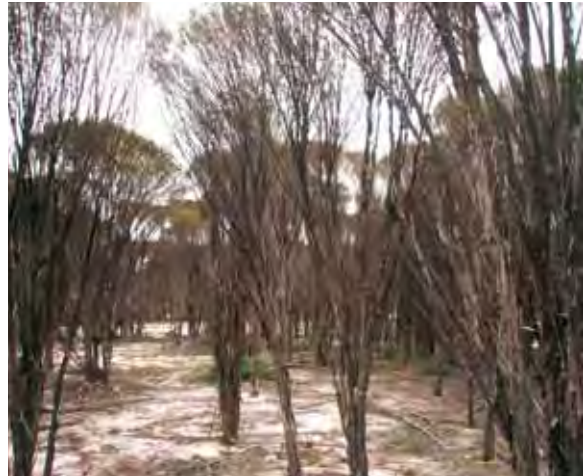
Photo A1.31: CR07

Very good condition vegetation association 2: *Melaleuca uncinata* Scrub over *Rhagodia drummondii* and *Maireana amoena* Open Dwarf Scrub over mixed Open Herbs.

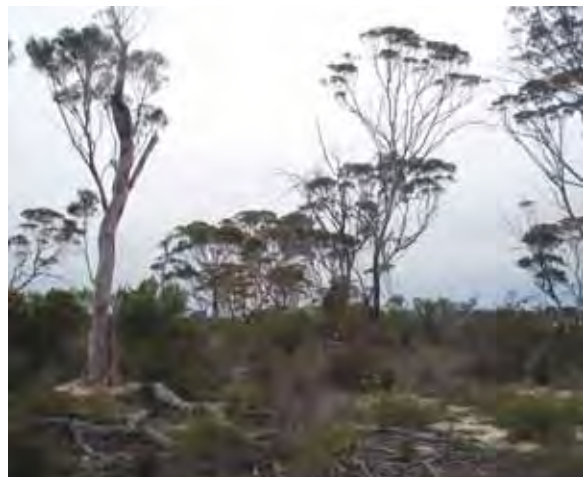
Photo A1.33: CR07

Excellent condition vegetation association 4: *Eucalyptus salicola* Open Low Woodland over *Dodonaea viscosa* subsp. *angustissima* and *Hakea preissii* Open Scrub over *Olearia dampieri*, *Westringia rigida* and *Platysace effusa* Dwarf Scrub over *Lomandra effusa* Very Open Herbs.

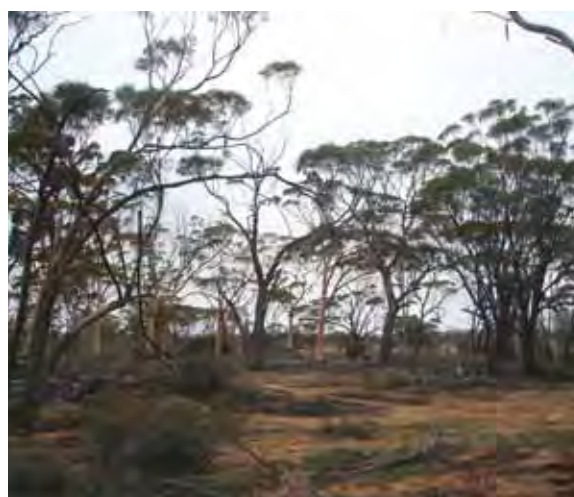
Photo A1.36: CR08

Very good vegetation association  
2: *Eucalyptus myriadena*,  
*E. salmonophloia* and *E. loxophleba*  
Open Woodland over *Olearia muelleri*  
Open Low Scrub over *Angianthus*  
*tomentosus* and *Brassica tournefortii*  
Very Open Herbs over *Austrostipa* sp.  
Very Open Tall Grass.

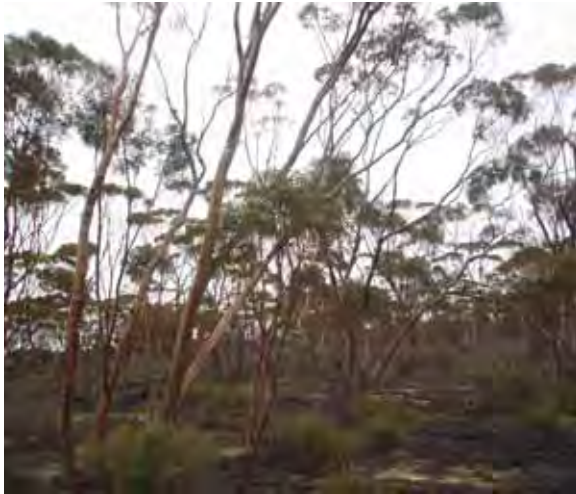
Photo A1.37: CR08

Excellent condition vegetation association 3: *Eucalyptus horistes* Very Open Tree Mallee over *Olearia dampieri* Open Low Scrub over *Lomandra effusa* Very Open Herbs.

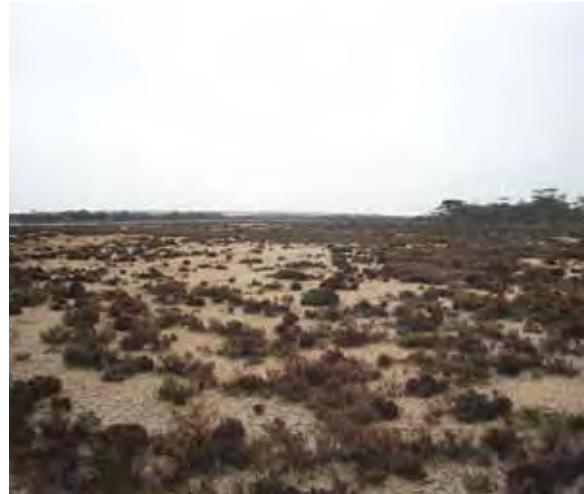
Photo A1.38: CR08

Degraded condition vegetation association 4: *Tecticornia* spp. Dwarf Scrub over *Mesembryanthemum nodiflorum*, *Cotula bipinnata* Very Open Herbs and *Parapholis incurva* Very Open Low Grass.

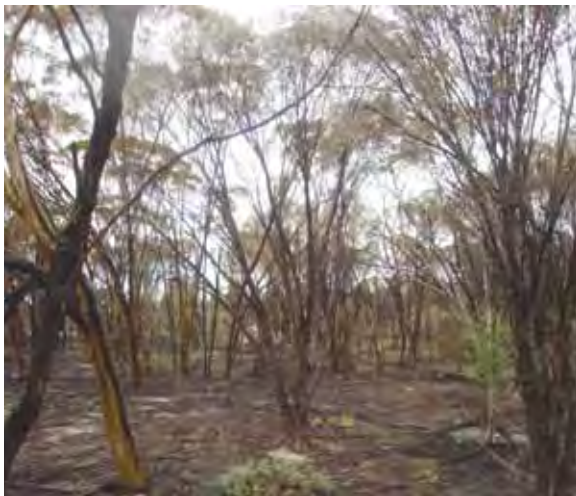
*Photo A1.41: CR09*

Very good condition vegetation association 1: *Eucalyptus alipes* Open Low Woodland over *Melaleuca atroviridis* Scrub over *Lycium australe* and *Rhagodia preissii* Open Low Scrub over Very Open Herbs.

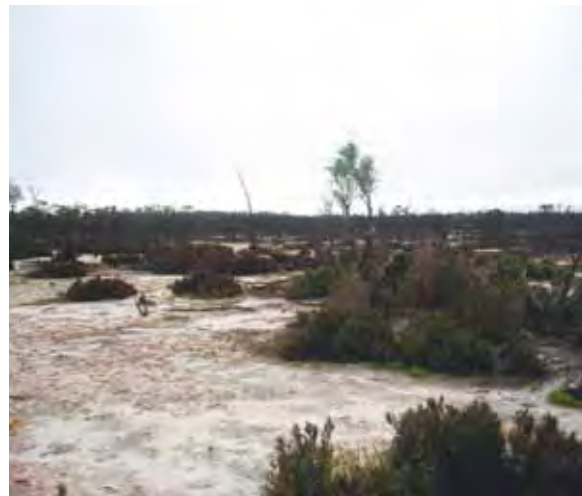
*Photo A1.42: CR09*

Completely degraded vegetation association 2: *Tecticornia* spp. Dwarf Scrub over *Mesembryanthemum nodiflorum*, *Senecio* sp. and *Hyalochlamys globifera* Open Herbs.

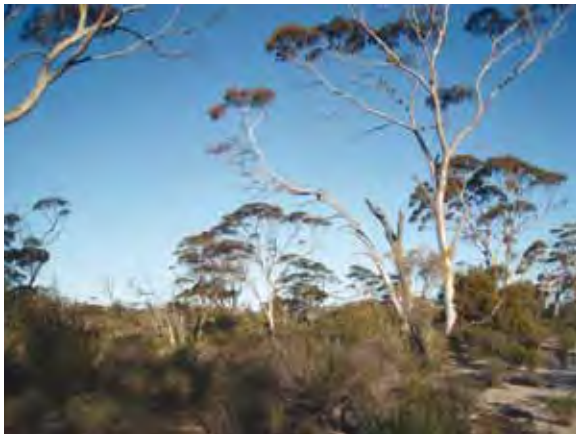
*Photo A3.1: Excellent condition woodland, Karlgarin Lake (CR06 Vegetation Association 7).*

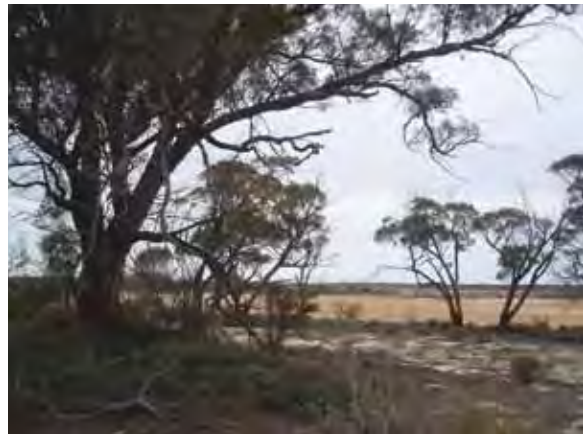
*Photo A3.2: Very good condition open woodland, Lake Gounter Nature Reserve (CR07 Vegetation Association 1).*

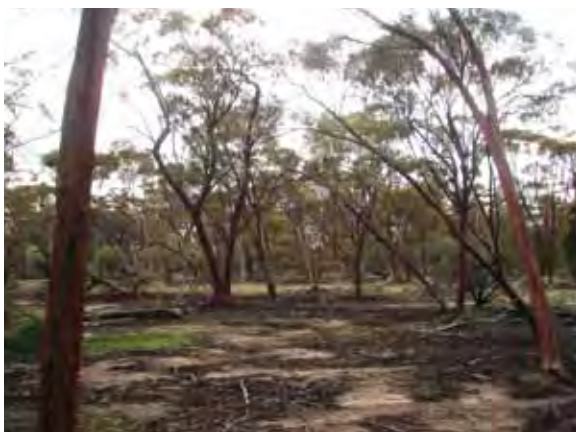
*Photo A3.3: Good condition open woodland, CR10 (Vegetation Association 7).*

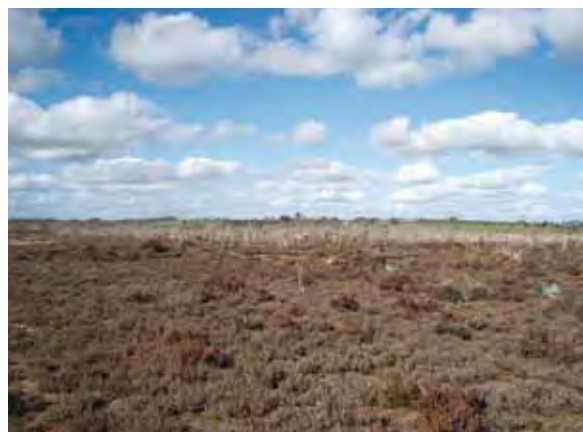
*Photo A3.4: Degraded condition scrub, Henderer's (CR03 Vegetation Association 1).*

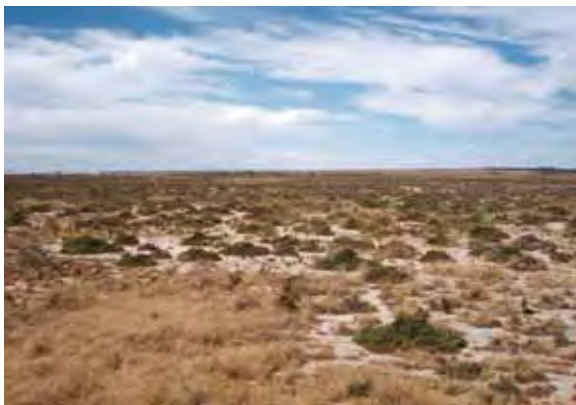
*Photo A3.5: Completely degraded dwarf scrub, Di Russo's (CR12 Vegetation Association 1).*

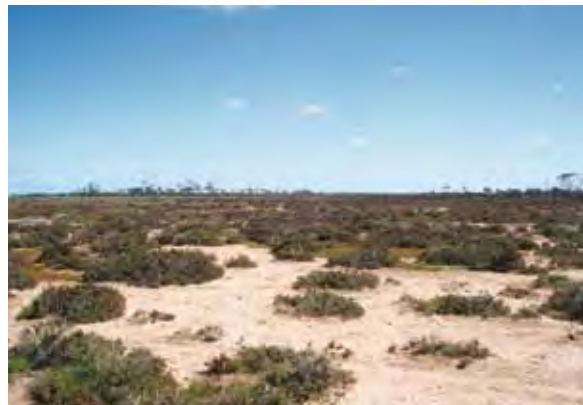
*Photo A3.6: Completely degraded vegetation (formerly samphire), Weewarra (CR04 Vegetation Association 5).*
