# River Action Plan for Gynudup Brook and Tren Creek

# River Action Plan for the Gynudup Brook and Tren Creek

2004

Prepared for the Capel Land Conservation District Committee and the  
Geographe Catchment Council (GeoCatch).

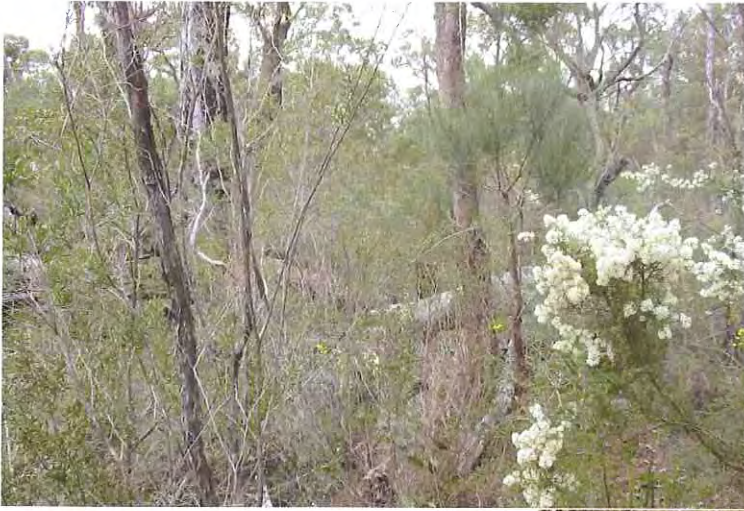
A Grade foreshore of the very upper reaches of Gynudup Brook in the State Forest. Although there is minimal flow in this section, the fringing vegetation provides habitat and shades the waterway.

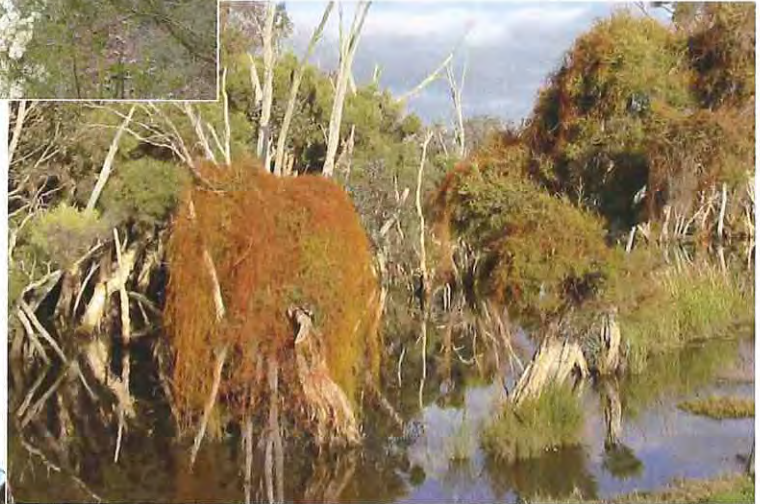
B Grade foreshore on Gynudup Brook near Capel River. Some understorey (mainly rushes and sedges) remains and helps to retard erosion, but there is significant weed growth.

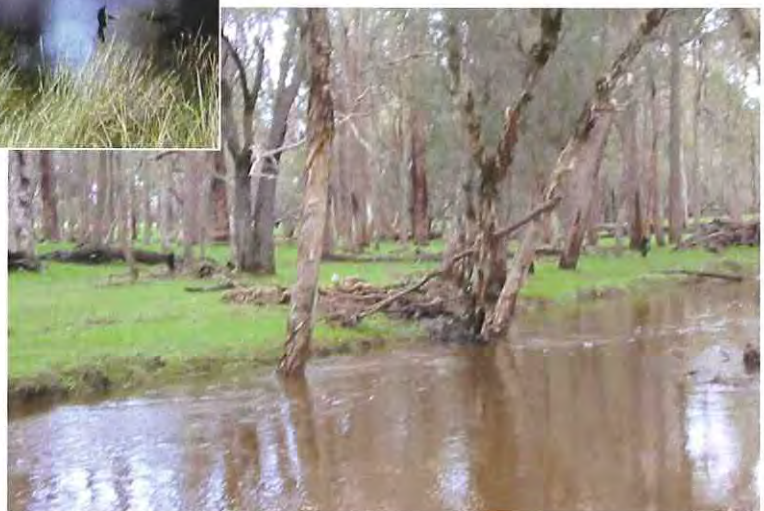
C1 Grade foreshore on Gynudup Brook. Note mature trees only, no exposed soil, and complete invasion by weeds, particularly grasses such as Kikuyu. This foreshore is very vulnerable to disturbance such as stock grazing and trampling. The grasses serve to hold the bank together slightly, but not as effectively as a variety of native species.

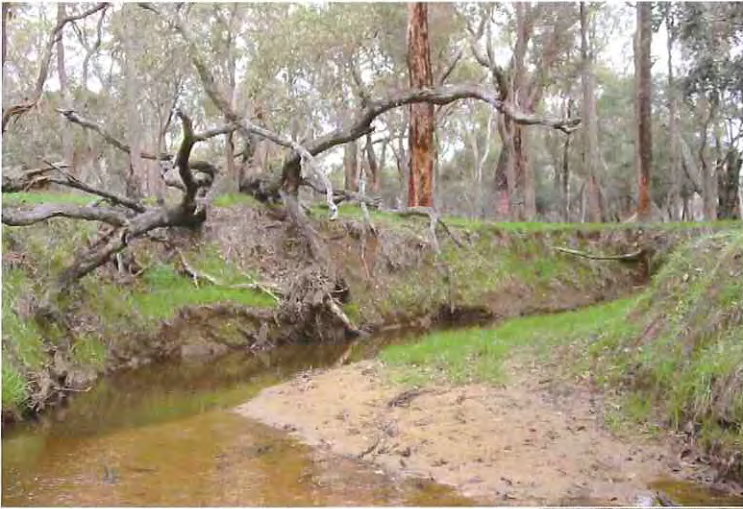
*C2 Grade foreshore on Gynudup Brook. Some erosion and sedimentation (point bar formation) is occurring, especially on bends. This is due to a lack of native understorey vegetation that serves to dissipate flows and hold the bank together.*

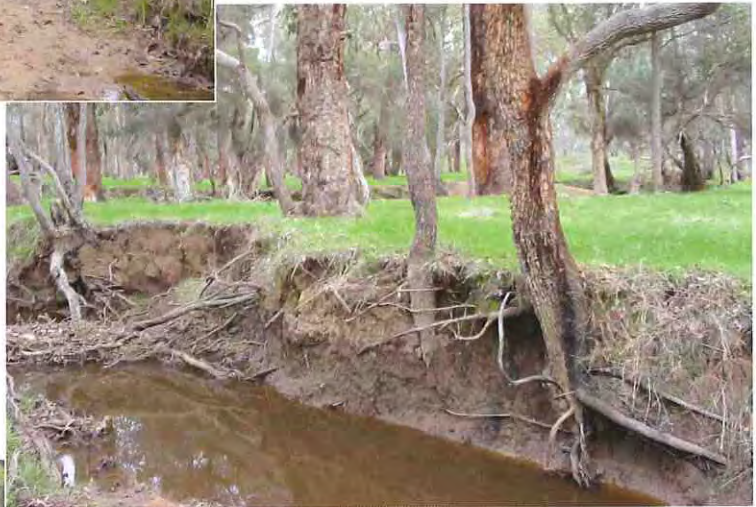
*C3 Grade foreshore. Tree roots are barely holding bank in place, with undercutting and subsidence apparent. Only mature trees remain, with no regeneration of local species, as a result of stock access and weeds. These trees are all doomed to be undermined eventually unless supported by revegetation projects using a variety of local species.*

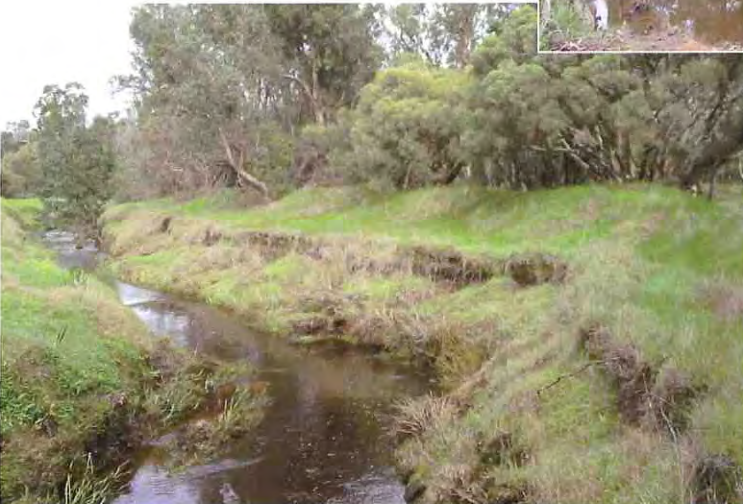
*D1 Grade foreshore on Tren Creek/Elgin Drain. Very little fringing vegetation apart from isolated mature trees and grassy weeds. Banks are subsiding with a large amount of sediment being transported downstream.*

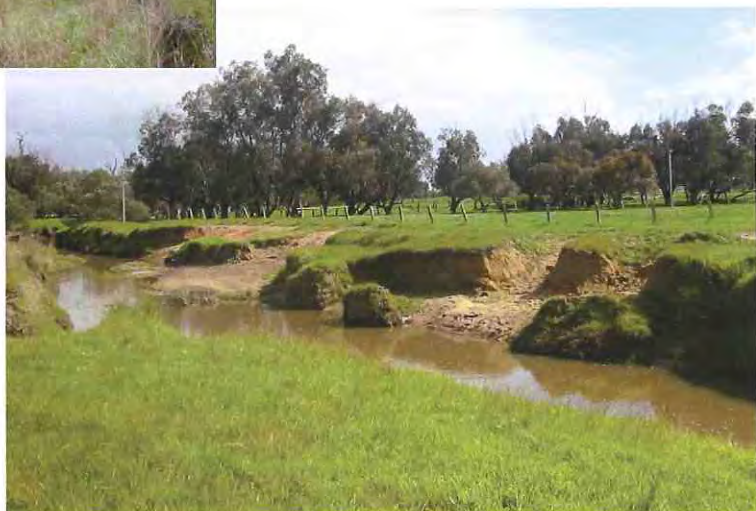
*D2 Grade foreshore. No fringing vegetation remains and banks are freely eroding, resulting in massive sediment transport downstream, loss of productive land and serious downstream water quality issues.*

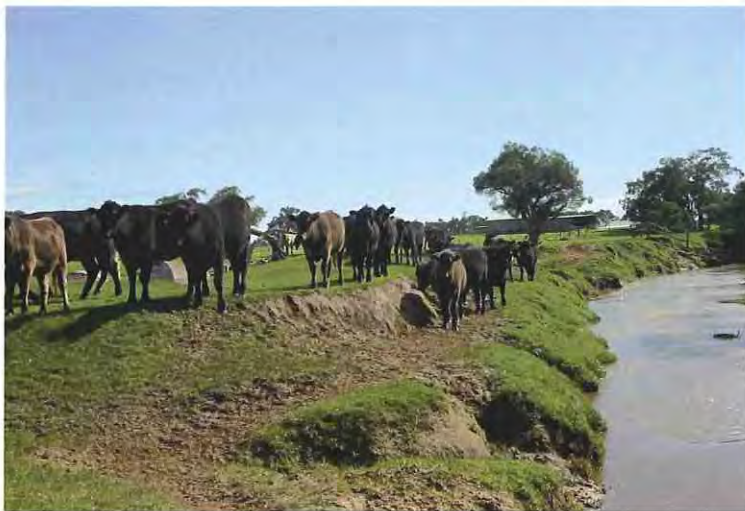
*D2 Grade foreshore, showing a major cause of problems in the catchment – unrestricted stock access.*

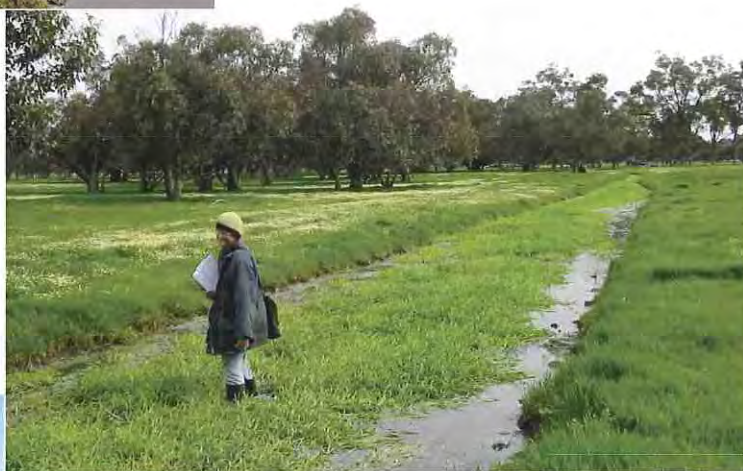
*D3 grade foreshore. This drain has no remaining fringing vegetation, and is heavily infested with exotic species. The banks are stable however, and erosion is not a significant issue in this part. It is important to ensure invasive weeds are well managed to minimise potential problems downstream.*

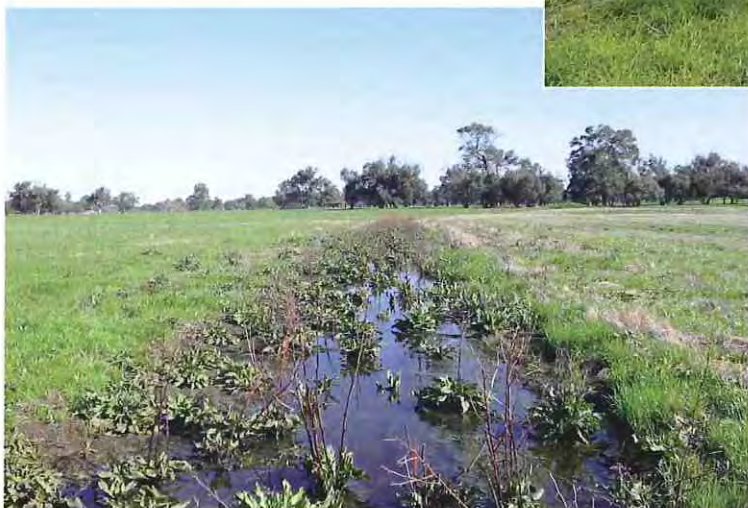
*D3 grade foreshore. This drain is approximately 1 metre wide, with very low flows. Due to the low flows, the grasses and clovers are able to hold the bank together and there is little erosion occurring,*
