Report on the Monitoring of Lake Austin Fringing Vegetation following 3 Years Dewatering Discharge from the Cuddingwarra Prospect.

**A report prepared for Harmony Australia Pty Ltd,
December 2002**

**by Eddie van Etten & Simone Vellekoop,
Centre for Ecosystem Management,
Edith Cowan University**

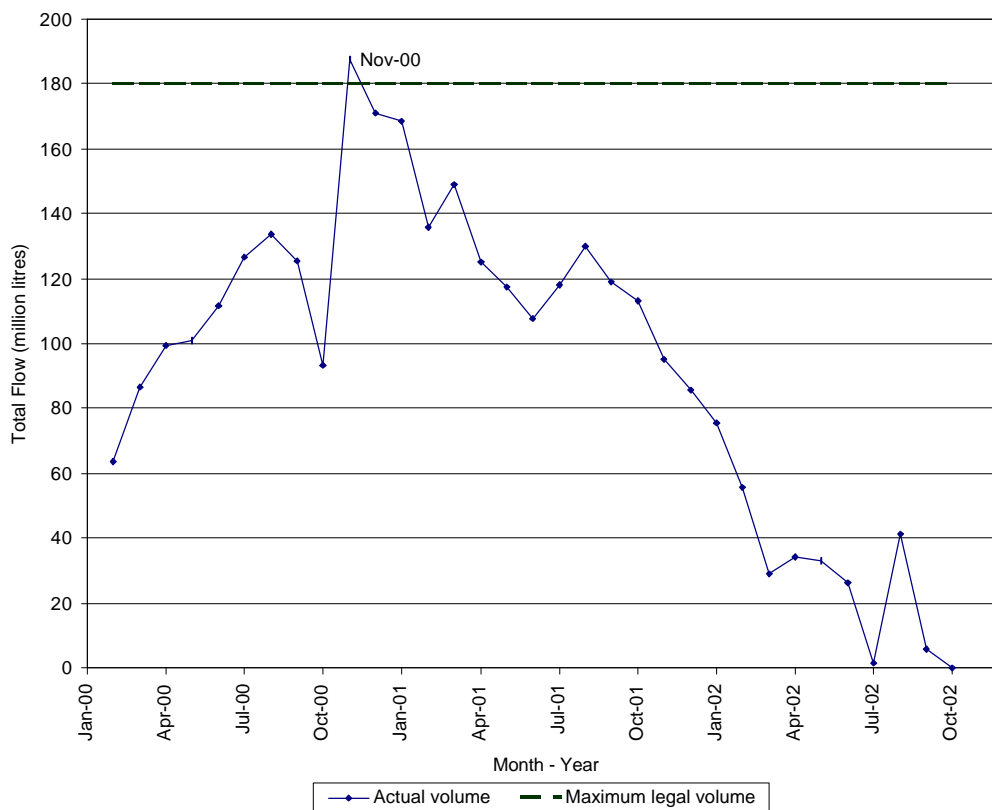
Figure 1. Monthly discharge volumes from the Cuddingwarra mines to Lake Austin from February 2000 to October 2002. Actual monthly volumes shown in solid line with maximum monthly limit in broken line. (Source: BBGO Environmental Department, 2002).

Due to concerns expressed in previous studies that discharge was potentially damaging fringing vegetation and preferentially entering adjacent inlet channels, the pipeline was extended in March 2000 from the lake edge some 600 m out onto the lake-bed. This was to encourage discharge flow towards the middle of the lake. In February 2001, floodwaters moved the pipeline several hundred metres so that it again discharged close to the fringing vegetation. The pipeline was secured back into its original location on around August of 2001.

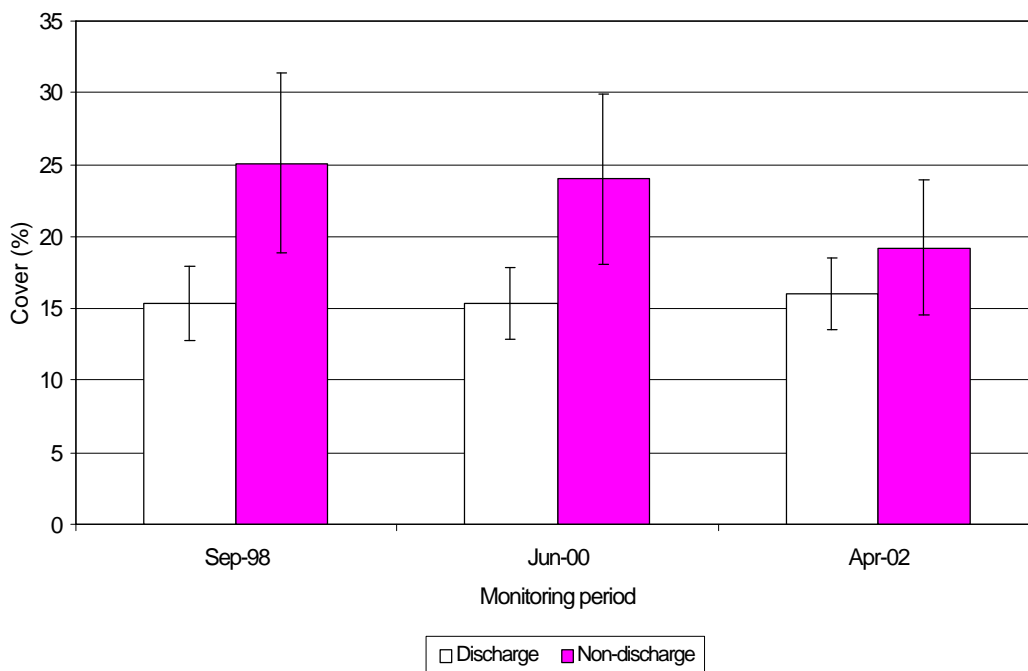
Figure 3. Mean and standard error of perennial species cover over all sites. The change in cover between the discharge and non-discharge sites was not significantly different over time.

No significant difference was found in the change to cover and abundance of perennial species between 'discharge' and 'non-discharge' sites for both periods 1998-2002 and 2000-2002 (Table 2). This is despite the fact that mean cover increased by around 5% (relative to initial values) across

both periods at discharge sites compared to a drop of 3-8% in non-discharge sites (Figure 3). Very high site to site variation in the degree of change at least partly explains the lack of statistically significant results. There were also no significant differences between 'discharge' and 'non-discharge' sites in the areas immediately fringing the lake and inlet channels (Table 4). These fringing areas were almost completely inundated for several months in the first half of 2000. This flooding resulted in a decline in cover of perennial species at both discharge and non-discharge zones, although to a far greater degree at non-discharge sites (1-2% compared to 22-28%; Table 4). However the decline in cover was in some ways compensated for by an increase in the abundance of perennial plants in these areas following inundation (Table 4).

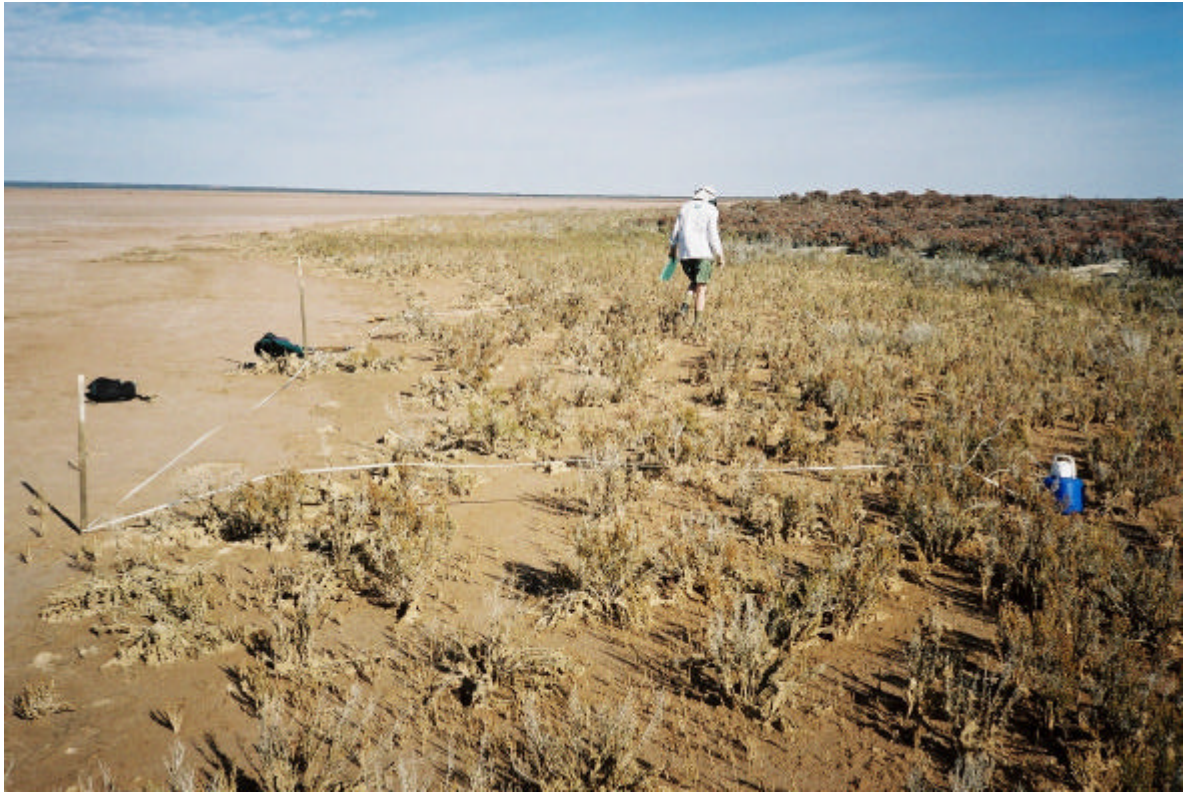
Photo 1. Fringing vegetation dominated by *Halosarcia fimbriata* showing dead and unhealthy mature plants. Also shown in the foreground are seedlings which have arisen following the 2000 flood.

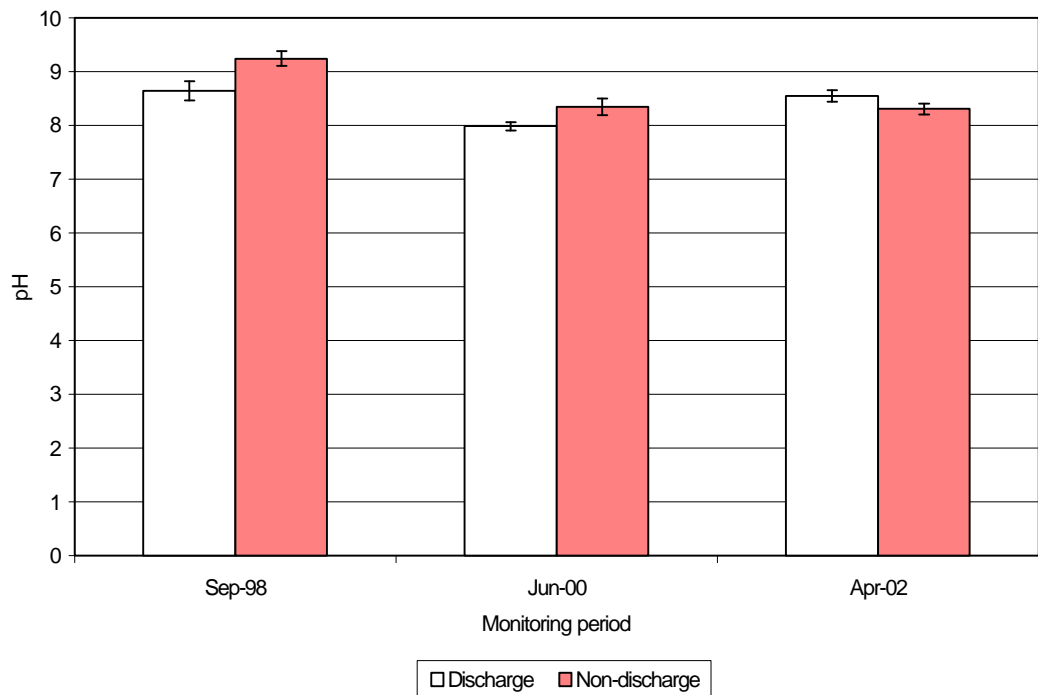
Figure 4. Mean absolute values and standard error of soil pH. The change in pH between the discharge and non-discharge sites was significantly different over 1998-2002 and 2000-2002 ($p=.006$ & $p=.001$ respectively).

The pH of the topsoil decreased following discharge to a greater degree (in both relative and absolute terms) in the non-discharge zone compared to the discharge zone (Table 6; Figure 4). Between 1998 and 2002, the pH declined by around 2% on average in the discharge zone, whilst in the non-discharge zone it was almost 11%; this difference was statistically significant ($p = 0.06$; Table 6). Between 2000 and 2002, the pH actually increased in the discharge zone by 5% whilst it declined by almost 3% in the non-discharge zone; again this difference was significant ($p=0.001$).

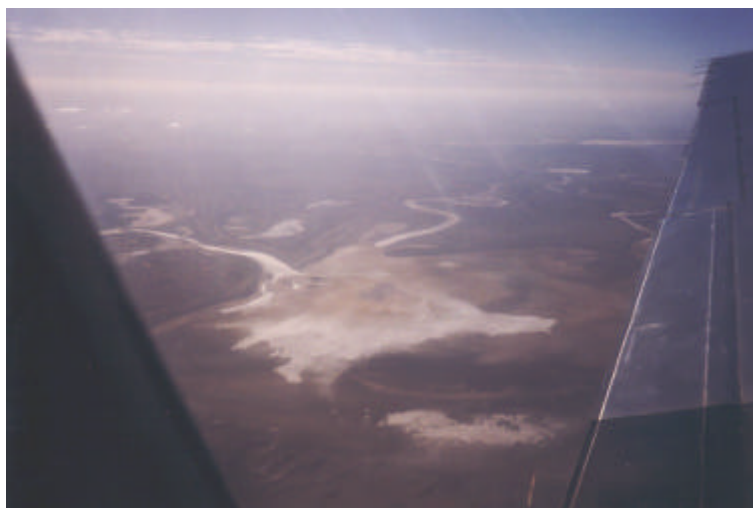
Figure 8. Evidence of surface salt on the lakebed surrounding the end of the discharge pipeline in April 2002, as seen from an aircraft. The visible salt is approx. 2 km in diameter (S. Vellekoop, 2002).

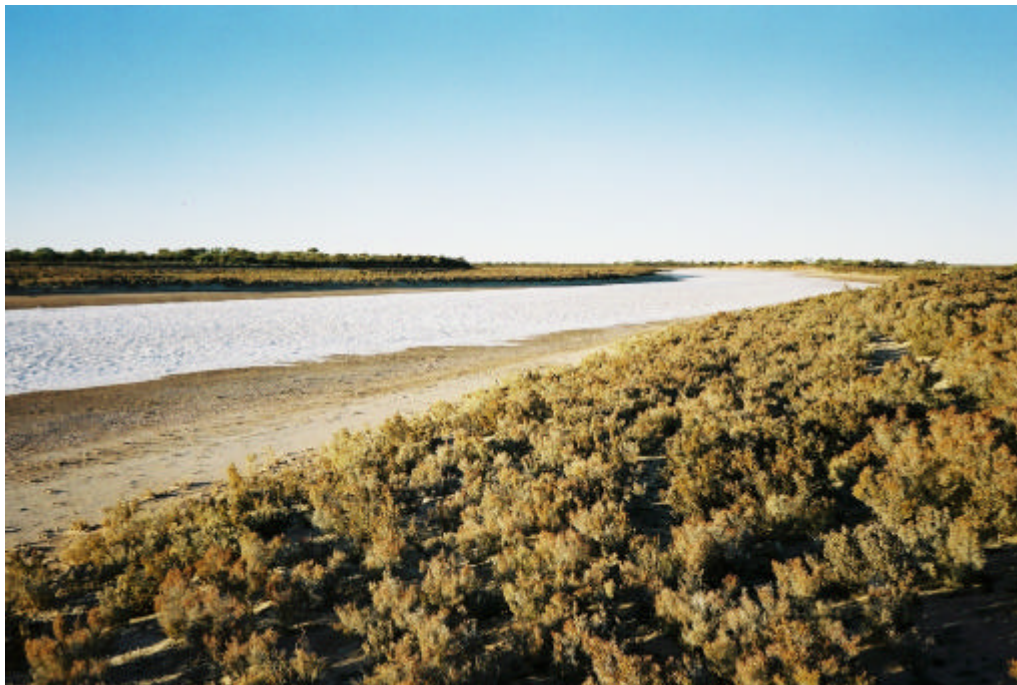
Photo 2. Salt tended to accumulate at the lowest elevations including the inlet channels. Lake Austin proper is to the left of the photo. (S. Vellekoop, 2002).
