# 'Sediment Snapshot' Pilot Trial

## Summary Report

*An analysis of baseline data and observations from twenty-six construction sites in the Perth South West Region over one week, focusing on sediment loss, presence and effectiveness of erosion and sediment controls and rates of legislative compliance*

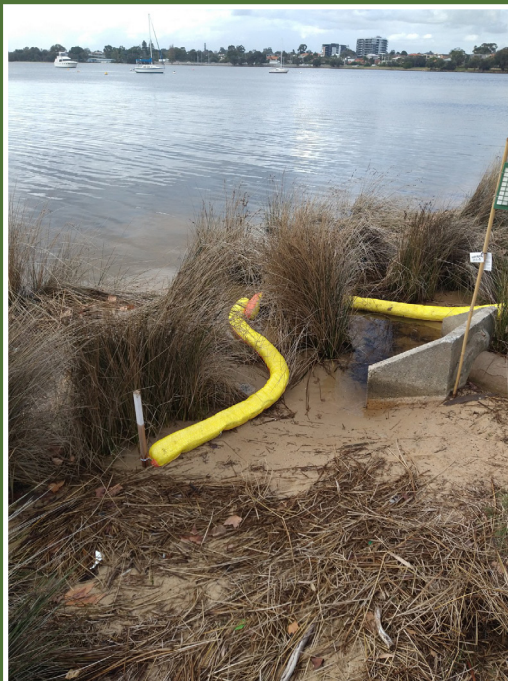
*LHS: Sediment plume in Swan River from Riviere Apartment Development in Canning Beach Rd, City of Melville. (Photo credit: David Bond)*

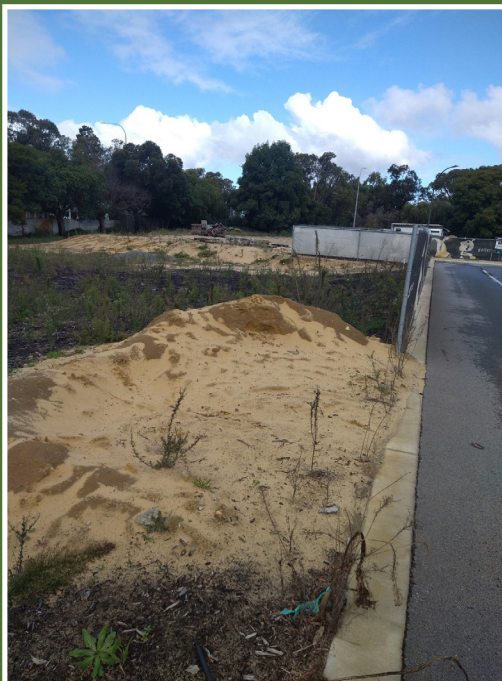
*Centre: Building sand evident in constructed wetland in Willagee subdivision, North Lake Rd/ Archibald St, City of Melville. (Photo credit: David Bond)*

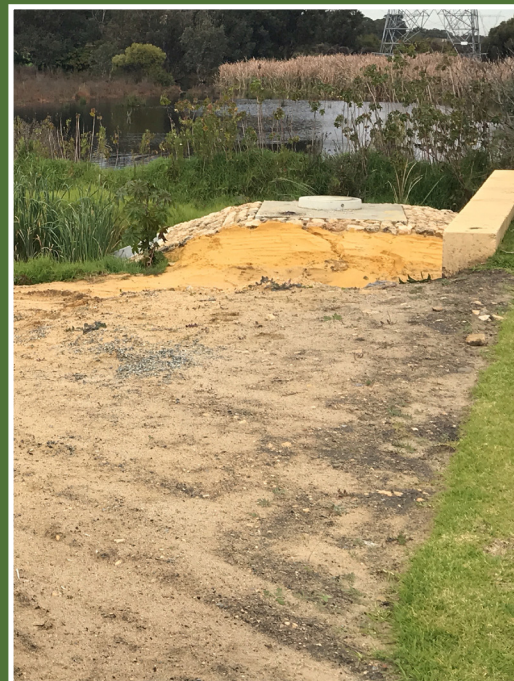
*RHS: Building sand from adjacent construction site encroaching on natural wetland, Market Street/Thomas Road, Casuarina, City of Kwinana. (Photo credit: Pia Hackshaw)*

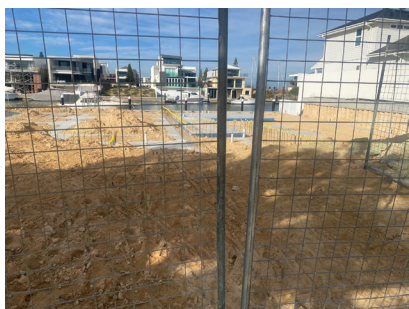
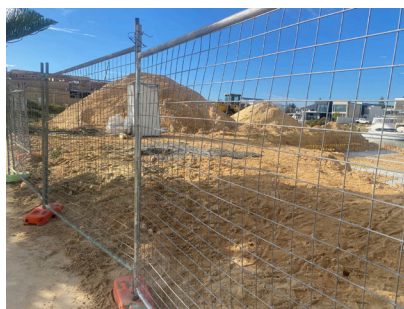
*Above left and centre: The absence of soil erosion and sediment controls at this canal development site in Orisno Boulevard in North Coogee in the City of Cockburn will result in degradation of the marine ecosystem.*

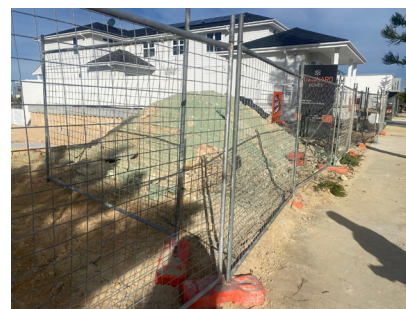
*Above right: Hydro-mulch quickly loses its structural integrity, resulting in wind or water transport of 'loose' sediment, as well as the constituents of hydro-mulch. Observed at lot on Chelydra Point North Coogee, City of Cockburn.*

6. Hydro-mulch used on vacant lots or on sand stockpiles at the Snapshot sites (to prevent sand drift by wind or water erosion) was mostly ineffective due to degradation of the product over time, so could not be considered to be a form of vegetative cover.
7. Frequent incidents of sediment loss deemed as a 'minor non-compliance' with legislative requirements by inspecting Officers demonstrate a larger cumulative sediment pollution impact. Ensuring the land development industry is more accountable for poor practice in the Perth South West region will improve environmental outcomes and reduce the current high level of private financial benefit to the land development industry, benefitting PSWMA region LGs and ratepayers.

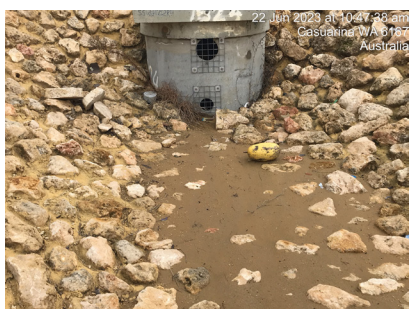
*Above left: Unmitigated sediment leaving subdivision site "drops out" when water velocity slows, filling up a new drainage asset in Market Street/Thomas Road, Casuarina, City of Kwinana. (Photo credit: Pia Hackshaw)*

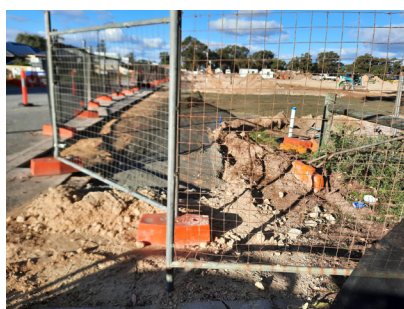
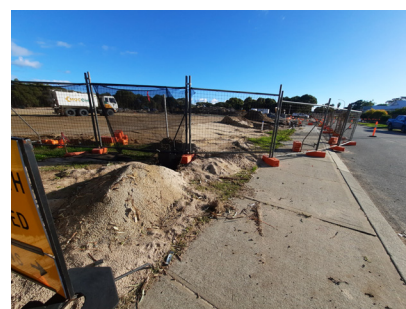
*Above centre and right: The use of a construction fence instead of a sediment control fence means sand drifts onto the footpath and onto the road, Lake Road, Rockingham LG. (Photo credit: Bronwyn Scallan)*

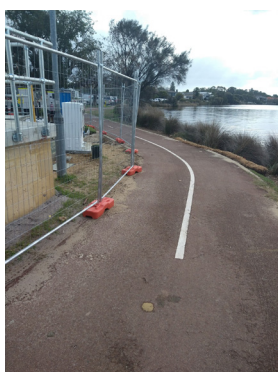
*Above left: Use of a construction fence at Riviere Apartment development, Canning Beach Rd in the City of Melville (adjacent to the Swan River) is not preventing sediment being transported from site. (Photo credits: David Bond)*

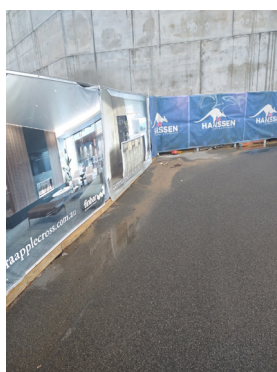
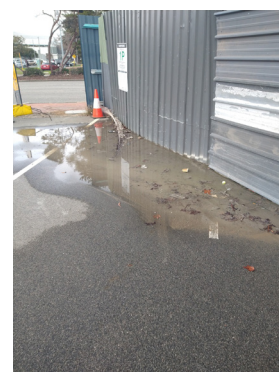
*Above centre and right: Sediment runoff not effectively captured by site geotextile mesh fence. Sabina Apartments development, Kintail Rd Canning Highway, City of Melville. (Photo credits: David Bond)*

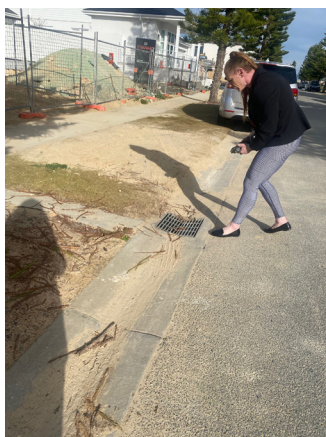
*Left: Sand drift into nearby drain at residential building site, Chelydra Point, North Coogee, City of Cockburn.*

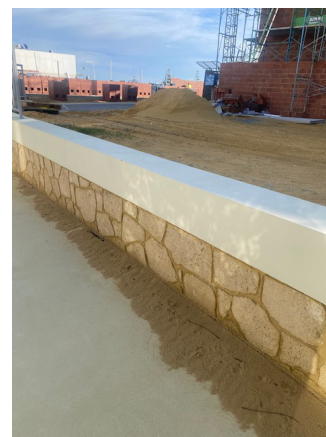
*Above left: Windich Rd, Mandogalup, City of Kwinana. (Photo credit: Bronwyn Scallan)*

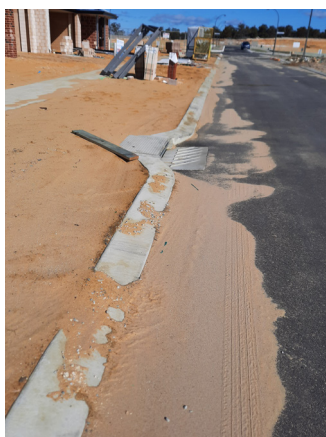
*Above centre: Use of a construction safety fence instead of a sediment control fence results in soil erosion and sediment runoff at Market Street and Thomas Road site in Casuarina, City of Kwinana, even when the slope has been recently revegetated. (Photo credit: Pia Hackshaw)*

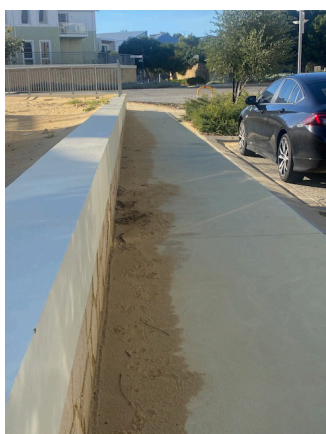
*Above left: Unmitigated sand drift from Orsino Boulevard, North Coogee, in the City of Cockburn becomes a pedestrian safety hazard as well as a form of pollution. (Photo credit: Lisa Brideson)*

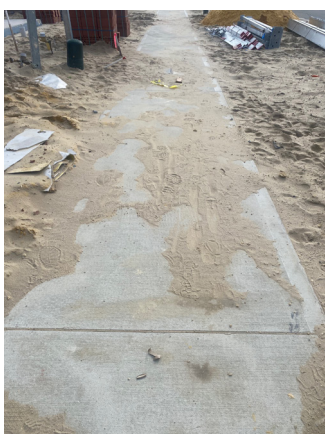
*Above centre: Unsafe sand drift onto footpath at residential building site in Torwood Avenue, Lake Treeby, City of Cockburn. (Photo credit: Alysha Kempf)*

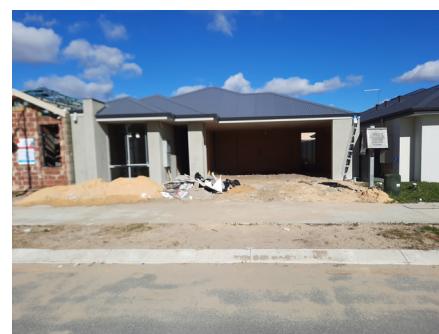
*Above right: Sand drifting from building site onto road, Boota Way, Hammond Park, City of Cockburn. (Photo credit: Bronwyn Scallan)*

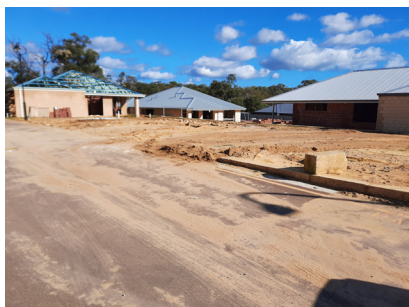
*Above left: Vehicle tracking of sand onto roads from residential building site in Bolam Lane, Wellard, a new subdivision in the City of Kwinana. (Photo credit: Bronwyn Scallan)*

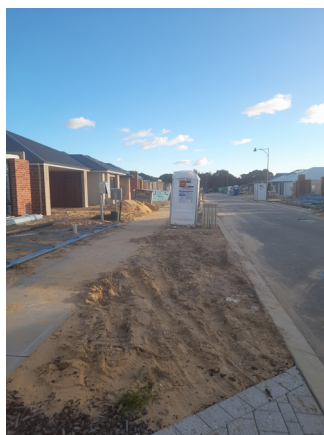
*Above centre: Vehicle tracking of sand from verge in Coracina Vista, Wellard, City of Kwinana. (Photo credit: Melissa Mykytiuk)*

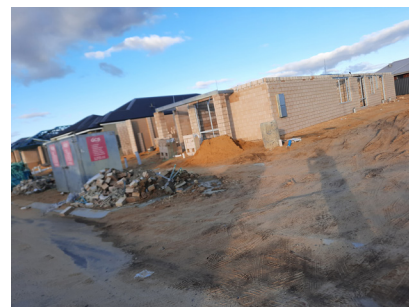
*Above right: Vehicle tracking of sand onto road from building site and adjacent vacant lot on Coracina Vista, Wellard, City of Kwinana. (Photo credit: Bronwyn Scallan)*

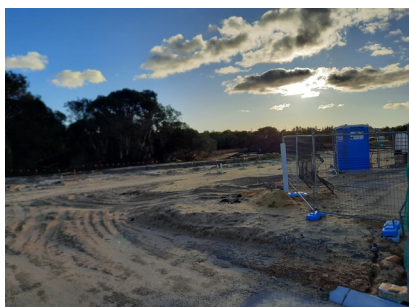
*Above left: Vehicular tracking of sand west accessway Malurus St/Corocina Vista subdivision, City of Kwinana. (Photo credit: Bronwyn Scallan)*

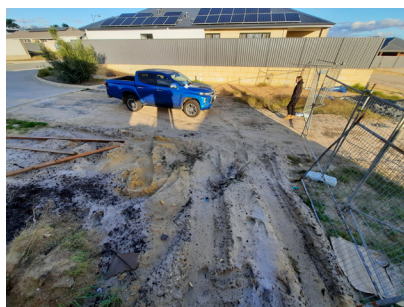
*Above centre: Vehicular tracking of sand east accessway Malurus St/Corocina Vista subdivision, City of Kwinana. (Photo credit: Bronwyn Scallan)*

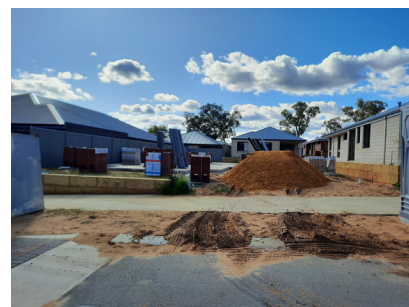
*Above right: Vehicular tracking of sand from lot on Ebrington Road, Wellard, City of Kwinana. (Photo credit: Bronwyn Scallan)*

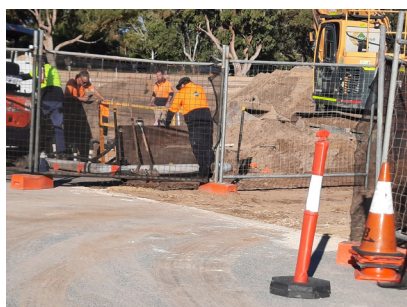
*Above left: Sand tracked on road by earthmoving machinery and trucks, Lake St subdivision Rockingham, Rockingham LGA. (Photo credit: Bronwyn Scallan)*

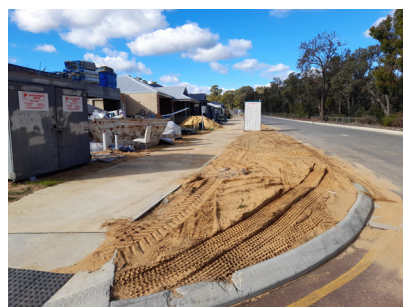
*Above right: Vehicle tracking of sand form verge, Lake St, Rockingham, Rockingham LG. (Photo credit: Melissa Mykytiuk)*

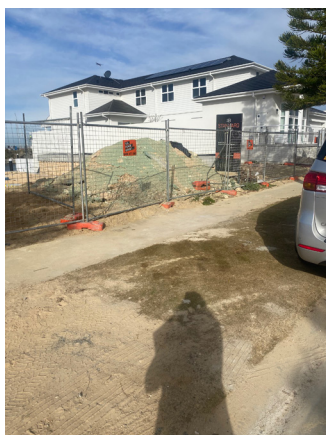
## Poor sediment management at Snapshot site entry/exit points

Above left: Lot in Chelydra Point North Coogee, City of Cockburn. (Photo credit: Alysha Kempf)  
Centre: Market Street/Thomas Road subdivision, Casuarina, City of Kwinana. (Photo credit: Pia Hackshaw)  
Above right: Poor sediment control on curb area in front of residential build on Ebrington Road, Wellard, City of Kwinana. (Photo credit: Melissa Mykytiuk)

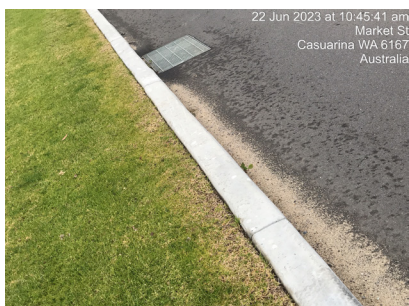
## Grassy verges effective at trapping some sand at two Snapshot sites, reducing the sediment pollution risk

Left: Thomas Rd/Market St Casuarina subdivision site, City of Kwinana. (Photo credit: Pia Hackshaw)

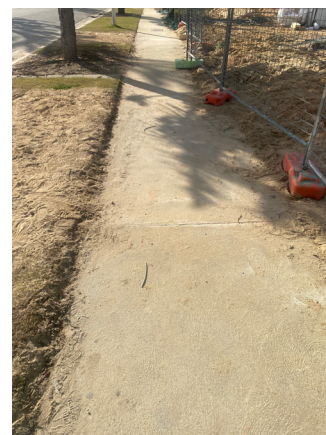
Right: Residential building site on Chelydra Point North Coogee, City of Cockburn. (Photo credit: Alysha Kempf)

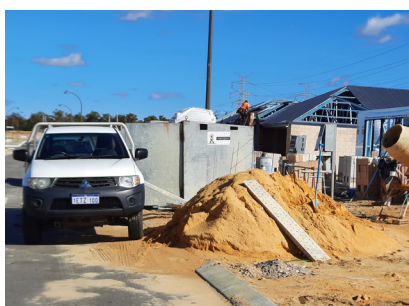
Left: Builders sand partially dumped on the road by sand carriers at building site on Windich Rd, Mandogalup; another new subdivision in the City of Kwinana. (Photo credit: Bronwyn Scallan)

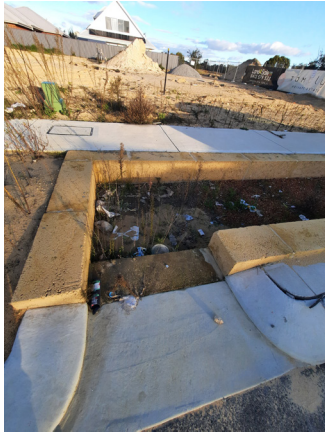
*Left: Raingardens installed in new subdivision to capture sediment at Coracina Vista, Wellard subdivision, City of Kwinana, rendered significantly less effective due to littering. (Photo credits: Bronwyn Scallan)*

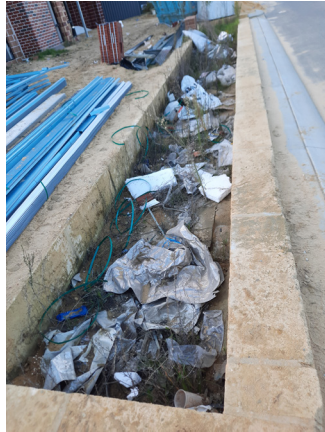
## Impacts of uncontrolled sediment on Water Sensitive Urban Design infrastructure at or adjacent to Snapshot sites

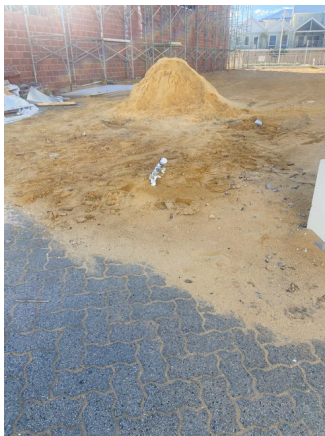
*Above left: Uncovered building sand stockpile migrating onto road, Orisno Boulevard, North Coogee, City of Cockburn. (Photo credit: Lisa Brideson)*

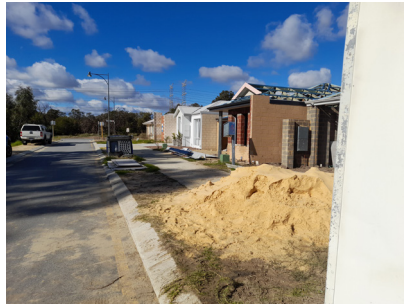
*Above centre: Uncovered stockpile of building sand Lot on Boota Way, Hammond Park, City of Cockburn. (Photo credit: Melissa Mykytiuk)*

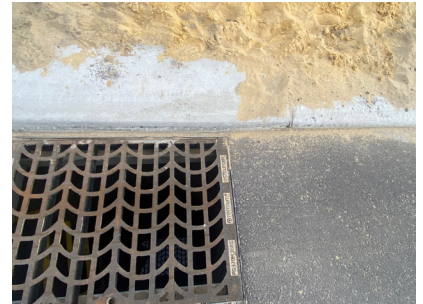
*Above right: Uncovered sand stockpile immediately adjacent to drain. Torwood Avenue, Lake Treeby, City of Cockburn. (Photo credit: Alysha Kempf)*

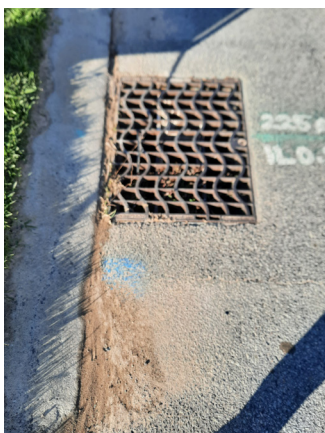
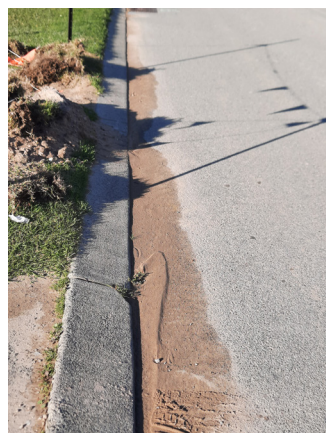
*Above left and centre: Lake St subdivision Rockingham, Rockingham LG. (Photo credit: Bronwyn Scallan)*

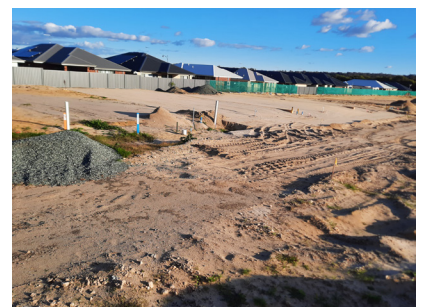
*Above right: Uncovered building sand stockpiles Malurus St subdivision North East access point, Wellard, City of Kwinana. (Photo credit: Bronwyn Scallan)*

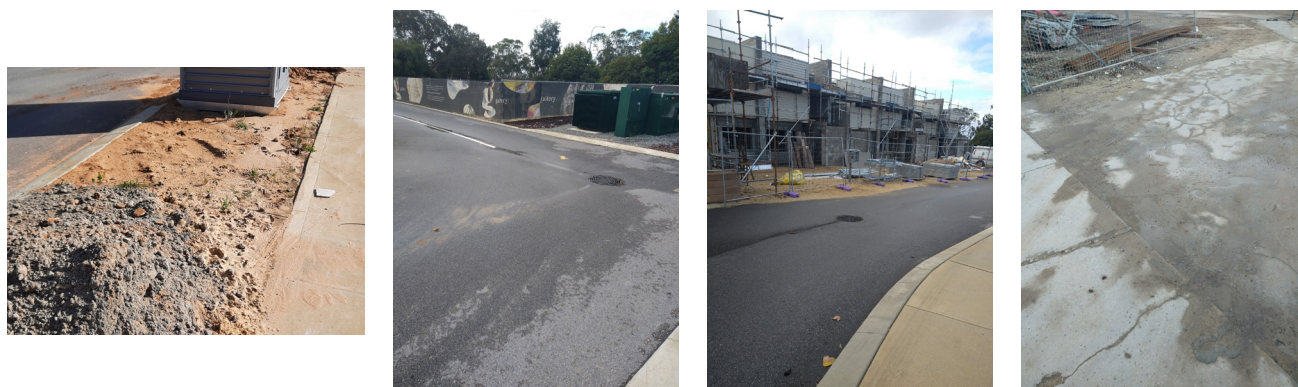
*Above left: Concrete wash dumped on top of soil and sand in verge at lot on Ebrington Road, Wellard, City of Kwinana. (Photo credit: Bronwyn Scallan)*

*Above centre: Concrete wash from two different sites into drains at subdivision near North Lake Rd and Archibald St (previously Carawatha Primary School) in Willagee, City of Melville. (Photo credits: David Bond)*

*Above right: Uncovered sediment and concrete wash on road, corner Kintail Rd/Canning Highway Sabina Apartments development, City of Melville. (Photo credit: David Bond)*

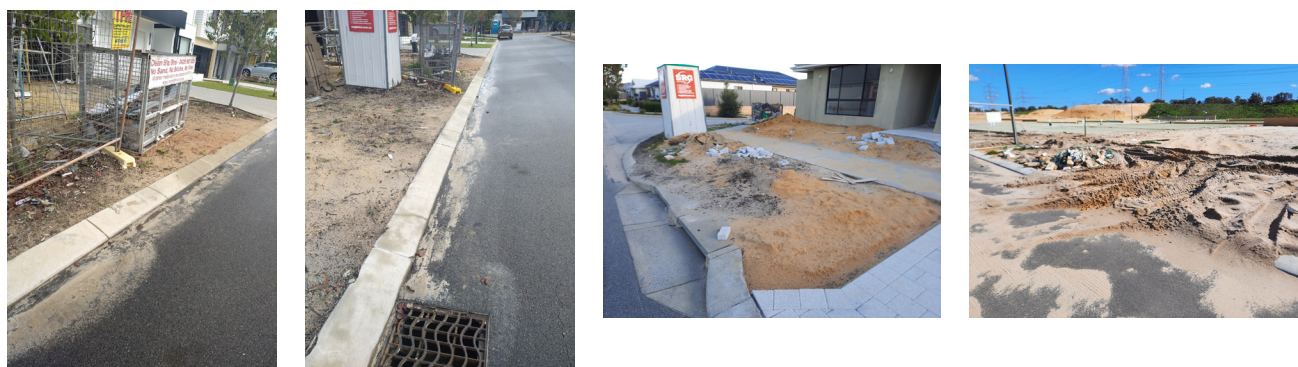
*Above left (LHS): Sand and concrete wash had been allowed to leave this apartment development on Kintail Rd in the City of Melville. (Photo credit: David Bond)*

*Above left (RHS): Sand and concrete wash had been allowed to leave this apartment development on Canning Beach Rd in the City of Melville. (Photo credit: David Bond)*
