FRESHWATER FISH
GROUP & FISH HEALTH
UNIT, Centre for Fish &
Fisheries Research,
Murdoch University

Aquatic fauna assessment of fire waterpoints in the Warren region, south-western WA

Report to :
Department of Parks and
Wildlife, Warren Region

June 2016

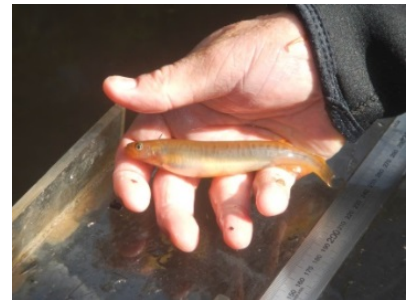
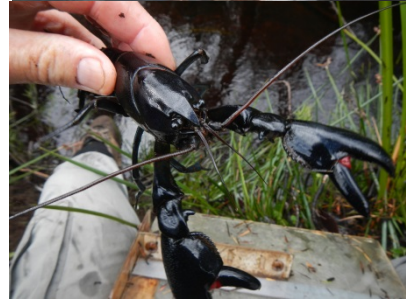
WP 141: Austin Road (Donnelly River Catchment)

Sampling Results		
Date	Aquatic Biota Captured	Mean Density (no. /m ²)
26/04/2016	Western minnow 4	0.15 ± 0.05
	Koonac 24	0.91 ± 0.5

Habitat Features					
Riparian Vegetation		Substrate (%)		Aquatic habitat (%)	
Native Cover (%)	Shade (%)				
85	35	Clay	80	Wood	10
		Sand	10		
		Gravel	10

Physical Characteristics						
Size (L x W (m))		Depth (m)		Bank Condition		
Current	Full Supply	Maximum	Average	Slope (Degrees)	Height (m)	Condition (1 - 5)
12 x 6	13.5 x 7	1.2	0.8	40	1.0	Moderate (3)

Connectivity							
Local drainage		Stream Order	Nearest stream	Distance (km)	Elevation (m)	Elevation from Stream (m)	Gradient from Stream (m/km)
Connected to Cow Brook		2	Donnelly River	2.5	217.0	27.0	10.8

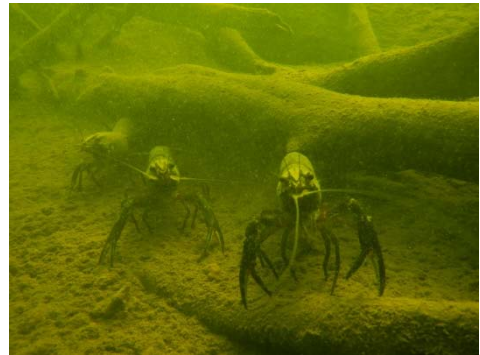
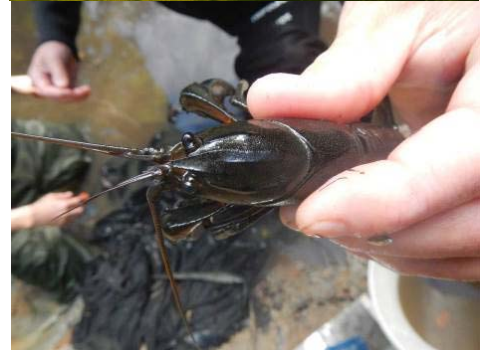
WP 323: Wells Road (Donnelly River Catchment)

Sampling Results		
Date	Aquatic Biota Captured	Mean Density (no. /m ²)
26/04/2016	Marron 83	1.8 ± 0.5
	Koonac 1	0.02

Habitat Features					
Riparian Vegetation		Substrate (%)		Aquatic habitat (%)	
Native Cover (%)	Shade (%)				
75	10	Clay	65	Wood	5
		Sand	30		
		Gravel	5

Physical Characteristics						
Size (L x W (m))		Depth (m)		Bank Condition		
Current	Full Supply	Maximum	Average	Slope (Degrees)	Height (m)	Condition (1 - 5)
13.6 x 9	19 x 12.5	1.0	0.6	20	1.5	Good (2)

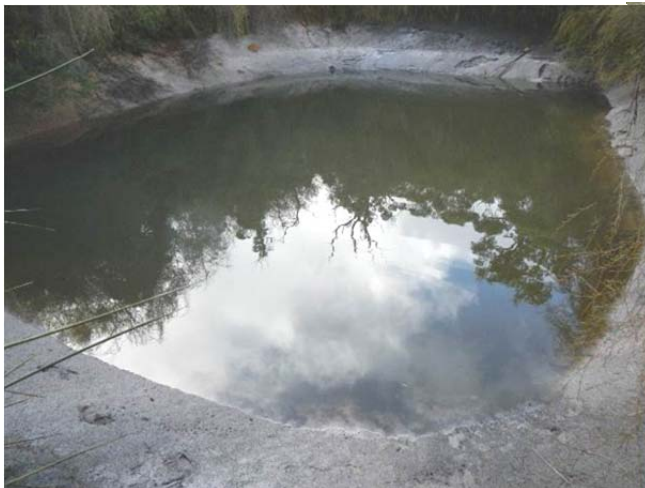
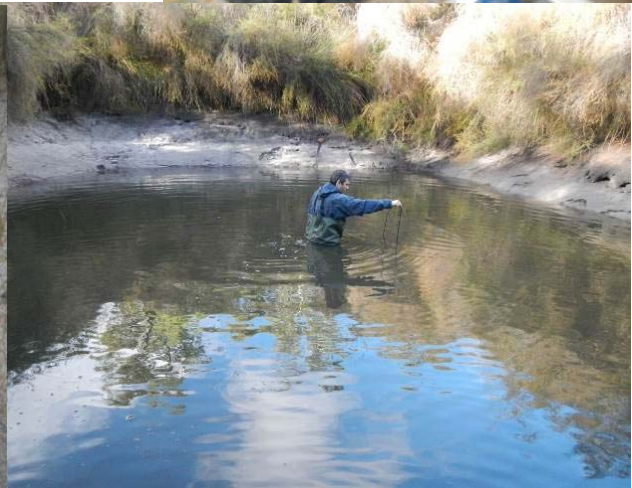
Connectivity						
Local drainage	Stream Order	Nearest stream	Distance (km)	Elevation (m)	Elevation from Stream (m)	Gradient from Stream (m/km)
Shallow depression	1	Donnelly River	3.4	290.0	60.0	17.6

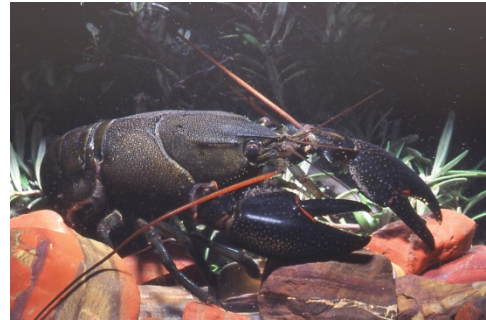
WP 81: Hogg Road (Gardiner Creek Catchment)

Sampling Results		
Date	Aquatic Biota Captured	Mean Density (no. /m ²)
27/04/2016	Koonac 55	1.5 ± 0.9

Habitat Features					
Riparian Vegetation		Substrate (%)		Aquatic habitat (%)	
Native Cover (%)	Shade (%)				
60	0	Clay	85	Wood	10
		Sand	10		
		Gravel	5

Physical Characteristics						
Size (L x W (m))		Depth (m)		Bank Condition		
Current	Full Supply	Maximum	Average	Slope (Degrees)	Height (m)	Condition (1 - 5)
10.5 x 7.3	13 x 12.6	1.6	1.0	70	1.3	Very Poor (5)

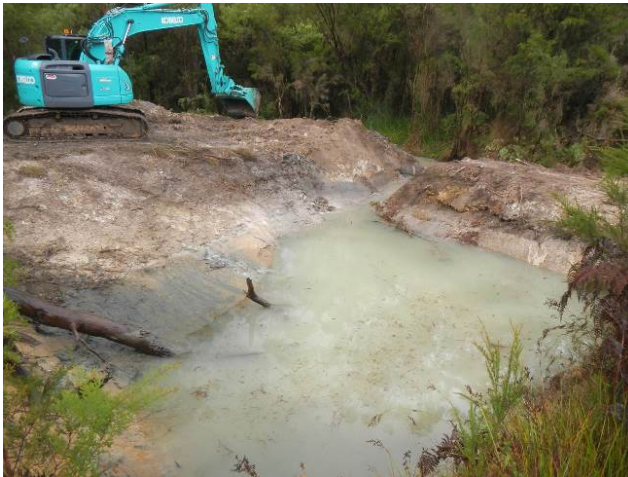
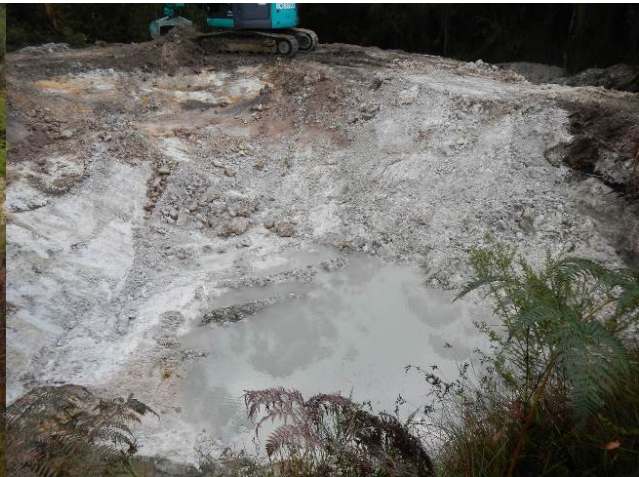
Connectivity							
Local drainage		Stream Order	Nearest stream	Distance (km)	Elevation (m)	Elevation from Stream (m)	Gradient from Stream (m/km)
Not connected to drainage line		1	Gardiner Creek	0.5	166.0	15.0	30

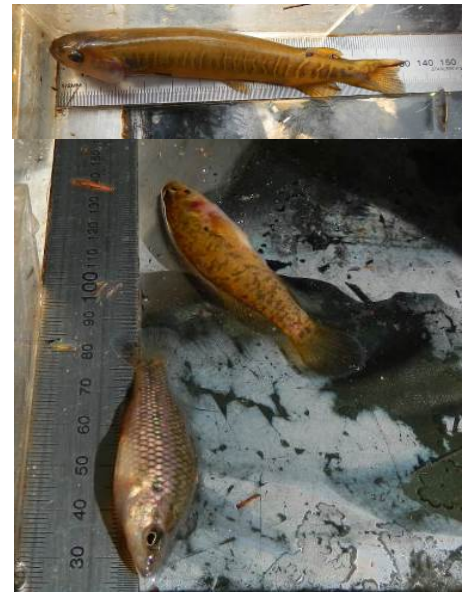
WP 71: Collins Road (Warren Creek Catchment)

Sampling Results		
Date	Aquatic Biota Captured	Mean Density (no. /m ²)
27/04/2016	Western minnow 1	0.02
	Western pygmy perch 12	0.23 ± 1.0
	Nightfish 2	0.17

Habitat Features				
Riparian Vegetation		Substrate (%)		Aquatic habitat (%)
Native Cover (%)	Shade (%)			
80	30	Clay	65	Wood 30
		Rock	30	Rock 10
		Gravel	5

Physical Characteristics						
Size (L x W (m))		Depth (m)		Bank Condition		
Current	Full Supply	Maximum	Average	Slope (Degrees)	Height (m)	Condition (1 - 5)
12 x 7.3	16 x 15	1.6	1.0	30	1.6	Good (2)

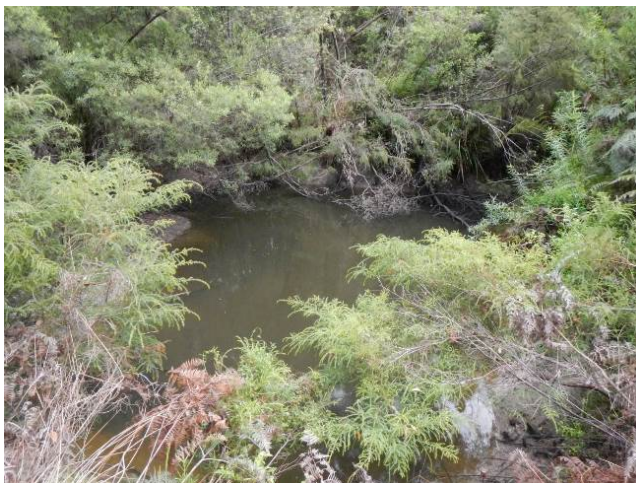
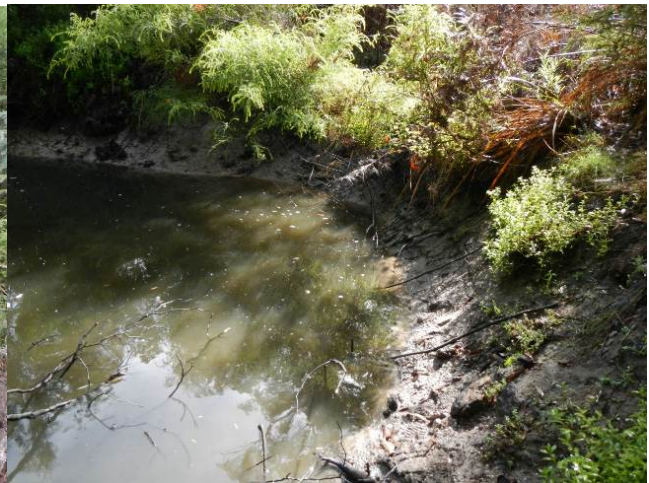
Connectivity							
Local drainage	Stream Order	Nearest stream	Distance (km)	Elevation (m)	Elevation from Stream (m)	Gradient from Stream (m/km)	
Connects in winter and spring	3	Warren River	3.8	100.0	30.0	7.9

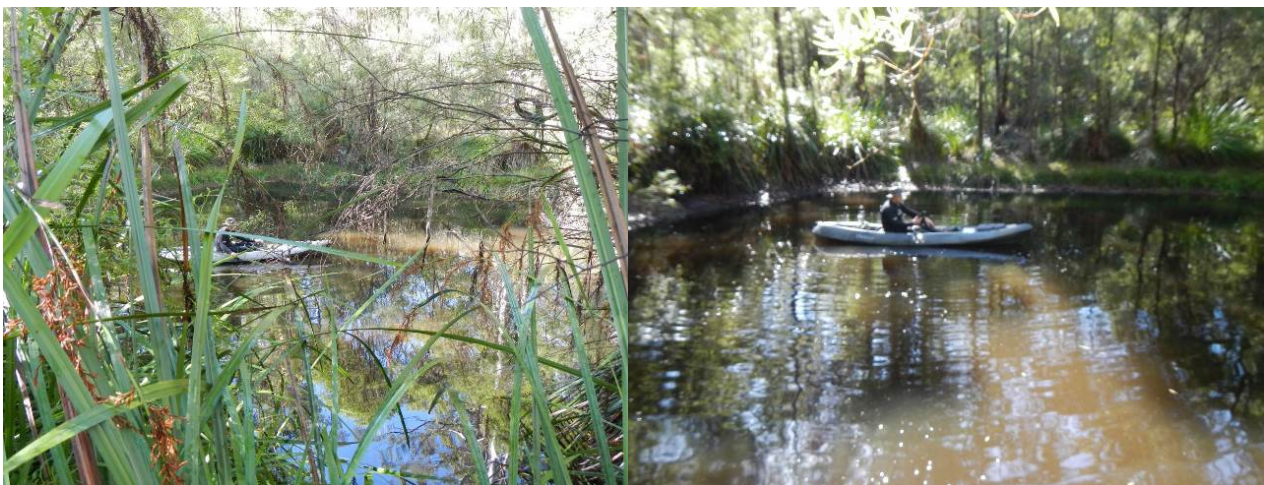
Physical Characteristics						
Size (L x W (m))		Depth (m)		Bank Condition		
Current	Full Supply	Maximum	Average	Slope (Degrees)	Height (m)	Condition (1 - 5)
16.2 x 15	20 x 18	2.6	21.8	30	1.0	Very good (1)

Connectivity							
Local drainage	Stream Order	Nearest stream	Distance (km)	Elevation (m)	Elevation from Stream (m)	Gradient from Stream (m/km)	
Poor - perched	1	Lefroy Brook	7.4	150.0	65.0	8.8

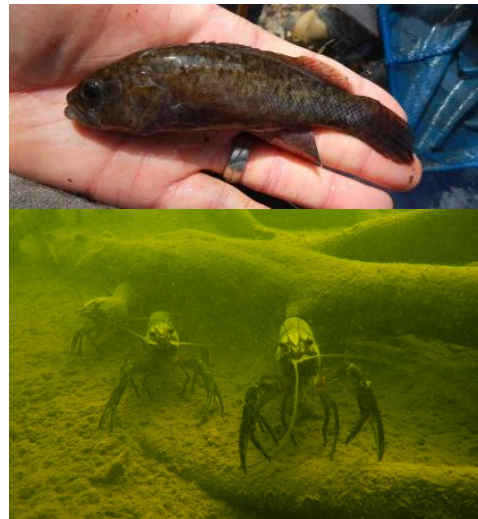
WP 66: Bannister Road (Warren River Catchment)

Sampling Results		
Date	Aquatic Biota Captured	Mean Density (no. /m ²)
27/04/2016	Nighfish 10	0.31 ± 0.08
	Marron 6	0.25 ± 0.07

Habitat Features					
Riparian Vegetation		Substrate (%)		Aquatic habitat (%)	
Native Cover (%)	Shade (%)				
80	20	Clay	70	Wood	50
		Gravel	30

Physical Characteristics						
Size (L x W (m))		Depth (m)		Bank Condition		
Current	Full Supply	Maximum	Average	Slope (Degrees)	Height (m)	Condition (1 - 5)
59 x 26	60 x 28	2.0	1.4	30, 70	1.8	Very good (1)

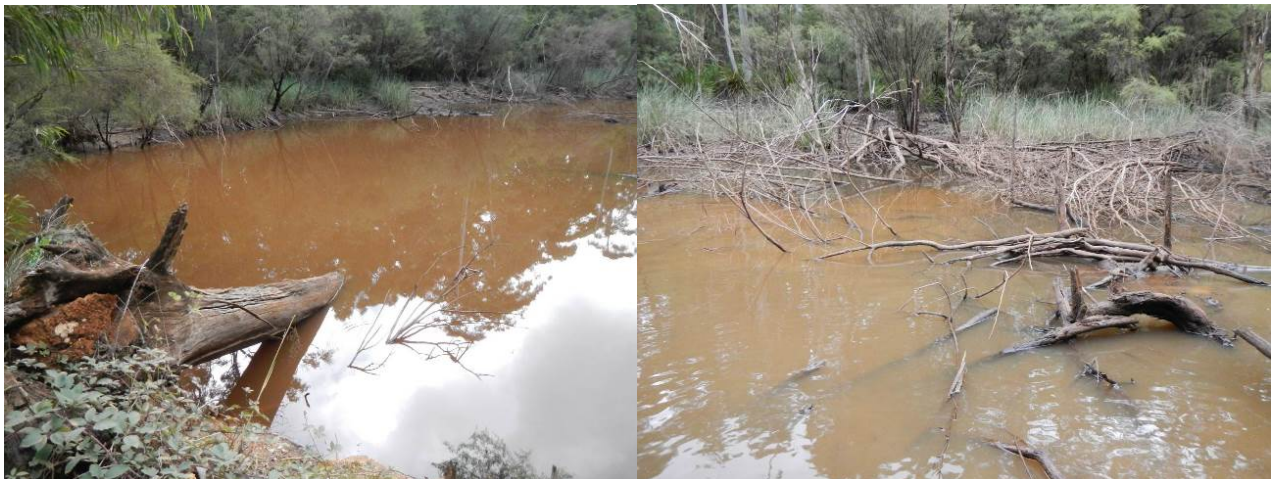
Connectivity							
Local drainage	Stream Order	Nearest stream	Distance (km)	Elevation (m)	Elevation from Stream (m)	Gradient from Stream (m/km)	
Connected to tributary	2	Warren River	3.2	140	44	13.8

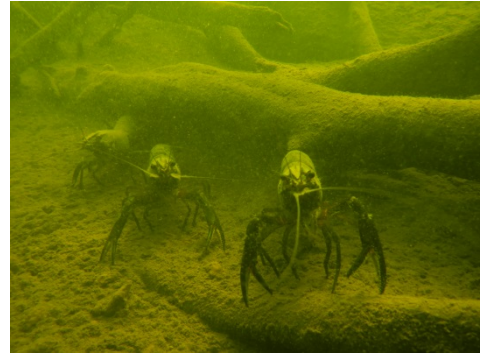
WP 318: Off Vasse Highway (Warren River Catchment)

Sampling Results		
Date	Aquatic Biota Captured	Mean Density (no. /m ²)
28/04/2016	Marron 45	1.1 ± 0.33

Habitat Features					
Riparian Vegetation		Substrate (%)		Aquatic habitat (%)	
Native Cover (%)	Shade (%)				
95	35	Clay	90	Wood	20
		Gravel	10	Plants	10

Physical Characteristics						
Size (L x W (m))		Depth (m)		Bank Condition		
Current	Full Supply	Maximum	Average	Slope (Degrees)	Height (m)	Condition (1 - 5)
28 x 15	29.5 x 16	3.3	2.5	80	0.3	Good (2)

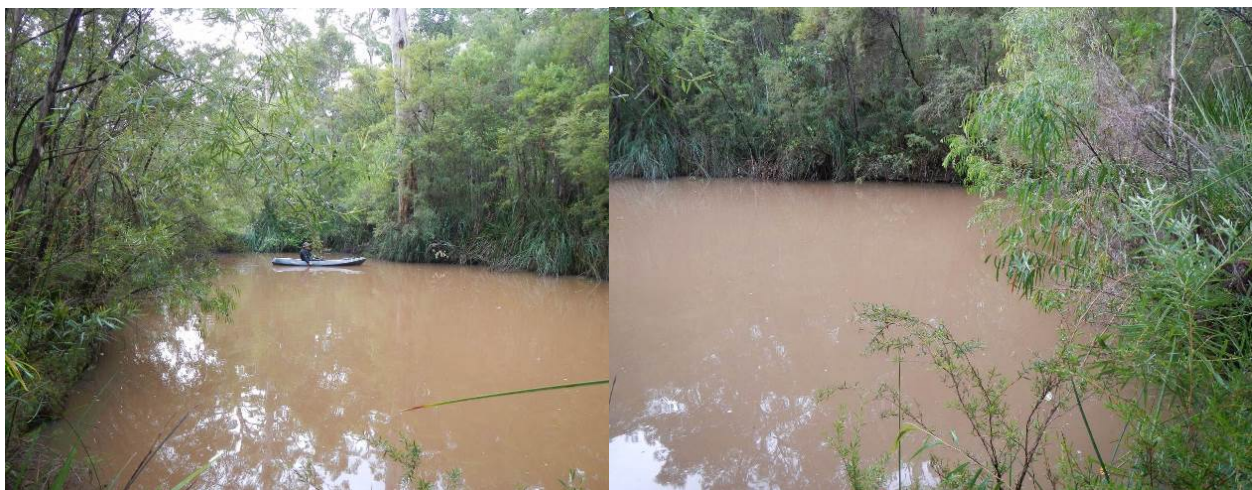
Connectivity							
Local drainage	Stream Order	Nearest stream	Distance (km)	Elevation (m)	Elevation from Stream (m)	Gradient from Stream (m/km)	
Connected to minor stream	1	Warren River	4.6	192	86	18.7

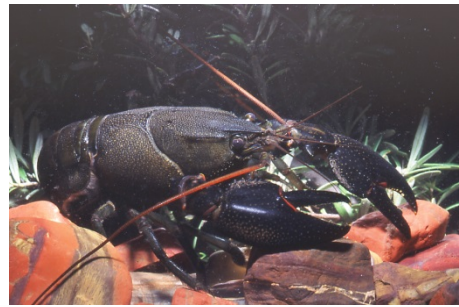
WP 347: Off Lower Shannon Road (Shannon River Catchment)

Sampling Results		
Date	Aquatic Biota Captured	Mean Density (no. /m ²)
28/04/2016	Koonac 12	0.53 ± 0.07

Habitat Features					
Riparian Vegetation		Substrate (%)		Aquatic habitat (%)	
Native Cover (%)	Shade (%)				
60	30	Clay	75	Wood	20
		Gravel	25

Physical Characteristics						
Size (L x W (m))		Depth (m)		Bank Condition		
Current	Full Supply	Maximum	Average	Slope (Degrees)	Height (m)	Condition (1 - 5)
12.5 x 7	21 x 15	0.3	0.2	45, 60	1.8	Poor (5)

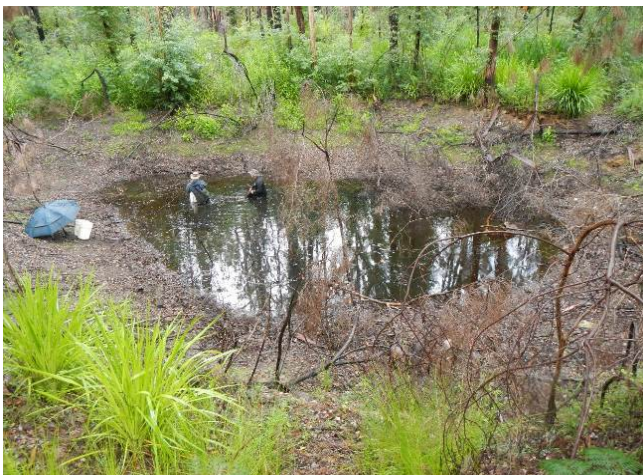
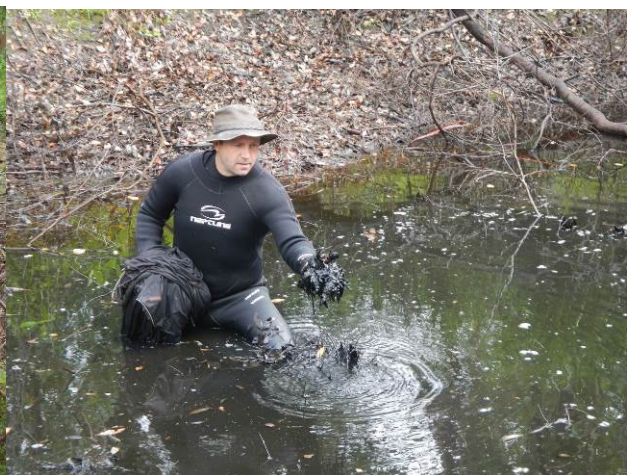
Connectivity							
Local drainage		Stream Order	Nearest stream	Distance (km)	Elevation (m)	Elevation from Stream (m)	Gradient from Stream (m/km)
Minor tributary of Shannon R.		2	Shannon River	0.3	160.0	8.0	26.7

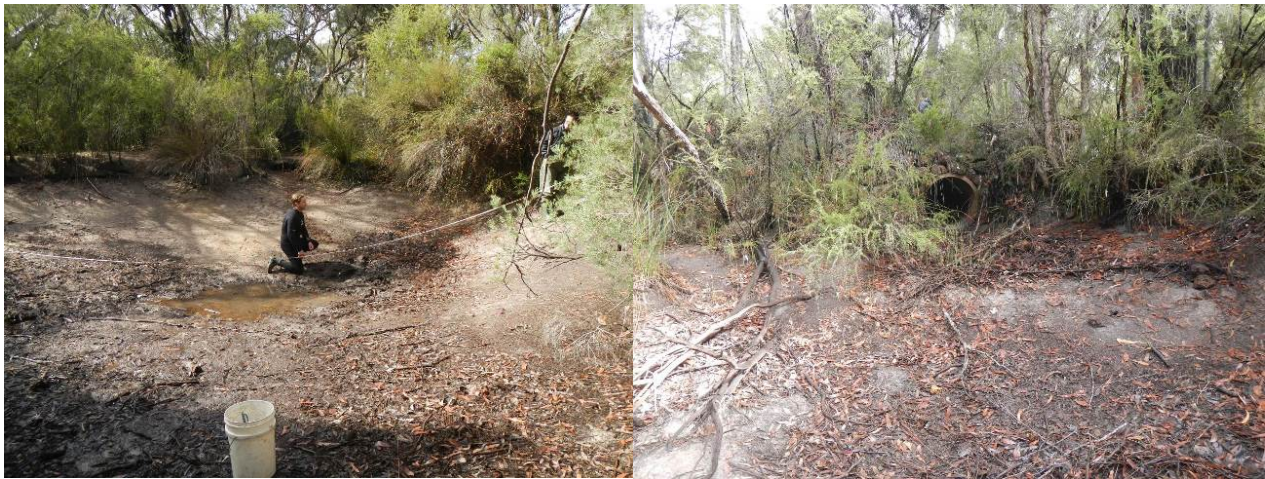
Physical Characteristics						
Size (L x W (m))		Depth (m)		Bank Condition		
Current	Full Supply	Maximum	Average	Slope (Degrees)	Height (m)	Condition (1 - 5)
1.8 x 1.2	15 x 12	0.1	0.0	35	1.7	Good (2)

Connectivity							
Local drainage	Stream Order	Nearest stream	Distance (km)	Elevation (m)	Elevation from Stream (m)	Gradient from Stream (m/km)	
Connected to major tributary Shannon R.	3	Shannon River	3.7	198.0	6.0	1.6

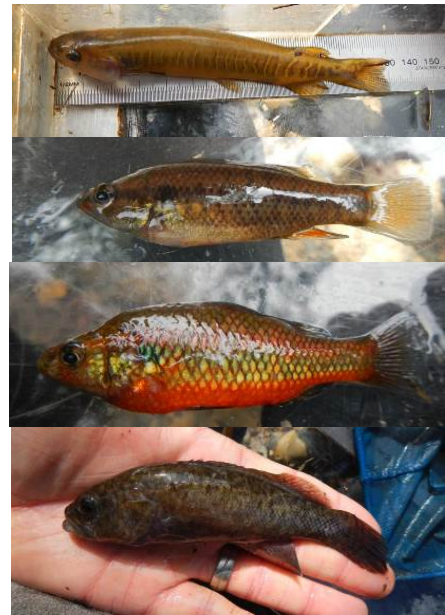
WP 299: Creek Bend Road (Shannon River Catchment)

Sampling Results		
Date	Aquatic Biota Captured	Mean Density (no. /m ²)
28/04/2016	Western minnow 90	1.61 ± 1.28
	Western pygmy perch 142	2.20 ± 0.10
	Balstons pygmy perch 12	0.43
	Nightfish 29	0.38 ± 0.26
	Marron 71	0.97 ± 0.58

Habitat Features					
Riparian Vegetation		Substrate (%)		Aquatic habitat (%)	
Native Cover (%)	Shade (%)				
95	15	Clay	90	Wood	5
		Gravel	10

Physical Characteristics						
Size (L x W (m))		Depth (m)		Bank Condition		
Current	Full Supply	Maximum	Average	Slope (Degrees)	Height (m)	Condition (1 - 5)
12 x 8	14 x 10	1.4	0.9	45	1.2	Good (2)

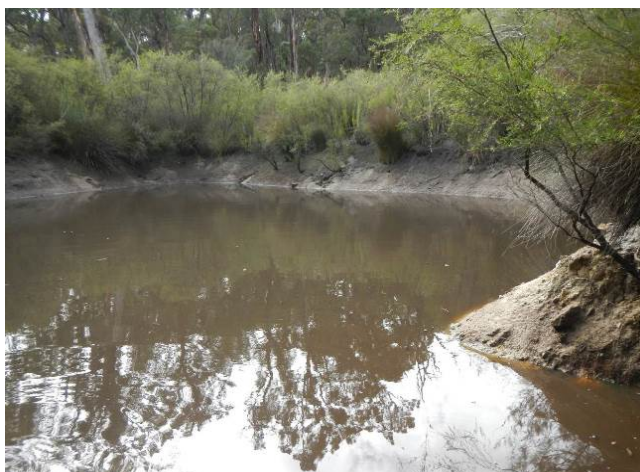
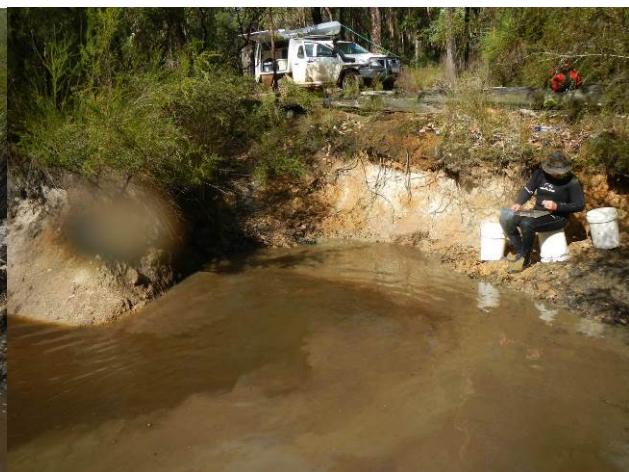
Connectivity							
Local drainage	Stream Order	Nearest stream	Distance (km)	Elevation (m)	Elevation from Stream (m)	Gradient from Stream (m/km)	
Connected to tributary of Shannon R.	2	Shannon River	0.6	191.0	3.0	5.0

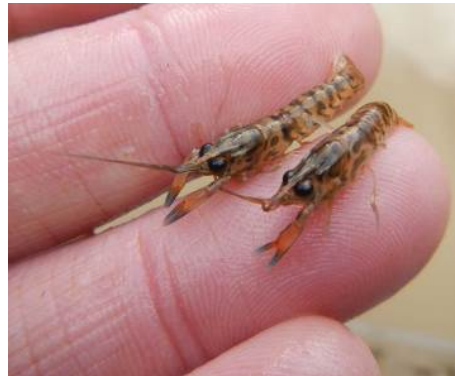
WP 92: Lockyer Road (Quinninup Brook Catchment)

Sampling Results		
Date	Aquatic Biota Captured	Mean Density (no. /m ²)
28/04/2016	Marron 82	2.72 ± 0.33

Habitat Features					
Riparian Vegetation		Substrate (%)		Aquatic habitat (%)	
Native Cover (%)	Shade (%)				
70	15	Clay	60	Wood	5
		Sand	30		
		Gravel	10

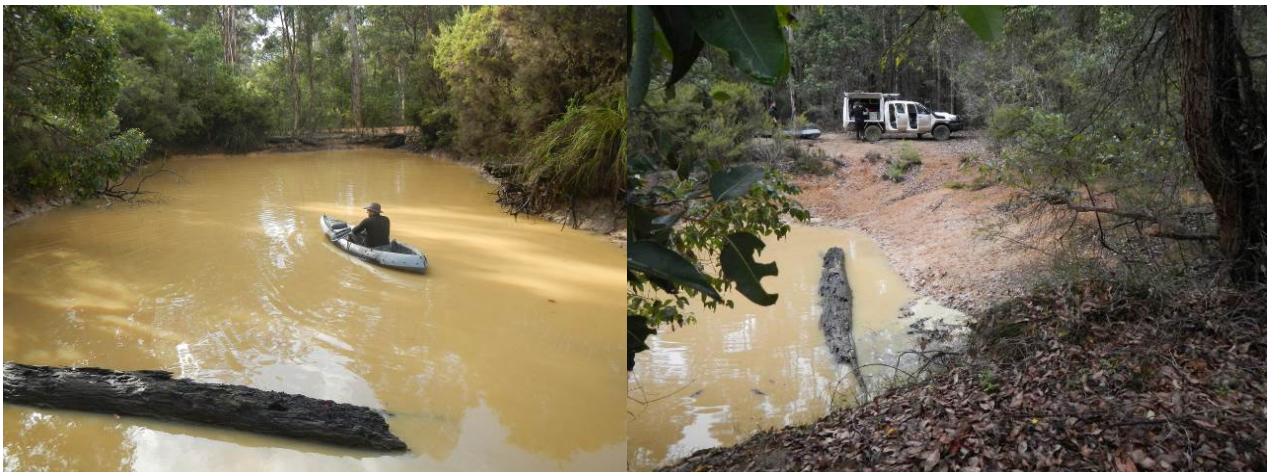
Physical Characteristics						
Size (L x W (m))		Depth (m)		Bank Condition		
Current	Full Supply	Maximum	Average	Slope (Degrees)	Height (m)	Condition (1 - 5)
30 x 11	35 x 13	1.8	1.2	85	0.8	Good (2)

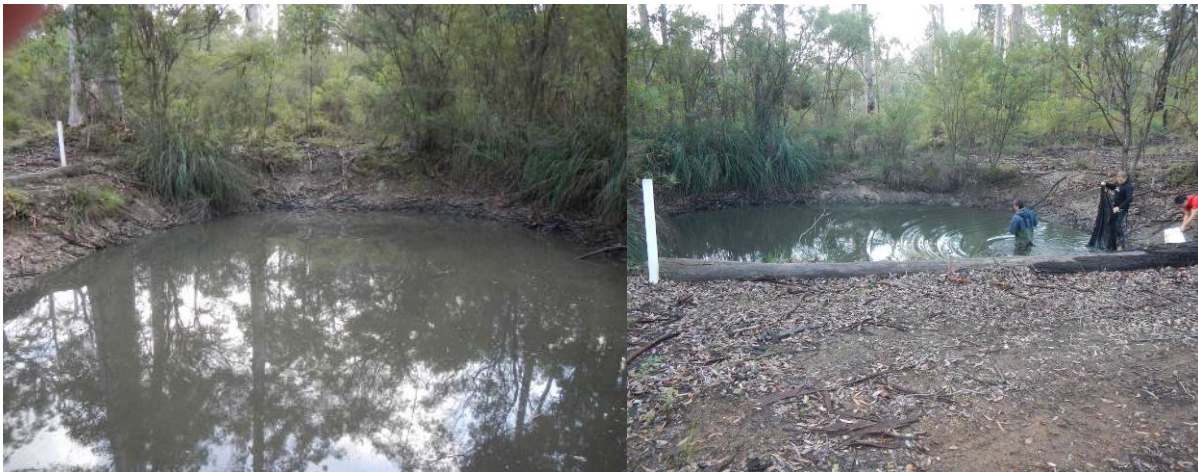
Physical Characteristics						
Size (L x W (m))		Depth (m)		Bank Condition		
Current	Full Supply	Maximum	Average	Slope (Degrees)	Height (m)	Condition (1 - 5)
11 x 8.6	11 x 10	1.1	0.8	45, 90	1.5	Moderate (3)

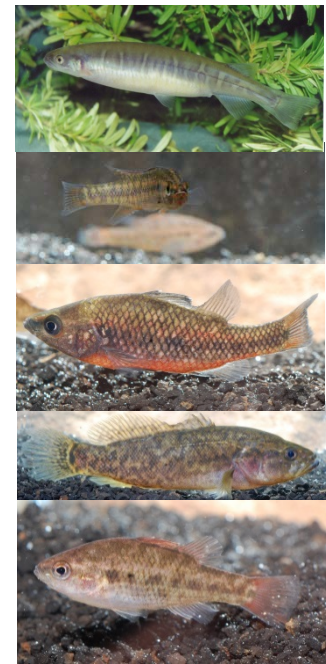
Little Pygmy Creek Refuge Fire Point

Sampling Results		
Date	Aquatic Biota Captured	Mean Density (no. /m ²)
30/04/2016	Western minnow 2	0.17
	Western pygmy perch 58	1.58 ± 0.27
	Balstons pygmy perch 28	0.91 ± 0.25
	Nightfish 29	0.38 ± 0.26
	Little Pygmy Perch 5	0.33

Habitat Features					
Riparian Vegetation		Substrate (%)		Aquatic habitat (%)	
Native Cover (%)	Shade (%)				
30	10	Clay	60	Wood	10
		Sand	30		
		Gravel	10

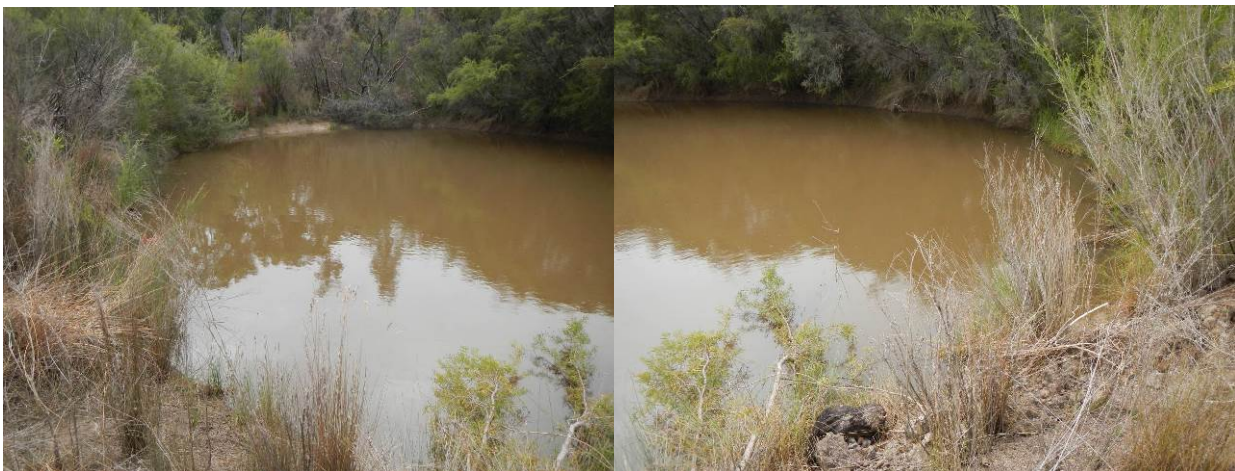
Physical Characteristics						
Size (L x W (m))		Depth (m)		Bank Condition		
Current	Full Supply	Maximum	Average	Slope (Degrees)	Height (m)	Condition (1 - 5)
16.5 x 9.5	18 x 11	3.2	1.5	25, 35	0.9	Good (2)

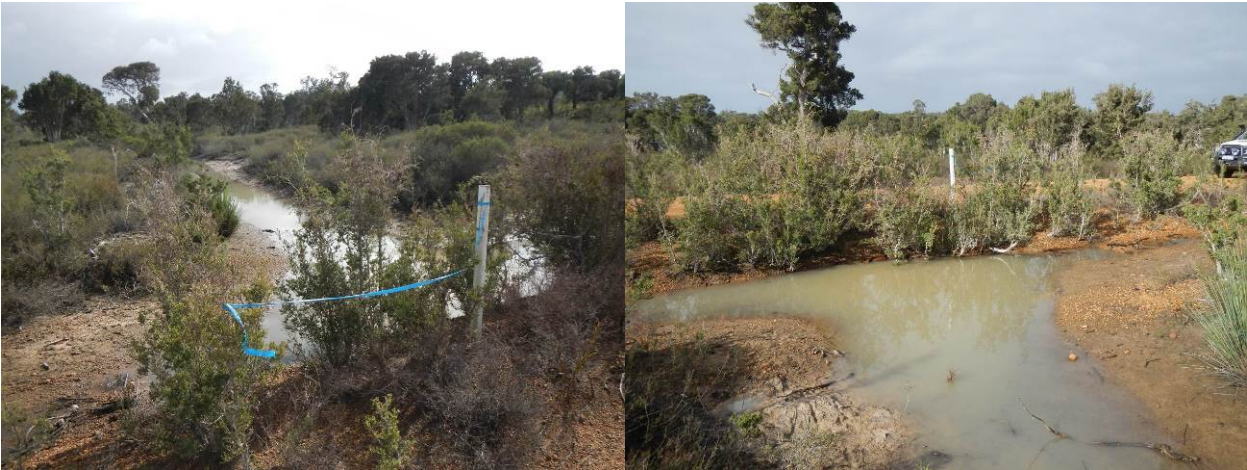
PWP 13: Hiker Road

Connectivity						
Local drainage	Stream Order	Nearest stream	Distance (km)	Elevation (m)	Elevation from Stream (m)	Gradient from Stream (m/km)
Upper Tributary	1	Frankland River	4.3	158	6	1.4

Water Quality (middle of water column)				
Temp. (oC)	EC (uS/cm)	TDS (mg/L)	pH	ORP (mV)
14.6	77	62	7.8	140

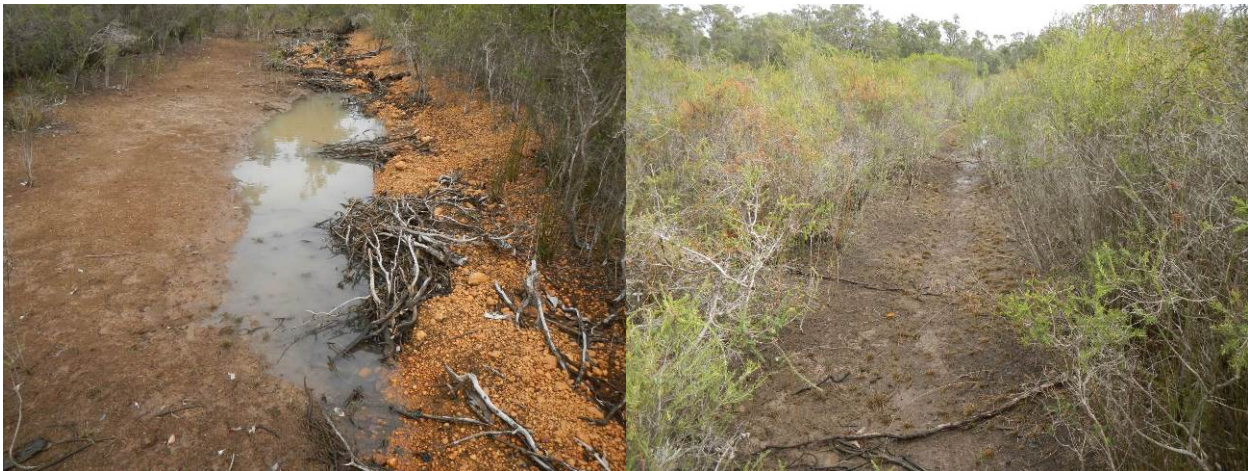
PWP 14: Durham Road

Connectivity						
Local drainage	Stream Order	Nearest stream	Distance (km)	Elevation (m)	Elevation from Stream	Gradient from Stream
Upper Tributary	1	Frankland River	13.9	217	87	6.3

Water Quality (middle of water column)				
Temp. (oC)	EC (uS/cm)	TDS (mg/L)	pH	ORP (mV)
15.4	90	72	7.6	126

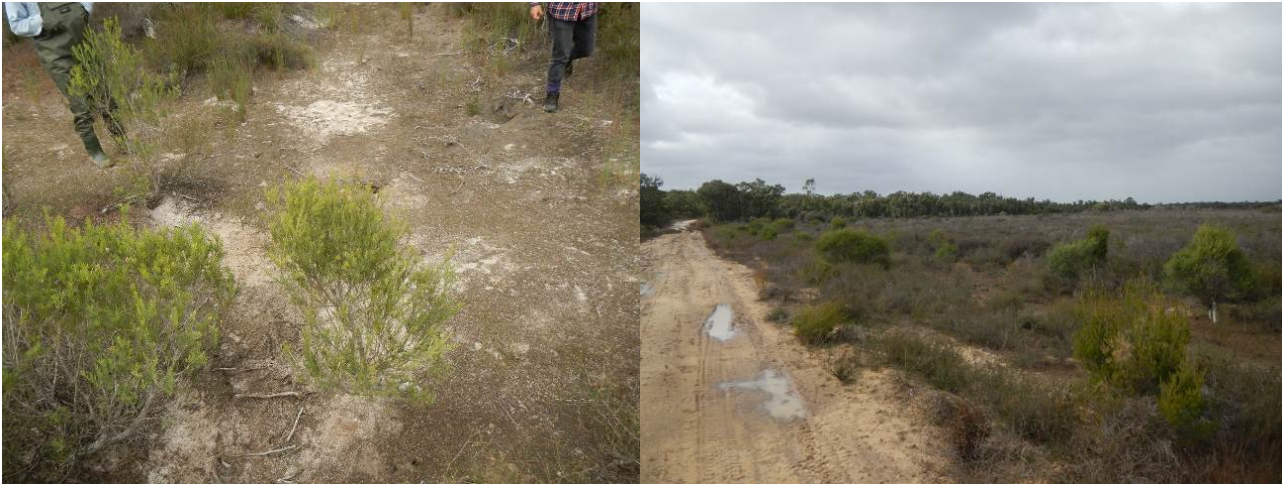
PWP 15: Bevan Road

Connectivity						
Local drainage	Stream Order	Nearest stream	Distance (km)	Elevation (m)	Elevation from Stream	Gradient from Stream
Upper Tributary, indistinct	3	Kent River	4.1	147	10	2.4

Water Quality (middle of water column)				
Temp. (oC)	EC (uS/cm)	TDS (mg/L)	pH	ORP (mV)
DRY

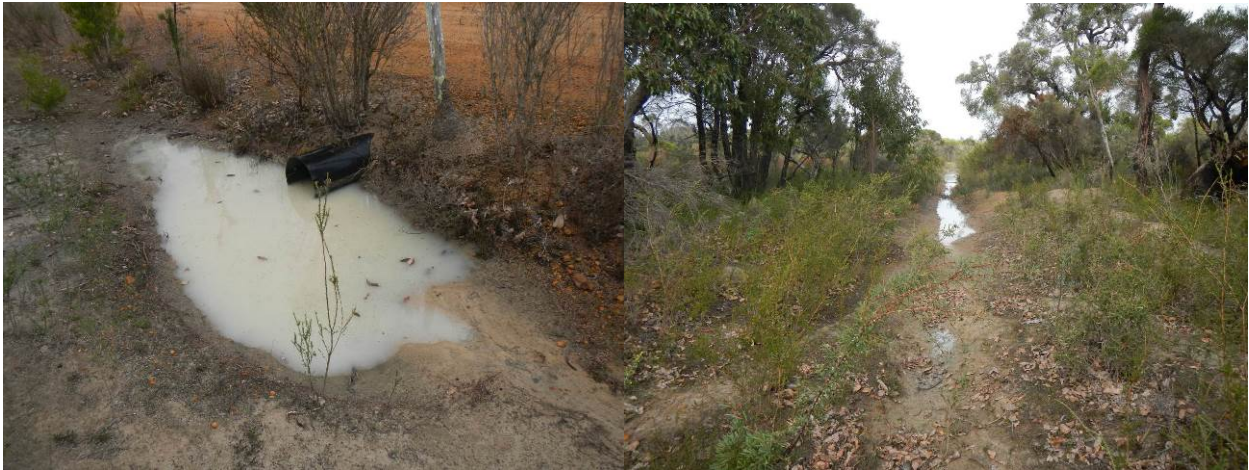
PWP 16: Corner of Watershed and Bevan Roads

Connectivity						
Local drainage	Stream Order	Nearest stream	Distance (km)	Elevation (m)	Elevation from Stream	Gradient from Stream
Upper Tributary, indistinct	1	Kent River	5.8	150	10	1.7

Water Quality (middle of water column)				
Temp. (oC)	EC (uS/cm)	TDS (mg/L)	pH	ORP (mV)
14.4	131	105	9.1	59

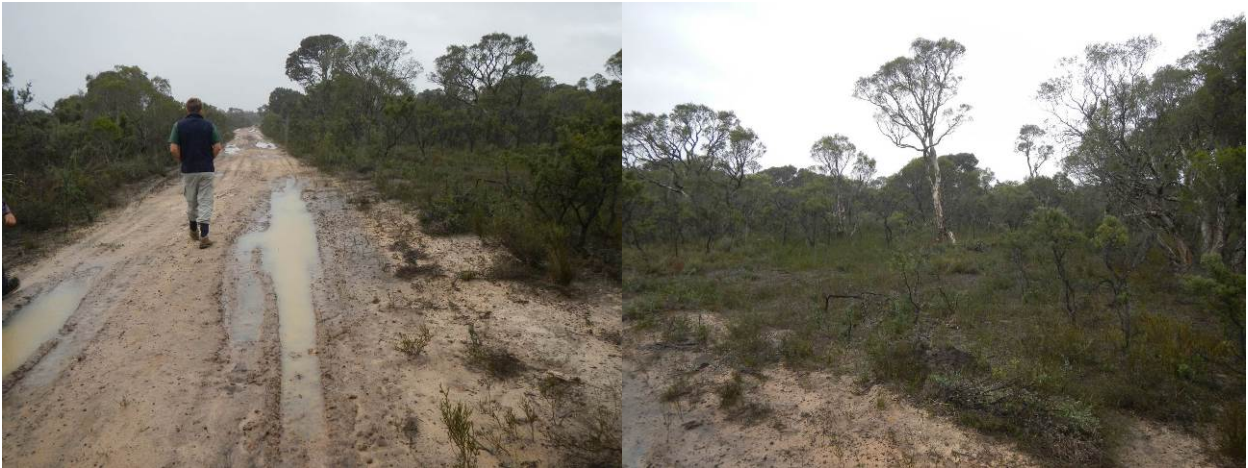
PWP 17: Corner of Watershed Road and Biro Track

Connectivity						
Local drainage	Stream Order	Nearest stream	Distance (km)	Elevation (m)	Elevation from Stream	Gradient from Stream
Upper Tributary, very indistinct	1	Kent River	13.9	200	50	3.6

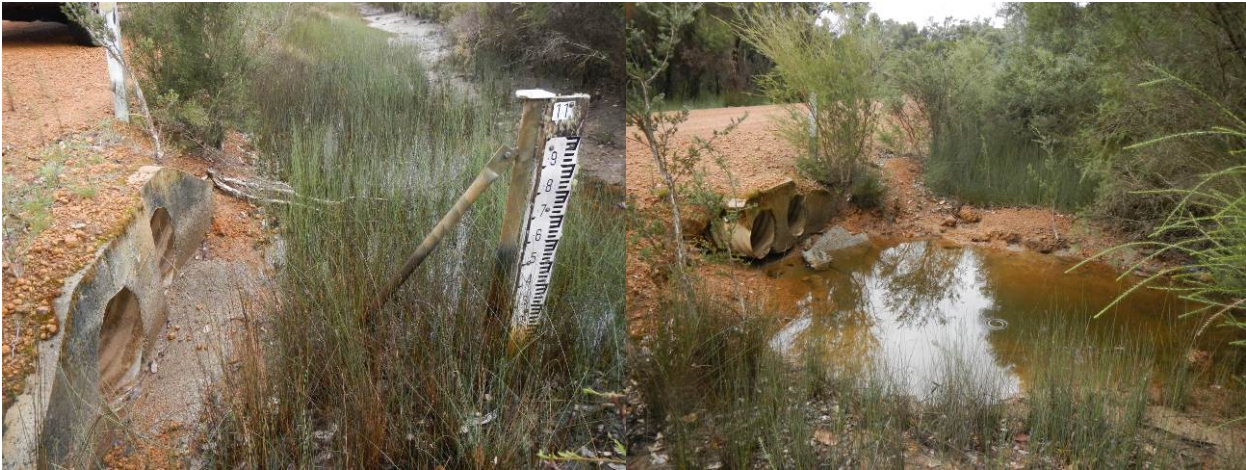
PWP 18: Perillup Road South

Connectivity						
Local drainage	Stream Order	Nearest stream	Distance (km)	Elevation (m)	Elevation from Stream	Gradient from Stream
On large Upper Tributary	1	Kent River	2.1	193	5	2.4

- *Very good connectivity to the Kent River*
- *Likelihood of Western Minnows colonising the waterpoint. However, relatively high salinity would probably prevent other species being present in this stream*
- *Koonac burrows observed*

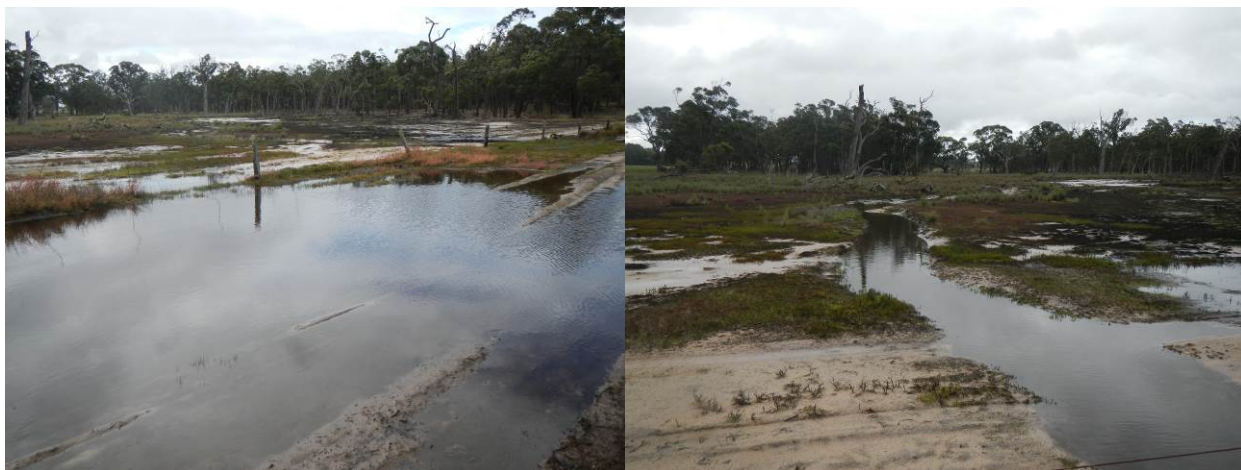
PWP 19: Off Clear Hills Road

Connectivity						
Local drainage	Stream Order	Nearest stream	Distance (km)	Elevation (m)	Elevation from Stream (m)	Gradient from Stream (m/km)
Upper Tributary	1	Denmark River	2.4	235	15	6.25

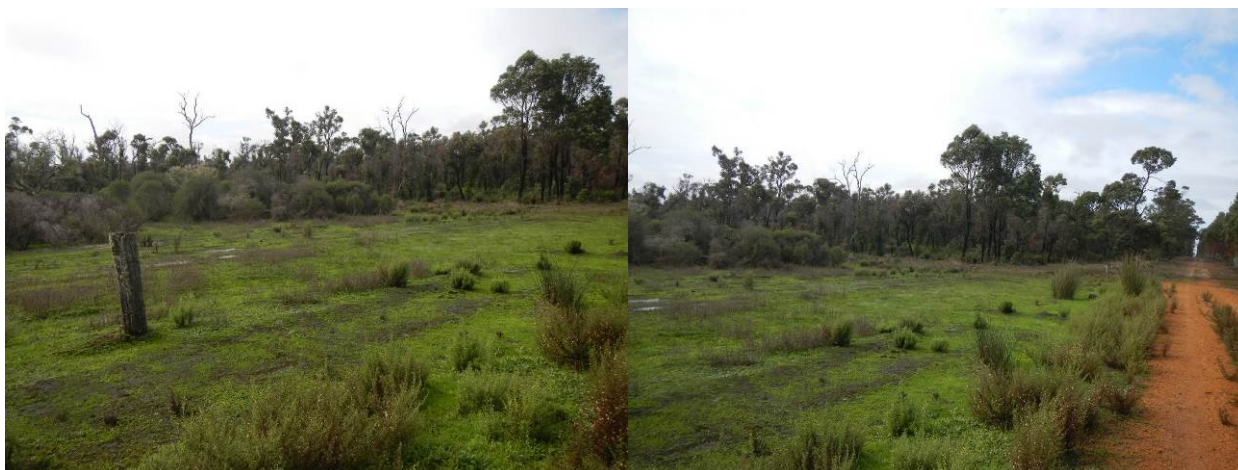
PWP 20: Off Clear Hills Road (Adjacent to Blue Gum Plantation)

Connectivity						
Local drainage	Stream Order	Nearest stream	Distance (km)	Elevation (m)	Elevation from Stream	Gradient from Stream
Shallow Upper Tributary	1	Denmark River	20.4	235	85	4.2

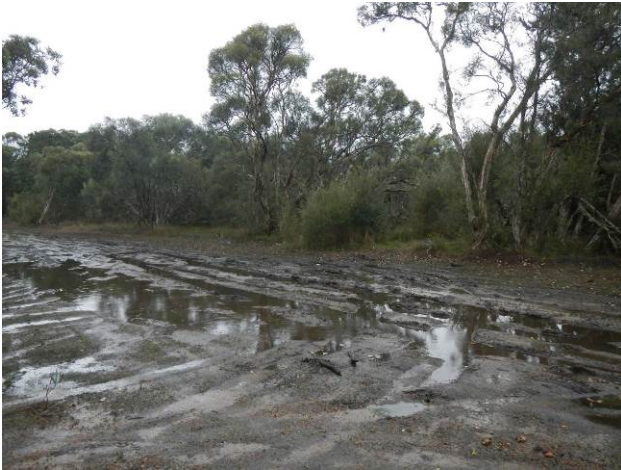
PWP 21: Off Pile Road

Connectivity						
Local drainage	Stream Order	Nearest stream	Distance (km)	Elevation (m)	Elevation from Stream	Gradient from Stream
Shallow drainage	1	Hay River	2.6	246	23	8.8

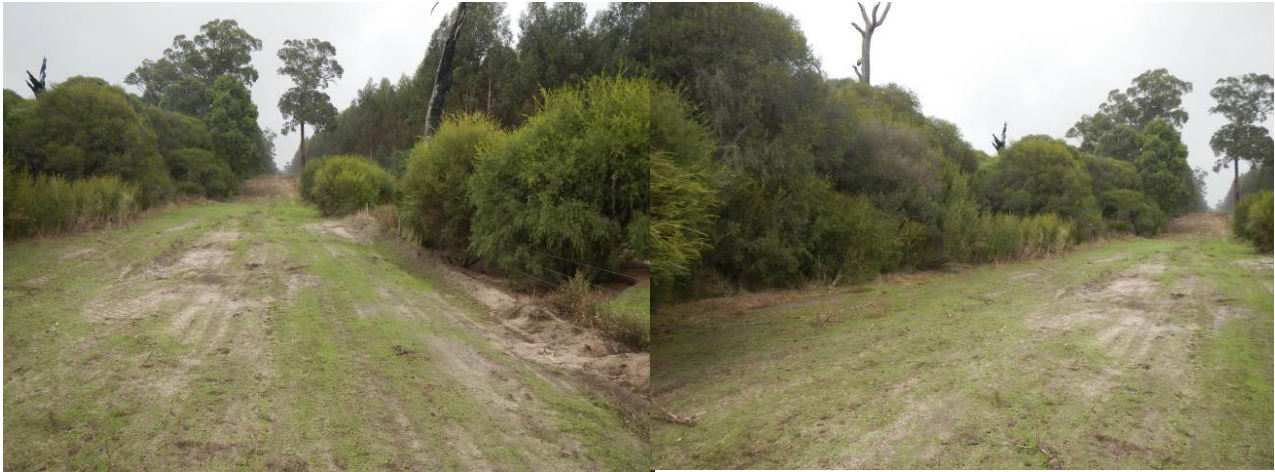
PWP 22: Seymour Road

Local drainage	Stream Order	Nearest stream	Distance (km)	Elevation (m)	Elevation from Stream	Gradient from Stream
Shallow drainage	2	Denmark River	11.7	200	45	3.8

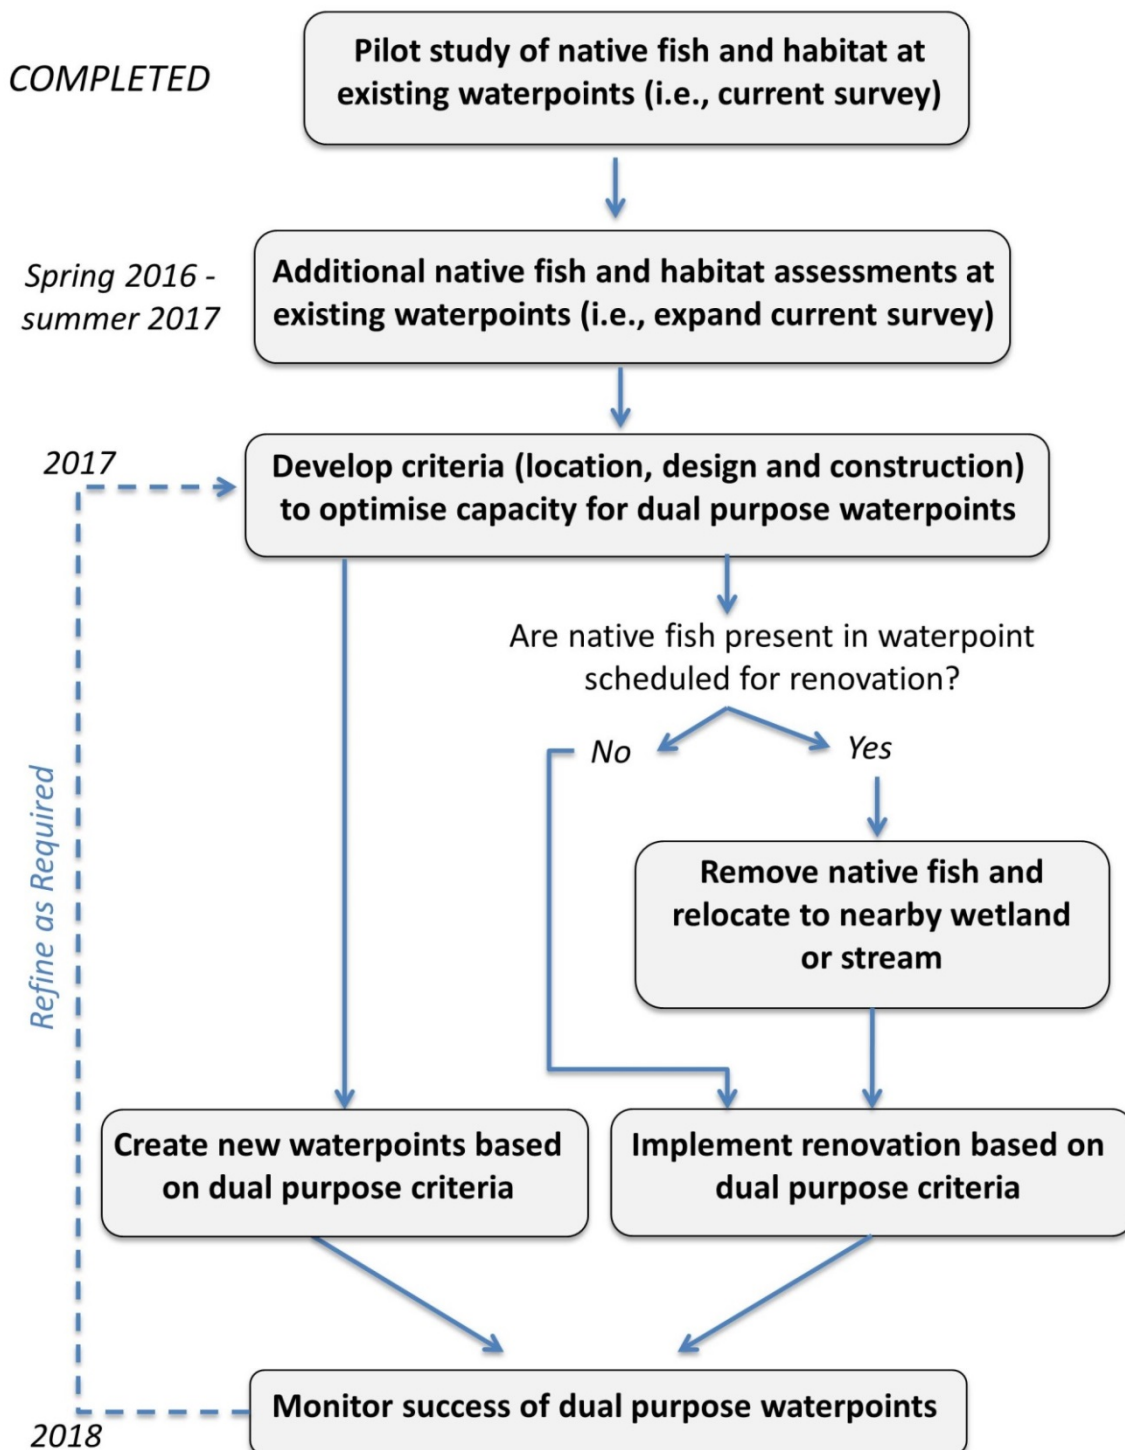
Figure 4: Proposed process for developing a robust protocol to design, create, manage and monitor dual purpose waterpoints for aquatic refuge and fire-fighting in south-western Australia.
