DEPARTMENT OF FISHERIES AND WILDLIFE
WETLAND — WATERBIRD SURVEY SHEET

WETLAND	WARR # 733113
LOCATION	Dundas Sluice

INSPECTED BY	J. LANE & G. PEACOCK
INSPECTION DATE	MON 27 Aug 1979
TIME START	1030 hrs.
TIME FINISH	— approx 1520 hrs.

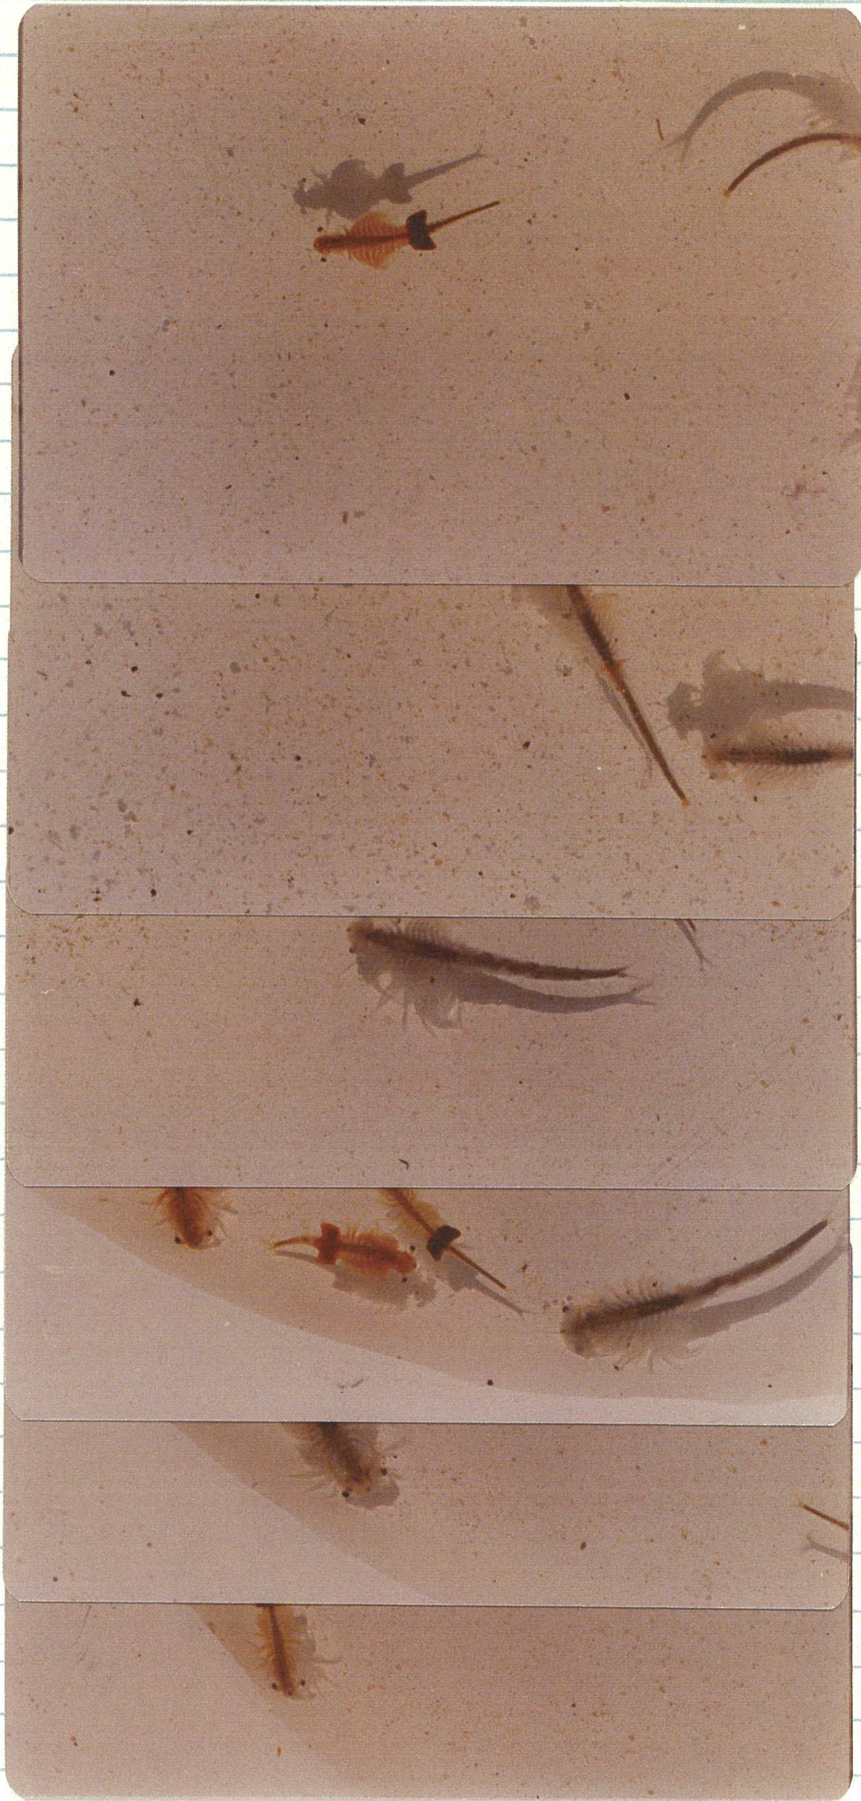
Photos 70:18-23 : Paratemia in water of WNR # 33113
(Dundee Shire) 27 AUG 1979.

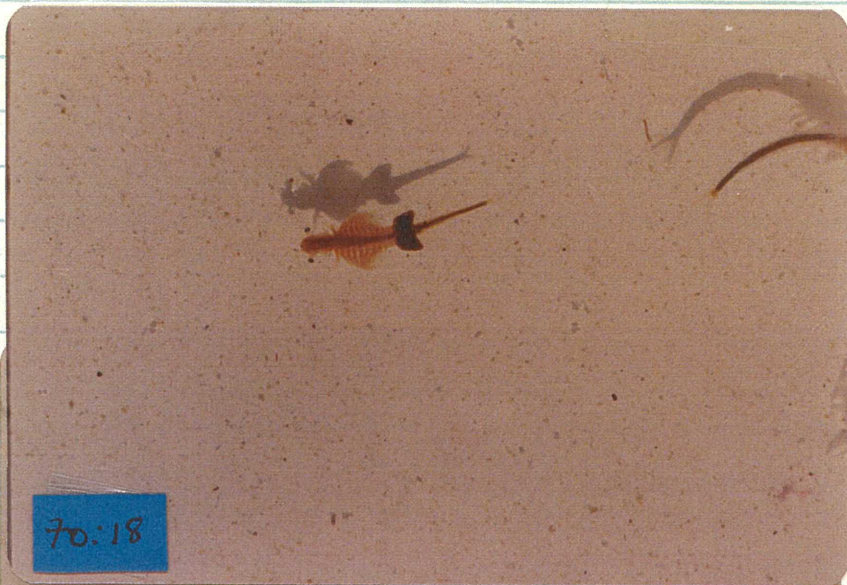
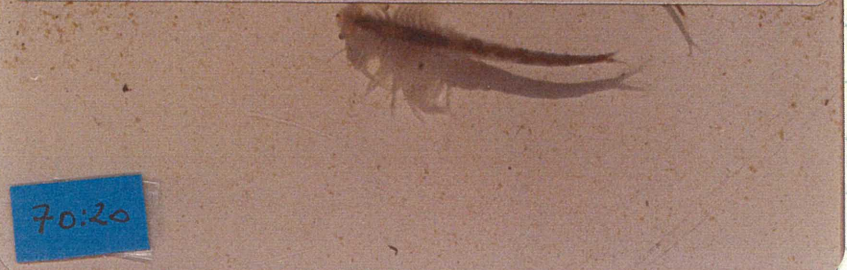
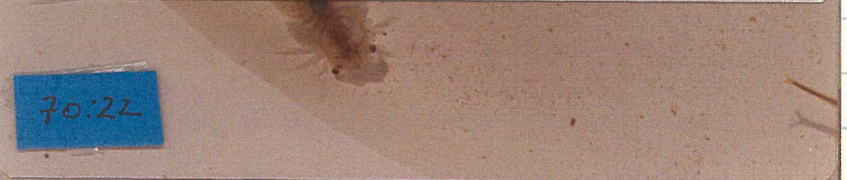
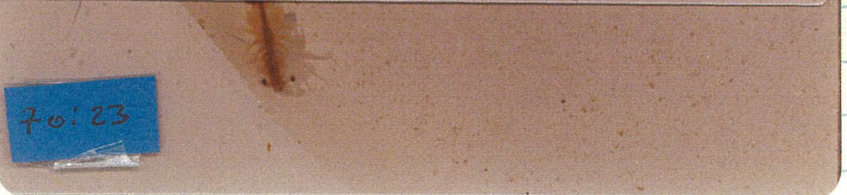
Photos 70:18-23 : *Pererkemia* in water of WNR ↑ 33113
(Dundee Shire) 27 AUG 1979.
