Just add **water:**

the Toolibin Lake inundation experiment

by Jennifer Higbid and Paul Drake

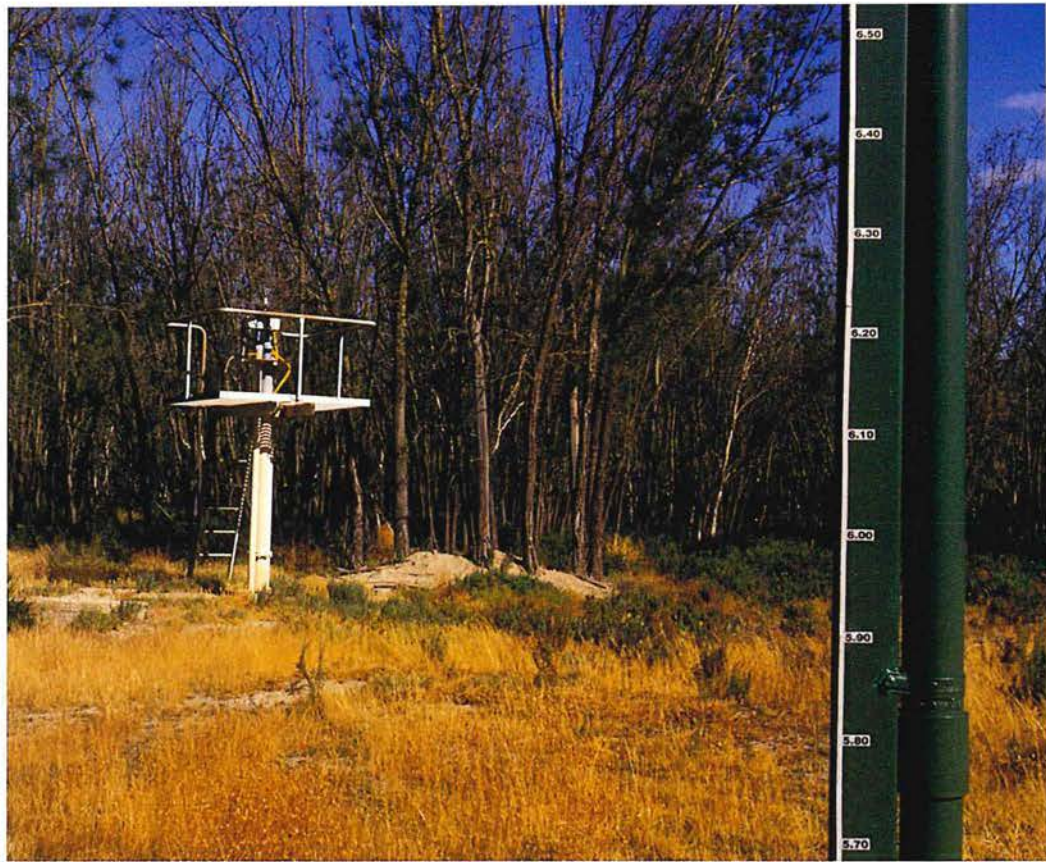
Right Toolibin Lake pumping station.
Photo – Marie Lochman

More recently, infrastructure that controls the outflow of water has been upgraded with a sump and shallow channels constructed on the lake bed to enable surface water to drain before it becomes too saline from evaporation. Importantly, better outflow control also means that surface water can now be removed from the lake before it connects directly with

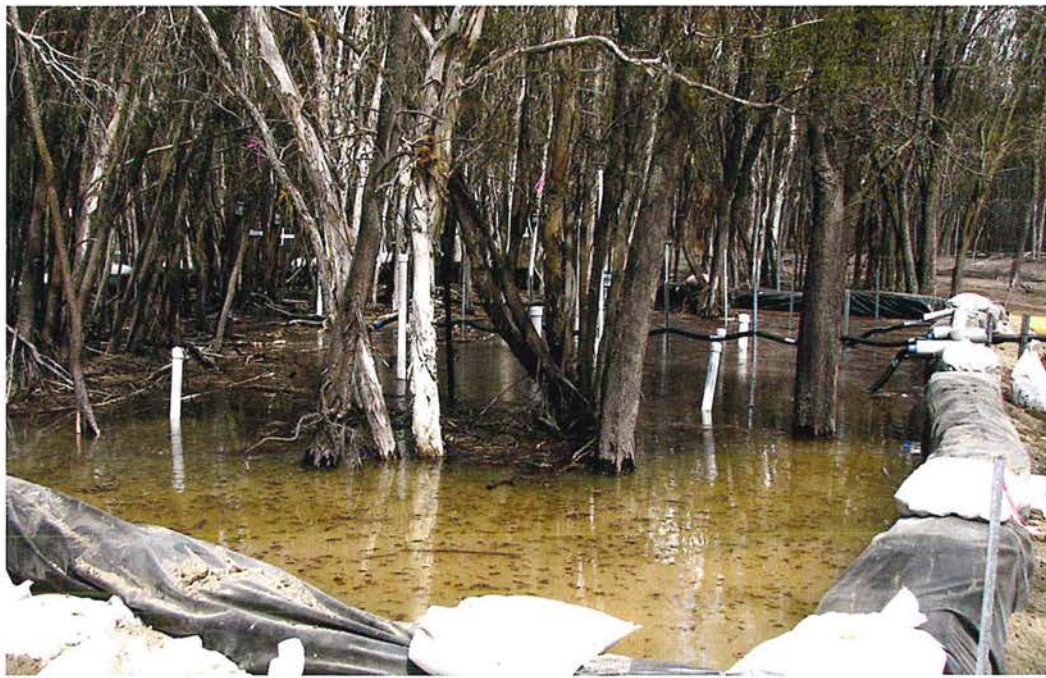
Centre right The bund established for the flooding trial.
Photo – Jennifer Higbid/DEC

A bund was created with sandbags, forming a rectangular plot about 15 metres long by 10 metres wide by 0.5 metres high. The bags were covered with polymer film to limit leakage. The plot contained more than 100 trees, both sheoaks and paperbarks, and a small group of these was fitted with sensors to measure tree girth and sap flow. Sensors were also set up to record changes in the depth and salinity of groundwater and surface water, and moisture and salinity in the soil profile. This design was replicated in a plot adjacent to the bund and a control plot about 50 metres from the bund. The bunded area was

made watertight and fenced to keep kangaroos out of the plot and away from the sensitive equipment. Now to add water.

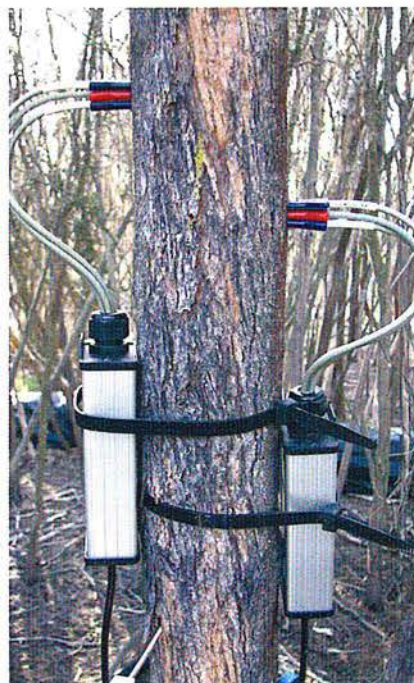
Below right Measuring sap flow.
Photos – Jennifer Higbid/DEC

Tree sap flow rose in both species, but mainly in the sheoaks, within several hours of inundation, as the rate of tree water use increased. Tree girth also increased—the sheoaks responded immediately to the available water while the paperbarks showed a slower, steadier response. Two months after the flooding trial, new growth was observed on the paperbarks and sheoaks within the bunded area. One male sheoak had even begun to produce flowers.
