# EFFECT OF BOAT MOORINGS ON SEAGRASS BEDS IN THE PERTH METROPOLITAN REGION

Environmental Protection Authority  
Perth, Western Australia  
Technical Series. No. 21 December 1987

R J Lukatelich, G Bastyan, D I Walker, A J McComb  
Department of Botany and Centre for Water Research  
University of Western Australia  
Nedlands WA 6009

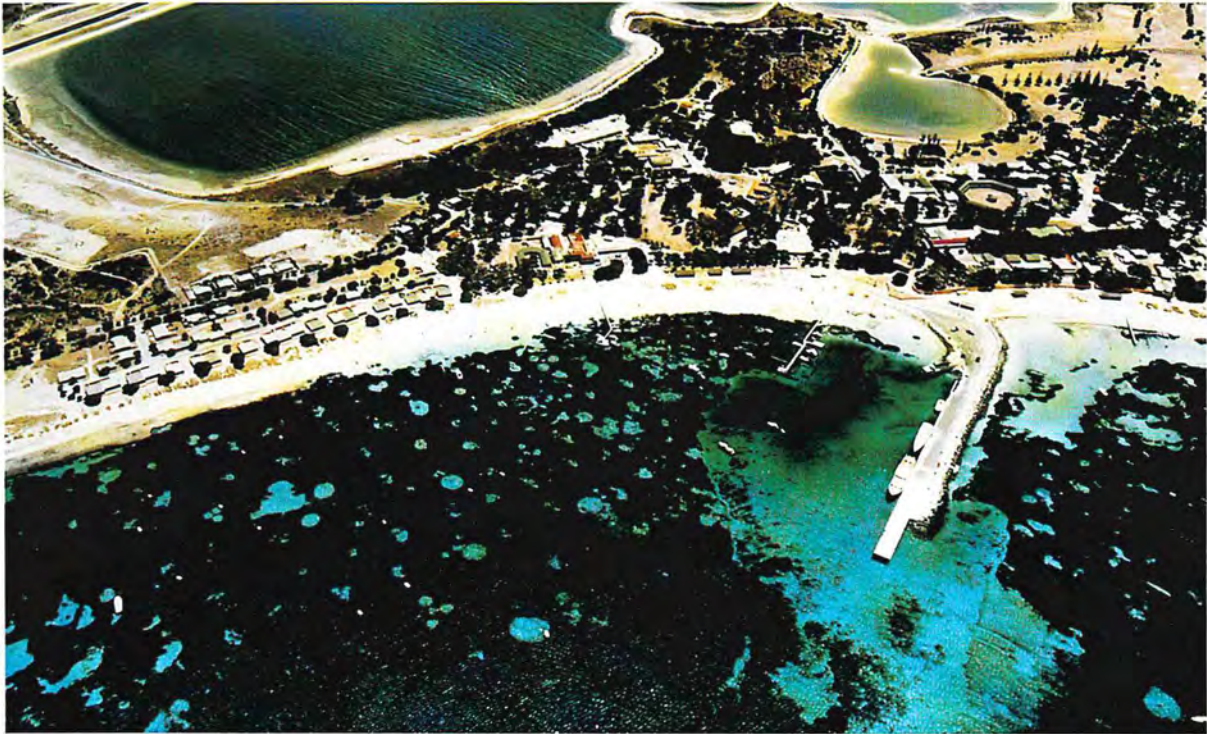
Figure 2. Aerial photograph showing damage to the seagrass meadow in Thomson Bay. Note the large sand patch around the ferry jetty. (Photograph : Lands and Surveys Department)

length of chain used. Most damage has occurred around Rottnest Island, which has large numbers of moorings. Around Rottnest Island (Figure 1a), the area lost due to boat moorings represents only 1.4% of the area of seagrass in the mooring regions. In Thomson Bay, which has the largest number of moorings, about 2.45 hectares of seagrass meadow has been lost as a direct result of boat moorings (Figure 2).

Ferries to Rottnest Island cause considerable sediment resuspension as they manoeuvre to come alongside and leave the landing jetty in Thomson Bay. The sediment plumes are advected by water currents over the seagrass meadows in Thomson Bay, and may take up to 1 hour to settle out, leading to decreased light reaching the seagrass. One obvious effect has been the change in the size of the sand patch adjacent to the jetty (Figure 2), which has increased from 2.8 hectares in 1967 to 8.7 hectares in 1987. The number of ferries and frequency of arrivals and departures has increased, resulting in an almost constant plume of resuspended sediment drifting across the seagrass meadows. If this increase in ferry activity continues it may have a detrimental effect on the seagrasses in Thomson Bay.

If the arrival and departure of the ferries occurred within a few time periods instead of throughout the day the number of sediment resuspension events could be kept to a minimum so the period of light reduction would also be minimized. This would reduce the extent of further damage to the seagrass meadows in Thomson Bay.

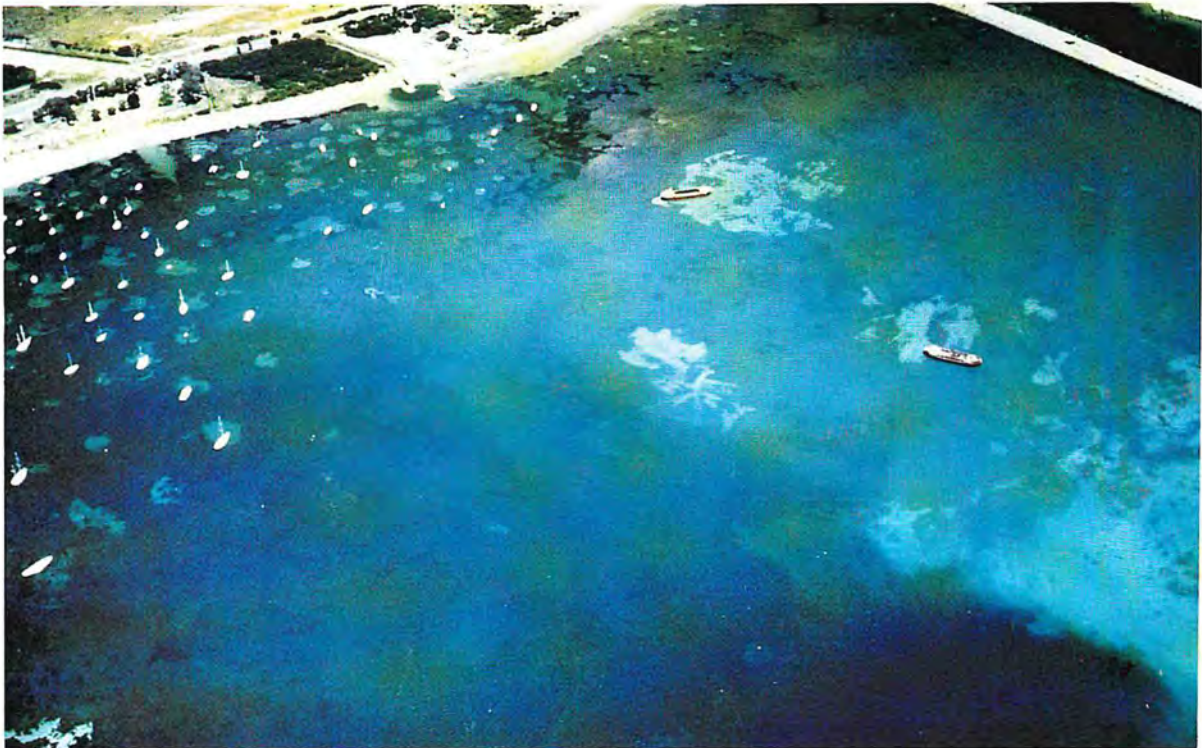
Figure 3. Aerial photograph showing damage to the seagrass meadow in Mangles Bay. Note the large scoured areas caused by the barges. (Photograph : S. Chape, State Planning Commission)

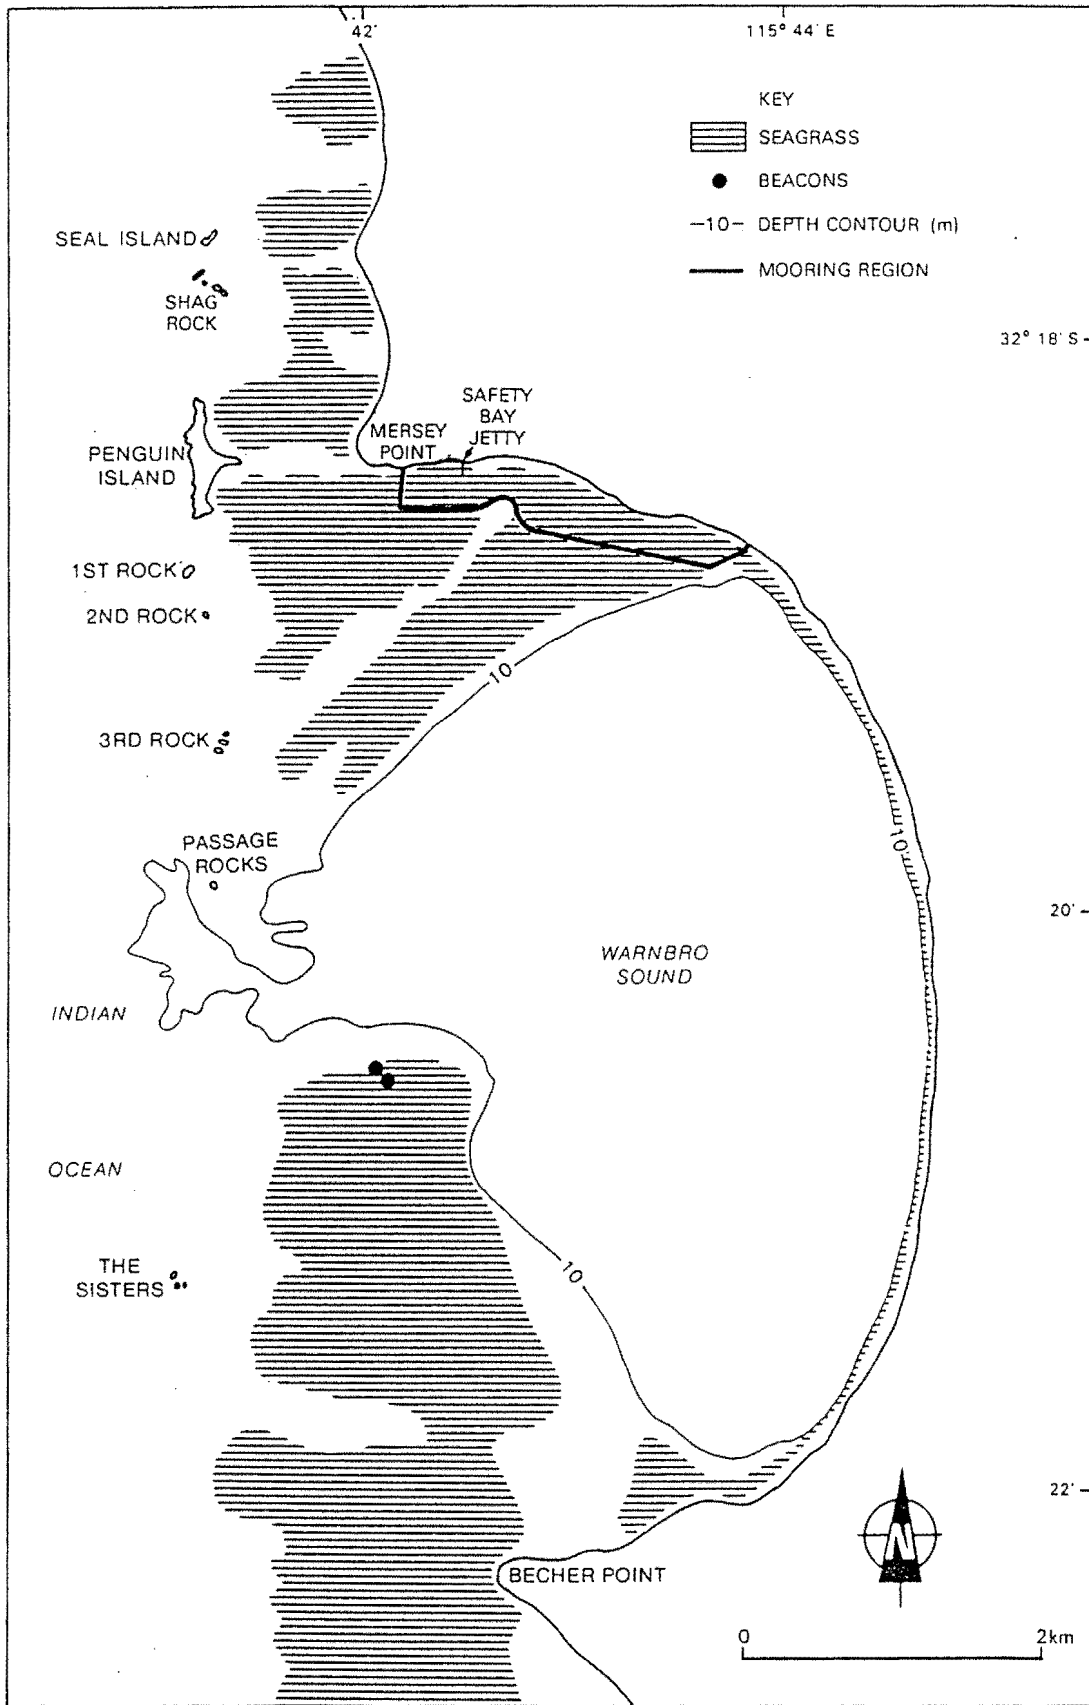
Figure 1e. Seagrass distribution from Shoalwater Bay to Becher Point (reproduced courtesy of Delta Holdings Pty. Ltd.) Location of the mooring region in Warnbro Sound is shown.

In Warnbro Sound most boat moorings are located between the Safety Bay jetty and the last boat ramp to the east of Safety Bay Road (Figure 1e). The moorings are generally placed between the shore and the 2.0 m AHD contour, an area of extensive *Posidonia* meadow. The area of seagrass within which the moorings are situated is about 21 hectares, of which some 0.45 hectares (2.1%) has been lost as a result of boat moorings currently in place. There were also numerous sand patches (blowouts) in this region that may have been scoured by moorings which have been removed, and if this is so the area of seagrass lost in this region due to moorings may be of the order of 2.7 hectares. As a proportion of the total area of seagrass in Warnbro Sound (940 hectares) the damage caused by the boat moorings is insignificant (0.05%). However, because the moorings are all located within one small region, the visual impact of the damage is striking.
