# It's safe to look down, now

**IMPROVEMENTS** in public safety at viewing lookouts in Karijini National Park (formerly Hamersley Range National Park) have been made with the installation of handrails and platforms at various locations within the park.

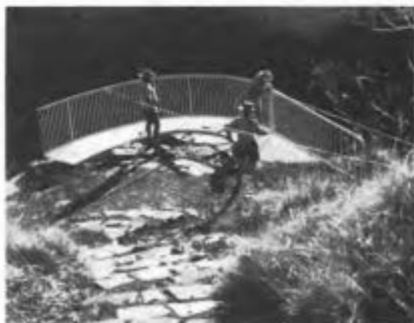
*Sections of the safety railing being fitted on-site at Joffre Gorge in the Karijini National Park.*

Platforms at the three other locations had been fabricated in bolt-together sections, and were a lot simpler to manhandle into position, before bolting down.

Anchors were used to hold down the structures and to offset damage to the cliff edges, caused by the thermal expansion of the structures, due to the wide-ranging temperatures of the Pilbara.
