Just add **water:**

the Toolibin Lake inundation experiment

by Jennifer Higid and Paul Drake

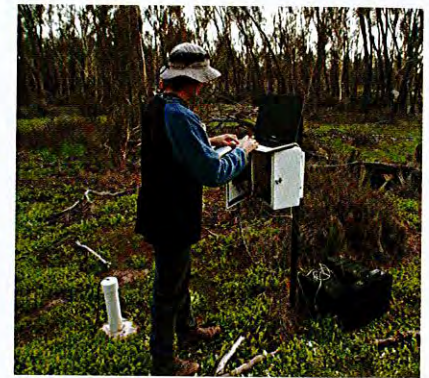
Above Maintaining equipment at Toolibin Lake.

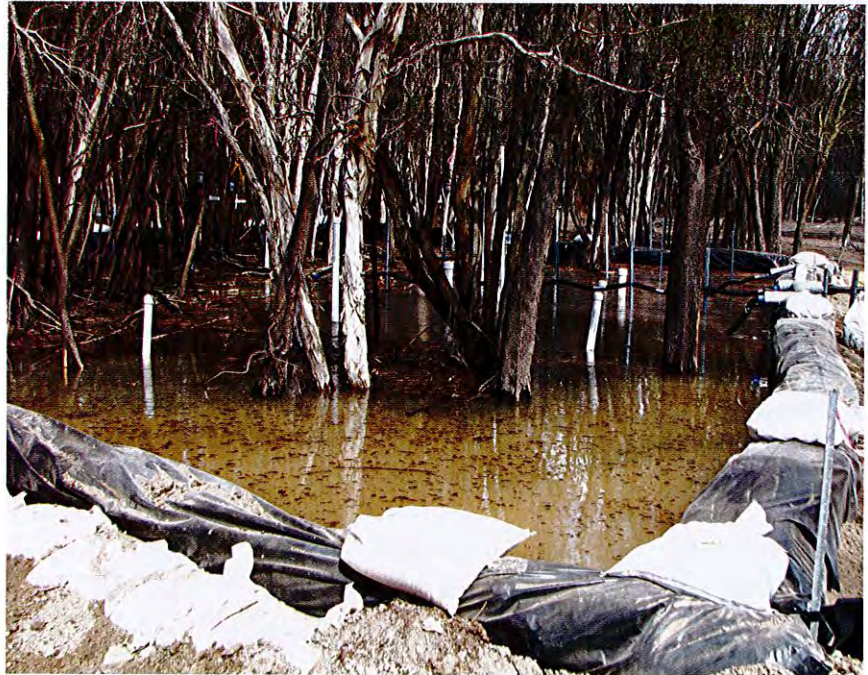
Right Toolibin Lake pumping station.
Photo - Marie Lochman

Under the guidance of the recovery plan, a variety of works, including revegetation and engineering interventions, have been implemented. The engineering works were designed to reduce the salinity of surface inflows and lower the saline groundwater beneath the lake. Works began in 1995 with the construction of a levee to divert saline surface water away from the lake, and in 1997 the first system of pumps was installed on the lake bed to lower the watertable (see 'Triple test: recovering natural biodiversity at Toolibin Lake and Lake Bryde', *LANDSCOPE*, Winter 2010).

More recently, infrastructure that controls the outflow of water has been upgraded with a sump and shallow channels constructed on the lake bed to enable surface water to drain before it becomes too saline from evaporation. Importantly, better outflow control also means that surface water can now be removed from the lake before it connects directly with
