*Saving a Wheatbelt
wetland refuge*

Unseasonal heavy rainfall earlier this year brought much life to Toolibin Lake, filling it for the first time in more than 20 years. But it also brought some unexpected challenges in managing this fragile Ramsar-listed wetland.

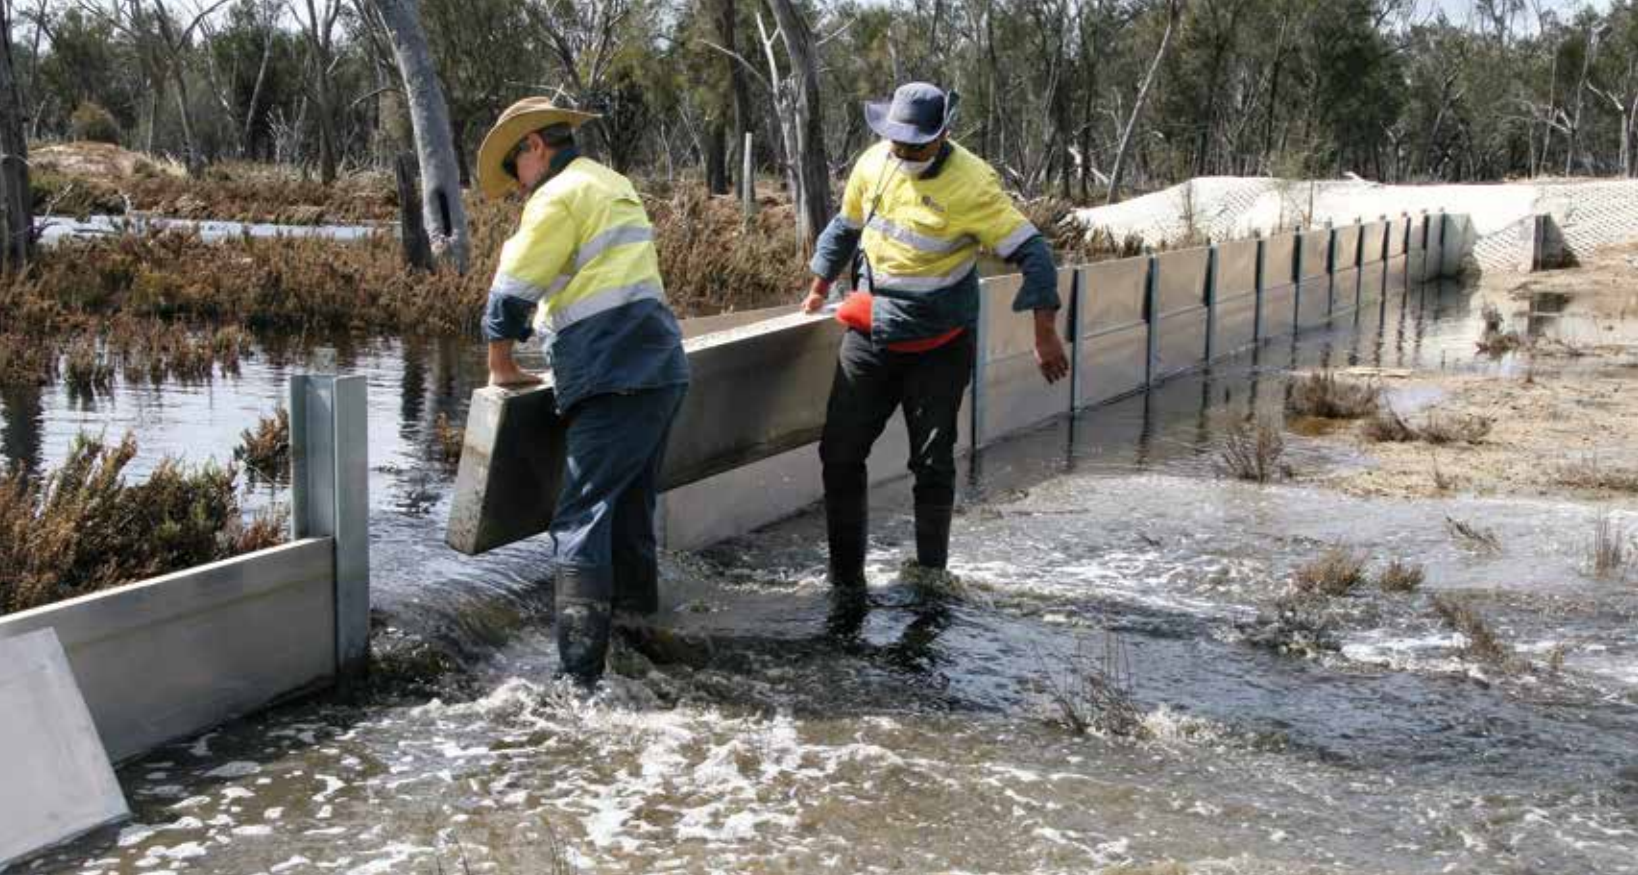
“A series of removable metal gates installed at the northern end of the channel are closed to direct freshwater into Toolibin Lake, and opened to divert water away when salinity levels become unacceptable.”

Left Diversion gates can be opened and shut depending on the saline levels of the water.

One of the key infrastructural components in the fight against altered hydrology at Toolibin Lake is a seven-kilometre-long, 20-metre-wide diversion channel constructed in 1995 around the western edge of the lake. This channel was designed to redirect saline water flows from upstream away from the lake itself, and into the sacrificial Taarblin Lake, which had already collapsed. A series of removable metal gates installed at the northern end of the channel are closed to

direct freshwater into Toolibin Lake, and opened to divert water away when salinity levels become unacceptable. The rain event of February 2017 was the first time the channel had been tested against such a large event.

When the rain fell, Parks and Wildlife Service staff saw a golden opportunity to allow freshwater into Toolibin. The water quality was tested upstream and staff determined it was fresh enough to be let into the lake. They then closed the metal gate panels, thereby closing off the diversion channel and allowing the nourishing freshwater to flow directly into Toolibin Lake. Staff tested the water quality periodically and opened the gates when the fresh flows ceased.

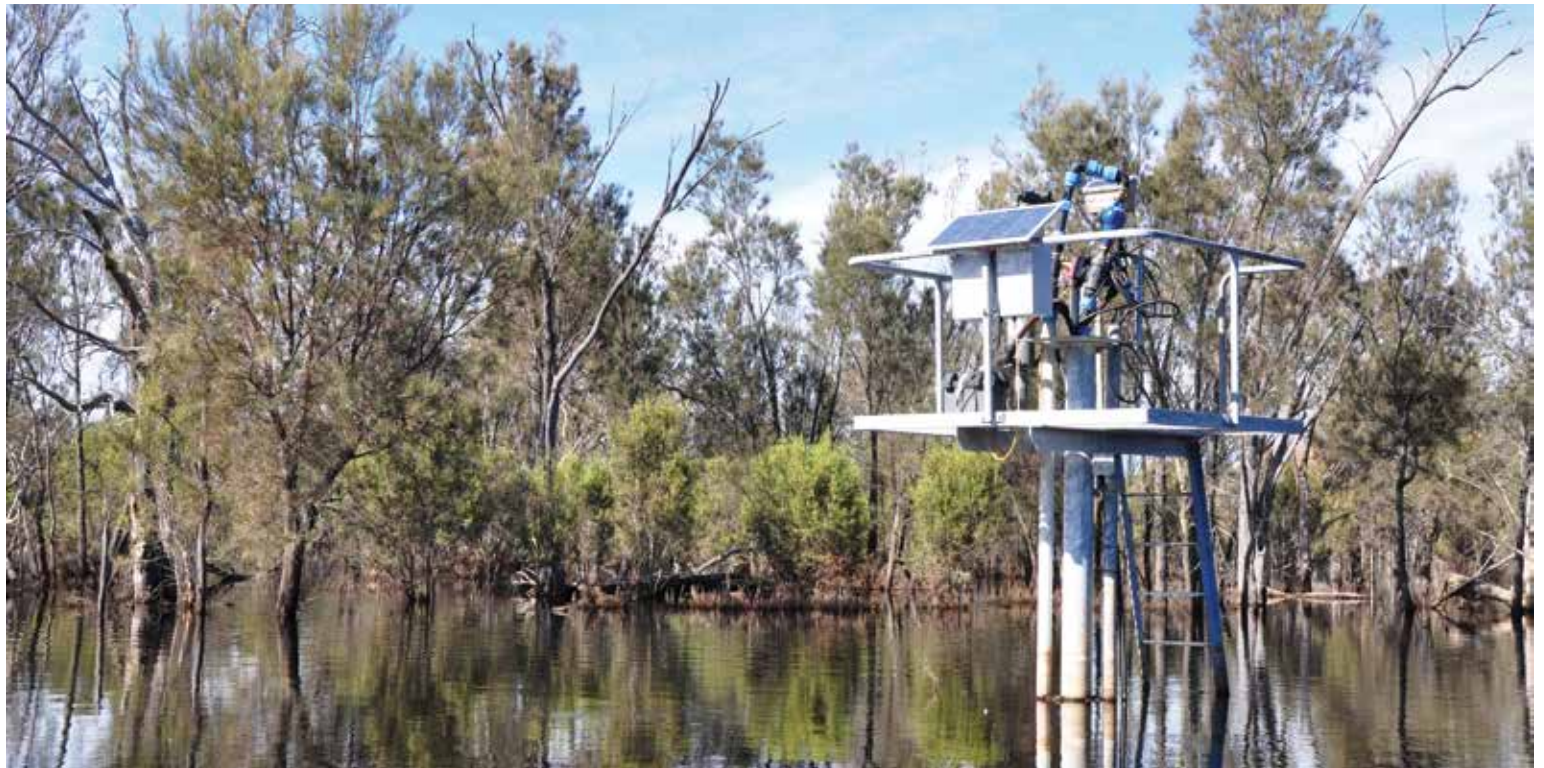
Above Pumps are used to remove saline water away from Toolibin.

One method being used to combat rising groundwater is the use of pumping stations. A system of groundwater pumps, some powered by wind and the others electrically, are installed across the lake to pump saline water away from Toolibin into Taarblin Lake.

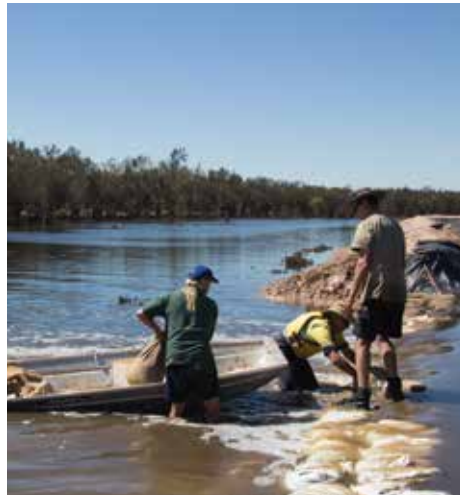
Right All staff from the department’s Narrogin and Merredin offices helped secure a breach of the diversion channel by hand.

news, it also presented some interesting challenges to overcome. A week after the fill, staff discovered a breach in the bund wall of the diversion channel. Without a fast fix, hydrologists predicted the ecological benefit of the fill would be lost as the water drained out. With extreme waterlogging in the reserve and surrounding properties, using heavy machinery to plug the breach was not possible. So within 24 hours, all staff from the department’s Narrogin and Merredin offices arrived on the scene to plug the breach by hand. A slow and arduous day of work ensued, with staff

loading about 1,800 sandbags with 50 tonnes of sand, transporting the bags via boat to the bund wall, then stacking them in place to plug the breach. By day's end, they had constructed a substantial sandbag wall and succeeded in retaining the fresh water in Toolibin Lake.
