Department of Conservation and Environment
Perth, Western Australia
Technical Series 7 March 1986

WITTENOOM AIRBORNE ASBESTOS STUDY

Pollution Control Division

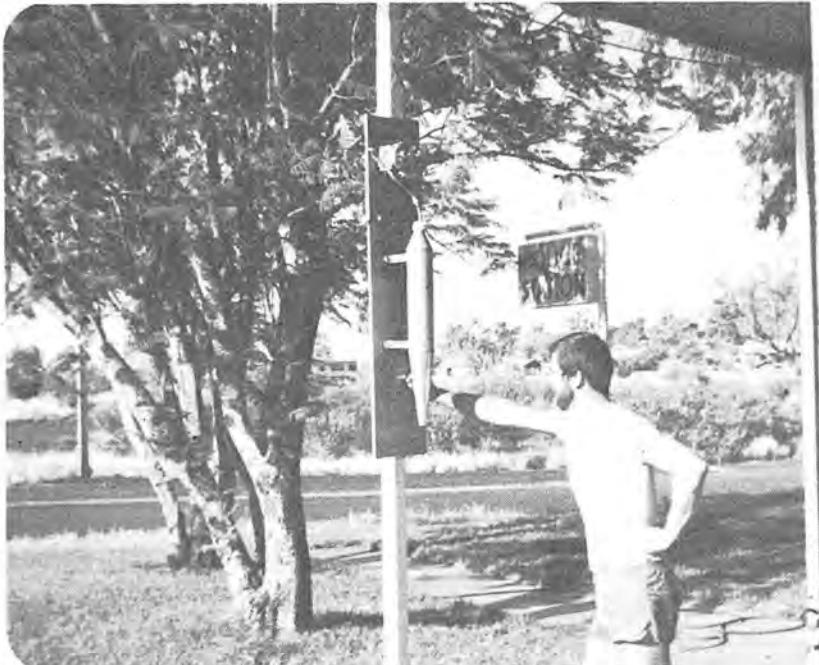
Photograph 1. Police Station Monitor

Sampling equipment identical to what used over five years by the State Health Department at the Wittenoom School, and by the Geraldton Building Company in the April Study was utilised at all sites. Samplers used in remote areas, ie Gorge, 43 km site and 9 km site were powered by two 12V lead acid batteries which were recharged daily by the sampling officer. The sampling officer also changed the filter cassettes daily and determined the air flow rates through the elutriator before and after each 24 hour sampling period. Clean filter cassettes were prepared in the Pollution Control laboratory in order to avoid risk of contamination (Photographs 1, 2, 3 and 4).

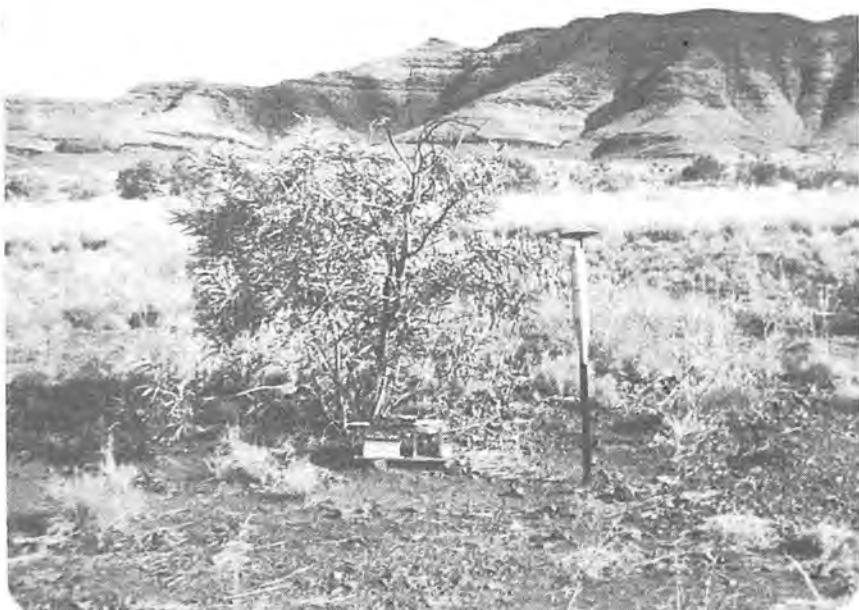
Photograph 2. 9 km Site Monitor

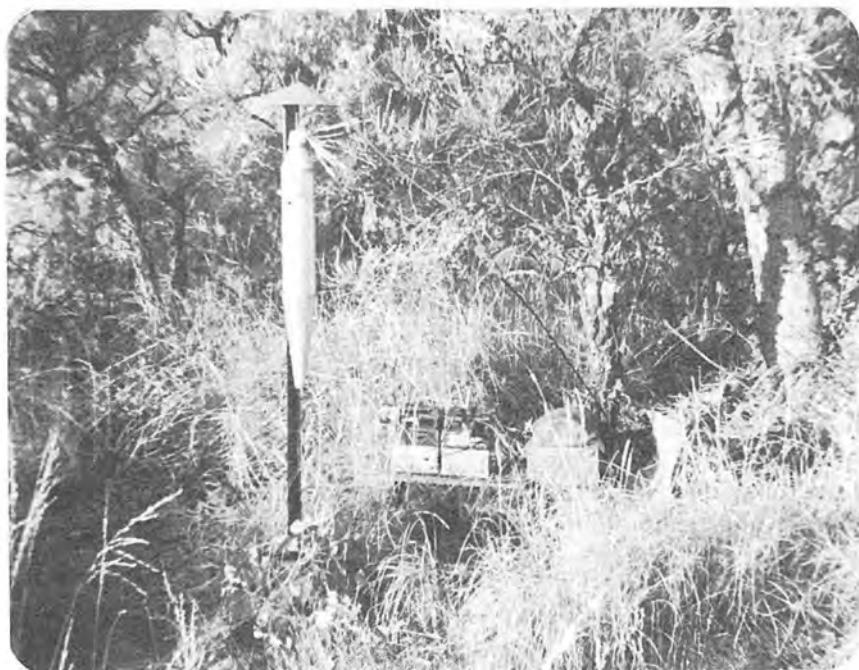
Photograph 4. Gorge Monitor
