"THE ASHFIELD FLATS-A STUDY OF PRESENT & POTENTIAL LAND USE"

**BY ANDREW BLAIR B.Sc. &
DAVID BLATCHFORD B.A. (Hons.)**

AUGUST 1978

BULLETIN No. 45

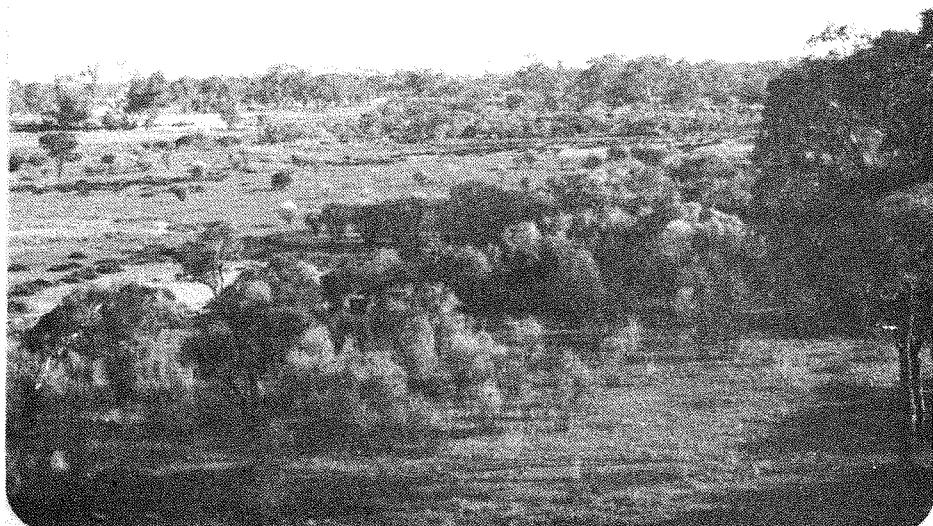
The alluvial soils of the flood plain are predominantly clays and loams. Because of their depositional nature, variations in elevation are minor and gradual (see Plates 2, 3, 4 and 5).

Plate 3 Flooded *Melaleuca* woodland (area B) looking S.W.

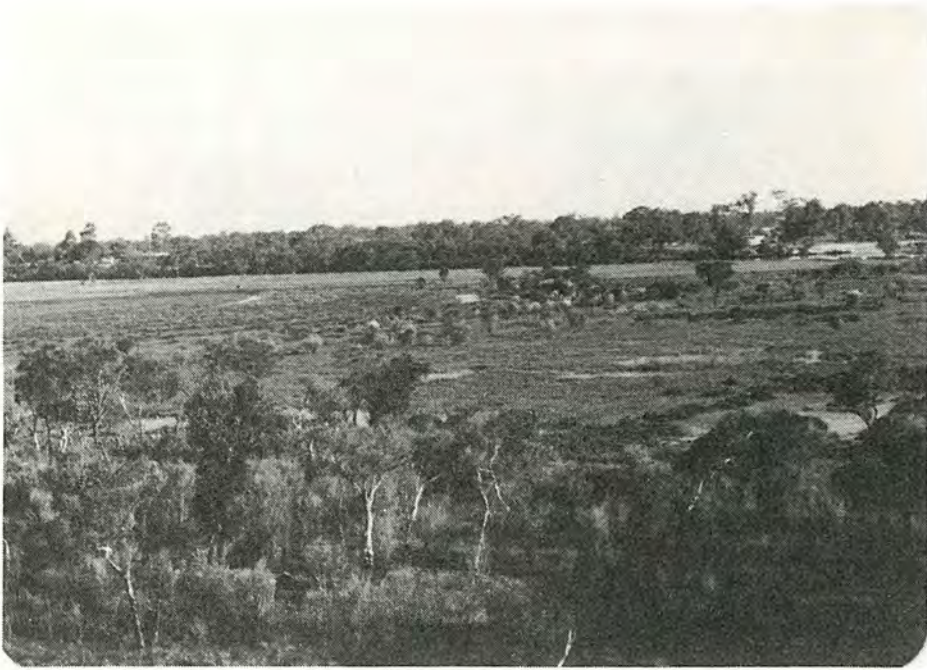
Plate 4 Flooded *Melaleuca* woodland and *Salicornia* spp looking south.

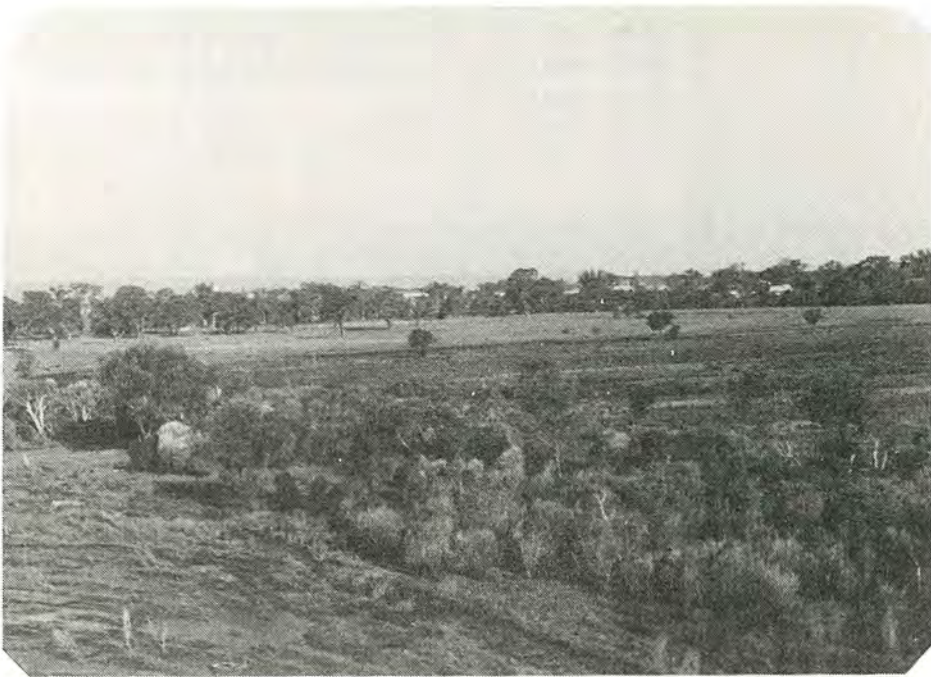
Plate 5 Flooded *Melaleuca* woodland and *Salicornia* spp flats, looking S.E.

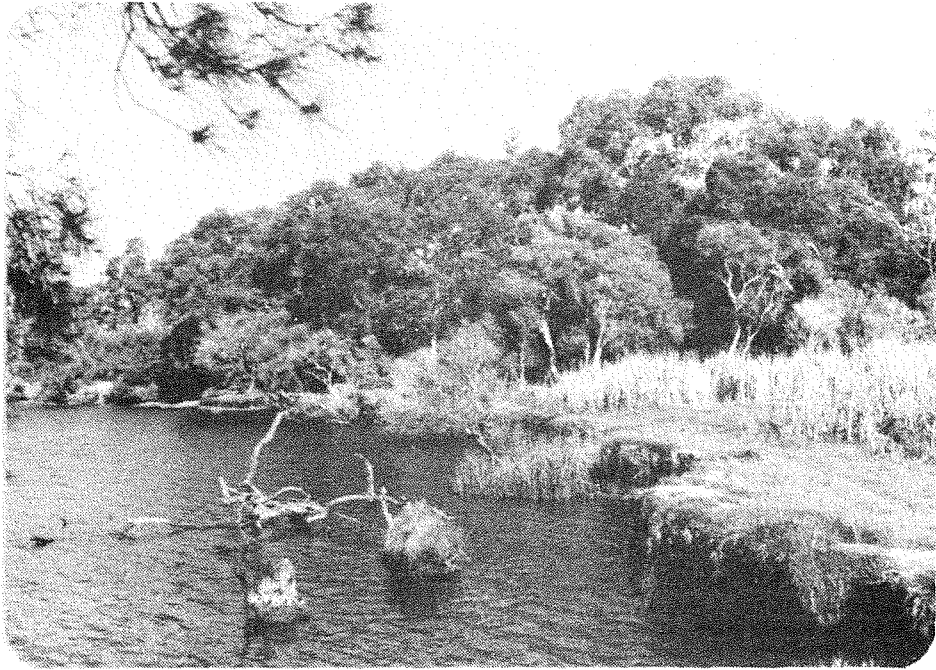
The western region of the Ashfield Flats foreshore is more vulnerable to the natural erosional forces of the Swan River because it is situated on the outside of a meander. Plate 6 indicates the extent of erosion in this area. Conversely, the eastern section is situated on the inside of a meander and thus represents a depositional zone. However bank erosion is also caused throughout the area by wash from boats.

Plate 6 Riverbank on S.W. foreshore showing *Casuarina obesa* in foreground, *Typha orientalis* in the middle, with *Eucalyptus rudis* at the rear. The absence of littoral vegetation and the resulting bank erosion is also apparent.

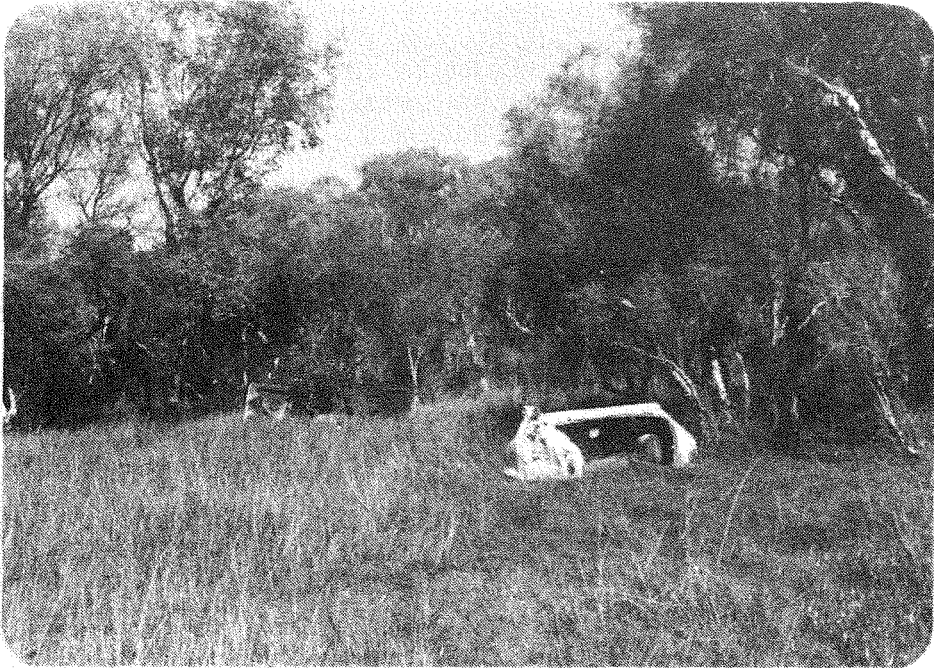
In the centre of the thicket there is a small open pool. Plate 7 shows the northern edge of this paperbark stand.

Plate 7 *Melaleuca raphiophylla* at northern edge of study area. (Woodland area C).

The wide-spread occurrence of car bodies and a variety of litter, are all evidence of man's influence on the area (see Plates 7 and 11).

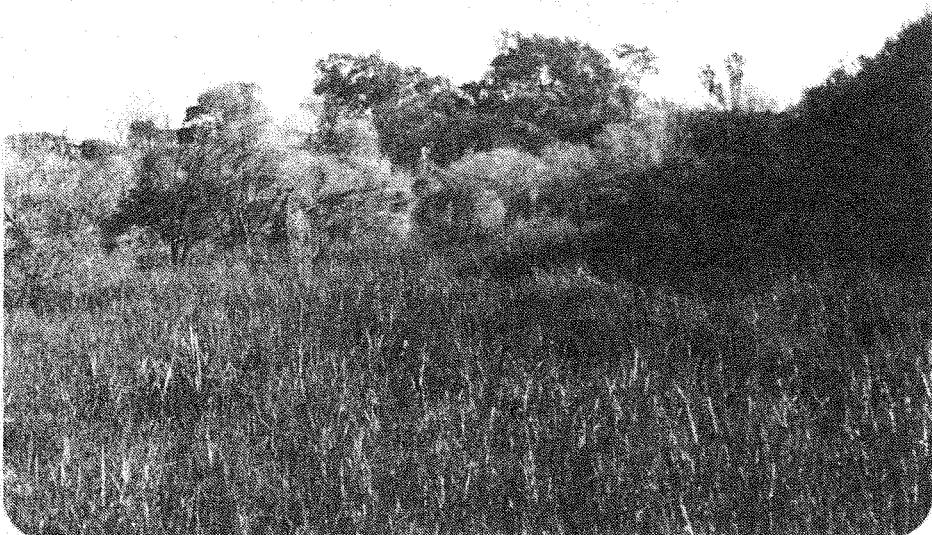
Plate 8 Central portions of Area D woodland.

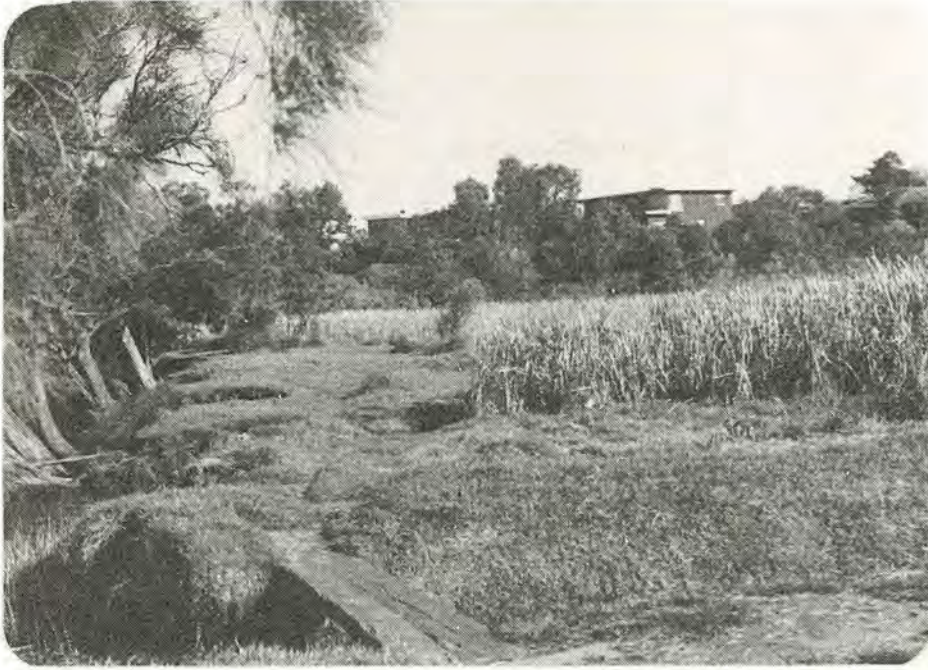
The establishment and growth of *Typha* is associated with disturbance, by man, of the natural wetland environment. *Typha* completely dominates a triangular area in the S.W. of the flat where it is present as a large dense stand. Most of these plants are dead, due to the short life span of the species and harsh summer conditions. Vegetative rejuvenation is slowly occurring, however, with small green shoots appearing amongst the old dead stalks. This large area of *Typha* is shown in Plates 9 and 10.

Plate 9 *Casuarina obesa* on river margin and extensive stand of *Typha orientalis*. The retreat of the river bank through erosion is evident.

In those areas where erosion has occurred, the river bank has vertical, vegetation-free sides. With continued wave action, the exposed bank is likely to subside gradually into the river. The riverbank flora, and/or effects of erosion can be seen in Plates 9, 14, 15, 16 and 17.

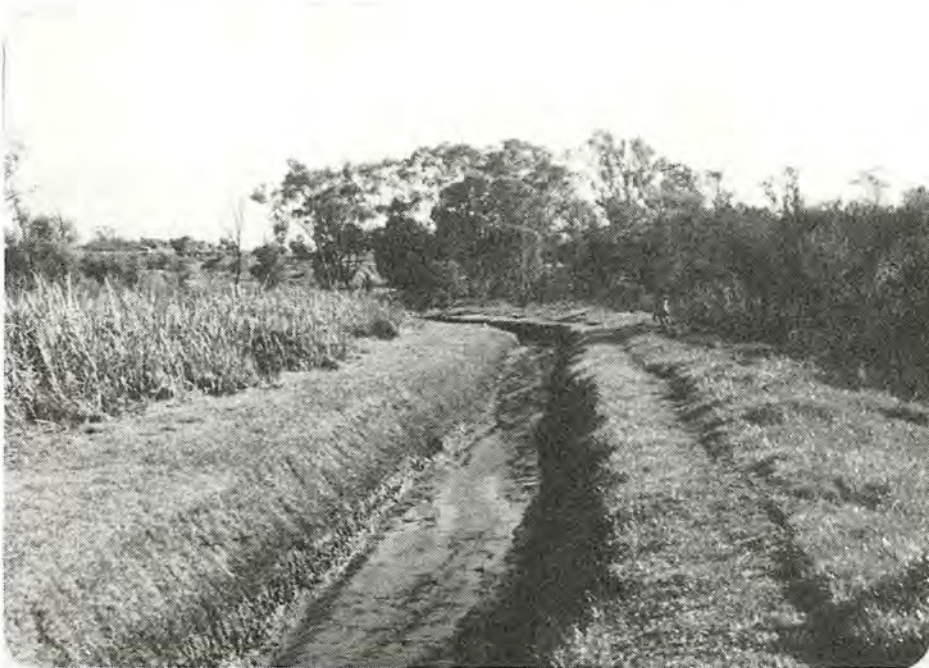
Plate 10 Couch grass and *Typha orientalis* fringing S.W. drain.

Two drains approximately 2.5 metres wide and normally 1.5 metres deep, traverse the area. (Plates 10, 12).

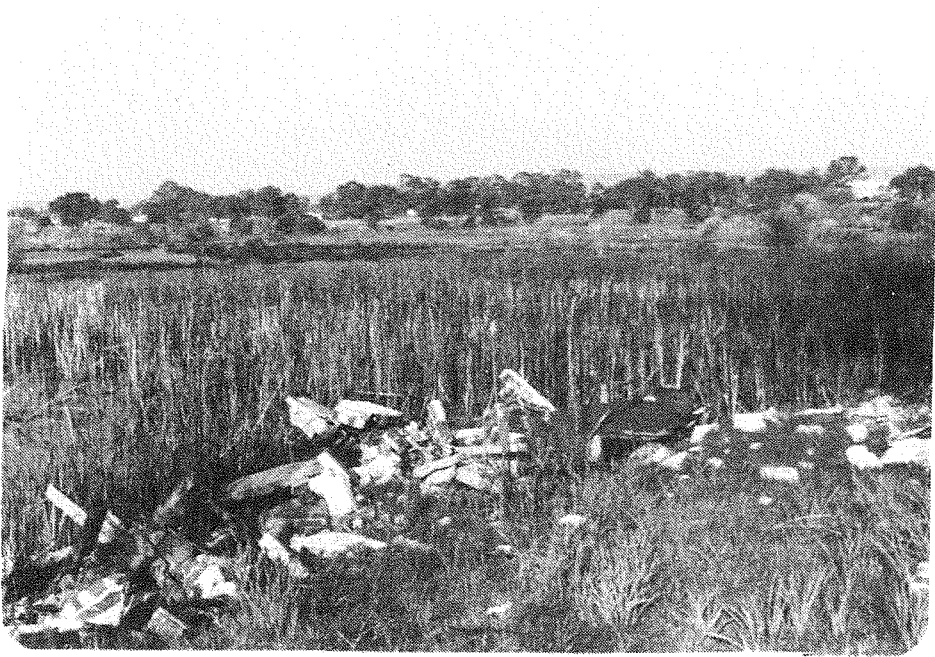
As has been mentioned earlier, *Typha* has infiltrated parts of the western fringing woodland (area B). This is due mainly to the disturbance of this area. An example of human disturbance leading to the establishment of *Typha* is shown in Plate 11.

Plate 11 Rubbish dump site with *Typha orientalis* behind.

Recommendation 5: Remove the refuse, car bodies, sheet iron, water tanks and other litter from within the proposed reserve boundaries, with minimal disturbance to adjacent areas.

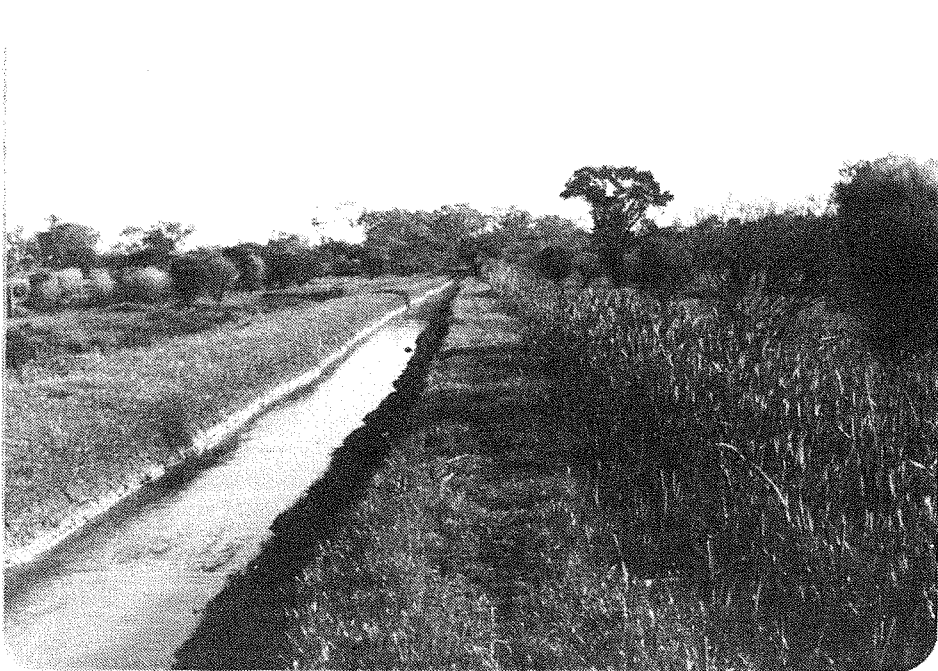
The growth of *Typha* is also associated with the drains crossing the area, which provide disturbed, higher banks on which the Bulrushes may be maintained. This is illustrated in Plate 11 and 12.

Plate 12 Eastern drain with *Typha orientalis* occupying the disturbed areas.

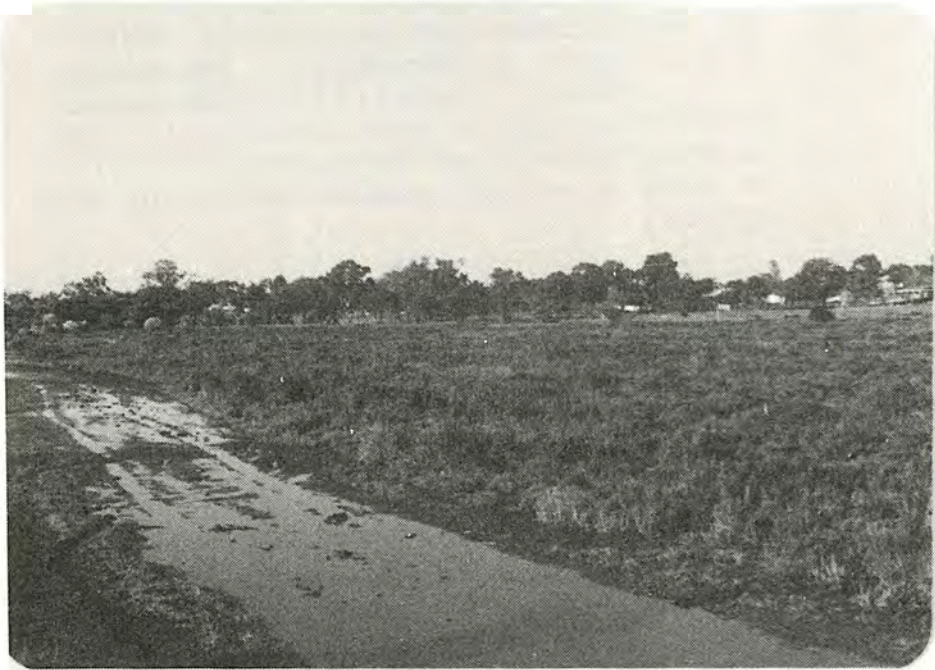
Samphire Heath (*Salicornia* spp) of which two species are present, extends over low-lying saline soils east of the main drain. It is an area which has been much degraded by vehicle access. Constant traffic has created well-worn, compacted tracks, upon which no vegetation will currently grow. When the area is flooded these tracks appear as open expanses of relatively deep water. An overview of the *Salicornia* flats can be seen in the background of Plates 4 and 5, while a clearer view can be seen in Plate 13.

Plate 13 *Salicornia* spp flats.

Note : Expanses of open water lying
in vehicle track depressions
(foreground and midground).

The central area of the *Salicornia* flats, east of the drain, is heavily scarred with tracks caused by vehicular traffic. Such disturbance has damaged the vegetation. Furthermore, because the vehicles have the effect of compacting the soil, regeneration of the vegetation is inhibited. The tracks create large pools that contain water for considerably longer than is normal on the flats area. Due to the permanence of the water, such pools may become mosquito breeding habitats - particularly during the spring and summer period.

Recommendation 6: Attempt to revegetate the *Salicornia* spp flats within the proposed reserve extensions.¹

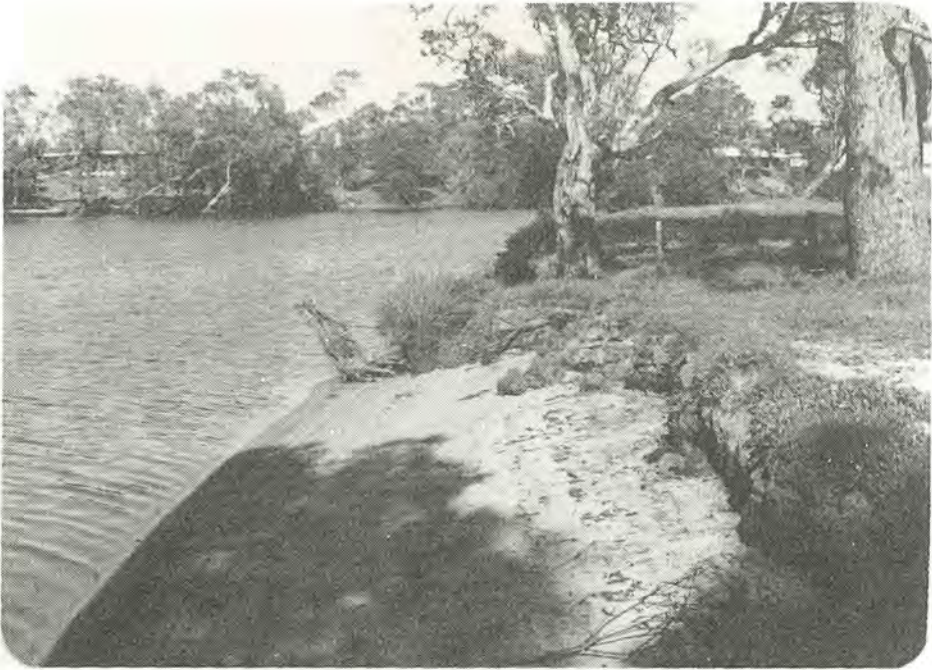
Plate 14 Riverbank erosion at Sandy Beach Reserve.

Recommendation 7: Employ methods that will enable the natural sedge communities normally occupying the shallow fringes of the river, to re-establish.²

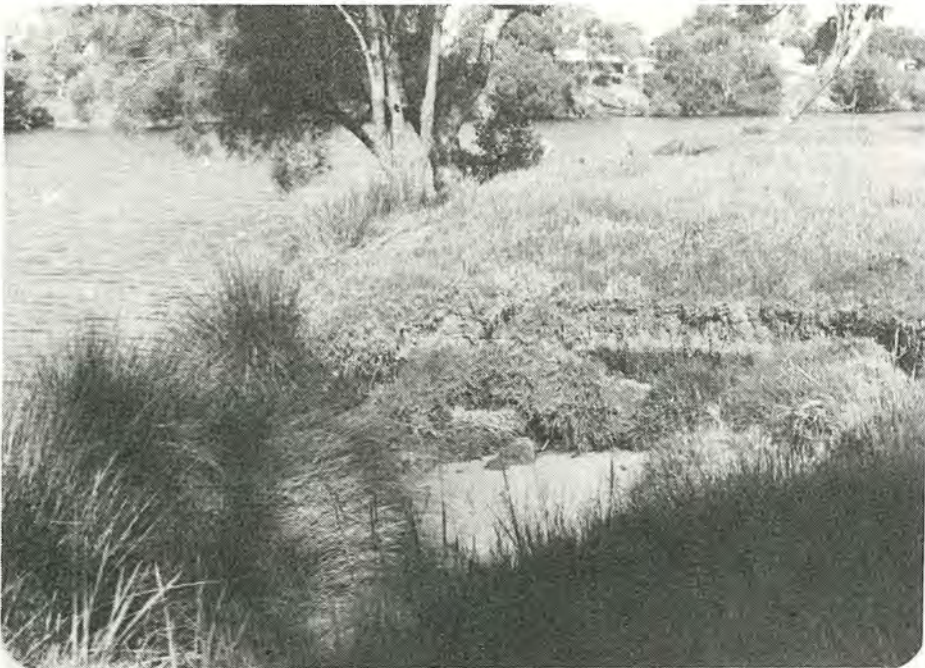
Plate 15 Destruction of riverbank vegetation together with littoral zone, leading to severe bank erosion.

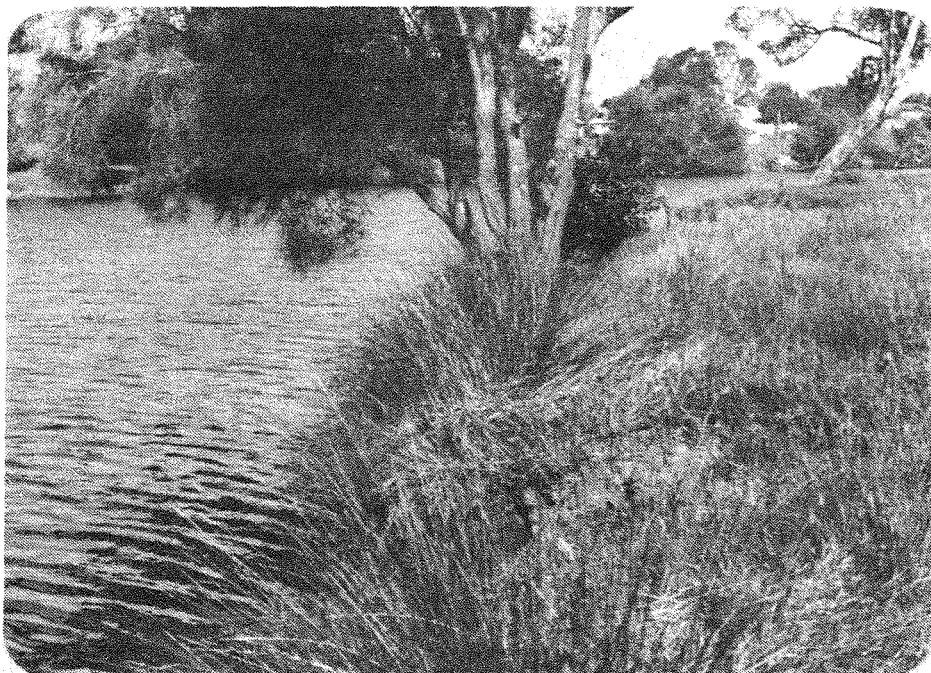
Plate 17 *Juncus maritimus* forming one of the few stands in the study area that remain in

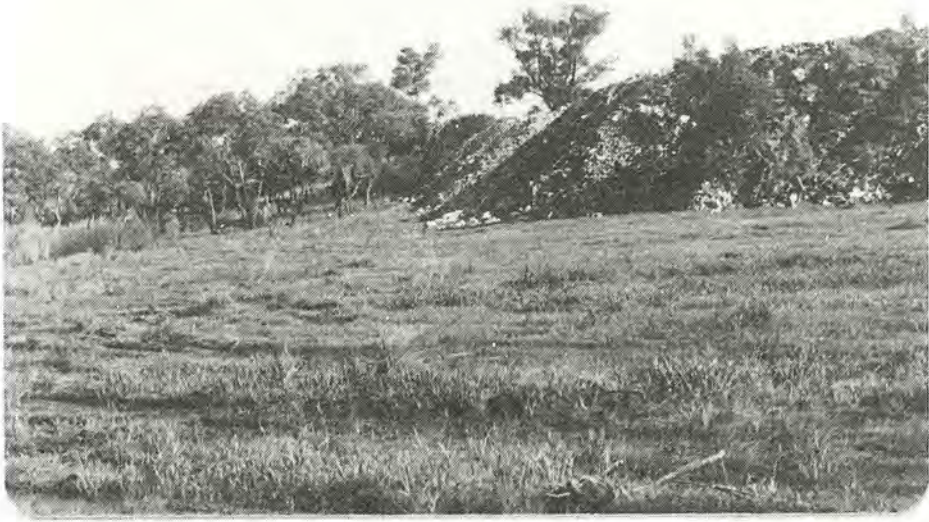
Plate 18 "Clean" fill on the northern edge of the study area.
