AN ENVIRONMENTAL REVIEW  
OF THE  
1979 AVON DESCENT

C. J. MURRAY

BULLETIN N<sup>o</sup> 70

September, 1979.

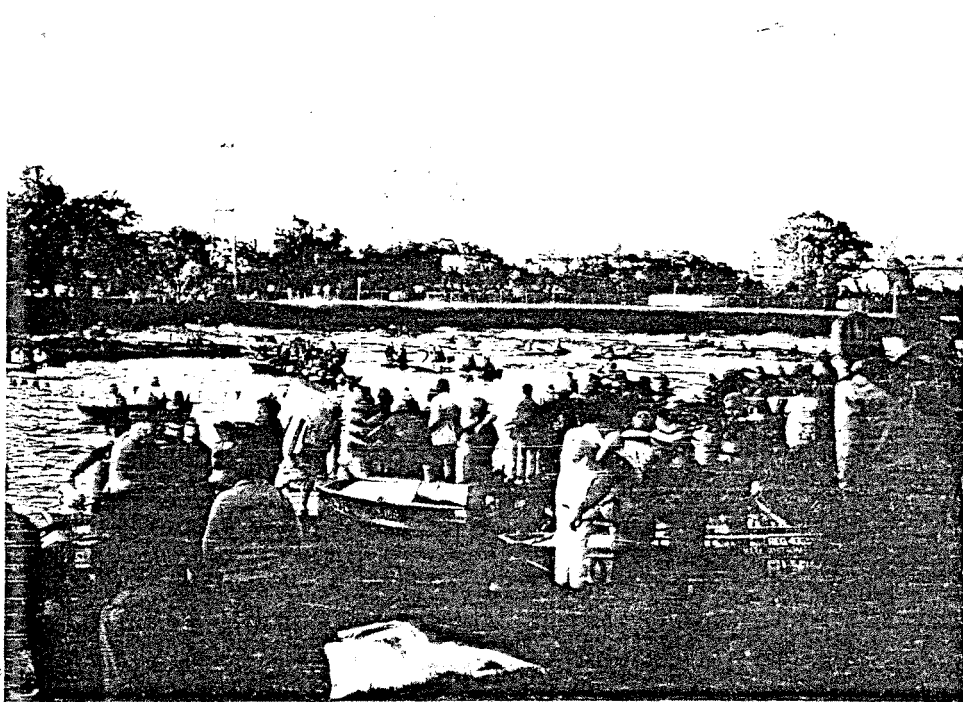
FIG 1

The Avon Descent has been conducted as a two day event since its inception in 1973, with competitions commencing at Northam and finishing at Perth, a distance of some 145 km. (Fig. 1.)

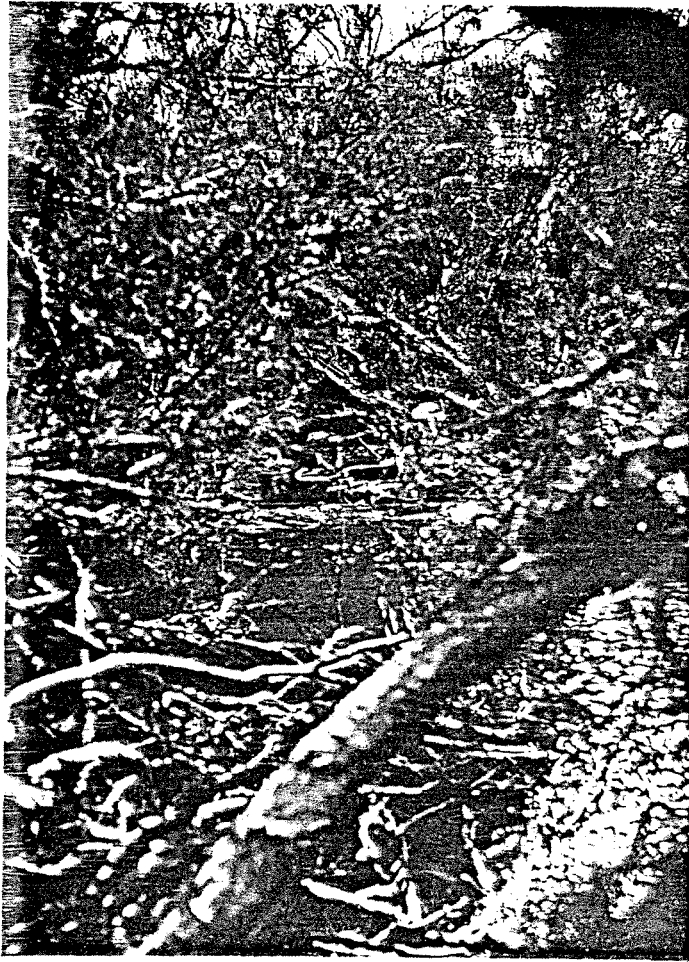
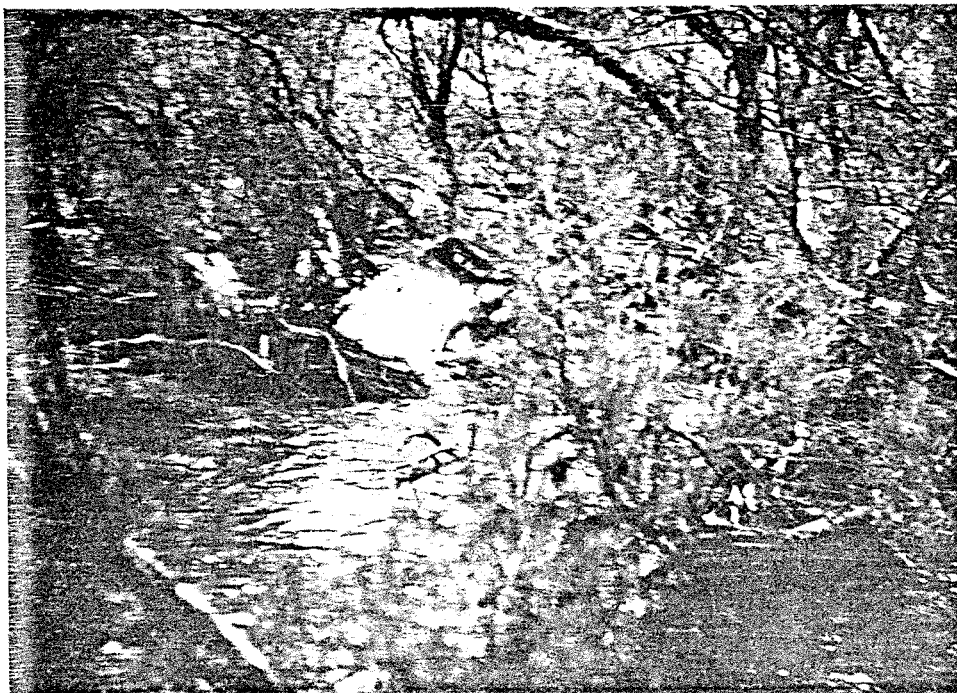
Fig. 11 \* 12 : Negotiating the thickets. The river channels were well defined, but the melaleucas still presented hazards for unwary competitors.

The low water level meant that the channels through the thickets were well defined, and the craft were able to navigate along them at very low speed (Fig. 10 and 11.) From observations made within the thickets, it is possible to say that while minimal damage to the vegetation resulted from this year's event, there is a definite potential for problems to occur in years of higher water levels. Several power boats were observed trying to force a passage through the vegetation, even though they were in defined water channels. In years when the water is 1 m higher than this year, the channels would not be defined in these thicket areas and there would be a very strong likelihood that power boats could attempt to force a passage through and hence have an impact on the vegetation. While the actual damage that they may cause has not been observed, there are grounds for concern. Canoes on the other hand, in part because of their size and construction and in part because of their mode of power, are unlikely to impact the melaleuca trees in any water level.

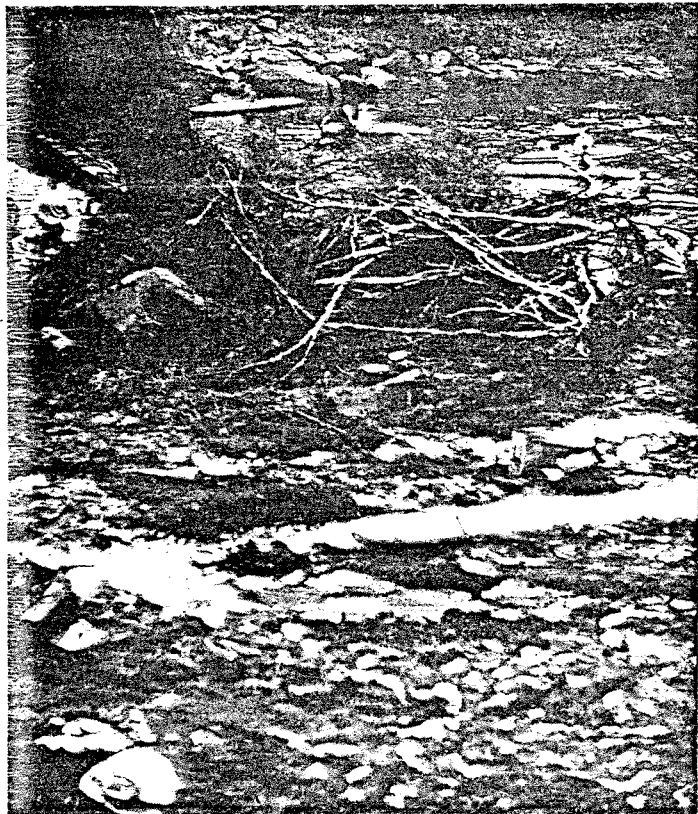
There was considerable pressure on this clearing as the competitors finished the first stage, and again when the second leg commenced. Some rain fell on Saturday night and while it did not cause too many problems at the quarry, this area on the river foreshore rapidly became very muddy and slippery (Fig. 16). A follow-up visit one week later showed that erosion had begun on the slopes, particularly in the bulldozer tracks which ran towards the river.

Fig. 16 : Following overnight rain, the clearing on Sunday morning was slippery and deep wheel ruts from the bulldozer collected water. Rubbish is evident in the foreground.

- d. Probably the most evident environmental impact of this year's race was the clearing of the foreshore vegetation at the quarry. No care had been taken in the conduct of this operation. This has resulted in further degradation of the area through erosion. As the land is part of the Avon Valley National Park, the question of rehabilitation, etc. rests with the National Parks Authority.

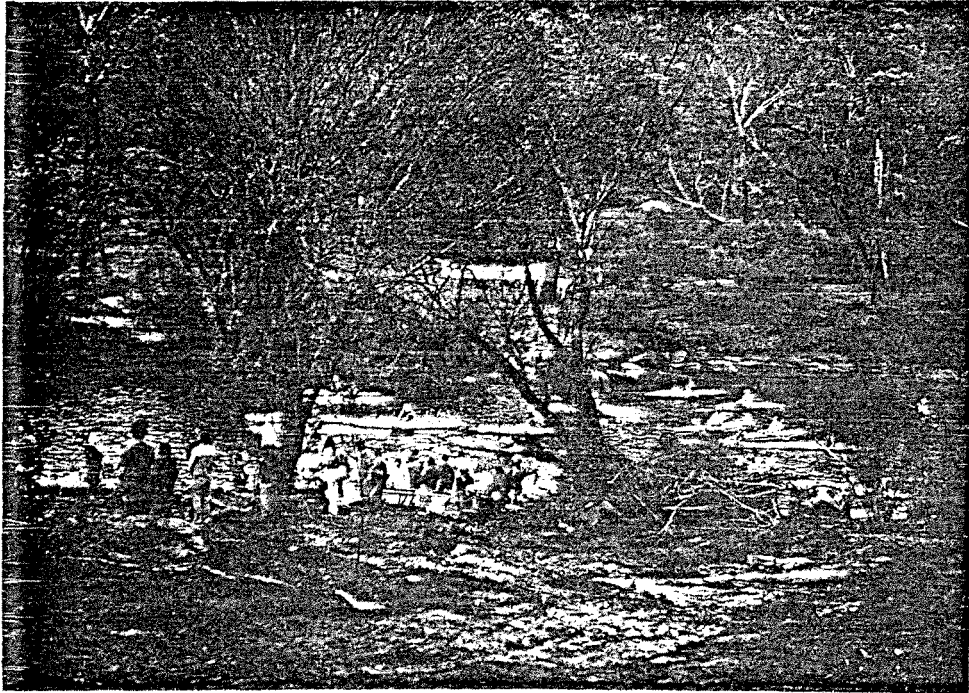
Fig. 17 : An early start on Sunday morning for the competitors, with spectators crowding the river bank.

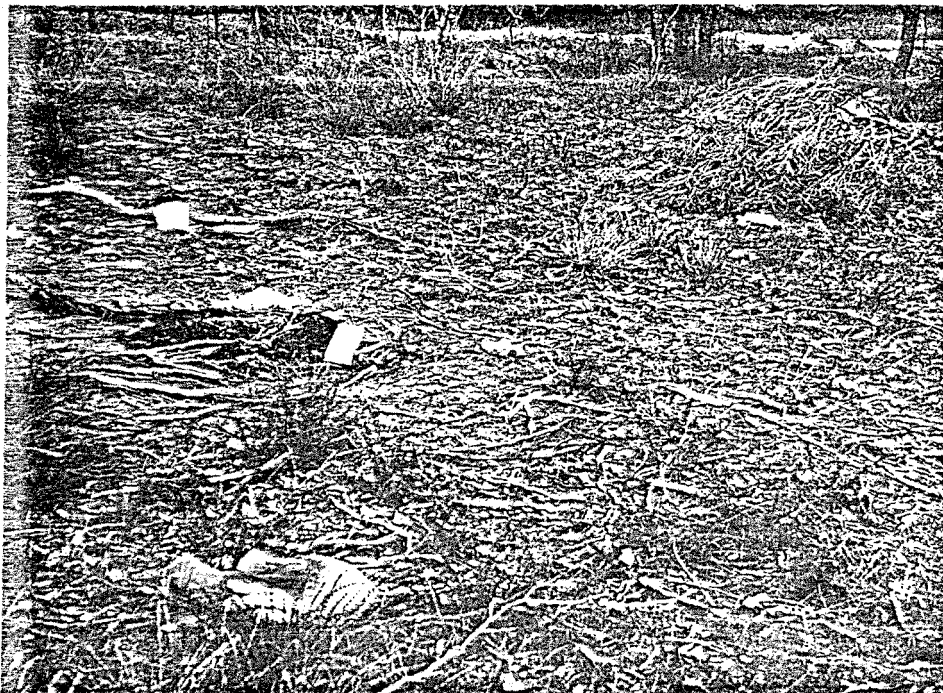
Fig. 24 : Aftermath. Rubbish lies in the bush at the quarry some 10 days after the race.

- f. No rubbish bins were provided in the camping area. This should have been one of the first aspects organised, as a lack of receptacles provides no encouragement for people to dispose of their rubbish properly. Also, while the organisers gave assurances that the rubbish would be collected after the event by the Town of Northam, this had not been carried out by Monday 30 July. In fact, the National Parks Authority cleaned up much of the quarry on that day. For hygiene reasons, arrangements should have been made to remove the rubbish on the Sunday, after the quarry had been vacated. Considerable amounts of litter and rubbish were observed in the adjacent bush two weeks after the event (Fig. 24).
