MORILLA SWAMP HYDROLOGICAL INVESTIGATION

RESOURCE MANAGEMENT
TECHNICAL REPORT **163**

**R J Speed, E B Lefroy and J A Simons
Agriculture Western Australia**

**ISSN 1039-7205
February 1997**

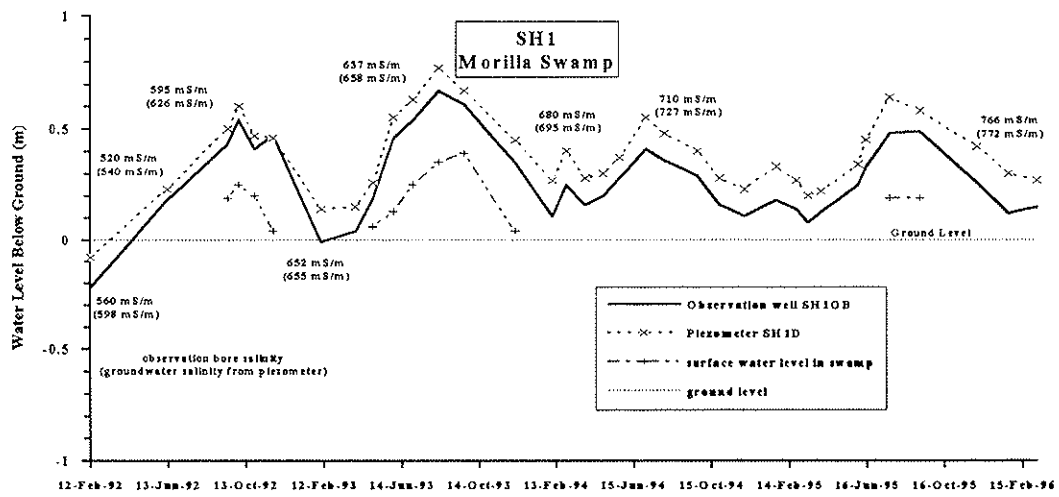
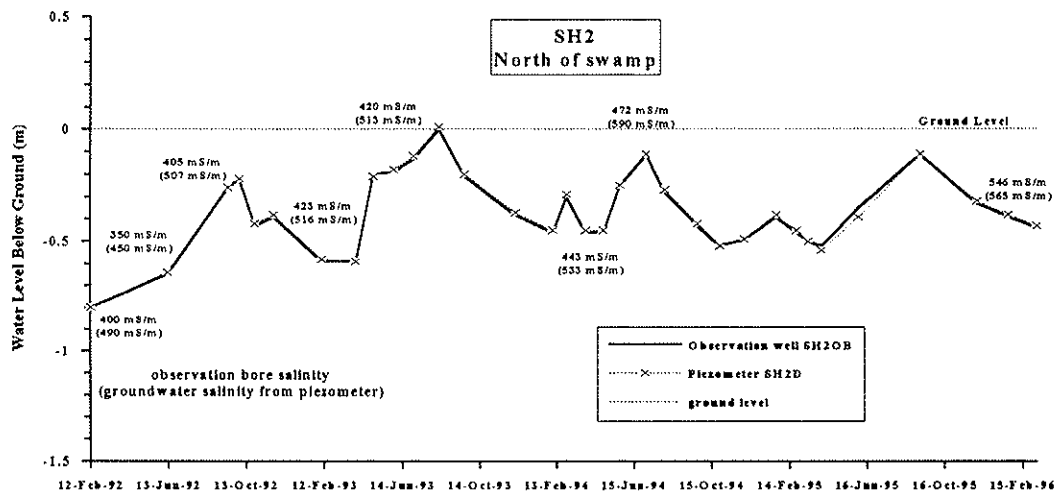
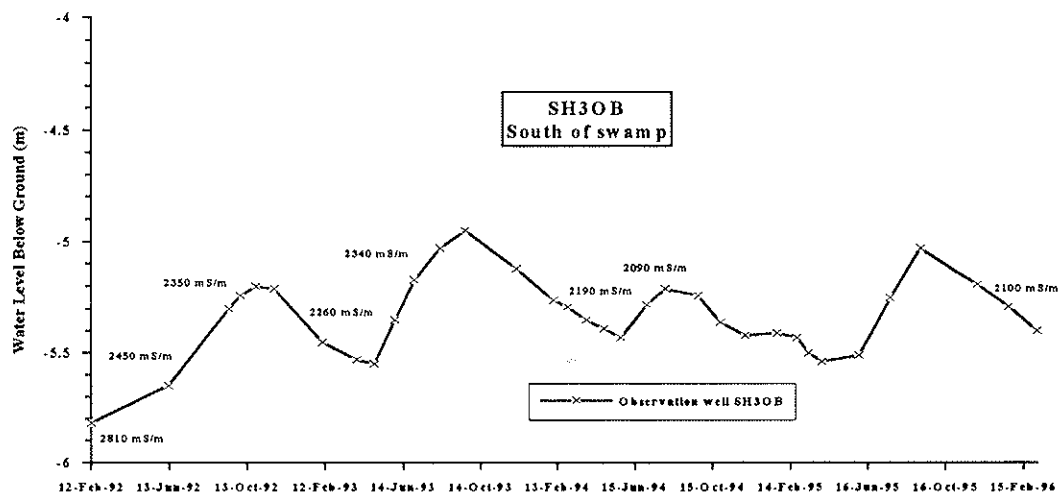
Figure 2. Hydrographs for groundwater monitoring sites.

The lowest groundwater levels were recorded at the beginning of monitoring in February 1992. The highest levels were in August 1993. Figure 2 displays hydrographs for the three monitoring sites relative to ground surface at the respective sites. There is artesian piezometric pressure at site SH1, both in piezometer SH1D and observation well SH1OB. This is evident from the difference in water level in observation well SH1OB relative to the swamp water level for periods when the swamp was inundated and the water level in the swamp is an expression of groundwater outcrop (Figure 2).

The seasonal peaks related to watertable recharge from rainfall are delayed by approximately a month in observation well SH3OB where the watertable is five or more metres below the ground surface compared to sites SH1 and SH2 where the watertable is within half a metre of the surface. This is indicative of matrix recharge delaying watertable response to seasonal rainfall.

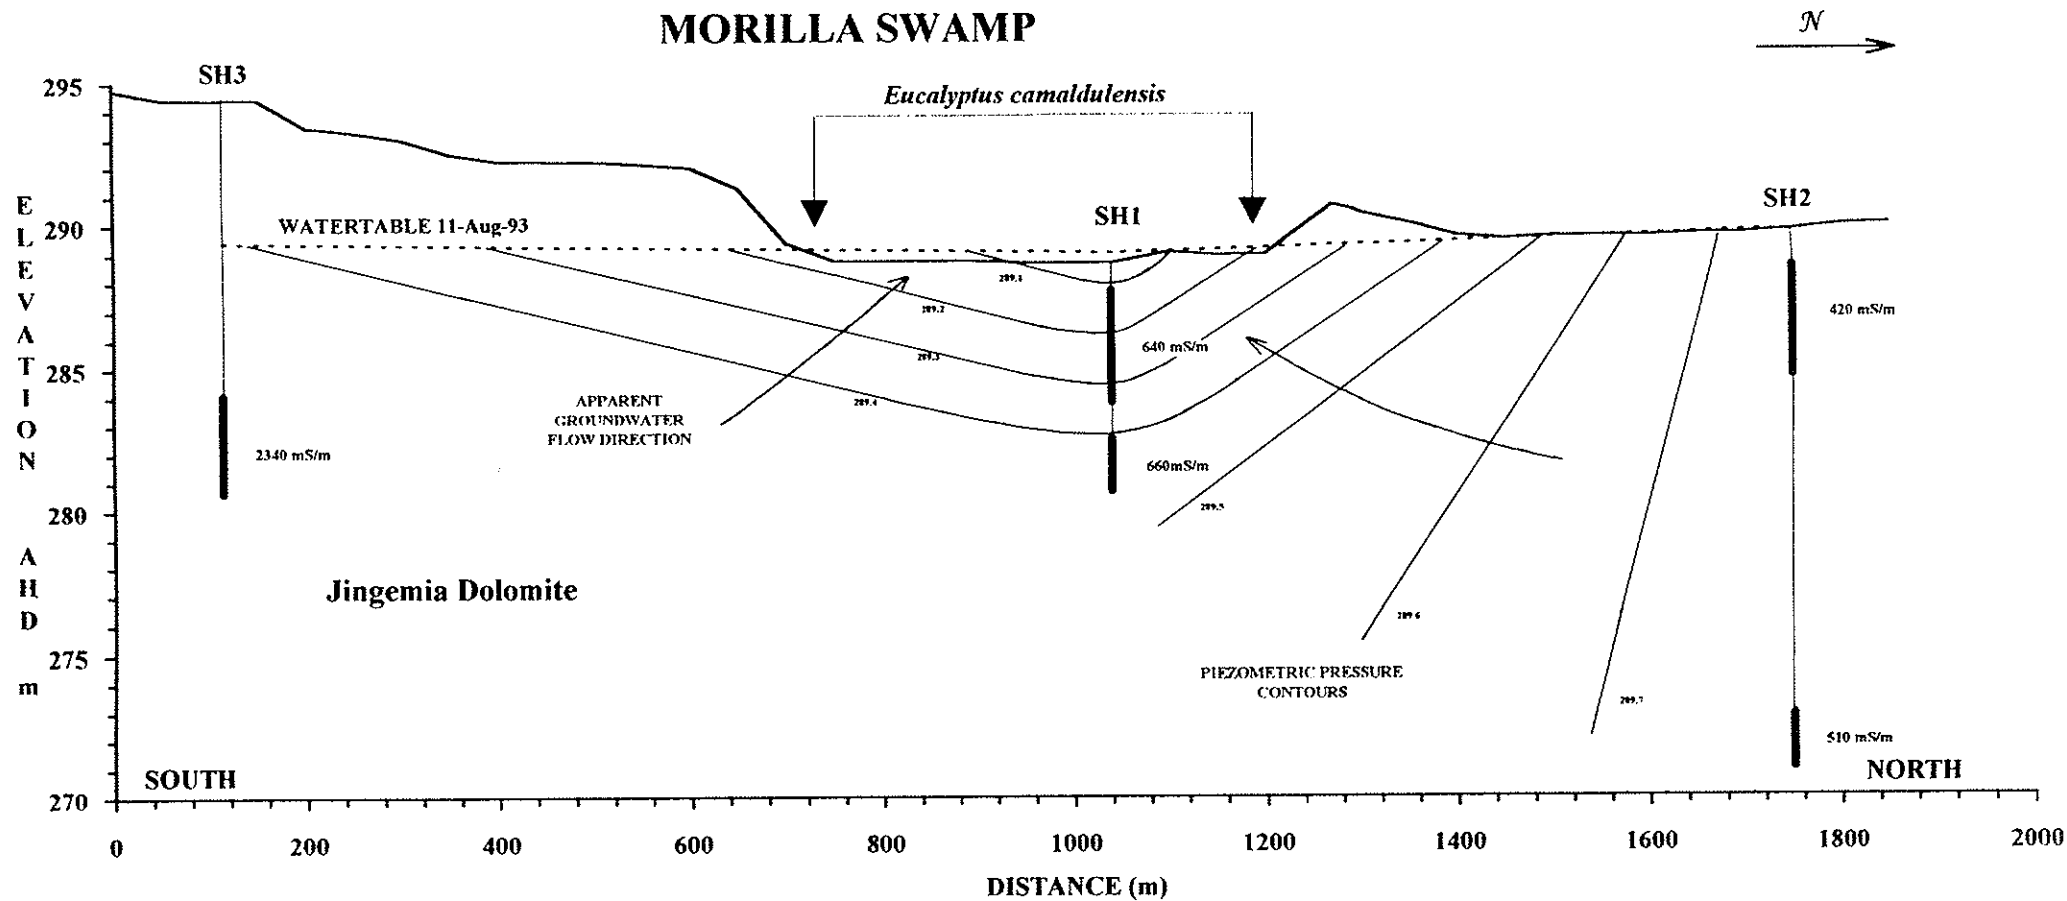
Figure 3. Hydrogeological cross section through Morilla swamp.

A hydrogeological cross-section is presented for the monitoring date of maximum hydraulic gradient (11 Aug 93) in Figure 3.

The hydrogeological cross-section (Figure 3) shows a groundwater gradient toward the lake from either side with upward pressure. This is consistent with the convergence zone described by Townley and Turner (1995) for surface water bodies coupled to groundwater. Figure 4 schematically depicts the dynamics of groundwater - surface water interactions within a regional flow system. The cross-section of Morilla Swamp (Figure 3) is across the up-gradient side of the lake.
