# RESEARCH

## THE VALUE OF OLD PHOTOGRAPHS

A.N. (Tony) Start  
and Tricia Handasyde

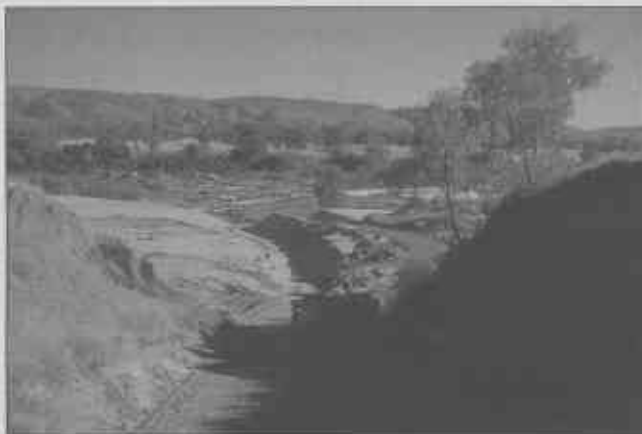
**Ivanhoe Crossing, June 1953.** Prior to construction of the dams upstream, the river was subject to huge floods in the wet season and dried back to pools during the dry season. Note the large sand bar which was deposited across the approach to 'the crossing' in the 1952/53 wet season. Photographer: W.A.C.Wright.

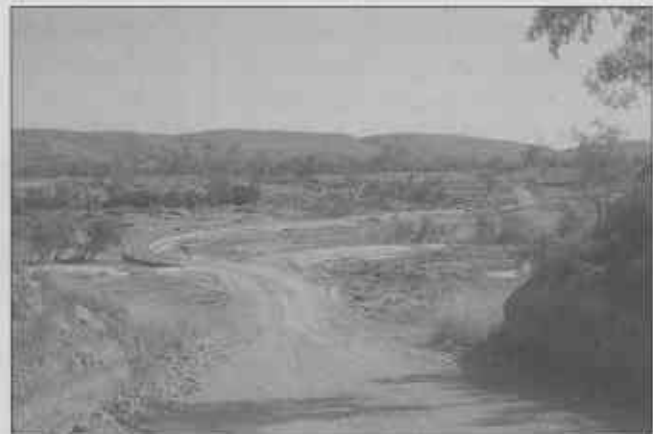
**Ivanhoe Crossing, August 1963.** Vegetation similar to 1953 photo. The large sand bar deposited in the 1952/53 wet season has been moved on. Photographer: A.Harris.

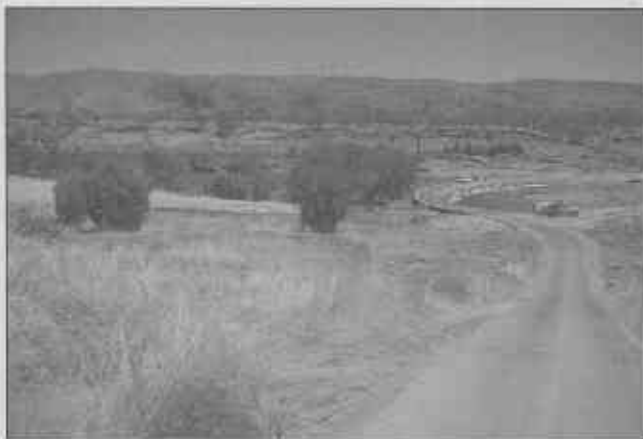
**Ivanhoe Crossing, 1972.** Vegetation similar to 1953 and 1963 photos however erosion of the far bank appears to have increased. The 'top' dam has been completed and the flow of the river will from now on be controlled. Photographer: M.Folkard

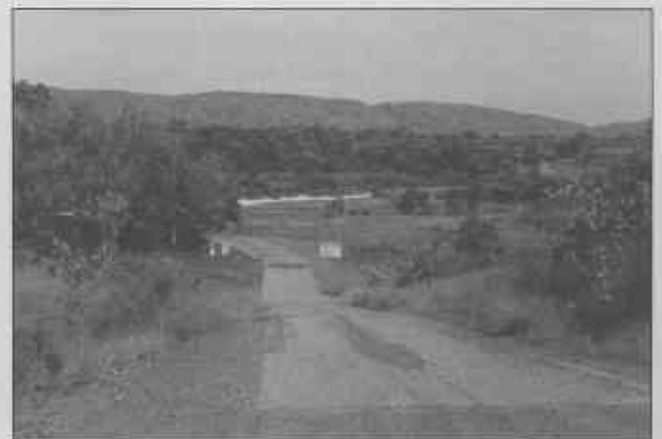
**Ivanhoe Crossing, April 2001.** For almost 30 years, downstream of Lake Argyle the river has flowed all year and floods have been controlled. The increase in vegetation along the river is enormous. The group of paperbarks growing to the left of the sweeping curve in 'the crossing' visible in the previous 3 photos are now obscured by a forest of figs and Leichardt trees. Photographer: A.N.Start

However all that changed after 1973 when the Lake Argyle filled. Waterlilies, cumbungi and several other aquatic plants rapidly colonised the shallows and forests grew along the channel margins. At Ivanhoe crossing, visitors picnic under a forest of figs and Leichardt trees that are ten metres tall. Understandably, they look at us disbelievingly when we tell them that this spot was a bare sandbank in 1973. But the photos prove it. You'll know what we mean when you look at these pictures.
