# Water notes

WN38 February 2009

## Management of sediment in pools of the Avon River system

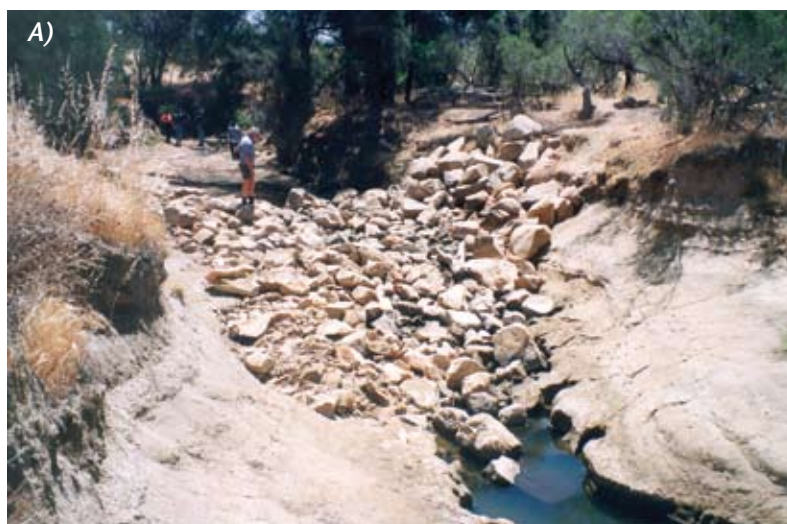
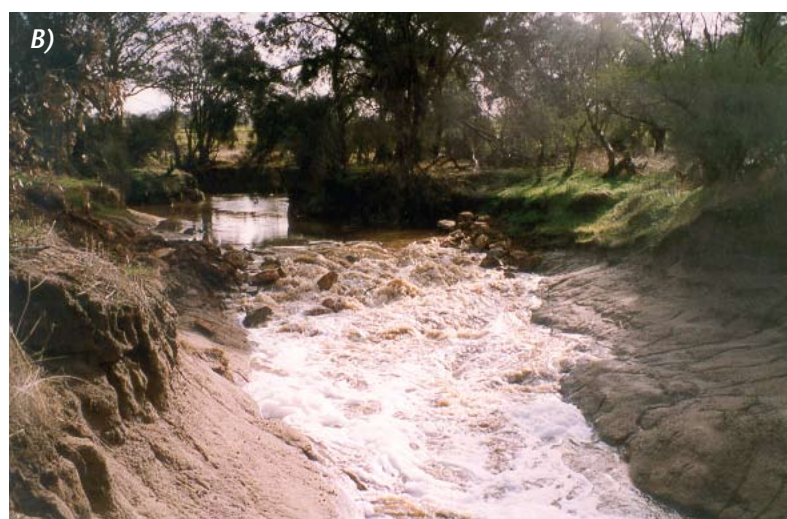
**Figure 2** Rock riffle sequence at Spencer Brook, a tributary of the Avon River, when dry (A) and when flowing (B)

A riffle is a high point in the stream bed that may consist of a rocky rapid, log bar or the natural accumulation of debris or coarse bed material. Water flow is typically relatively shallow, fast and rough over the riffles causing the 'bubbling' noise of a stream. The stream forms a pool upstream of the riffle, which helps to slow flow, trap sediment and control erosion. Pool-riffle sequences can be artificially constructed to stabilise the river bed itself until longer-term improvements in the catchment take effect (Figure 2).

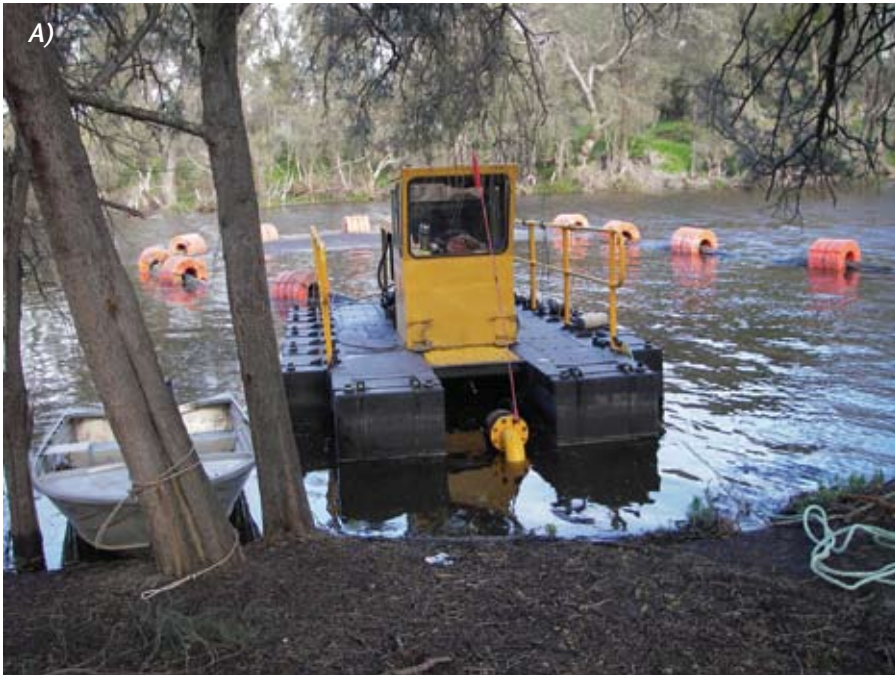
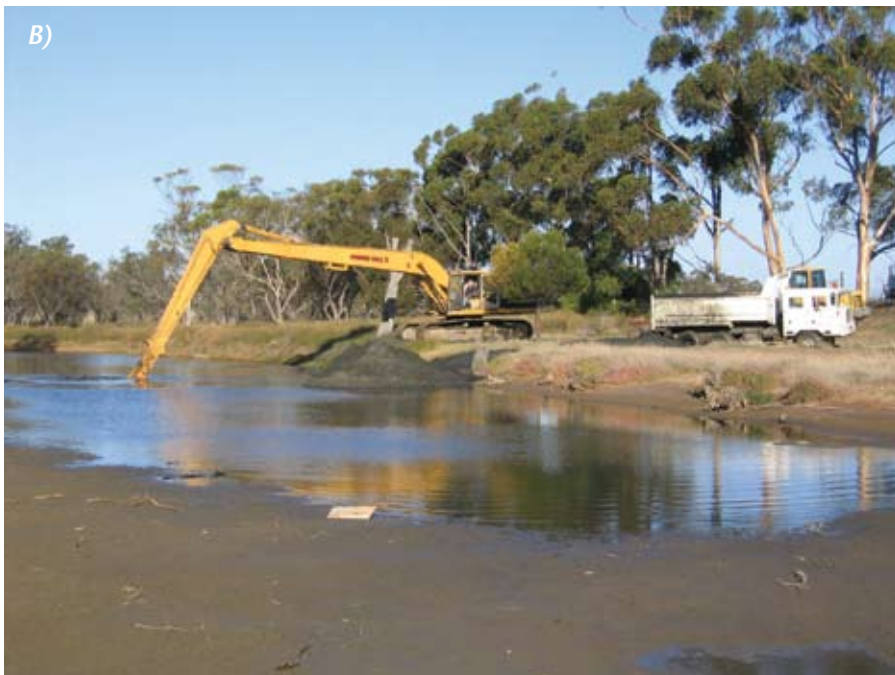
*Figure 3 Depending on the site, a dredge (A) or a long-reach excavator (B) may be more suitable for extracting sediment*

Sediment removal is planned taking into account the effects on pool ecology and disturbance to the sensitive riparian vegetation surrounding the pools. Access for machinery and the logistics of transporting the sediment off-site need to be considered. The choice of machinery (dredges or long-reach excavators for example) will depend on the individual characteristics of the pools (Figure 3).

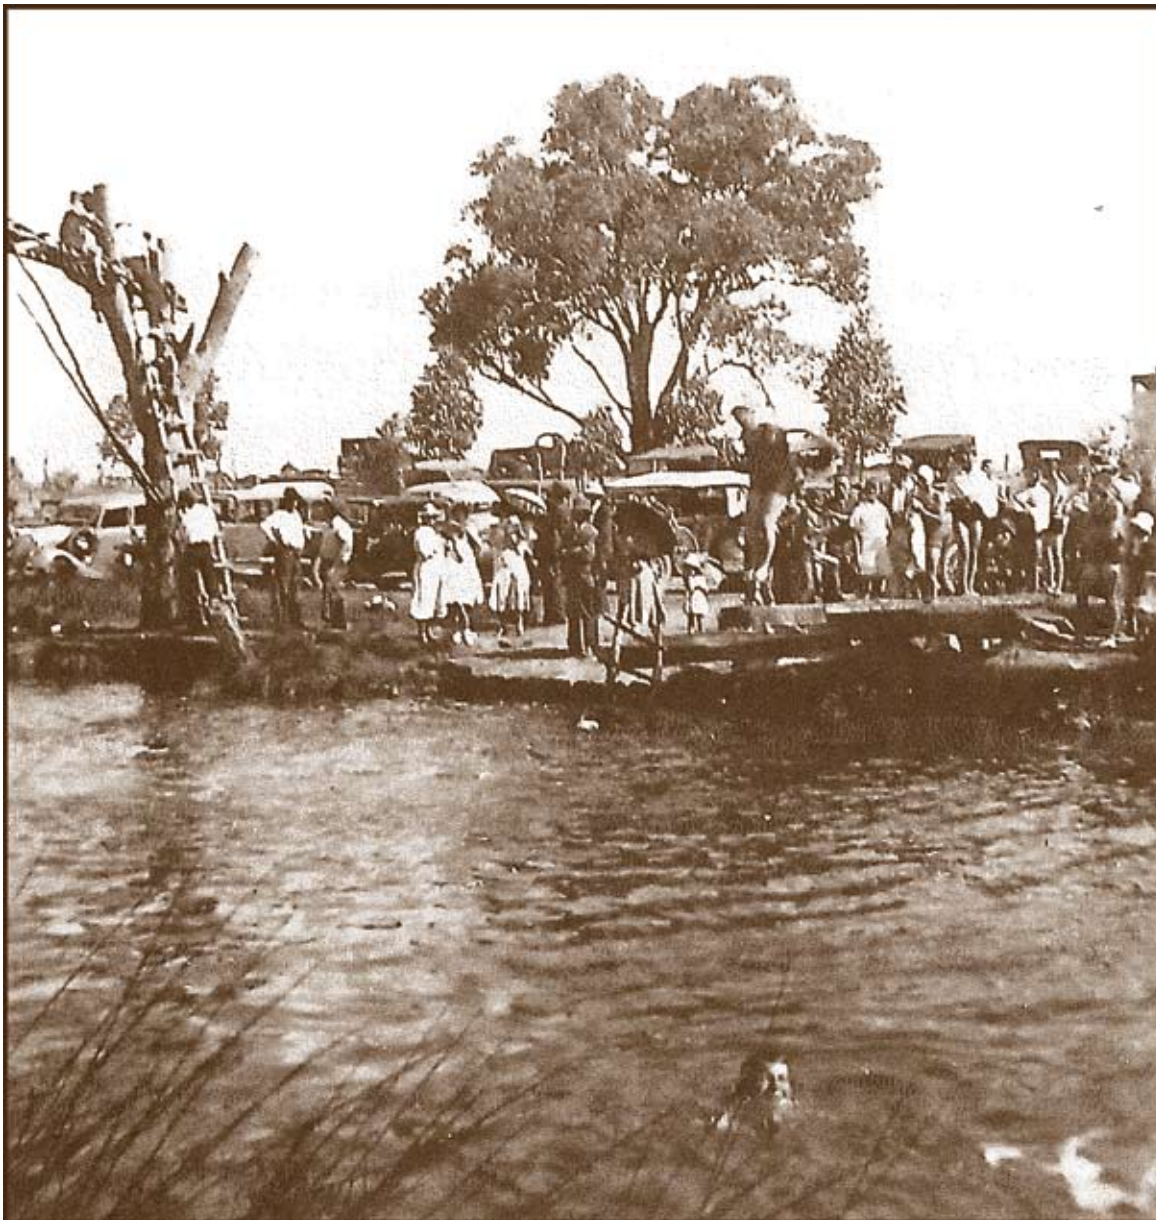
*Figure 4 One Mile Pool was once used widely for recreation by the local community (photo courtesy of Judy Williams)*

One Mile Pool is located approximately 1.5 km north of Brookton along the Avon River South Branch. Before it filled with sediment, One Mile Pool was valued by the local community for recreation (Figure 4), as well as being a drought refuge for fauna in summer. The pool also held great significance for the local Aboriginal community.

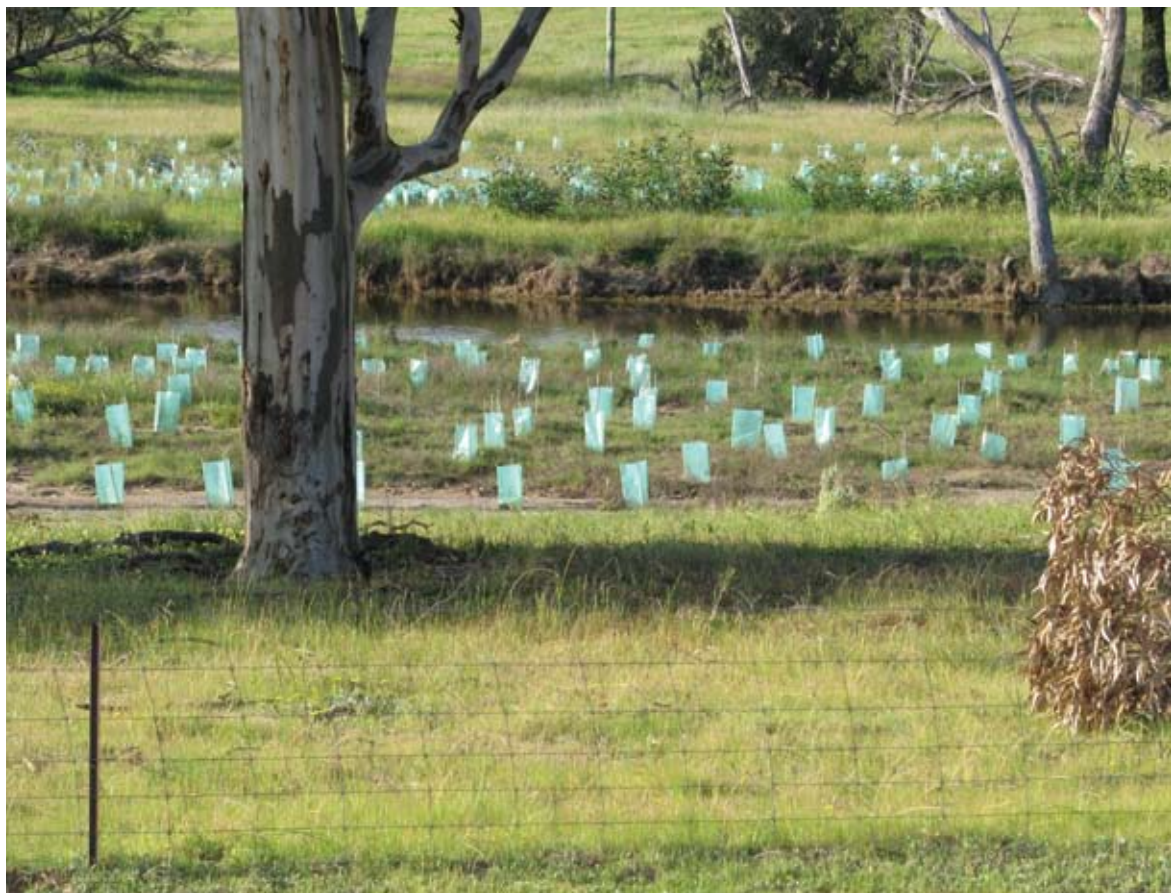
*Figure 5 Fencing and revegetation of the riparian zone were important parts of the pool restoration project at One Mile Pool on the Avon River South, near Brookton*

In May 2007, approximately 3000 m<sup>3</sup> of coarse sediment was removed from the pool using a long-reach excavator, increasing the pool depth from 0.5 m to 2.5 m. An extensive re-vegetation program was conducted in August 2007 and July 2008, after weed control and ripping of the area surrounding the pool had been completed, and fencing was constructed along the riparian zone to keep cattle out (Figure 5).

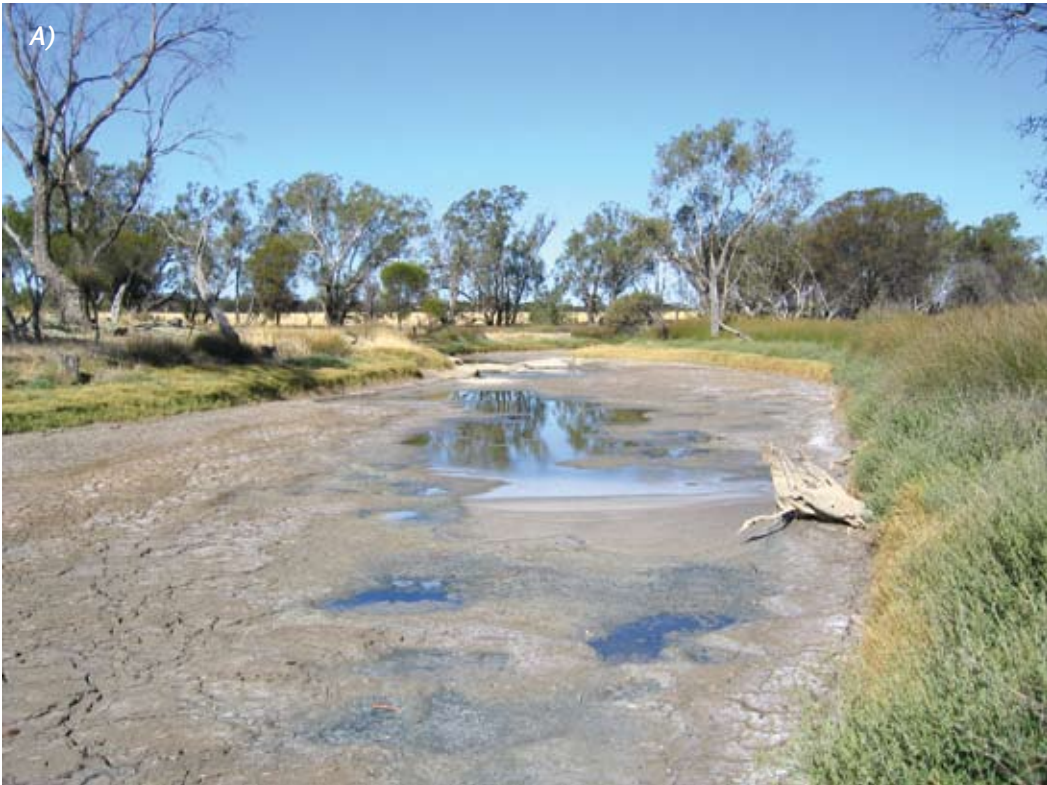
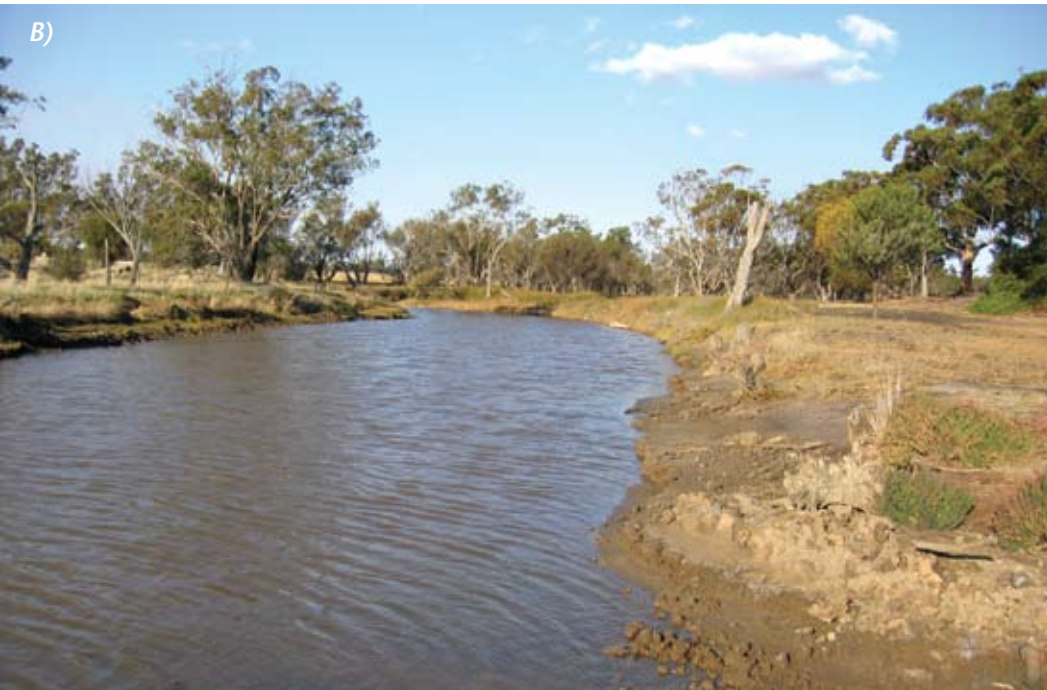
*Figure 6 One Mile Pool before (A) and after (B) sediment extraction*

Monitoring has shown that the plantings were successful and that the pool has maintained its depth. The results of this pool restoration project mean that local communities that once enjoyed the natural beauty of this ecosystem can do so once more (Figure 6).

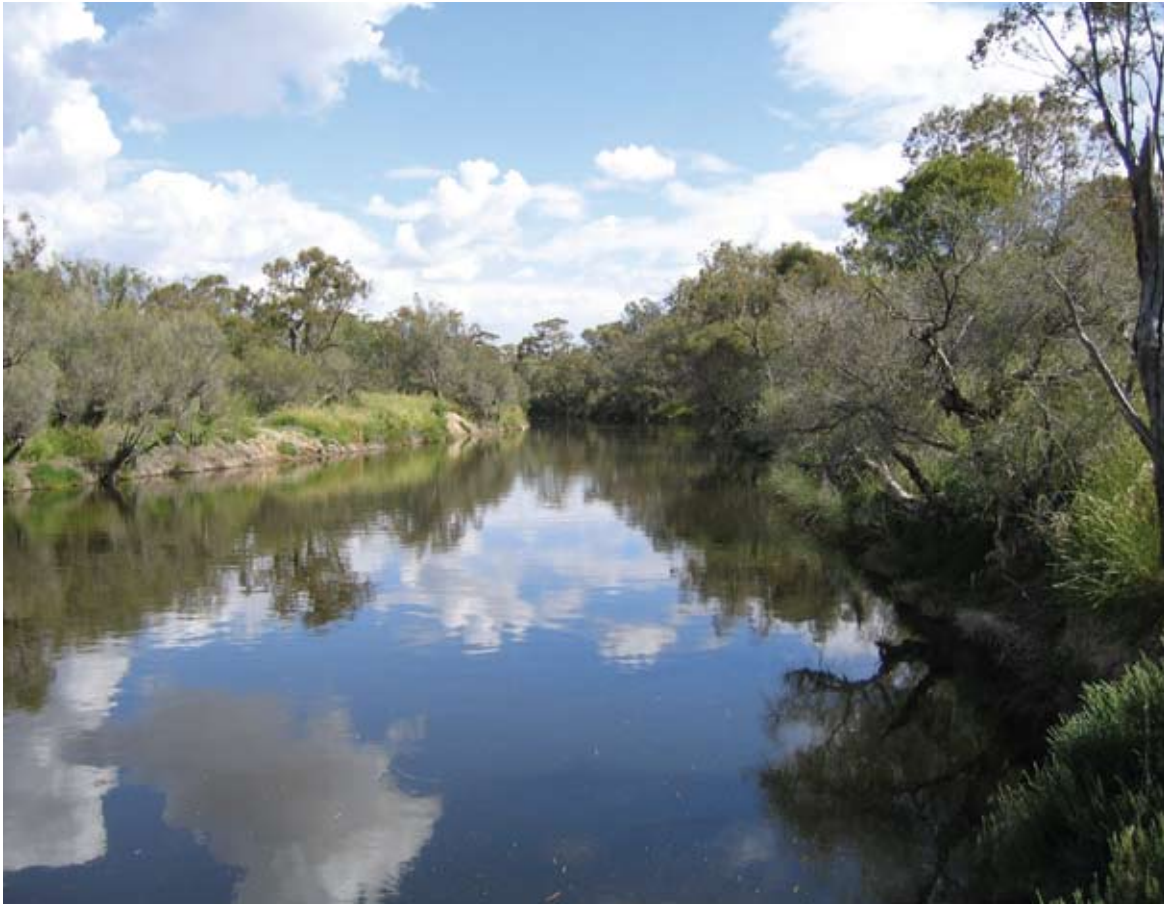
*Figure 7 A successful pool restoration project at Boyagarra Pool on the Avon River*

Boyagarra Pool is a 600 m stretch of the Avon River located 19 km north-east of Brookton (Figure 7). In 1999, a management plan was developed by the Water and Rivers Commission and the University of Western Australia's Centre for Water Research, based on the ideas of the Friends of Boyagarra Pool (consisting of adjoining landholders and members of the Brookton community). A restoration project has been under way since February 2000 to carry out the recommendations made in the management plan. This has included revegetating the riparian zone, excavating to remove excess sediment from the pool and fencing a section of the pool. From 2000 to 2002, a mixture of trees, groundcovers, shrubs, sedges, rushes and native grasses were planted at several areas across the site. The denuded banks caused by sediment extraction works, the surrounding floodplain and the floodway upstream of the pool were all revegetated to stabilise the mobile sediment that would otherwise refill the pool.

Excavation of the pool was undertaken in two parts. In April 2001, when the pool was relatively dry, the top half of the pool was excavated to a depth of 2 m and then in April 2002 the downstream half of the pool was excavated. A total of 6000 m<sup>3</sup> of sediment was removed.
