# ESTUARIES AND COASTAL LAGOONS OF SOUTH WESTERN AUSTRALIA

AN INVENTORY

## WELLSTEAD ESTUARY THE ESTUARY OF THE BREMER RIVER

Estuarine Studies Series No. 1.

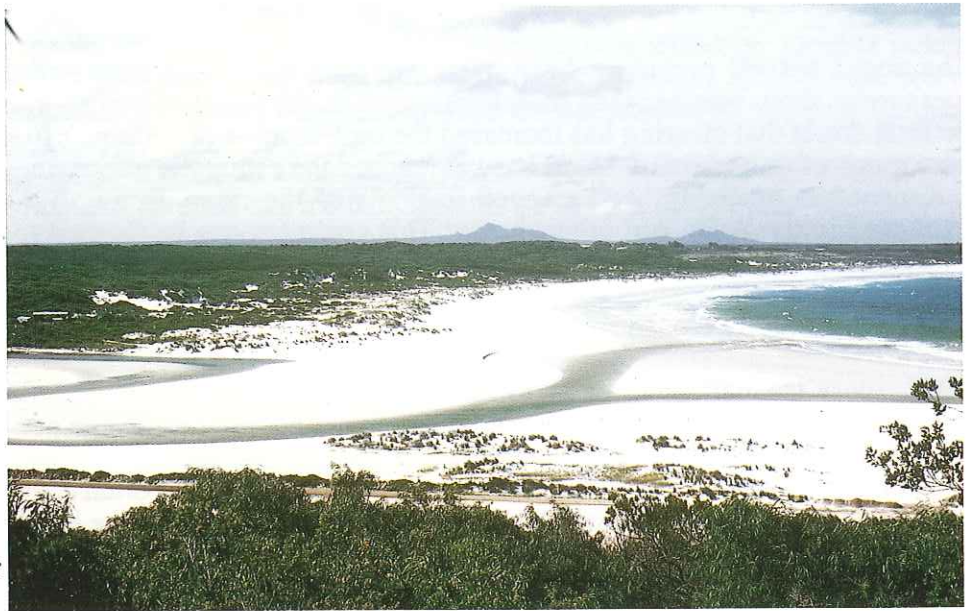
Wellstead Estuary bar  
17 October 1978.
