Assessment, evaluation and a comparison of planned and unplanned walk trails in coastal south-western Australia

Keywords: Trail assessment, environmental characteristics, maintenance features, West Cape Howe and Torndirrup National Parks

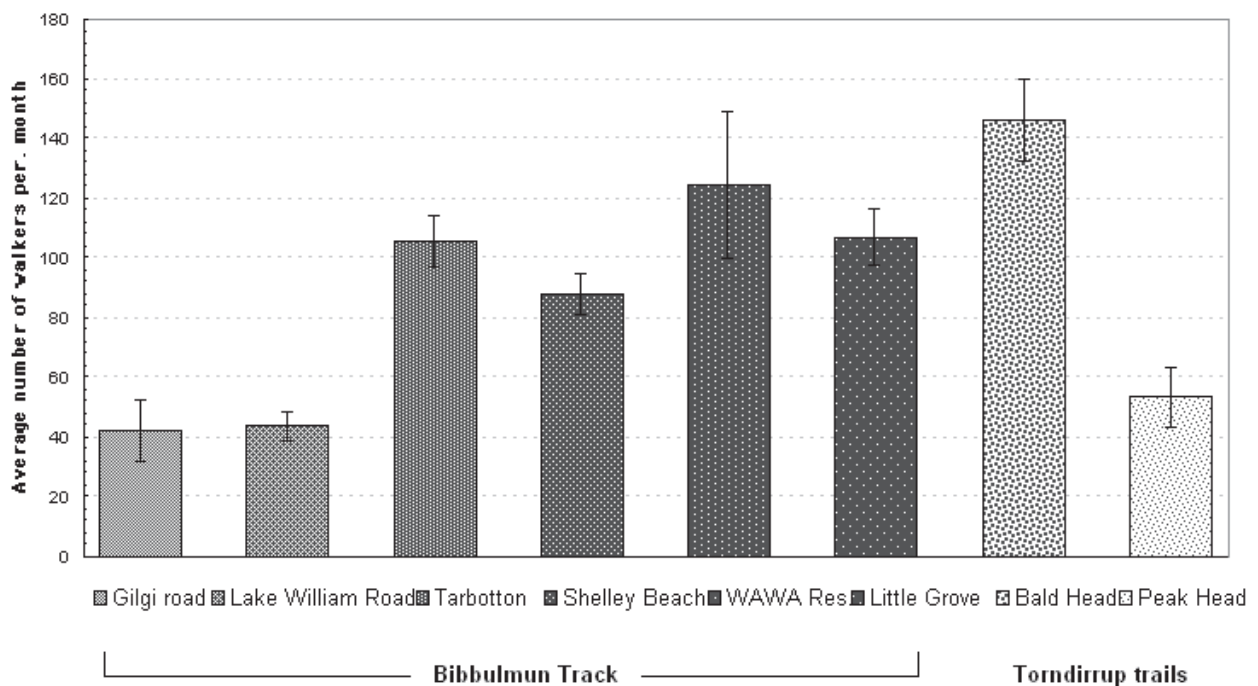
Figure 5. Average numbers of walkers per month on the Bibbulmun Track between Denmark and Albany, and the Bald Head and Peak Head trails in TNP

Data on trail usage from electronic pedestrian counters placed at selected positions on the Bibbulmun Track, between Denmark and Albany between 1996–2003 and at the beginning of the Bald Head and Peak Head trails between 1996–1999 are indicated below (Figure 5).

gathered as a result. For example in the case of the Bald Head trail, the data logger that recorded trail usage between 1996–1999 (Figure 5), was positioned at the beginning section of the trail (car park end) and would not represent those walkers that did not complete the whole trail. A more reliable way of recording trail usage and exploring the relationships between use factors and degradation would be to position a trail counter on a known problem section. Temporal changes in erosion on and off the trail could then be recorded by point sampling techniques at the same location the counter is positioned and thus related to trail use with an increased level of confidence.

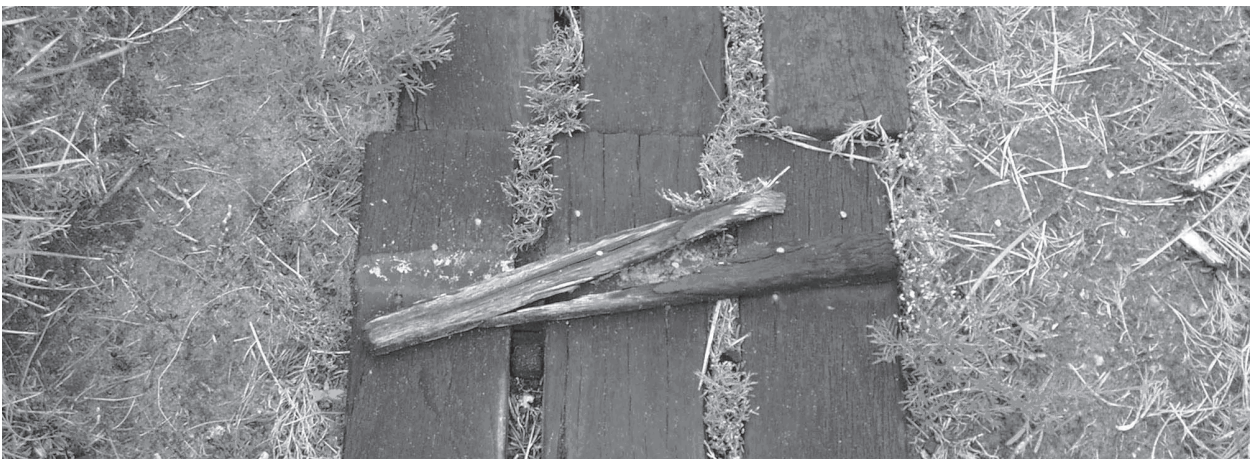
Figure 10. A charred board-walk with split cross tread and protruding nails, moderate-poor condition but moderate-excellent / excellent effectiveness rating for Bibbulmun Track in WCHNP

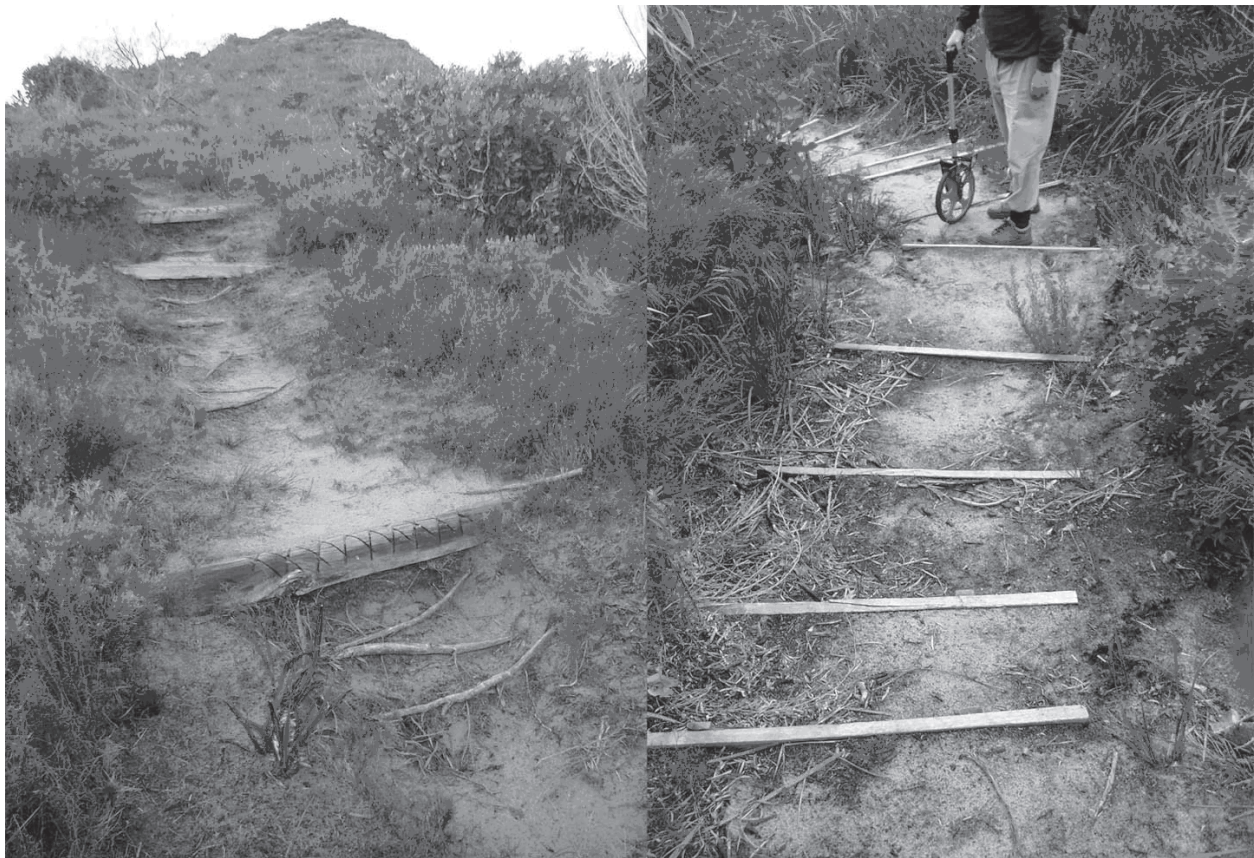
Figure 11. Water bars (left) with a tread space > 1m showing water erosion at the base of each bar due to the on trail waterfall created during surface water flow. Grouped steps (right) on a steep slope with a tread space of < 1m, show no signs of water erosion or soil movement. Bibbulmun Track in WCHNP

Moderate-poorly effective maintenance features on the Bibbulmun Track such as water bars were mainly located on the Tarbotton trail. The sheer number of water bars on the Bibbulmun Track (551) meant that some water bars had attracted a moderate-poor effectiveness rating because they had been undercut by deflation. The non-continuous maintenance features on the Bald Head trail were mainly directional signs on exposed granite and were sometimes difficult to detect from a distance, leading to disorientation that can ultimately lead to trail proliferation. Water bars on the Peak Head trail were mainly of poor

effectiveness and did not seem to be arresting erosion as well as the numerous exposed tree roots that were acting as surrogate water bars on severe sections of trail degradation. A water bar should be aligned on a 45–60° angle to the trail. Water bars that were positioned at 90° in relation to the trail and lacked the angle necessary for the diversion of surface water appeared to create a lip that surface water could fall over and erode the soil at the base of the water bar (Figure 11). In some cases it was difficult to establish whether or not the feature was meant to be a water bar or a step. Groups of steps on slopes > 10° with widely spaced treads were observed to be eroded at the stair base due to the effects of vertical water spillage over the step lip. The effectiveness rating of grouped steps on slopes > 10° was markedly increased if the tread space between each step was < 1m with 60cm treads being suggested as a standard for single lane walking trails in Tasmania (Parks and Wildlife Service Tasmania, 1994). Mende and Newsome (2006) in their assessment of walking trails in the Stirling Range National Park, south-western Australia, noted that the effectiveness of a maintenance feature was not necessarily dependant on its condition but related more to the proper placement of the feature and the number of such features along a given trail. This was also observed to be the case from the results of the assessment for the three assessed trails in this study.
