In River Science 13 we explained how artificial oxygenation worked and in River Science 14 we talked about previous oxygenation trials on the Canning River. Since then, a full-scale oxygenation plant treating 2 km of river has been installed on the Canning River over the summer of 1999/2000. The installation of this plant, which was funded by the Coast and Clean Seas and Swan-Canning Cleanup Programs, represented a progression from the testing of oxygenation, to its application as a remediation technique for the Canning River upstream of Kent Street Weir. An open tender process was used to select a contractor to design, build and operate the plant, in contrast to the initial trials which were conducted in collaboration with research partners.

The oxygenation trial lasted from 17 October 1999 to 15 May 2000

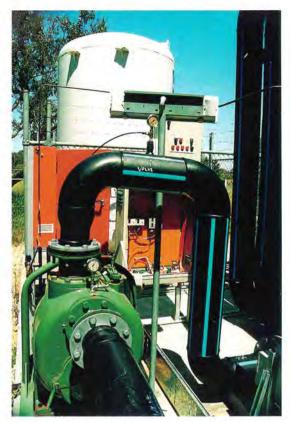
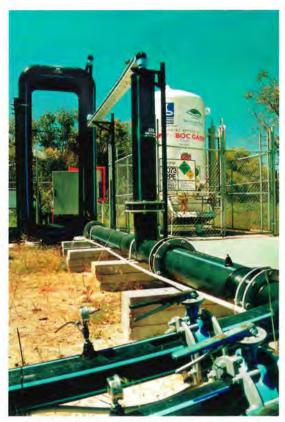
Figure 3: One of the two oxygenation plants used in the 1999/2000 project. Left: water pump in foreground with control panels and oxygen vessel behind. Right: Distribution pipes in foreground with oxygen dissolver and oxygen vessel in background

A new oxygenation plant was installed at Camsell Way on the grounds of an existing Water Corporation pump station. The excavation of a 70 m trench from the river to the plant was required to lay the pipes connecting the oxygenation plant to the river. Due to the close proximity of the new plant to houses, soundproofing was used to reduce noise levels to a minimum. The installation of the new plant began on 6 January 2000 and was completed on 15 February 2000.

The oxygenation plant at Bacon Street operated reliably during the six months of operation, and after some fine tuning the new oxygenation plant also operated reliably. Approximately 90% of the oxygen injected into the water by the plant remained dissolved after being returned to the river.
