HAZARD ALERT

Department of
Environment and Conservation

Alert No: 20

Identified Hazard: Snatch Straps improper usage

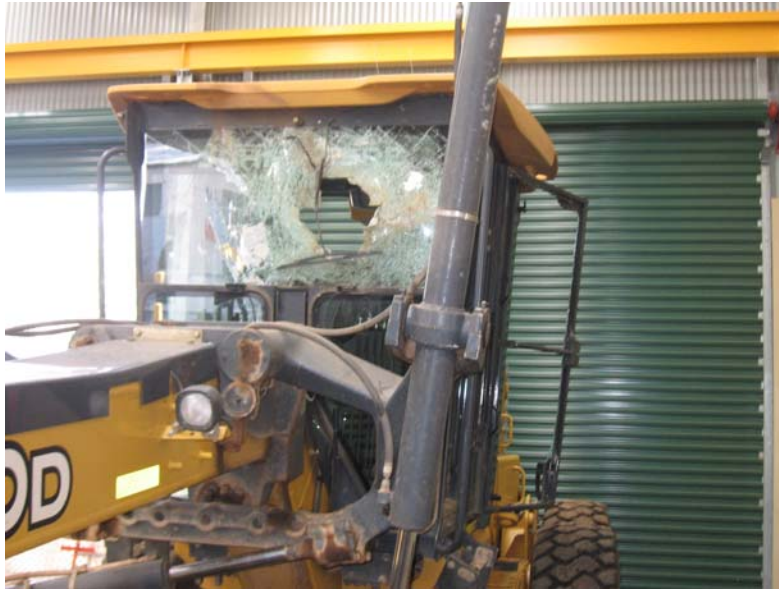
Using a Snatch Strap to recover a bogged grader (external agency) the snatch strap was torn apart resulting in one half of the snatch strap ricocheting back into the windscreen of the grader. The operator of the grader suffered severe eye injuries from glass impact.

Damage caused by the snatch strap torn apart and ricocheting back into the graders windscreen. The operator of the grader suffered severe eye injuries from glass impact.

- **NEVER use a snatch strap if you have not been trained in the proper usage.**
- **READ the JSA prior to using the snatch strap.**
- **Use rated snatch straps for the task.** (a bogged grader or large earth moving equipment may require in excess of a 50 tonne strap, often the issue is the mounting i.e. 30 tonne strap with 10 tonne D shackles)
- Never place a Snatch strap over a tow ball
- ONLY use dedicated tow points as described in vehicle manual.
- Always ensure snatch strap is dry prior to being stored)
- Do not expose snatch strap to any petroleum based products, acids or alkaline products.
- Prior to using the snatch strap inspect for damage.

All snatch straps must be fitted with an **ANTI RECOIL SAFETY STRAP** all DEC heavy fleet straps should have them, should the strap or mounting point fail this anti recoil safety strap will stop the recoil Straps not fitted with the anti recoil safety strap are to be sent to Fleet Section for modification and inspection

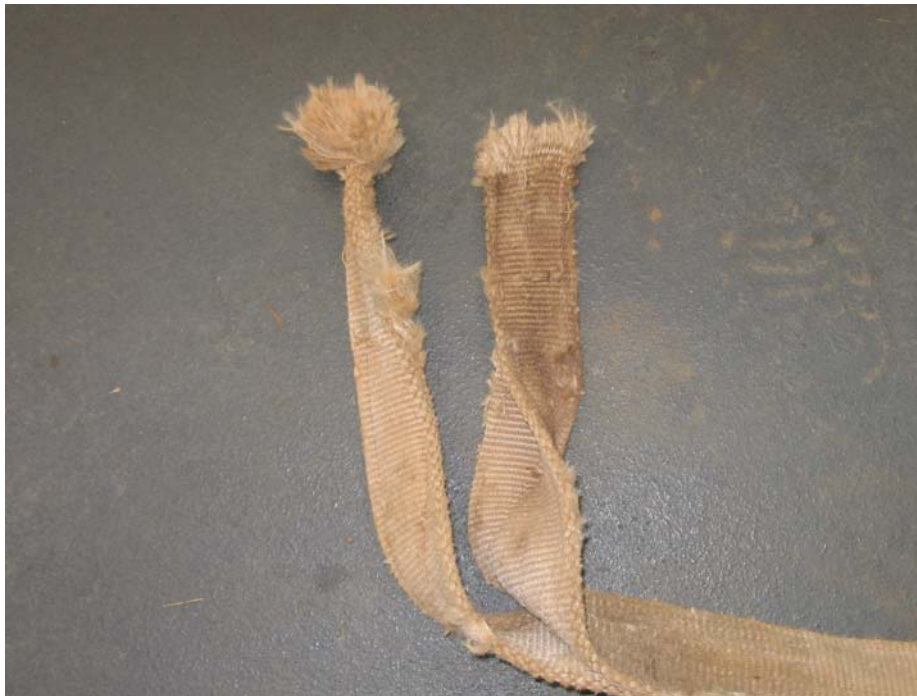
Damaged Snatch Strap

Damage may include:

- Frayed materials
- Loose stitching
- Cuts & abrasions

If the snatch strap exhibits any of the above discard the snatch strap.
