# SPECTACULAR RECOVERY IN THE ORD RIVER CATCHMENT

A.L. Payne, I.W. Watson and P.E. Novelty  
Department of Agriculture, Western Australia

July 2004

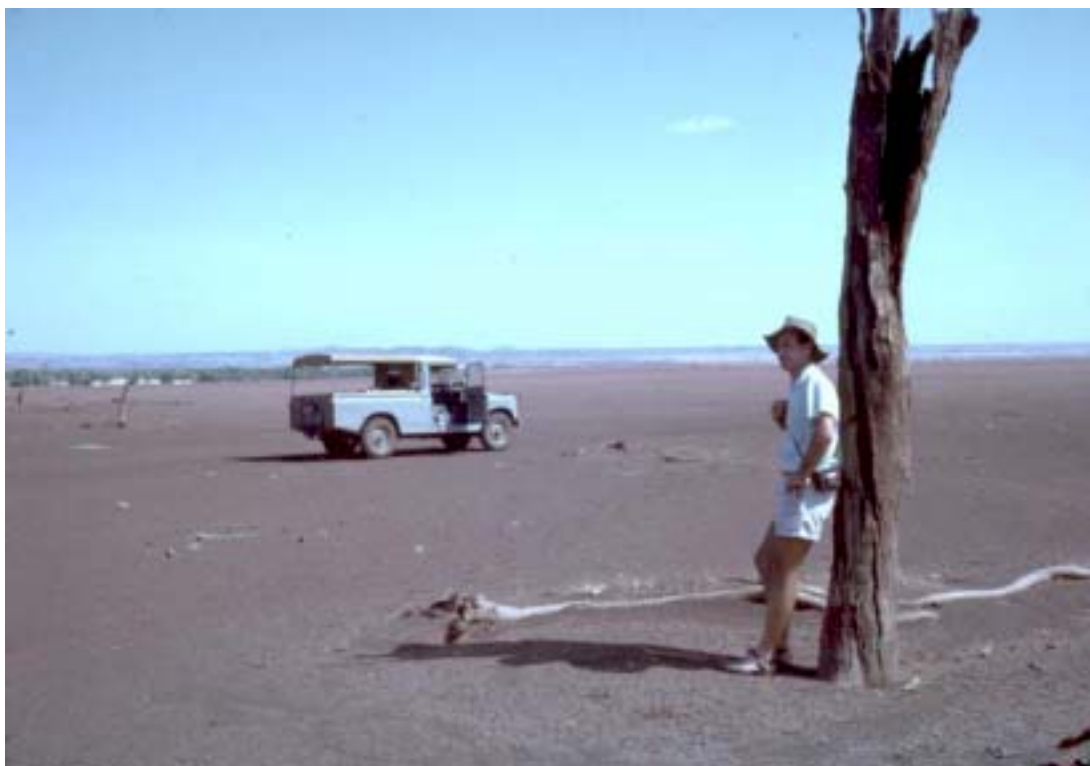
**Photo 1.** Severely sheet eroded plains of the Nelson land system in July 1963. For a short time after the wet season these plains supported sparse miniature annual grasses and herbs but, for most of the year, they were bare and exposed to the action of wind and water.

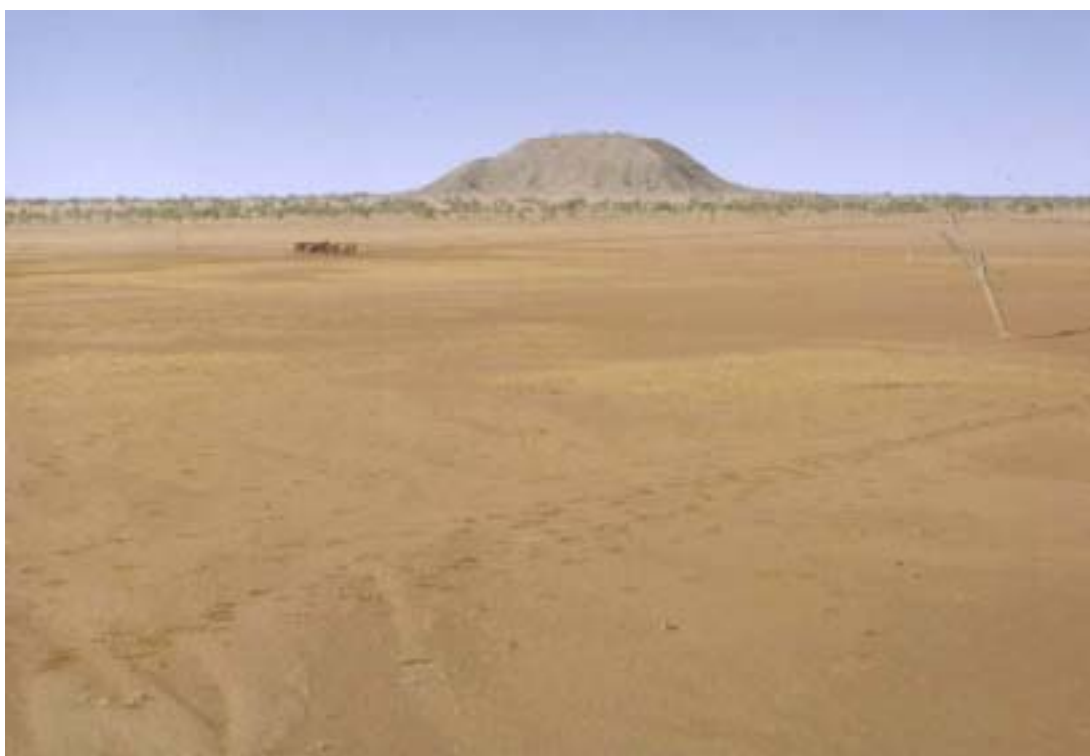
**Photo 2.** Degraded and sheet eroded plains near Mt Panton (NT) in July 1965. A few residual patches support sparse grasses but most of the surface is bare.

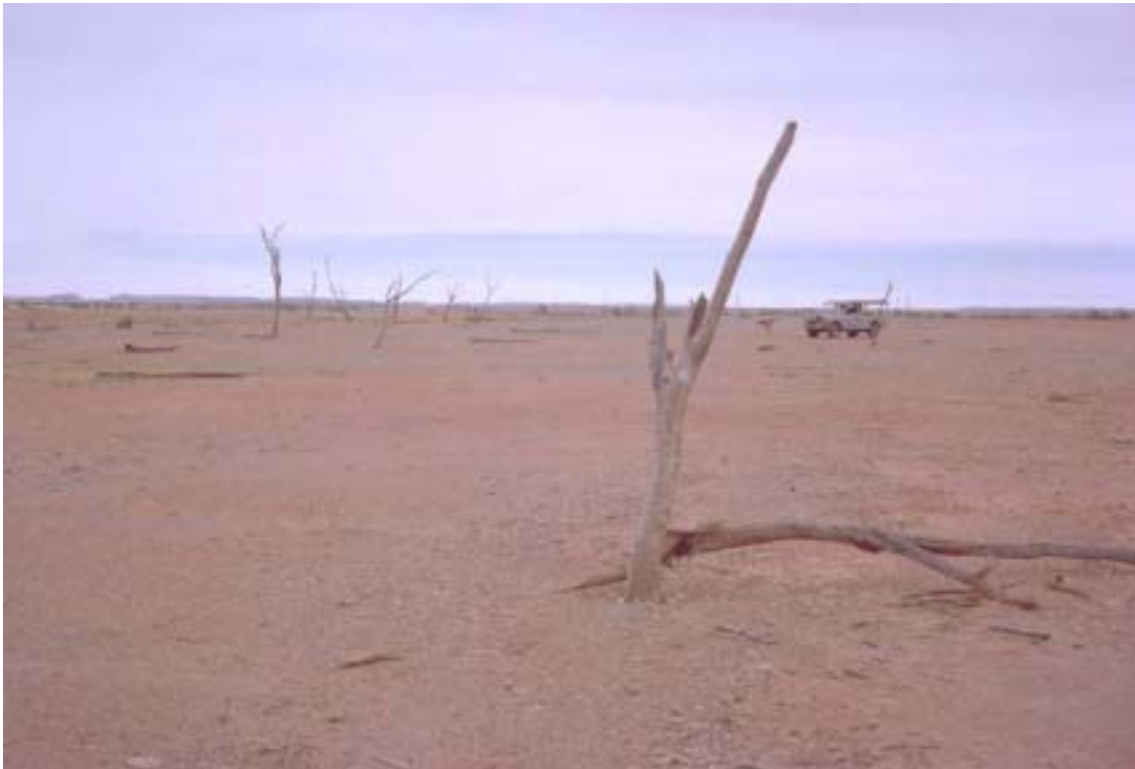
**Photo 3. Degraded plains of the Nelson land system which previously supported biennial and perennial grasses with a scattered overstorey of small eucalypt trees. June 1962.**

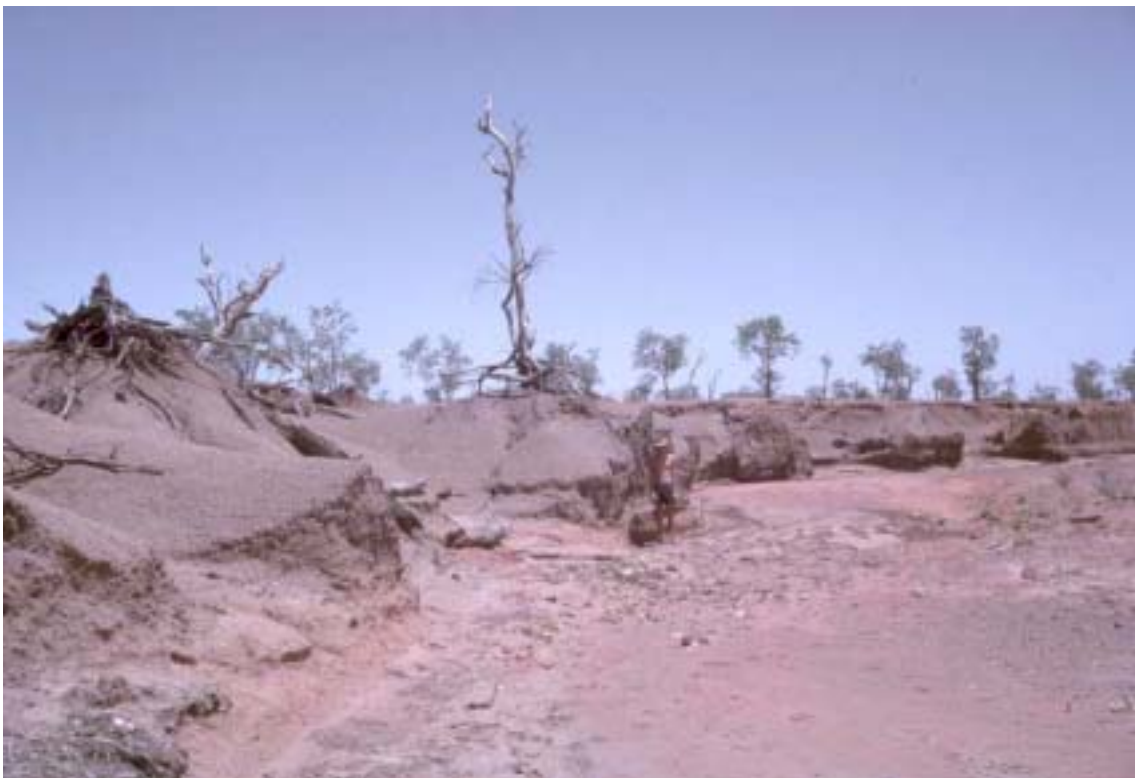
**Photo 4. Active streambank erosion on a minor tributary of the Ord River. March 1964.**

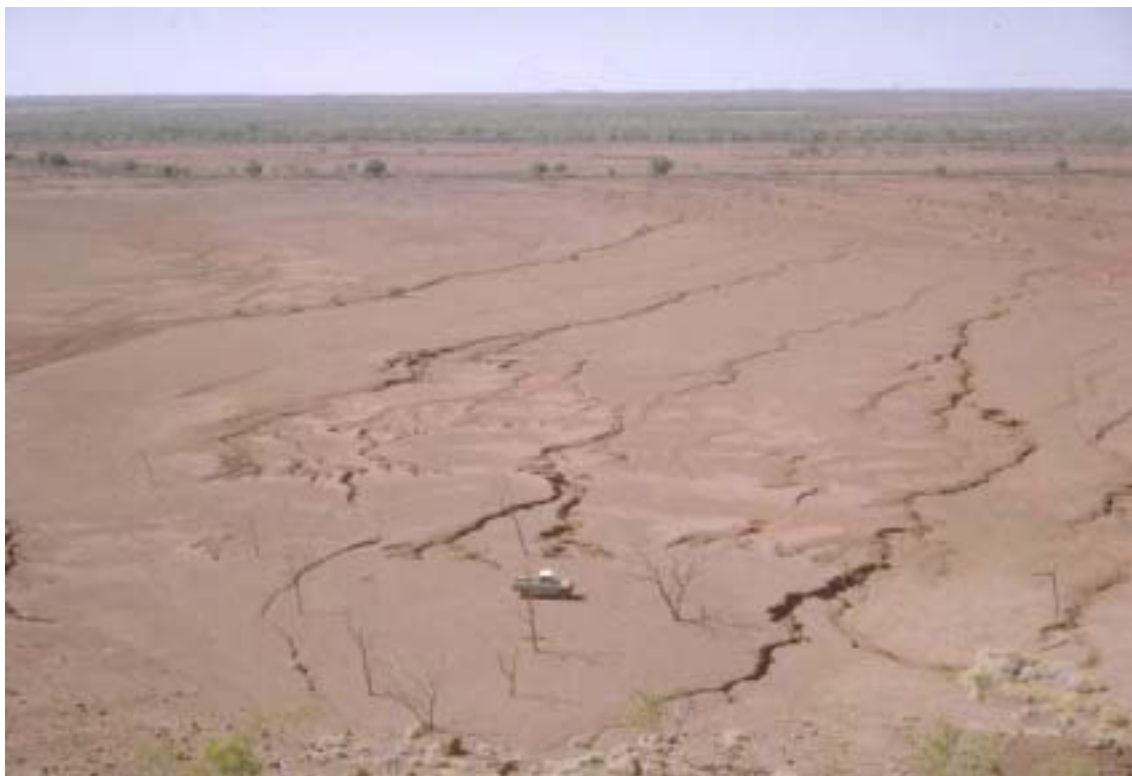
**Photo 5.** Bare and eroded slopes and plains of the Nelson land system in August 1963. Note the dead trees in the foreground, suggesting how degraded this land had become.

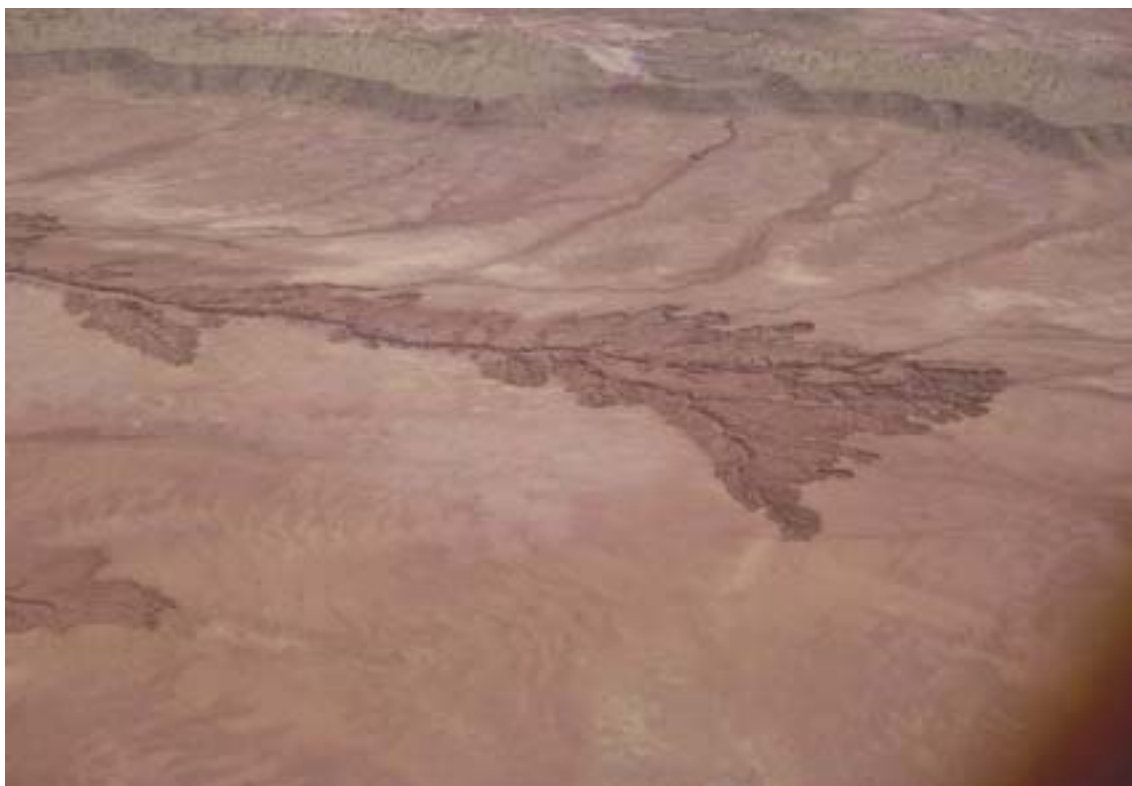
**Photo 6.** This photograph, taken in August 1963, shows a massive gully system on the lower plains of the Nelson land system. A line of low limestone cuestas in the background stands above the red plains. Vegetation is restricted to bands of sparse grass on micro-terraces arranged more or less on the contour and separated from each other by narrow strips of bare sheet-eroded ground.

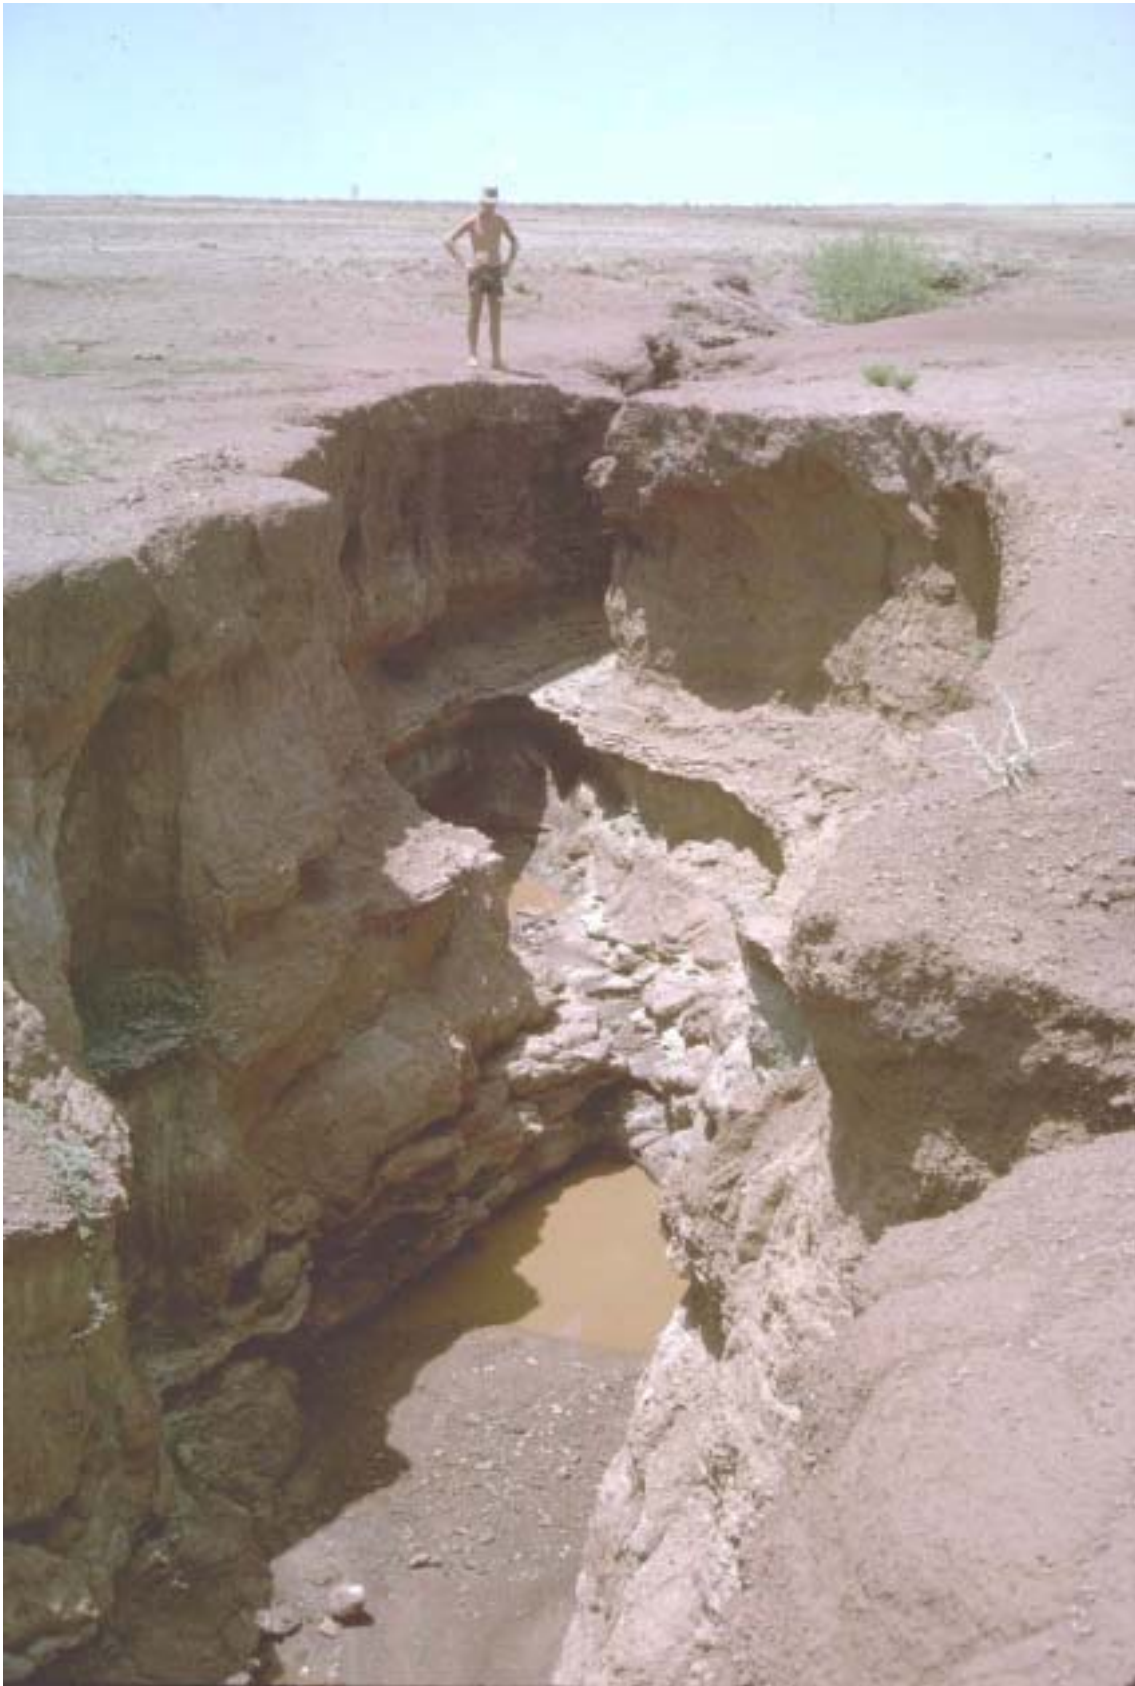
**Photo 7.** Gullies on the lower slopes of the Nelson land system were frequently incised many metres through the calcareous red soils and underlying soft shale and siltstone sediments. March 1964.

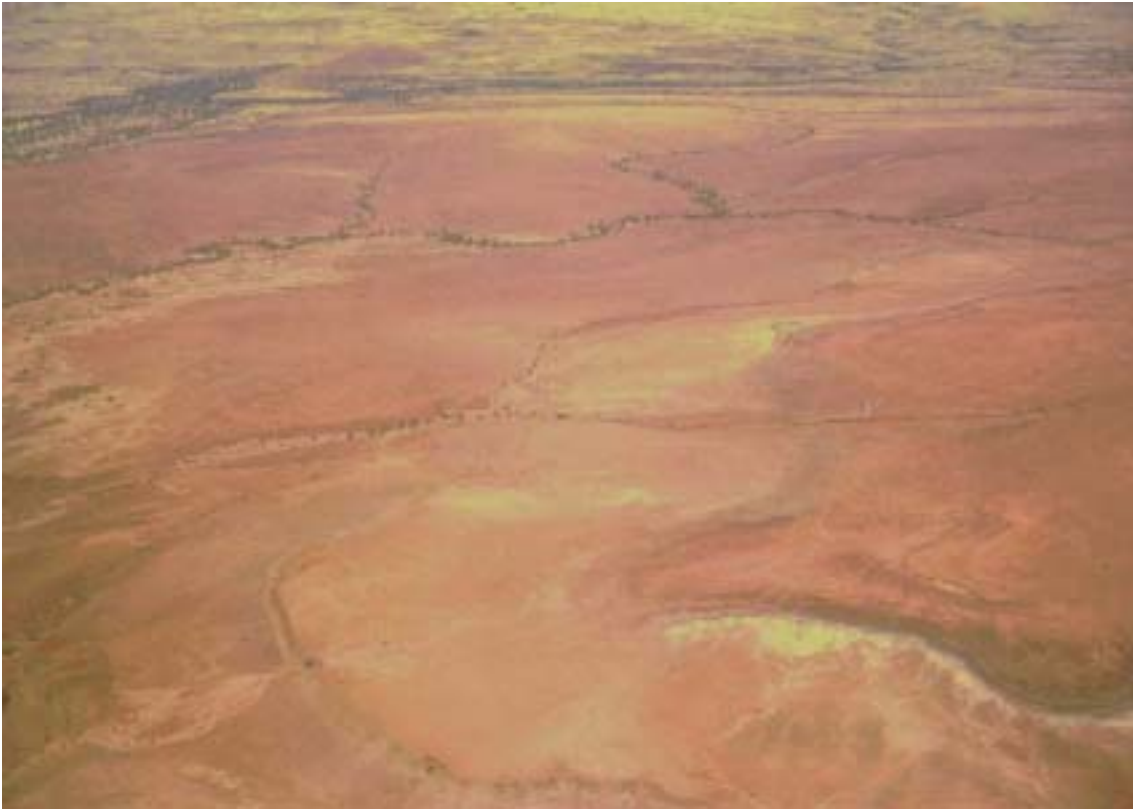
**Photo 8. Bare red ridges and slopes of the Nelson land system. August 1963.**

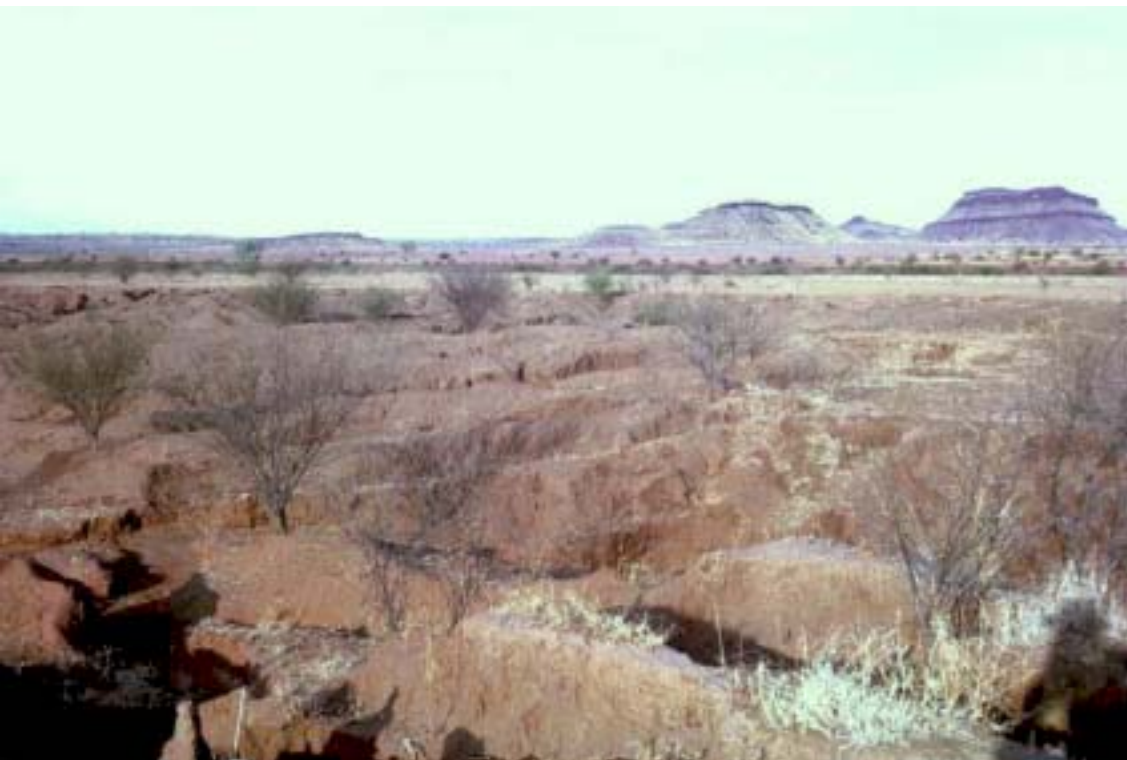
**Photo 9. Active gully erosion on alluvial frontage plains of the Ord River with White Mountain Range in the background. October 1963.**

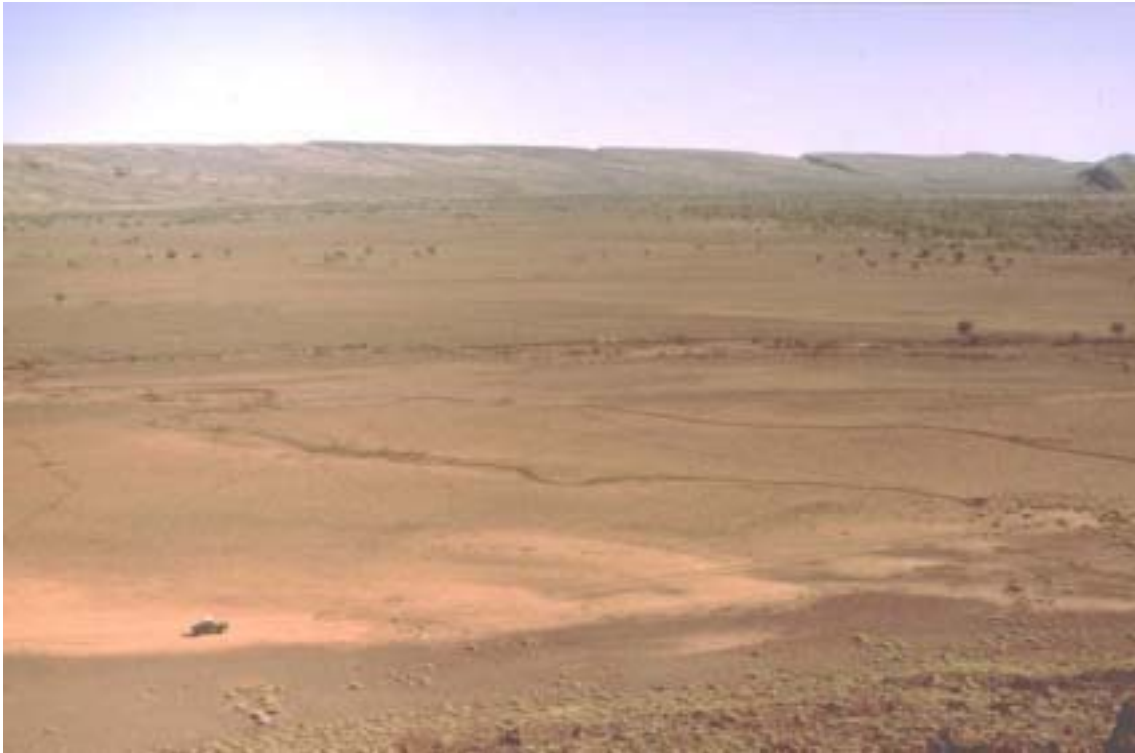
**Photo 10. Bare and eroding plains of the Gordon land system in the Elvire River valley. Originally part of Flora Valley Station, now Fox River Station. July 1964.**

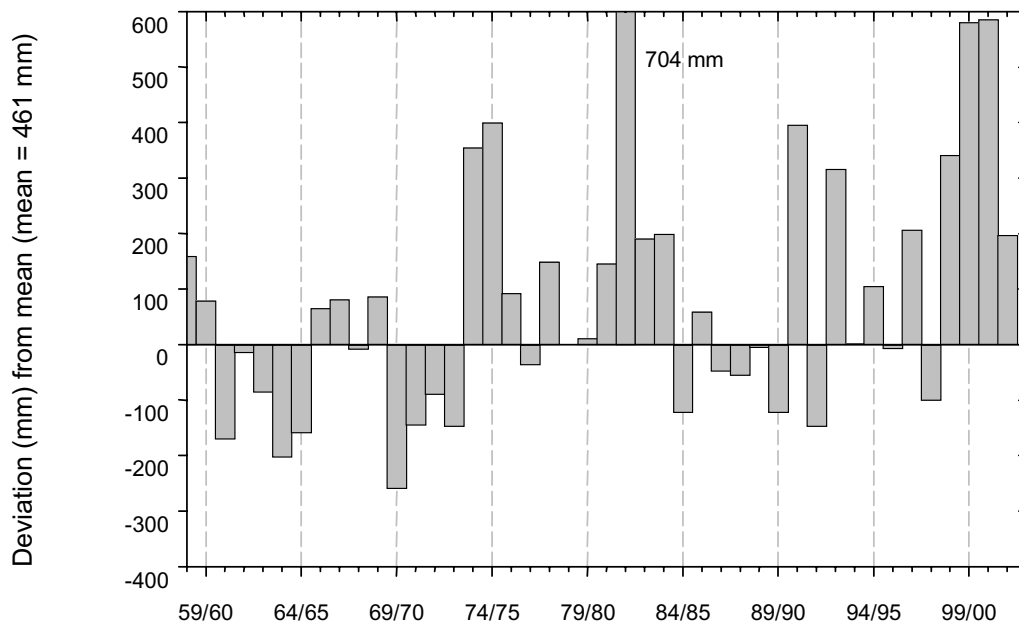
Figures 2 and 3 show the annual deviations from the mean rainfall at ORRR depot and Fox River Station since 1959/60. In general, the early years of the project were characterised by below average seasons but runs of very good seasons occurred from the mid-1970s to the early 1980s and also during the 1990s from 1992/93 onwards.

**Figure 3. Annual (July to June) rainfall deviation from long term mean at Fox River Station (1959/60-2001/02).**

For most years of the last decade rainfall on the Reserve has been well above the average (see Figures 2 and 3), a situation which was a major driver of the observed changes. As the plant communities on the Reserve are now dominated by long-lived perennial species, a return to a more normal rainfall pattern is unlikely to reverse the recent trends in the condition of the soils and vegetation in the Reserve.

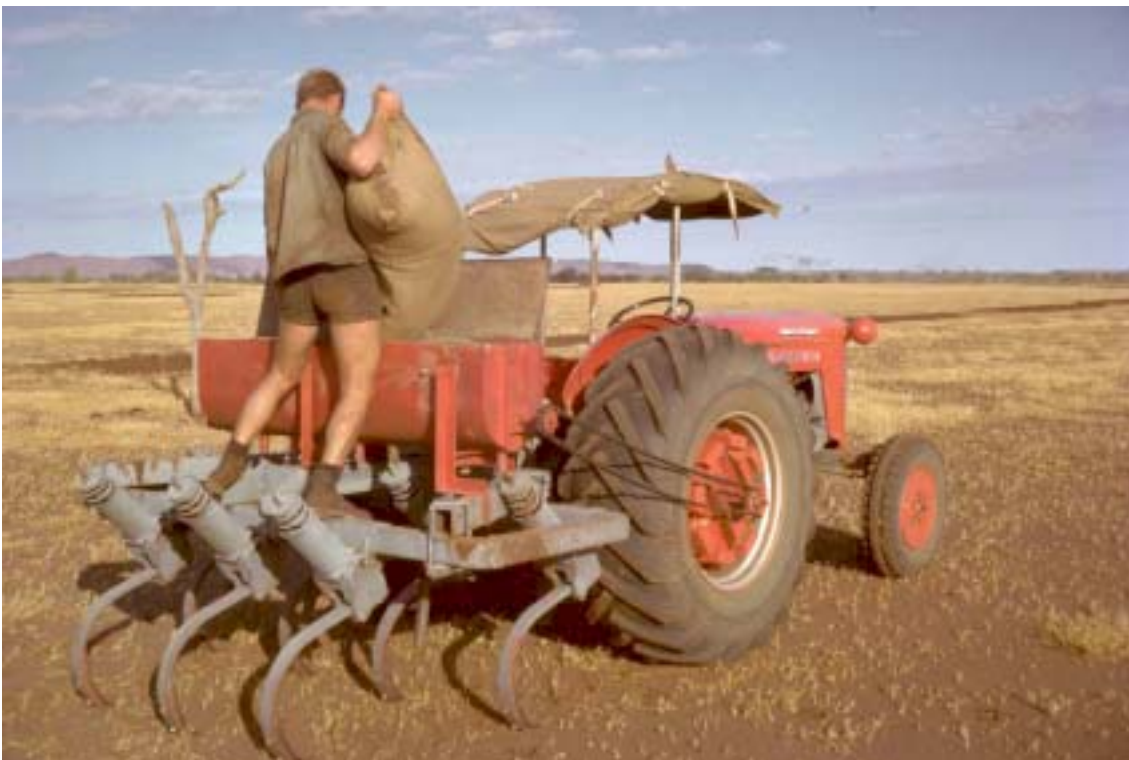
**Photo 12. Contour strip cultivation and seeding with light equipment began in the project area in 1960. This photograph, taken in February 1965, shows a three point linkage mounted chisel plough and chain driven seed box. Seed mixtures were usually buffel and Birdwood grasses and kapok bush.**

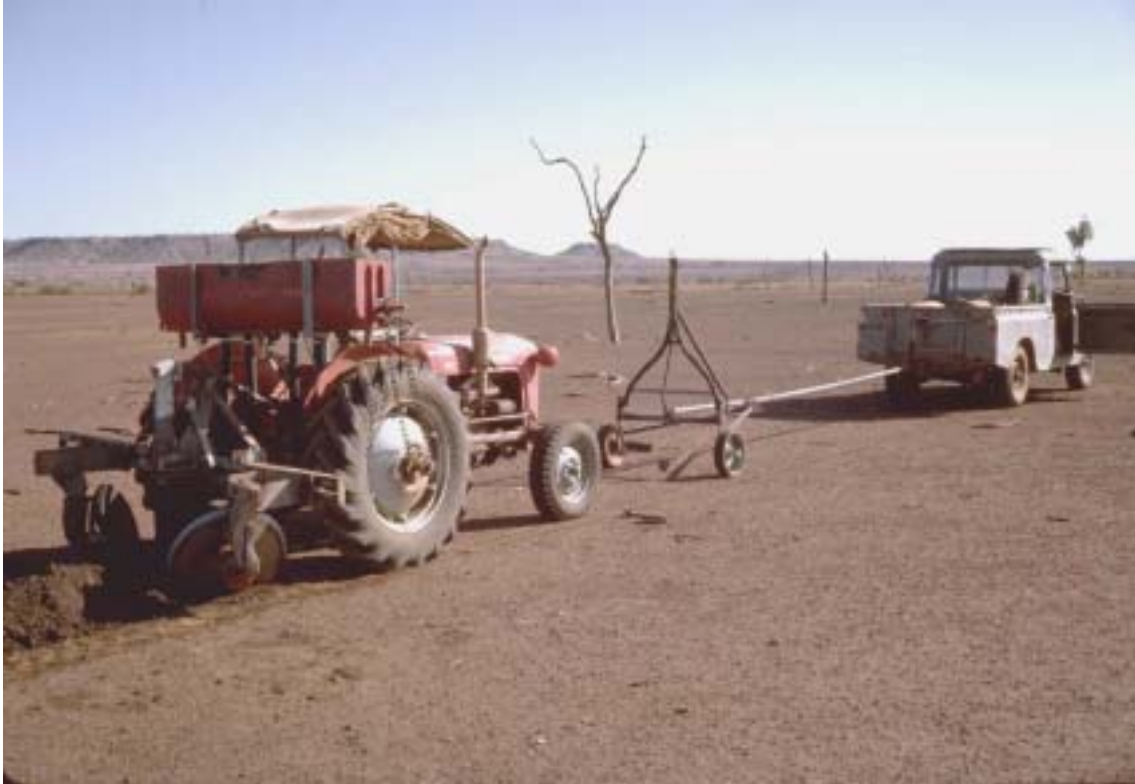
**Photo 13. A tractor equipped with a twin opposed disc plough and centrally mounted ripper is following a mobile hose level which is marking the contour line. June 1964.**

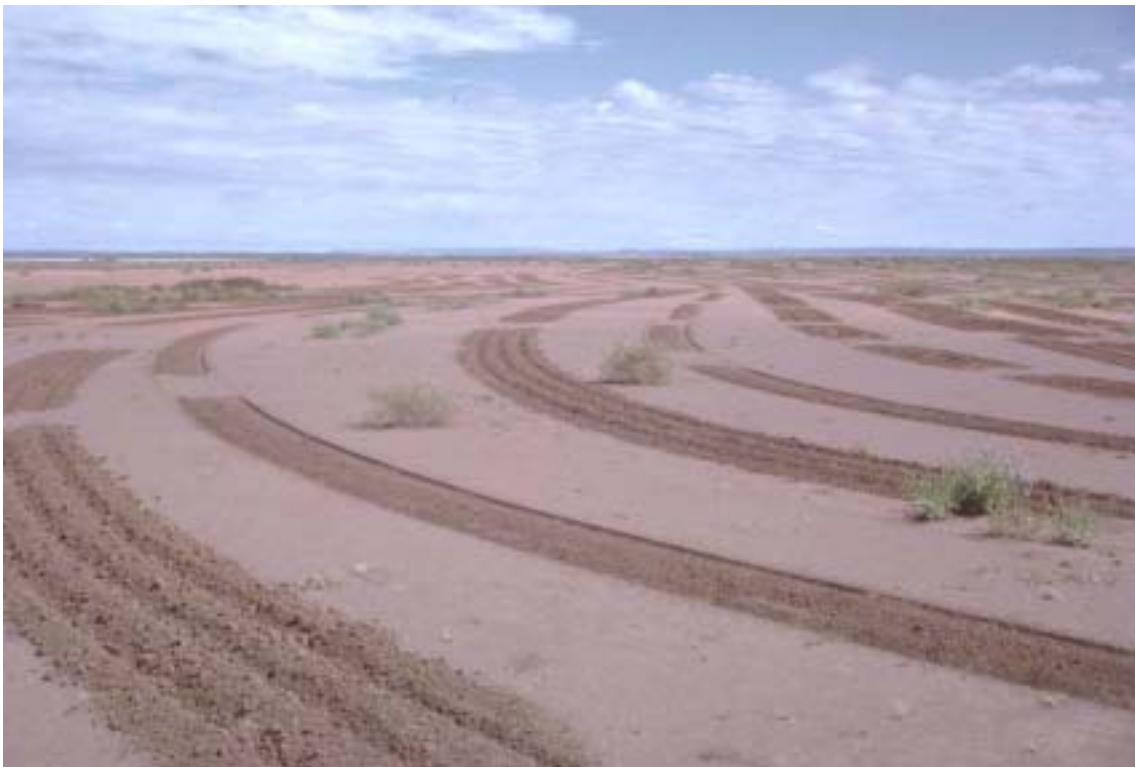
**Photo 14. Discontinuous, strip contour cultivations on a degraded plain of the Nelson land system. Additional cultivations between these original workings were frequently undertaken in subsequent years. June 1962.**

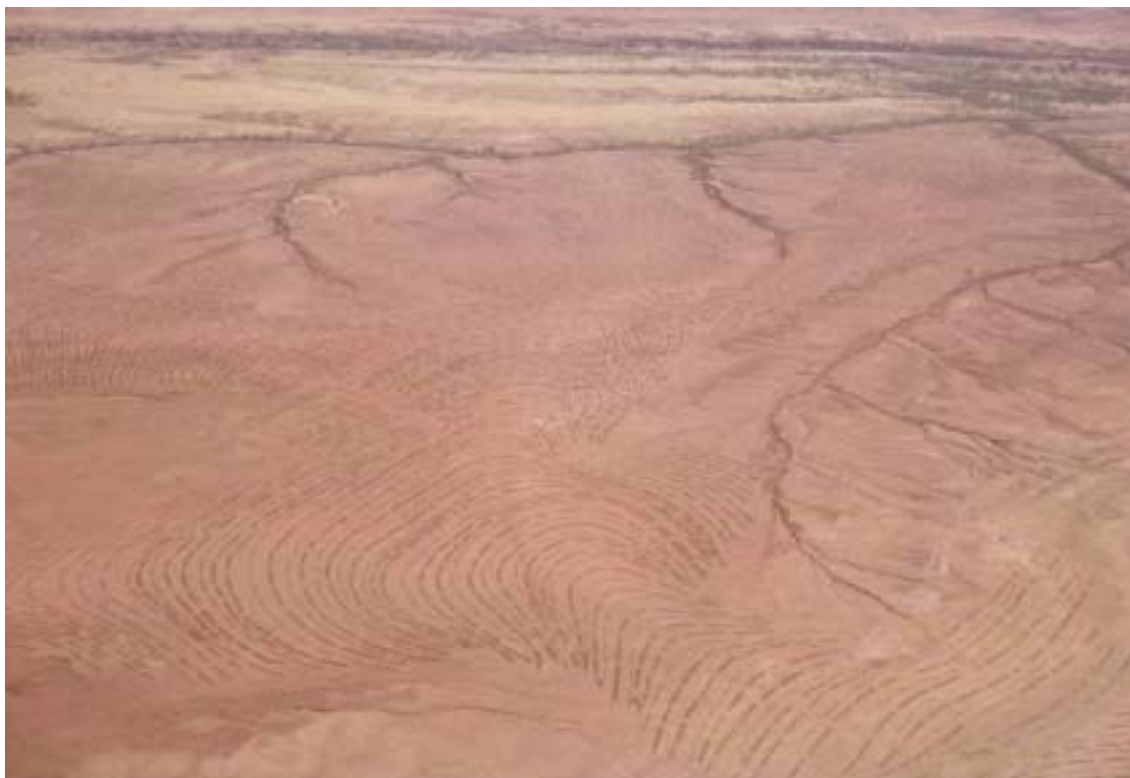
**Photo 15.** This aerial view, taken in July 1963, shows the patterns of cultivation on the broad, bare interfluves between the gullies and creek lines of the Nelson land system.

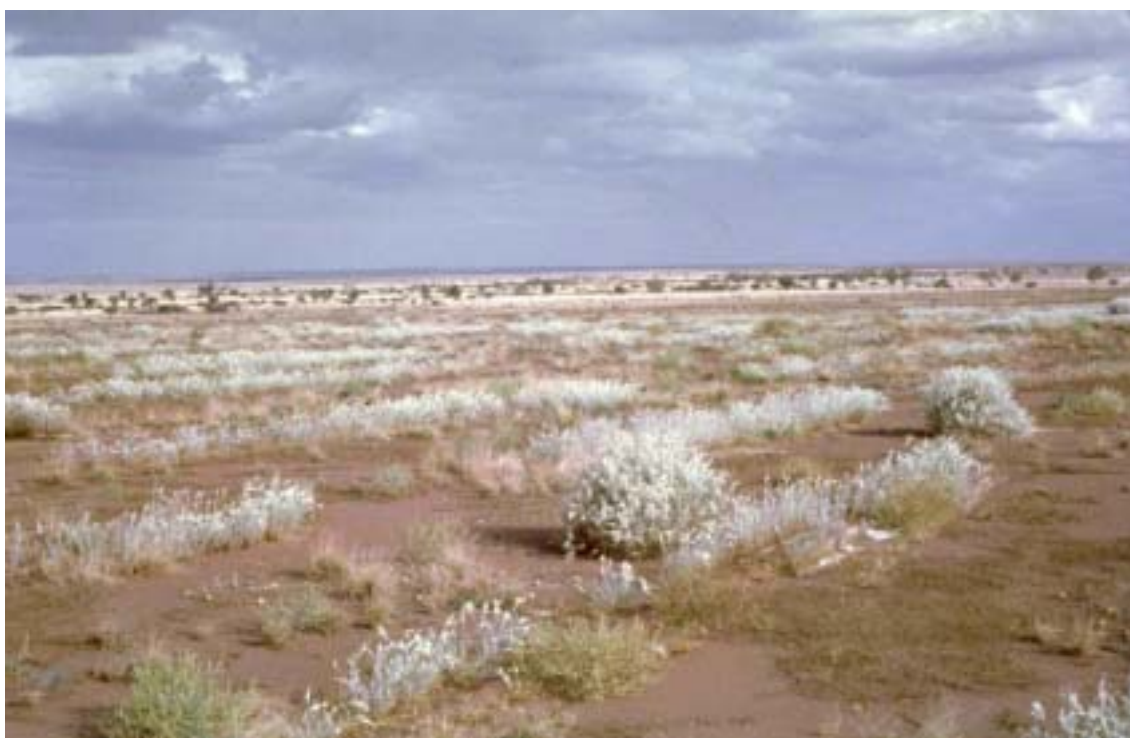
**Photo 16.** The introduced kapok bush proved to be an excellent primary coloniser in the early years of the project. This photograph, taken in 1965, shows young stands of kapok bush and grasses established along cultivation lines.

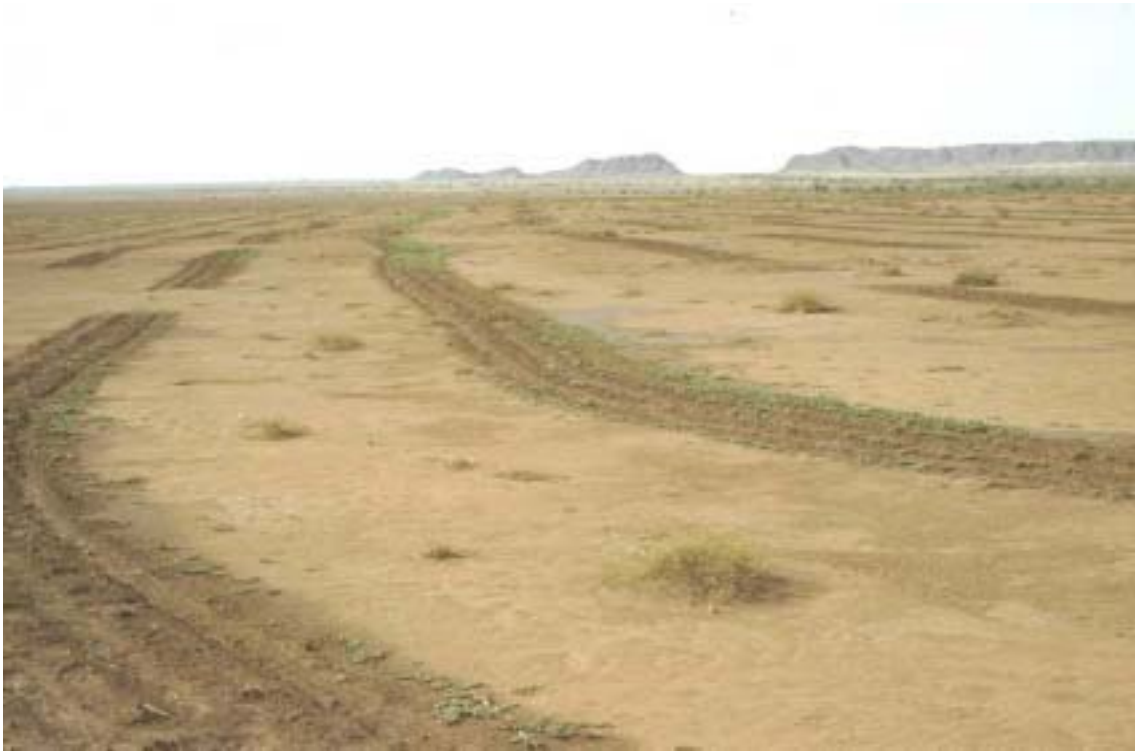
**Photo 17. Chisel plough workings after light rain, Turner Plains early 1960s.**

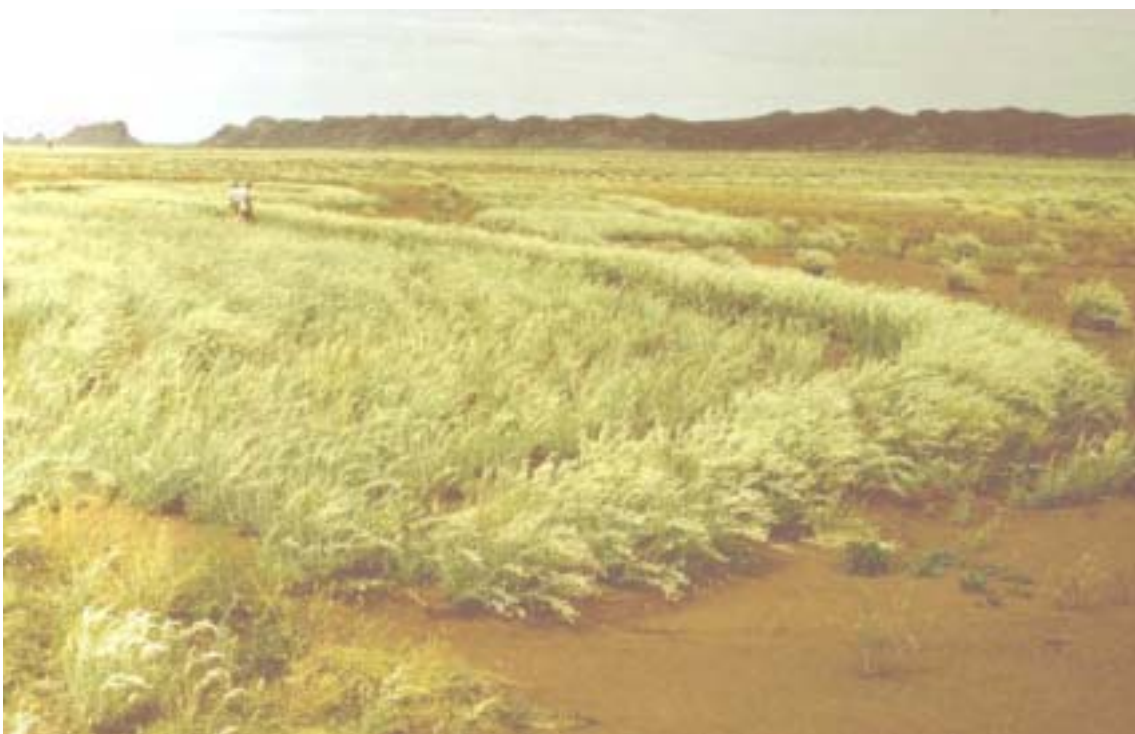
**Photo 18. This dense stand of kapok bush was established on banks and in ponded areas on Turner Plains by April 1966. Large quantities of seed were collected by hand from these areas for use elsewhere in the project.**

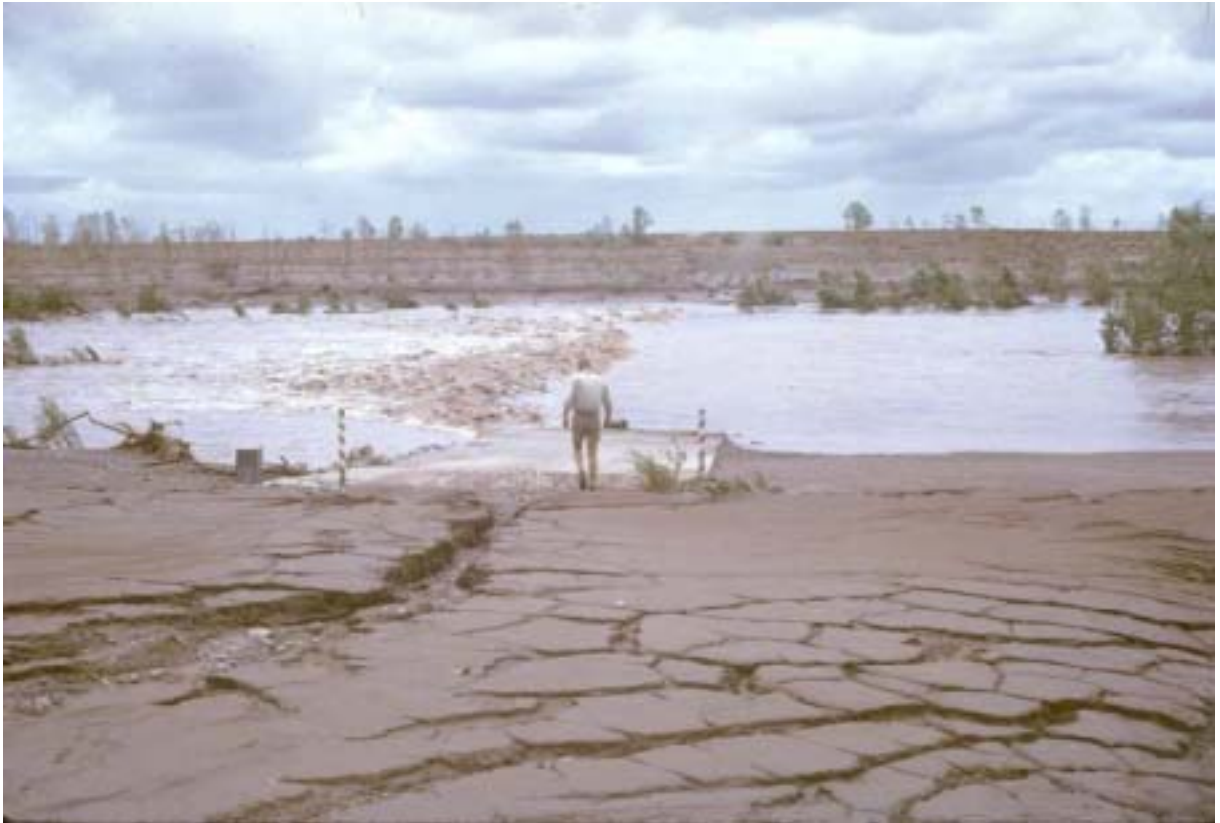
**Photo 33. Duncan Road crossing on the Negri River showing large amounts of sediment deposited on the crossing by the river. May 1963.**

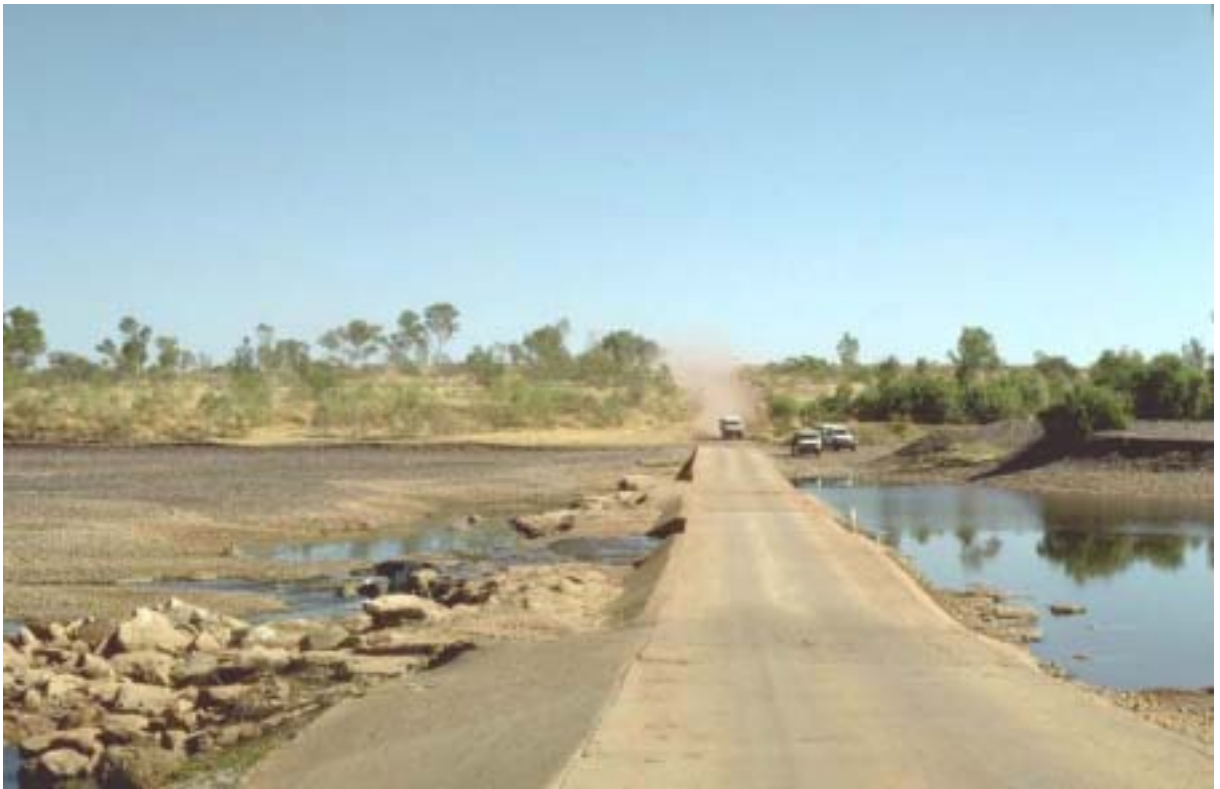
**Photo 34. Duncan Road crossing on the Negri River, August 2002. The vigour of the eucalypt trees on the far bank of the river has improved considerably since 1963.**

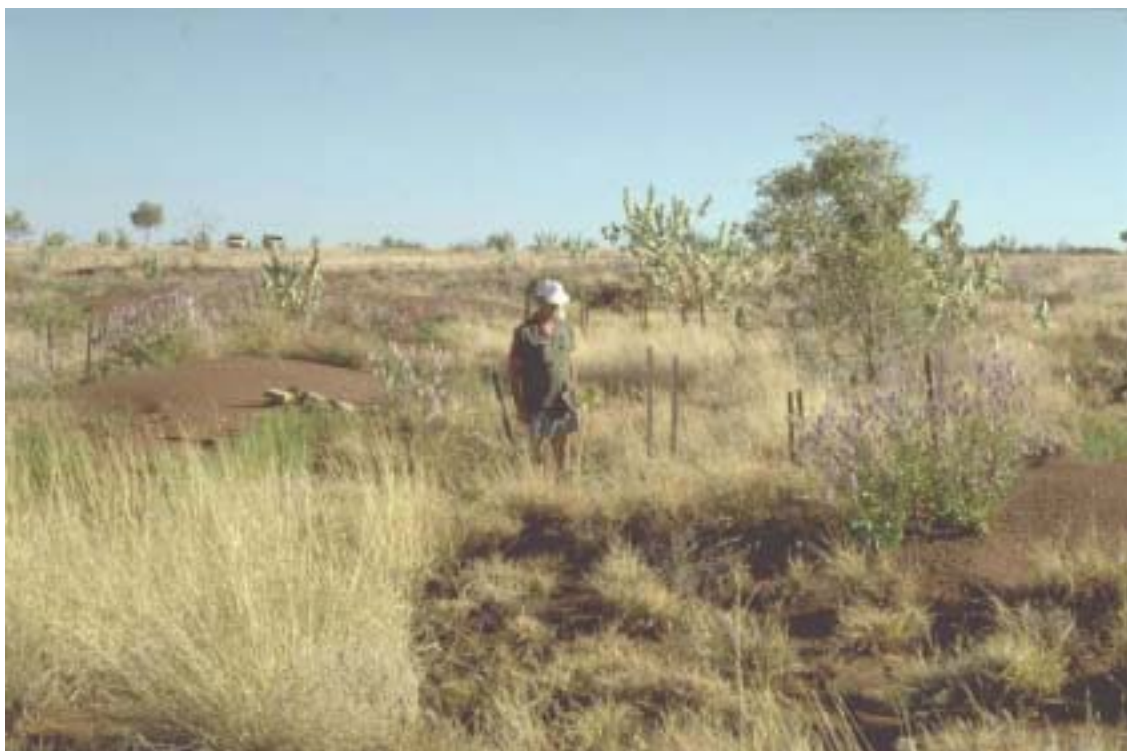
**Photo 35. Gully control test area on the lower slopes of the Nelson land system. August 2002.**

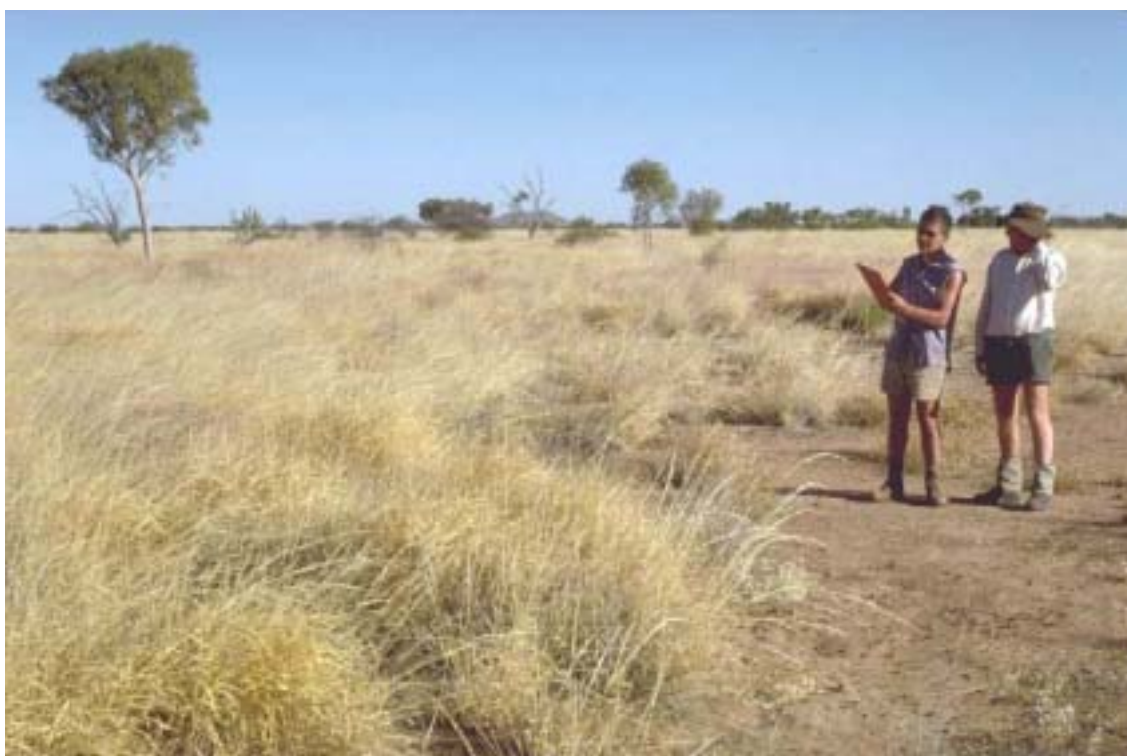
**Photo 36. Revegetation on a ponded scald on the Gordon land system, Fox River Station. August 2002.**

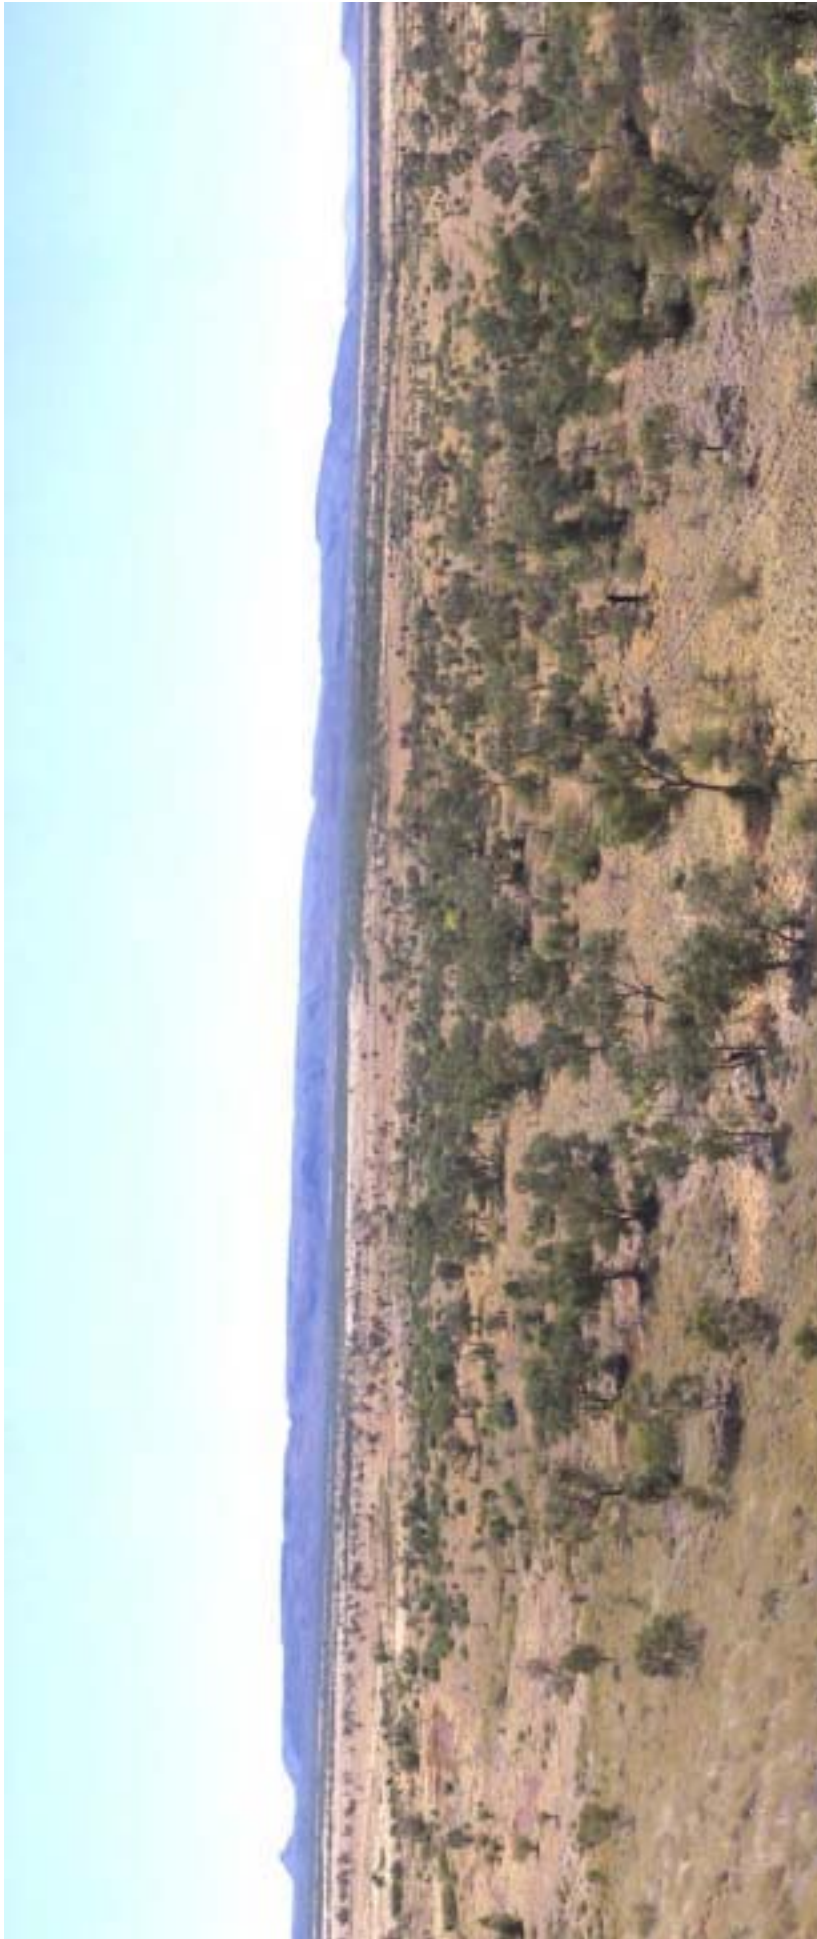
**Photo 39.** The Elvire River valley (Fox River Station) has regenerated remarkably in the last 20 years. This view, from near Stallion Yard, was taken in August 2002. In the 1970s light aircraft were able to land on scalded flats then in the left of the photo.
