# Lake Argyle sedimentation - 2006 survey

**Salinity and land use  
impacts series**

Report no. SLUI 42  
January 2010

RNM Dixon, DW Palmer

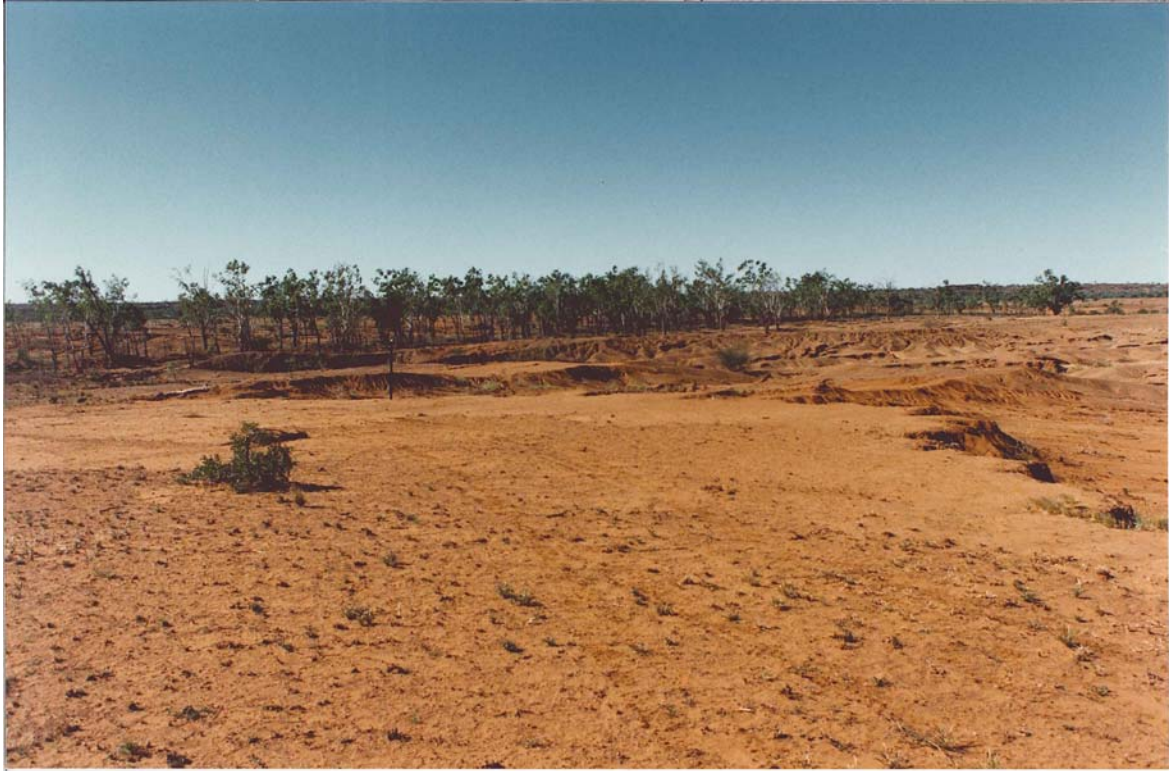
*Figure 8 Gully network on the floodplains of the Upper Ord River catchment at the time of the 1991 survey*

In August 2002 the Department of Agriculture did a field inspection of 32 sites of the Ord River Regeneration Reserve (Fig. 2) and found dense ground cover of introduced and native perennial grasses over large portions of the Reserve (Payne et al. 2004). Active soil erosion was rarely seen during the inspection but occasionally occurred on areas up to a few hundred metres in extent. Five sites were assessed as having slight or minor erosion. Twenty-seven sites had stable soil surfaces. The increased rainfall in the last decade has contributed to the dominance of long-lived perennial species. A return to average rainfall patterns is not likely to reverse the condition of the soils and vegetation in the Reserve (Payne et al. 2004). An example of a gully network is shown in Figure 8.

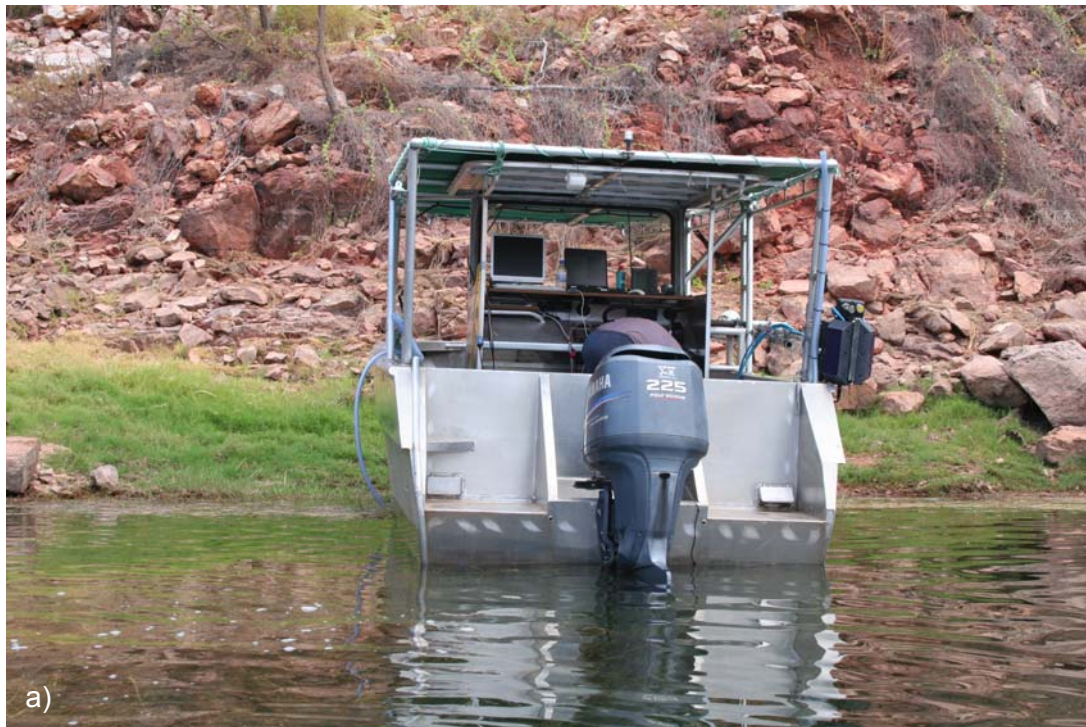
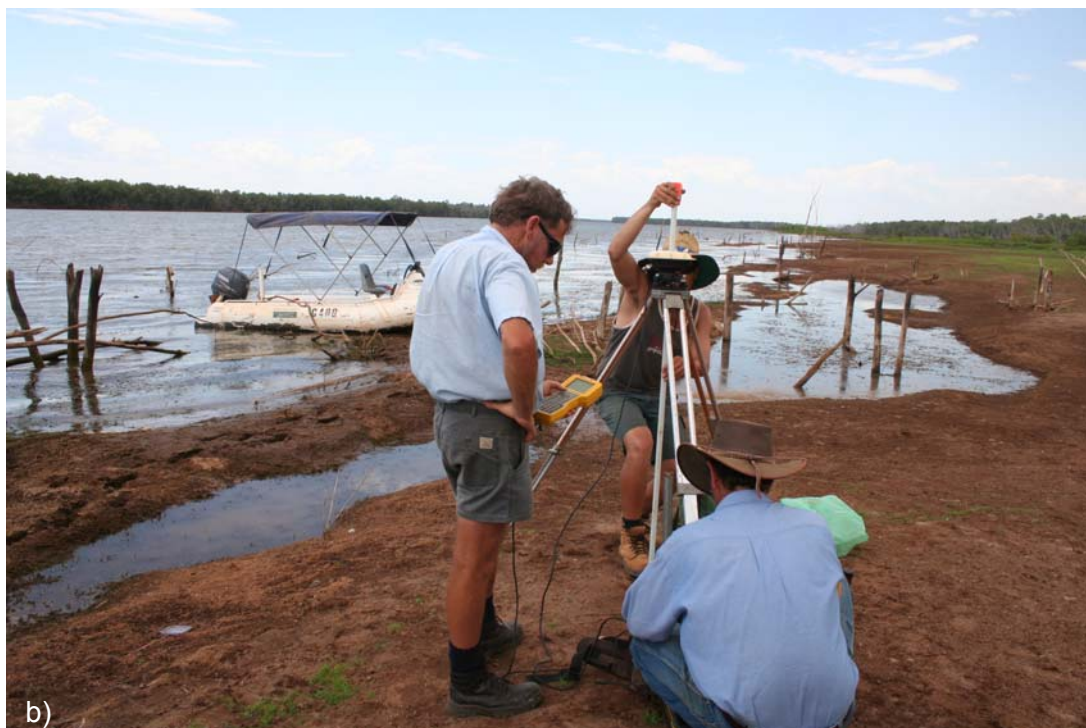
Figure 9 (a) Survey boat with hydrographic survey equipment (b) Land survey of historical cross section 7, facing north, taken on 26 October 2006

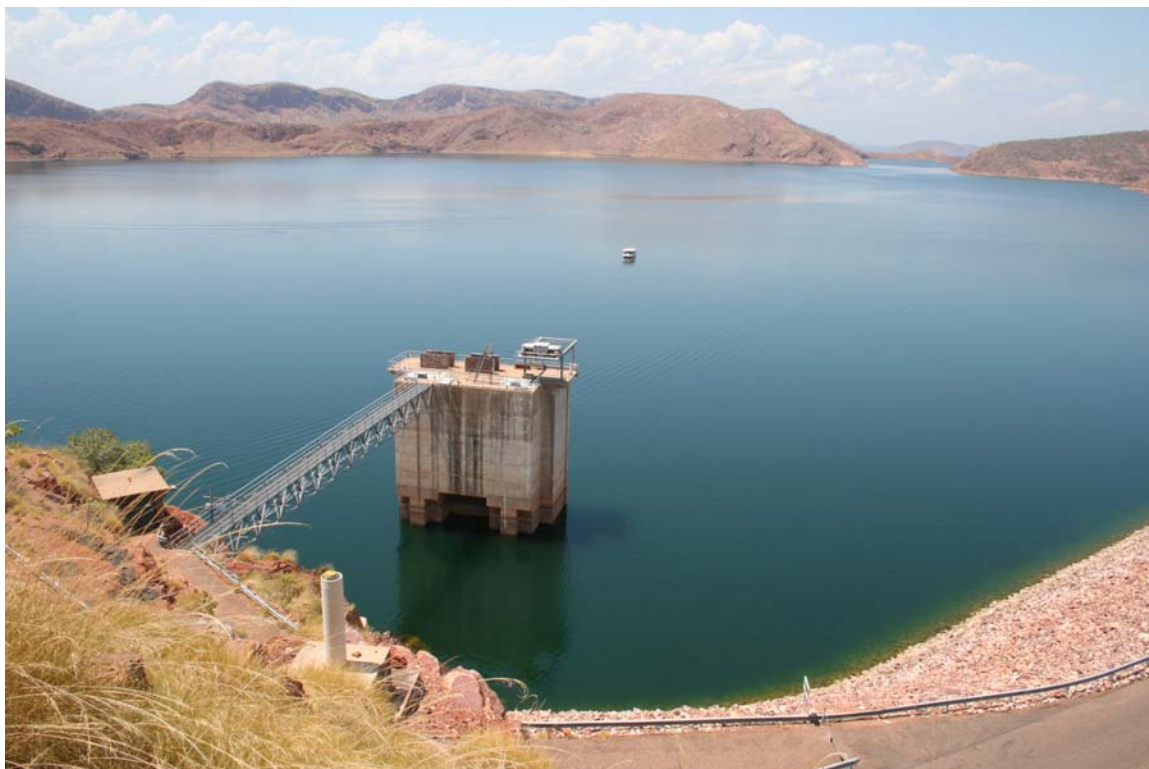
*Figure 10 Lake Argyle near the Ord Dam, 26 October 2006*

The 2006 survey had two tide recorders 60 km apart to measure the water levels in Lake Argyle. These levels were measured to work out the elevations of the sounded depths which were referenced from the surface of the lake (Fig. 10). There was a water level anomaly of 300 mm between the two recorders. Whelans' GPS baselines and data were rechecked and reprocessed and produced identical results and miscloses the second time (Appendix A).

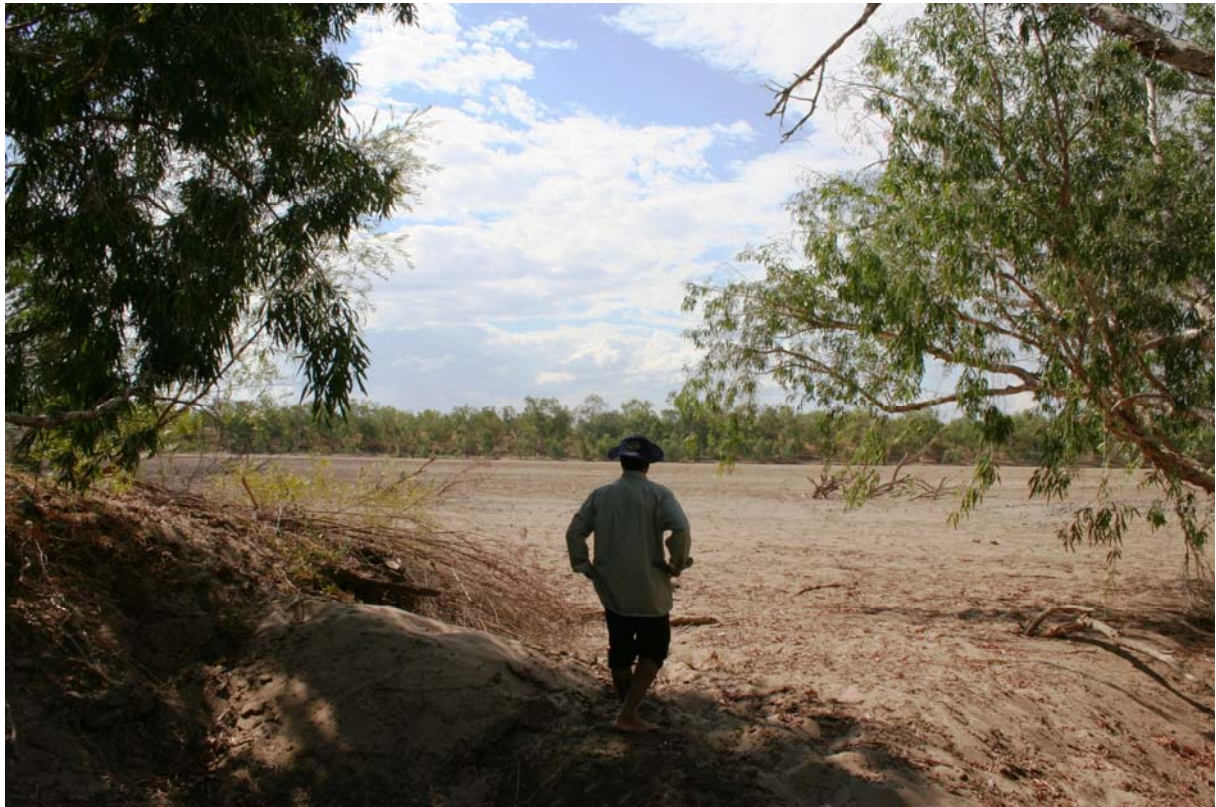
*Figure 14 Sediment at Bow River, 8 km from the confluence of the Bow and Ord rivers*

Section 9 intersects the Bow River at 10.8 km from the confluence of the Bow and Ord rivers. Some sediment was not captured for the final 2.8 km of the Bow River. The boat could only reach to 8 km from the confluence at the time of the 2005 hydrographic survey (Fig. 14). The flood waters that enter the lake must be very high and turbulent. See the evidence in Figure 15. Note the flood debris 6 m high in the trees and the fallen tree in the photograph taken on 26 October 2006.

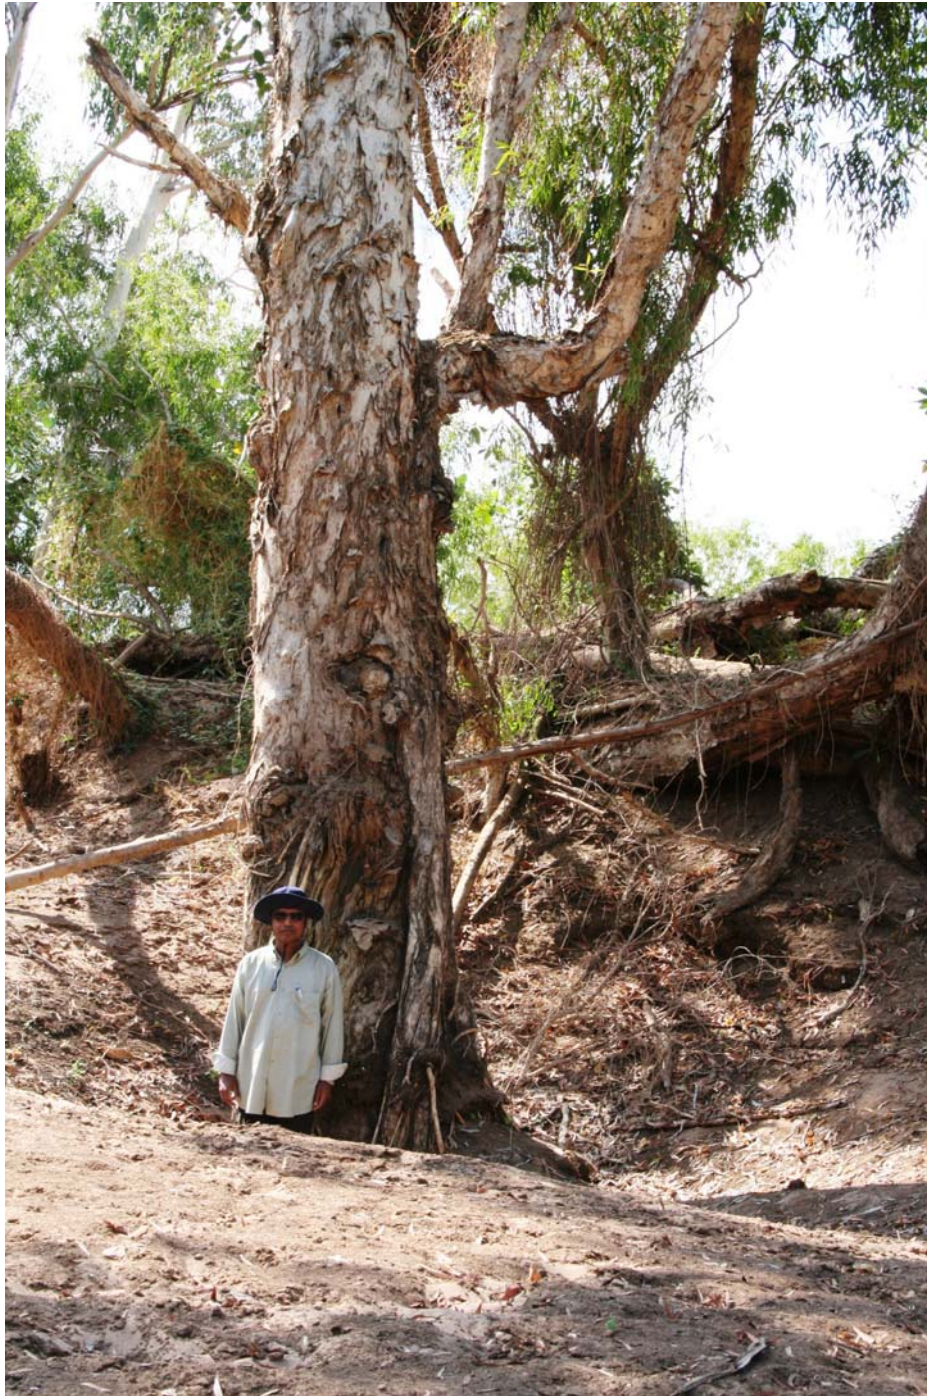
*Figure 15 Evidence of the power of the approximate 6-m flood waters in the Bow River 8 km from the confluence of the Ord and Bow rivers*

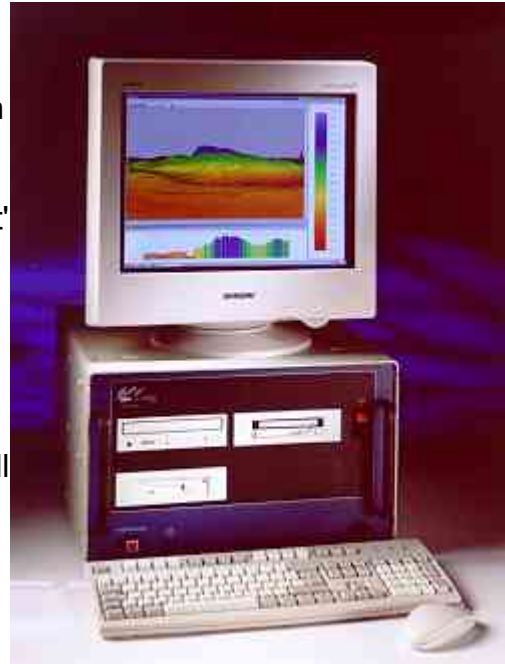
The GeoSwath real-time swath bathymetry features include calibration, test and diagnostic software. The post processing/QA software includes calibration functions that calculate static factors, ray bending and speed of sound corrections. Depth and contour graphics can be output in a range of file formats including ASCII, HPGL and DXF for use in proprietary CAD packages and customer's software.

The GeoSwath swath bathymetry system is easily portable and can be deployed using an overside mount on vessels of opportunity or a hull mount for more permanent installations. In common with other GeoAcoustics products GeoSwath is modular allowing users to utilise existing equipment such as motion sensors and positioning systems.

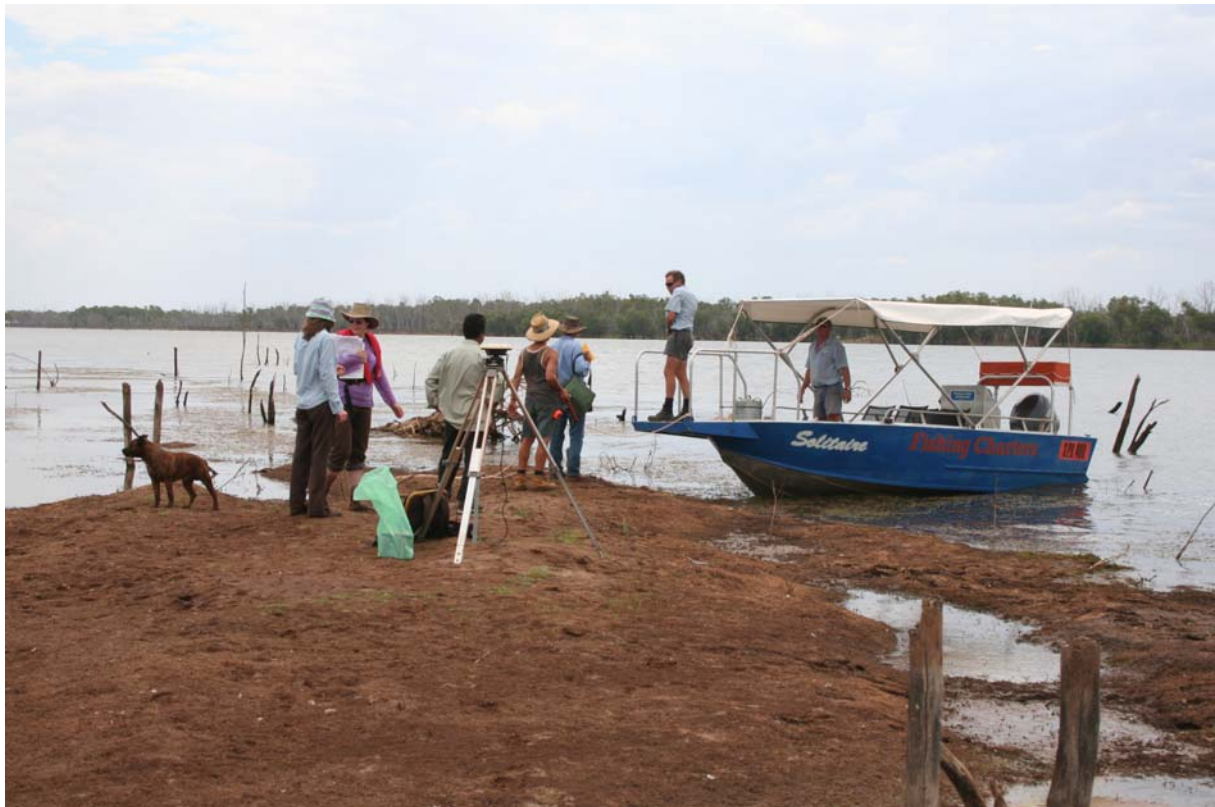
Figure 27 Land survey of Section 14: facing south
