SERPENTINE RIVER MANAGEMENT PLAN

STAGE 1 - GOEGRUP LAKE TO BARRAGUP BRIDGE

WATER AND RIVERS COMMISSION REPORT WRM 12

A report to the Peel Inlet Management Authority
from the Serpentine River Working Group

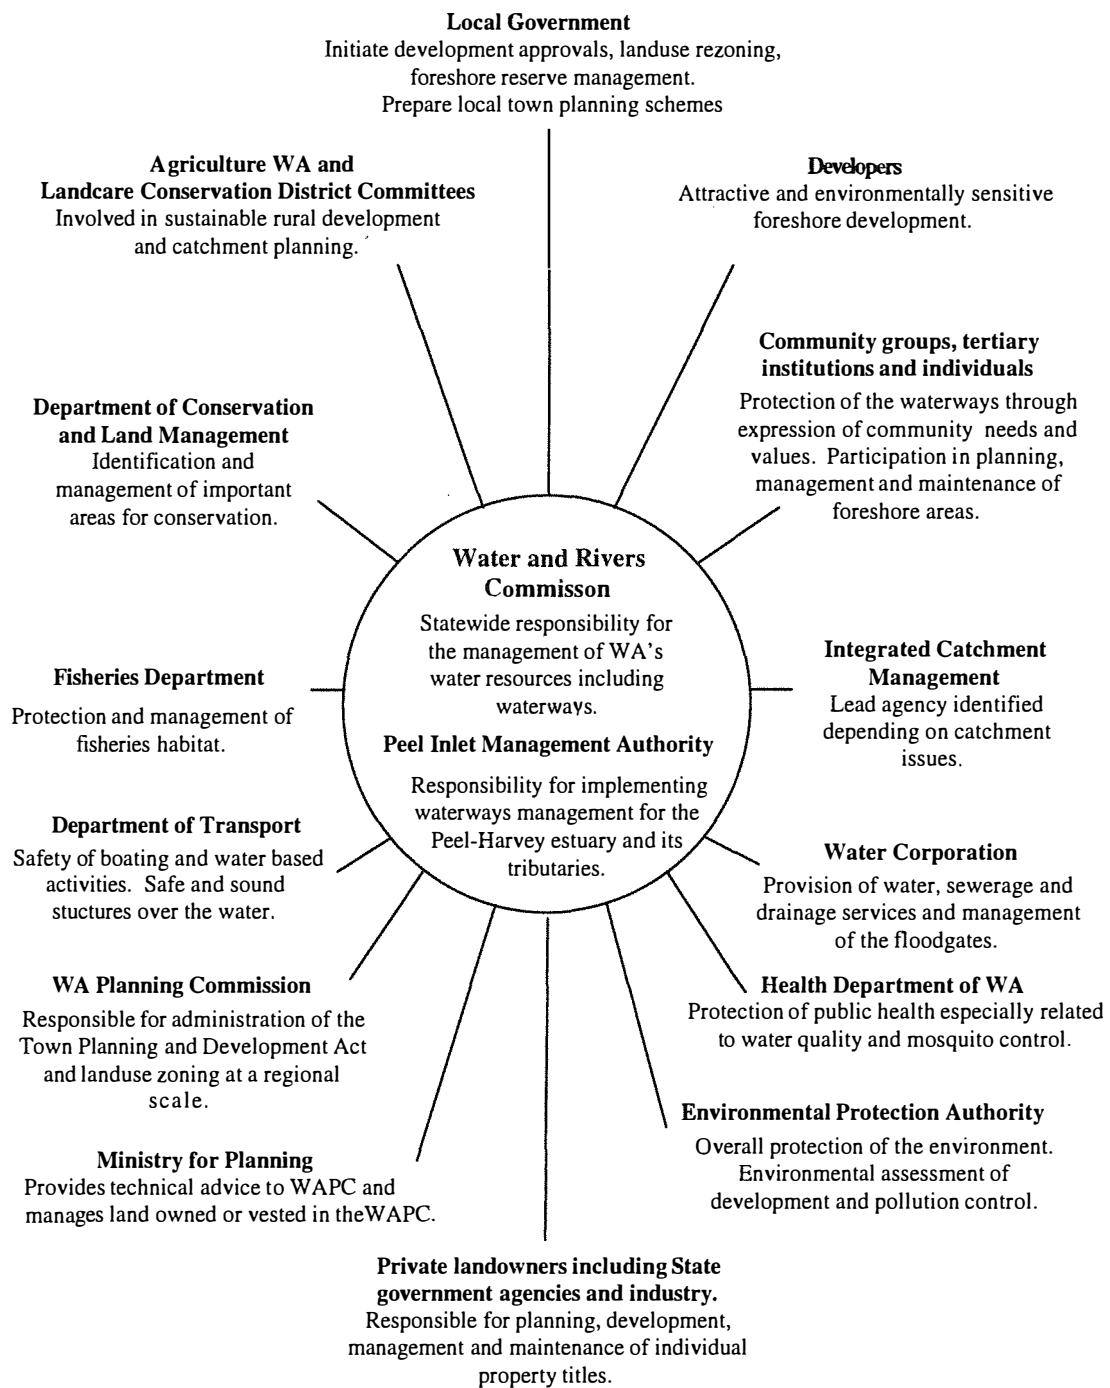
Figure 1. The role of WRC and PIMA in relation to other organisations and groups in waterways planning and management.
