# GWAMBYGINE POOL MANAGEMENT PLAN

# AVON RIVER MANAGEMENT AUTHORITY GWAMBYGINE POOL MANAGEMENT PLAN

Prepared by  
Viv Read & Associates

WATER AND RIVERS COMMISSION  
WATER RESOURCE MANAGEMENT SERIES  
REPORT NO WRM 27  
NOVEMBER 2001

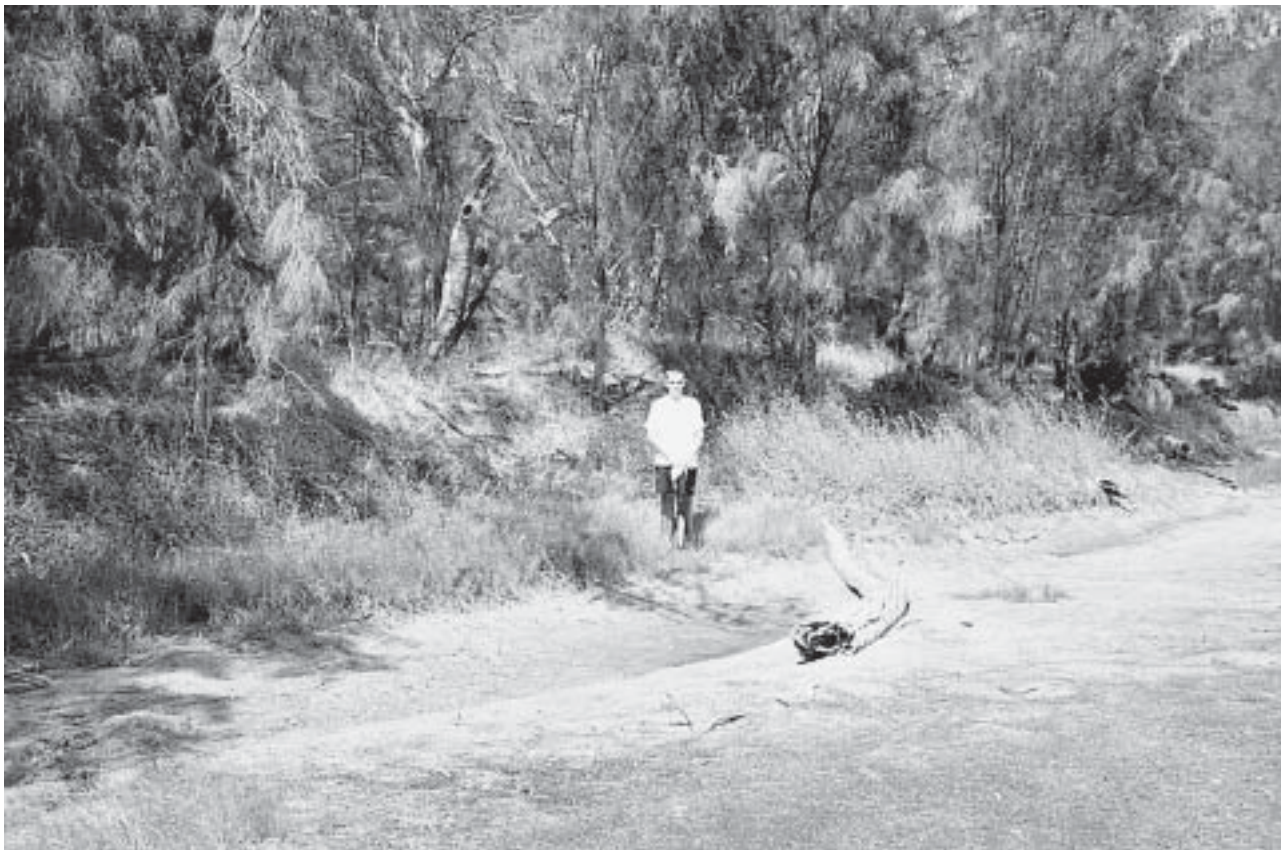
Photo 2: Spoil banks remaining from the River Training Scheme.

Disturbance of the river bed upstream of Northam by the RTS during the 1965–1969 period caused channelisation that significantly increased stream flow velocity. Because the channel bed was ripped to encourage scouring, the

exposed river banks began to erode. Bank erosion is greatest during high flow when more of the banks are in contact with stream flow. The river has adequate power to transport coarse sediments into the pools but inadequate power to excavate the sediments from the pools.

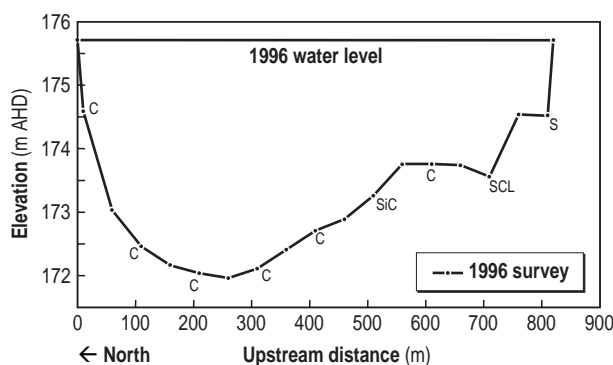
Figure 2.1: Gwambygine Pool Bed Elevation (from JDA, 1997)

Gwambygine Pool is 1109 metres long (without sediment infill) and 38 metres wide. The maximum depth measured in November 1996 was 3.75 m (JDA, 1997) but the water level then was 25 cm below the discharge channel invert so the maximum depth is 4 m. The depth of the pool decreases to a depth of 2.25 m at a distance 550 m from the outlet (Figure 2.1). The average depth is 2.43 m based on 18 measures at 50 m intervals along the length of the pool (JDA, 1997).

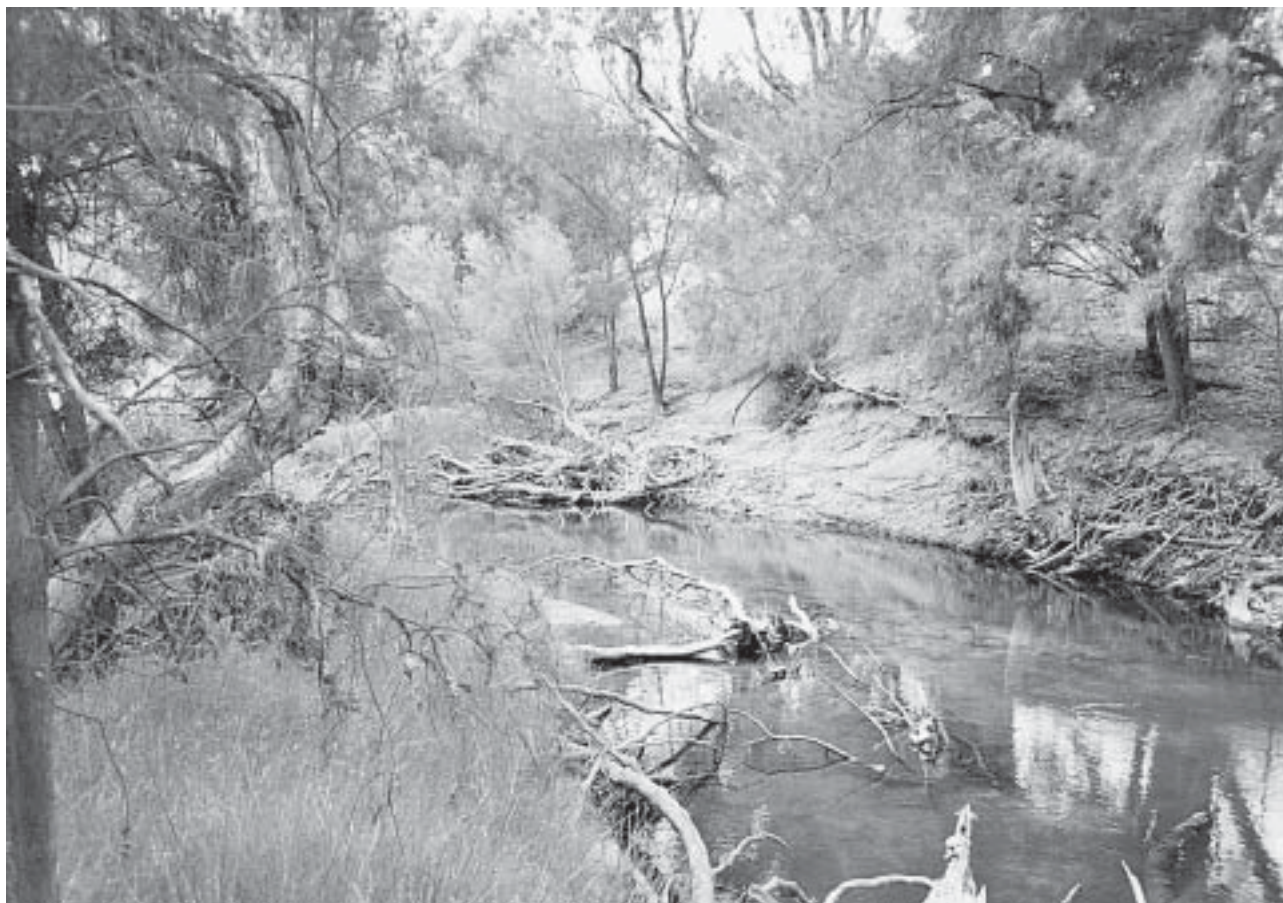
**Photo 3: Narrow channel at the southern end of the pool.**

Stream flow entry to Gwambygine Pool is through a narrow channel that causes increased stream velocity and hence increased bed load transport capacity. The narrow channel

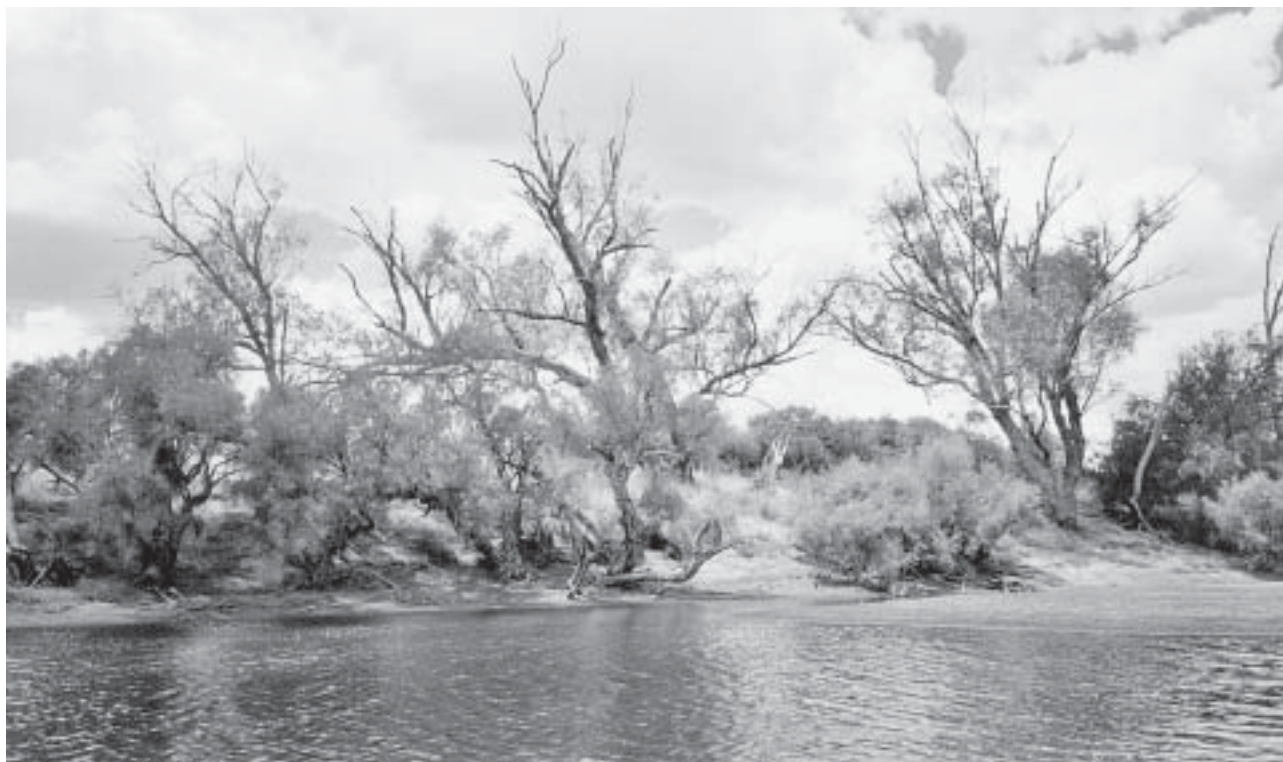
Photo 4: Degenerate *Eucalyptus rudis* on the east bank.

has three dominant species (Flooded Gum, *Eucalyptus rudis*, Sheoak, *Casuarina obesa* and Paperbark, *Melaleuca raphiophylla*) with no understorey species other than annual weeds. The Flooded Gums are not regenerating and in places are senescent or dead. The cause may be a rising regional groundwater table increasing salinity in the root zone. Flooded Gums are more susceptible to salinity than Sheoak. Some waterbirds and other fauna require these trees for roosting and nesting. The vegetation on this bank was classified (after Pen and Scott, 1995) as C1 (understorey with weeds only, no erosion) during the Avon River Survey in 1996. The RCS has listed understorey species that do occur in the fringing vegetation during botanical surveys. These include extensive halophyte flats below the exit of the pool, and behind the levees.

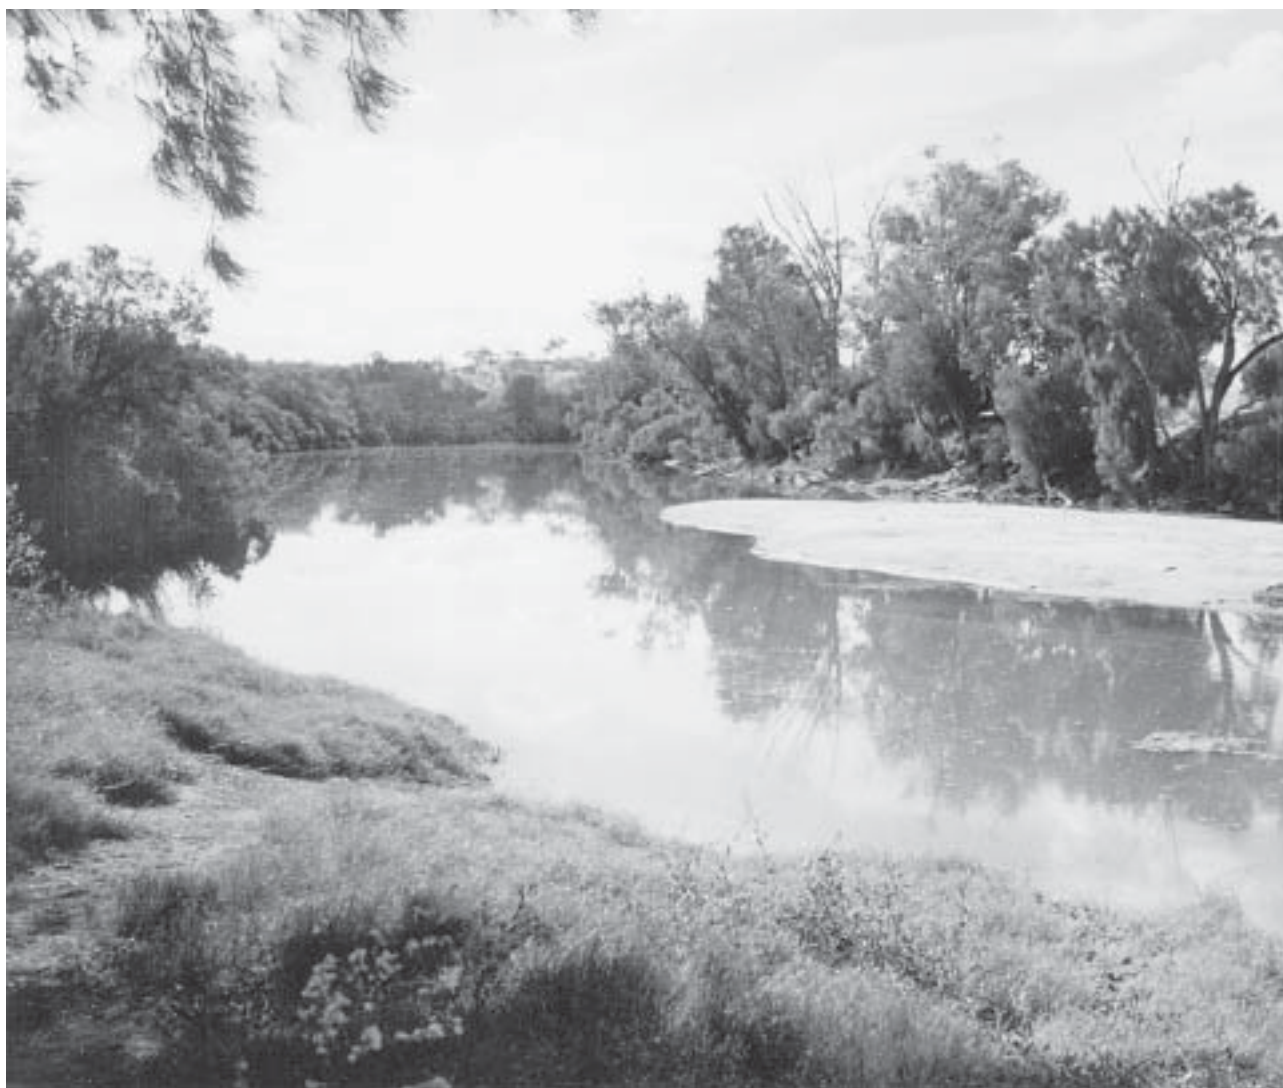
**Photo 8. Coarse sediment in the pool.**

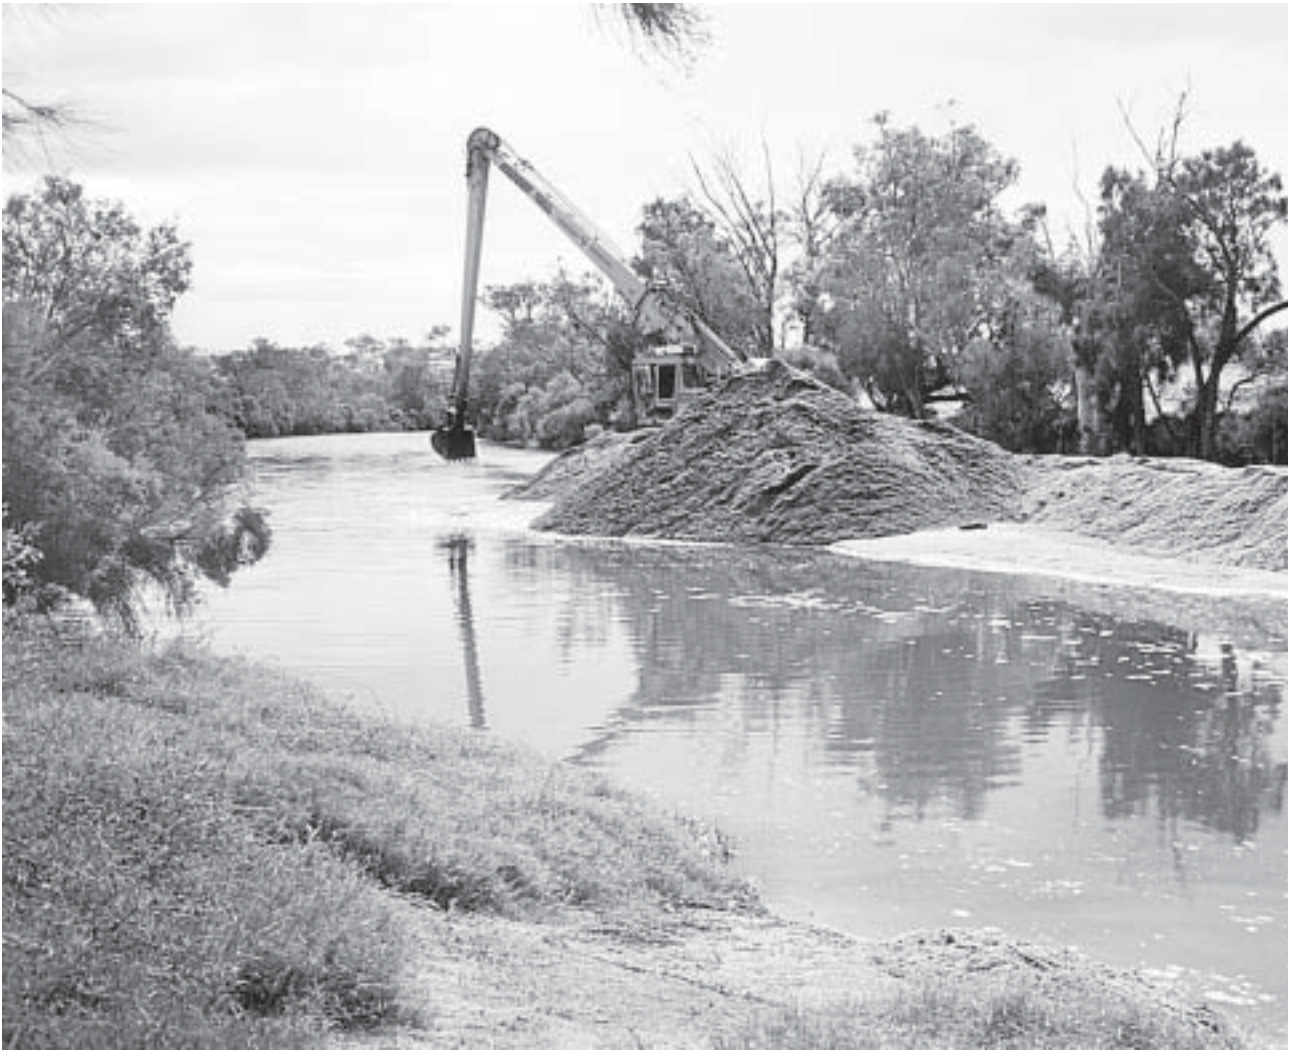
**Photo 9. Excavation of sediments from the pool.**

3. Remove sediment from the river bed.	Excavation during summer of potentially mobile sediments. This could cause some disturbance of partially stabilised areas. Costs could be similar to excavation of sediments from the pool.

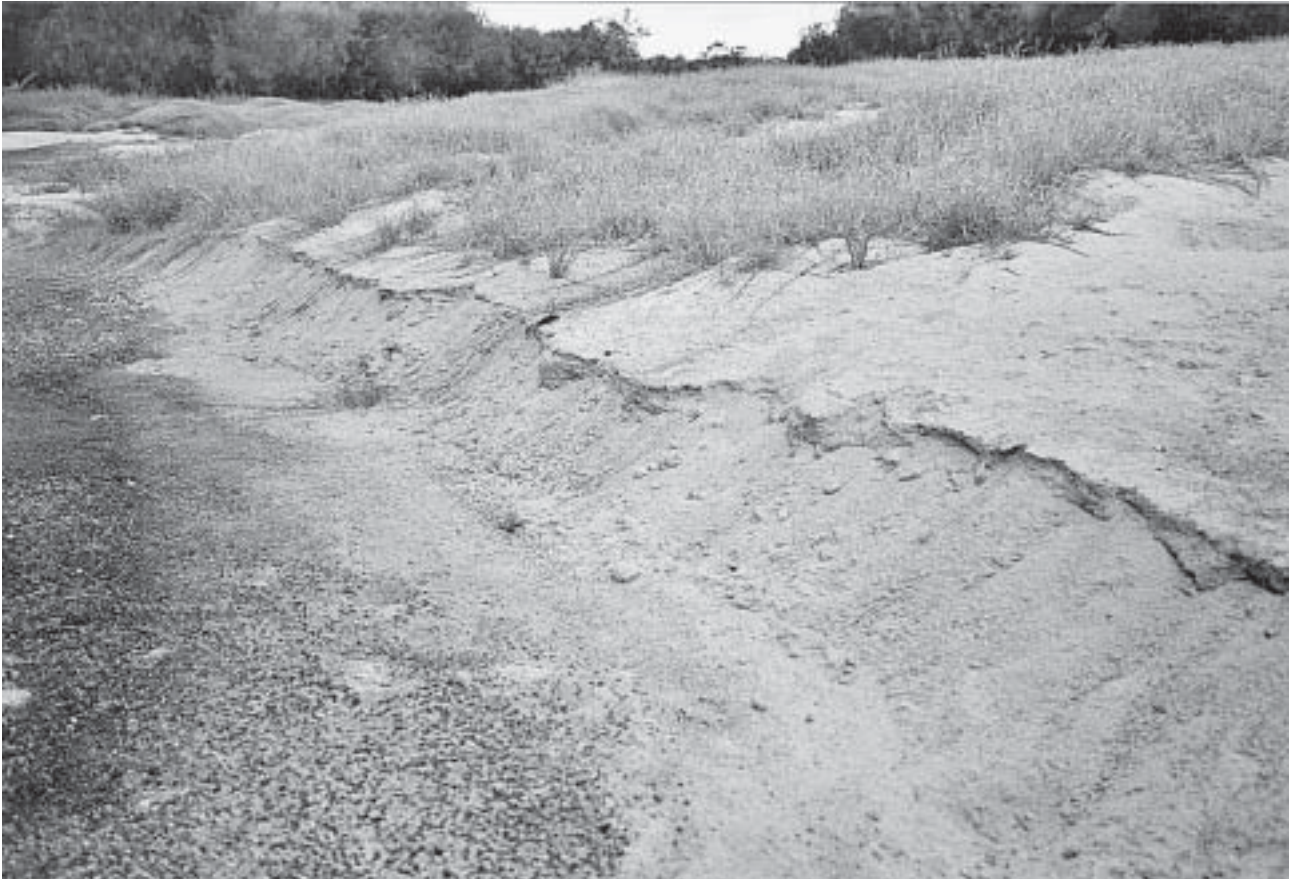
**Photo 10. Unconsolidated sediment upstream of the pool.**

Options	Comments
1. Increased natural revegetation of unconsolidated sediment.	Since exclusion of stock, salt water couch and <i>Frankenia</i> sp. colonise and stabilise some but not all sediment. Moisture status and salinity may determine the extent of colonisation. Disturbance by grazing, locusts, chemicals or fire in the river bed will destabilise the sediments.

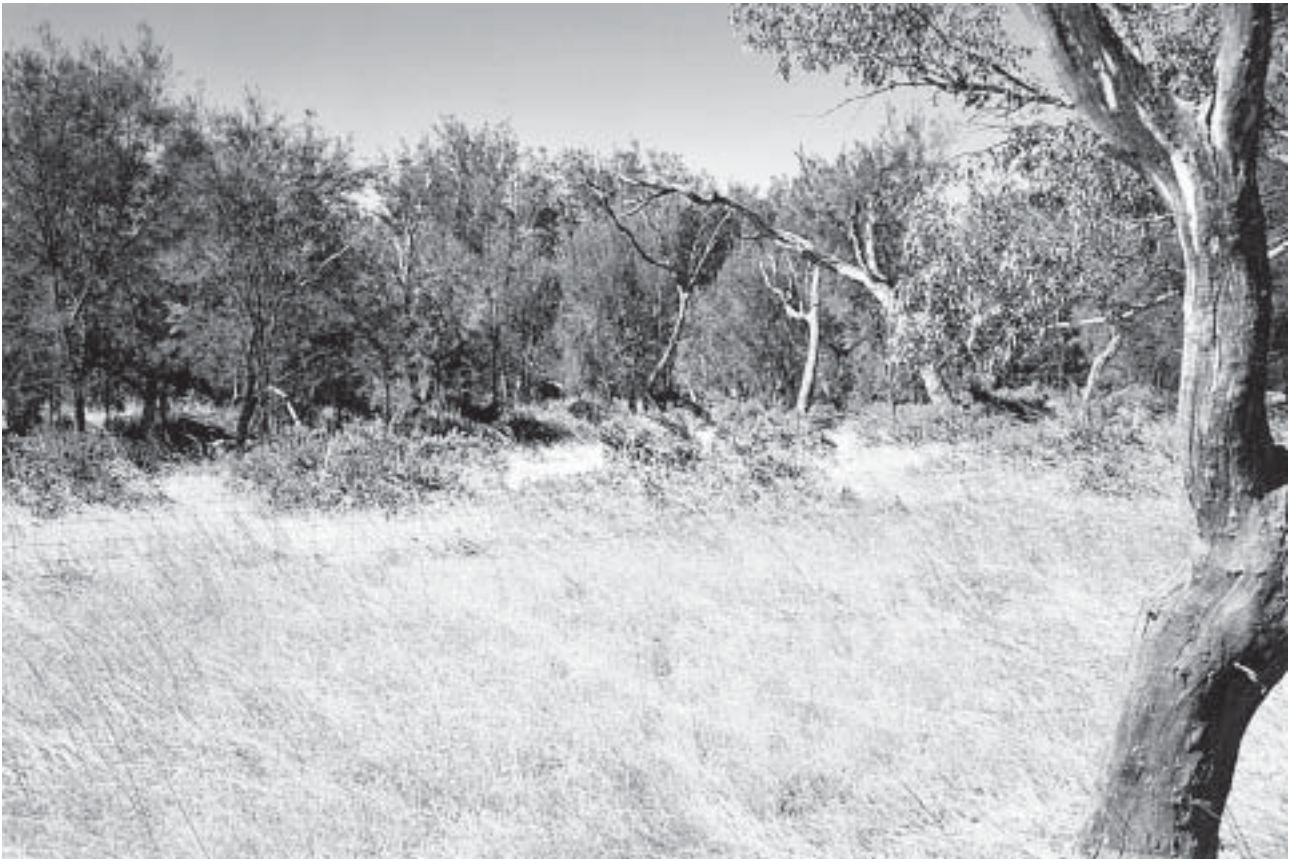
**Photo 11: Grazed and ungrazed (background) floodplain.**

Considering these issues, it is recommended that fencing for stock control in the riparian zone be continued and maintained. Any disturbance to the fragile revegetation process of unconsolidated sediments in the bed of the river is a risk.

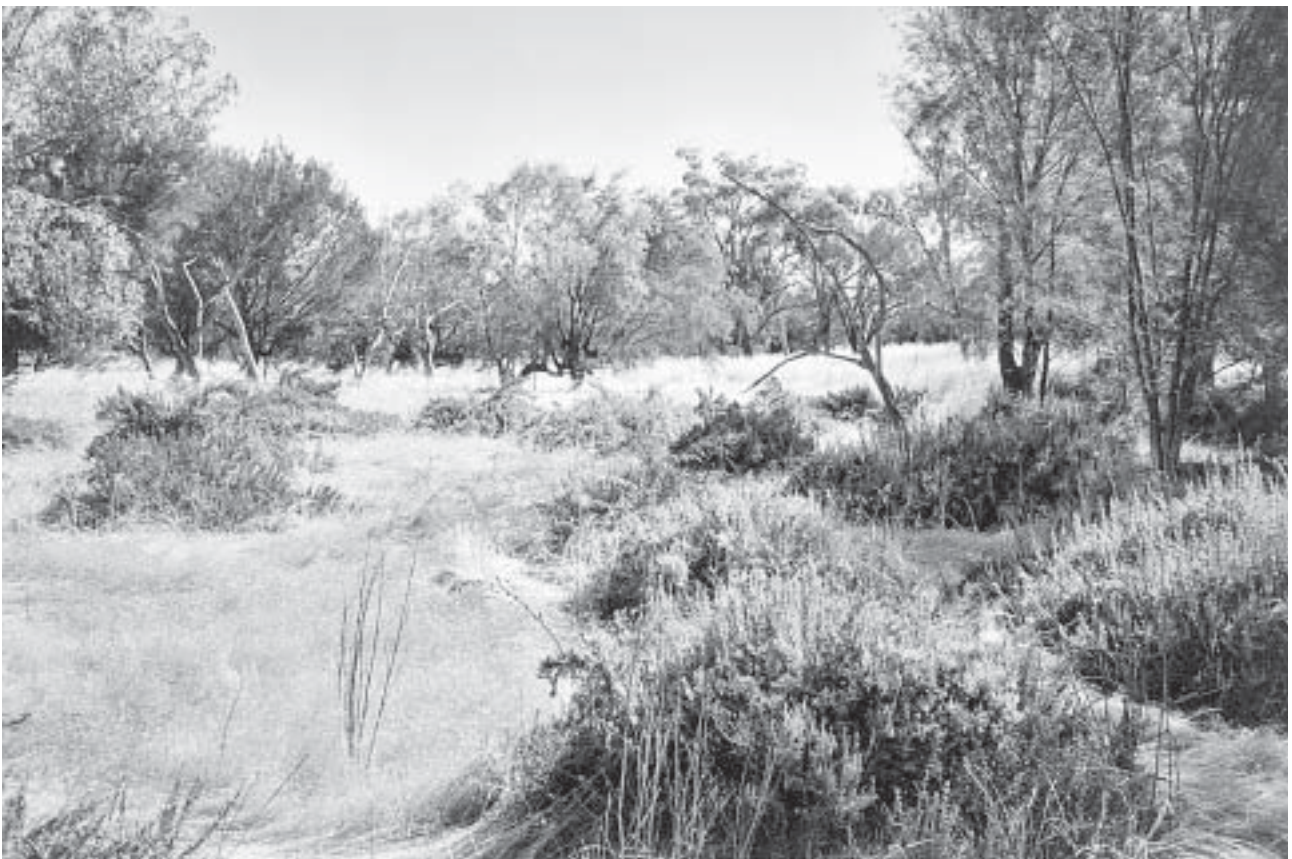
**Photo 12: Regeneration in the floodplain.**

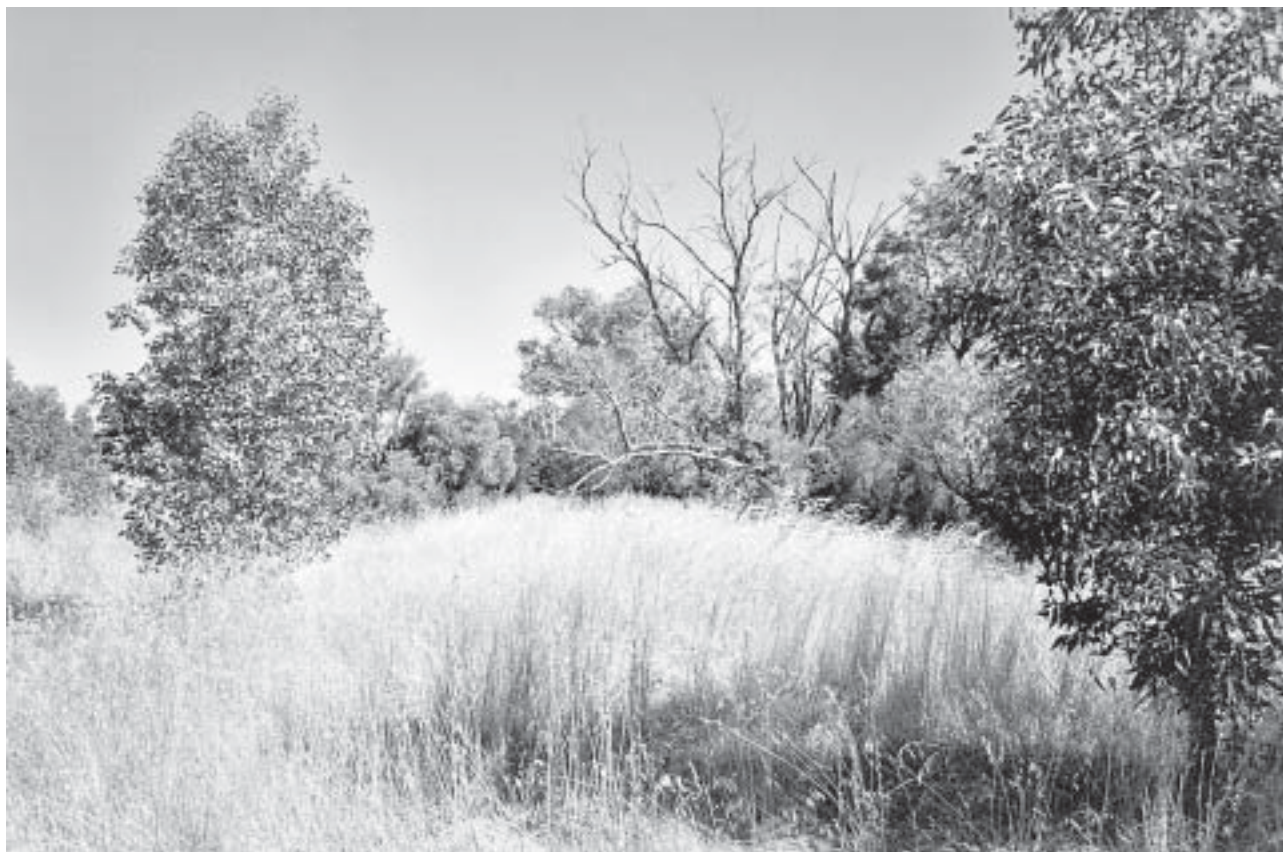
**Photo 13: Wild Oats in revegetation site of the east bank of the pool.**

The major task is to control broad-leaf weeds and Wild Oats. Long-term un-grazed areas show that weeds will eventually be suppressed by canopy closure of natural vegetation, however, this does not remove the short term weed problem, nor will it exclude all weeds. Control can be by chemical sprays, managed grazing/slashing or judicious burning. Trial of each of these separately and in combination under varying conditions is recommended. There are sites well suited for trials in the Reserve, the fenced area on the east bank or in the fringing vegetation of Avon Location 501 (Marr).
