# FORESHORE AND CHANNEL ASSESSMENT OF WUNDOWIE WETLAND AND MAGNOLIA CREEK

DEPARTMENT OF ENVIRONMENT  
WATER RESOURCE MANAGEMENT SERIES  
REPORT No WRM 38  
APRIL 2004

The objective of this project was to document the current condition and future needs of Wundowie Wetland and Magnolia Creek. This was achieved through consistent field surveys, which were undertaken in consultation with adjacent landholders and the Local Government Authority. The project emphasises community consultation.

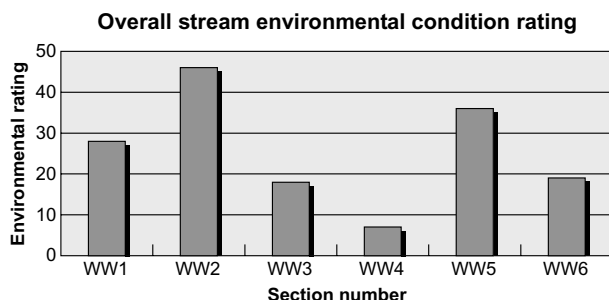
**Figure 1: Overall stream environmental health rating.**

Excellent	Good	Moderate	Poor	Very poor
WW2	WW5	WW1	WW3 WW6	WW4

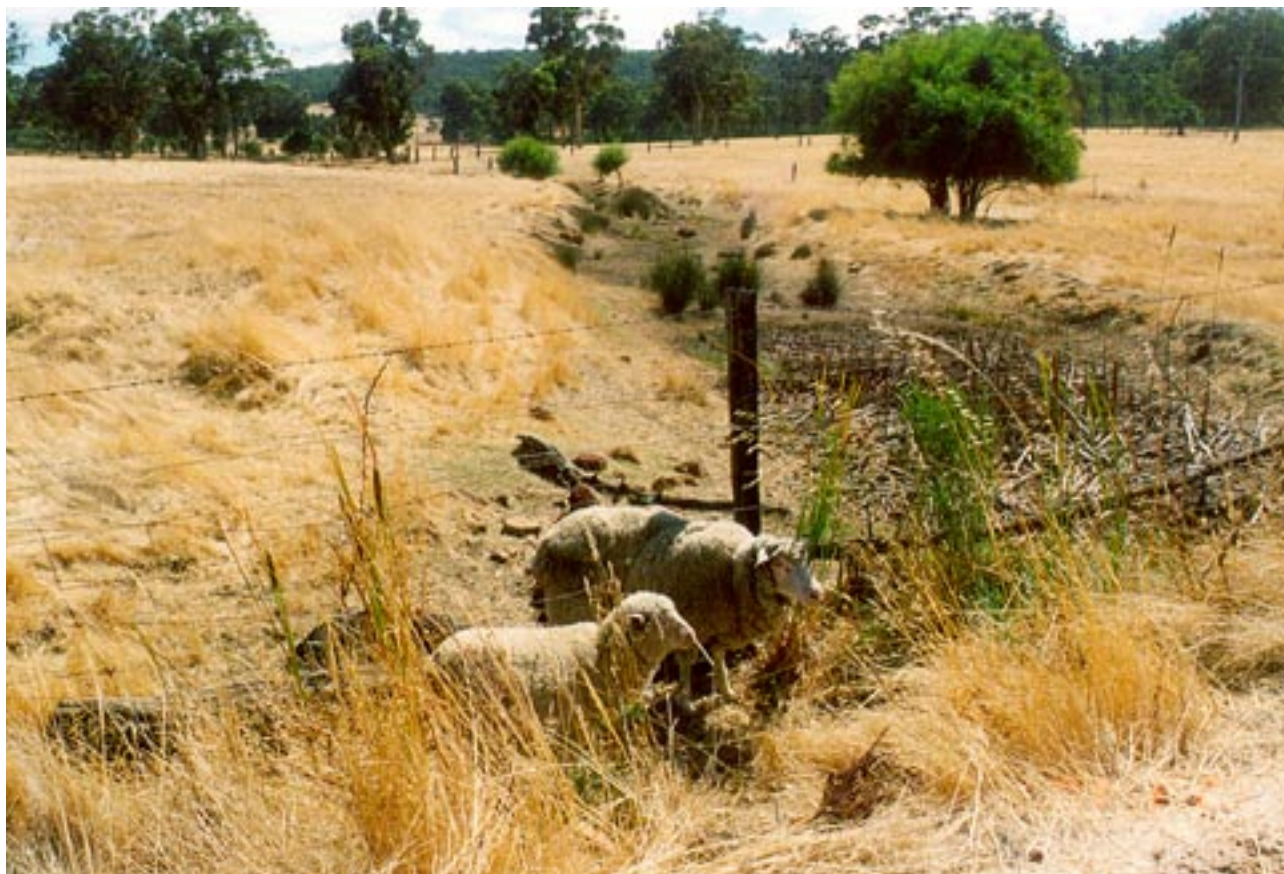
**Photo 1:** Stock accessing the riparian zone eat vegetation, trample regrowth and exacerbate erosion of banks and creekbed.

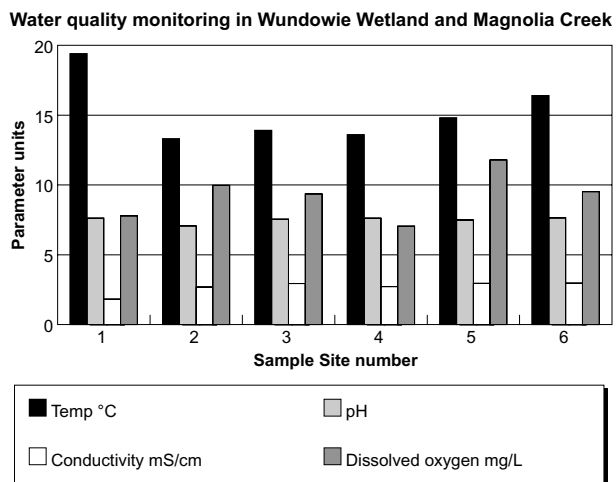
Figure 2: Water quality monitoring results.

In addition grab samples were taken at four of the sites (sample sites 1-4). These were brought to a NATA registered laboratory for the determination of phosphorus and nitrogen concentrations, suspended solids content and determination of turbidity the using standard methods. Table 17 provides the sample site co-ordinates (MGA Zone 50) and a brief site description. Table 18 shows sample results while Figures 2 and 3 graph these results.

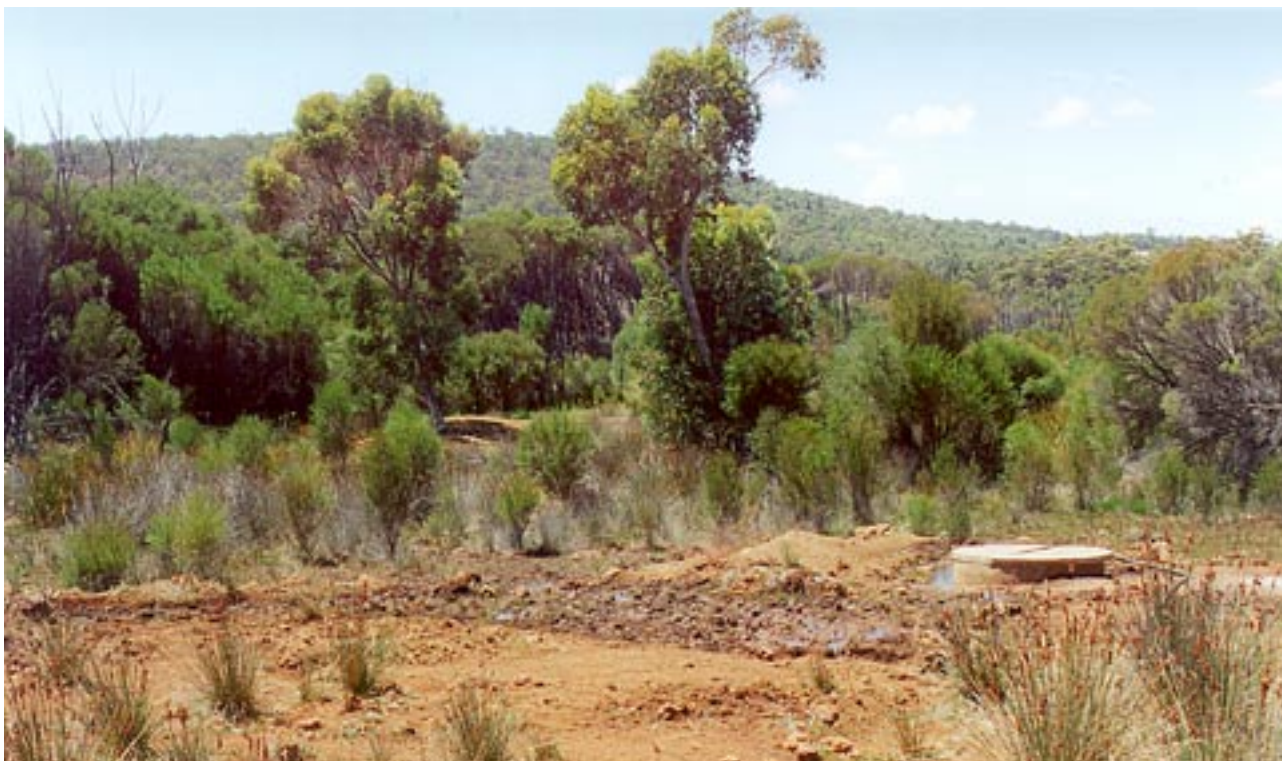
**Photo 2: WW1 – This area, now dry, was permanently wet prior to unseasonal dry conditions and pumping of water from the wetland.**

Stock have access to the wetland. The property boundary fence runs along the flow channel cutting through the wetland.

This section provided an excellent diversity of habitats as it contained permanent water and rated B for the overall foreshore condition.

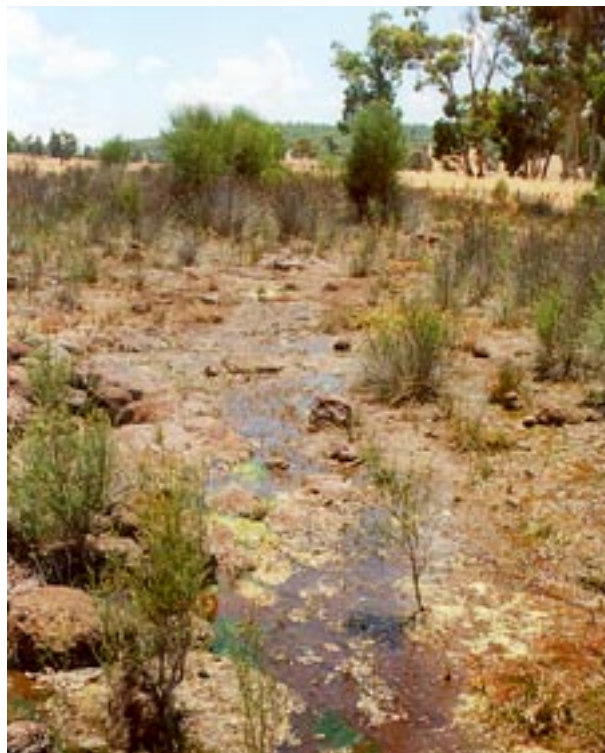
**Photo 3: WW1 – A steady trickle of water coming from the freshwater soak.**

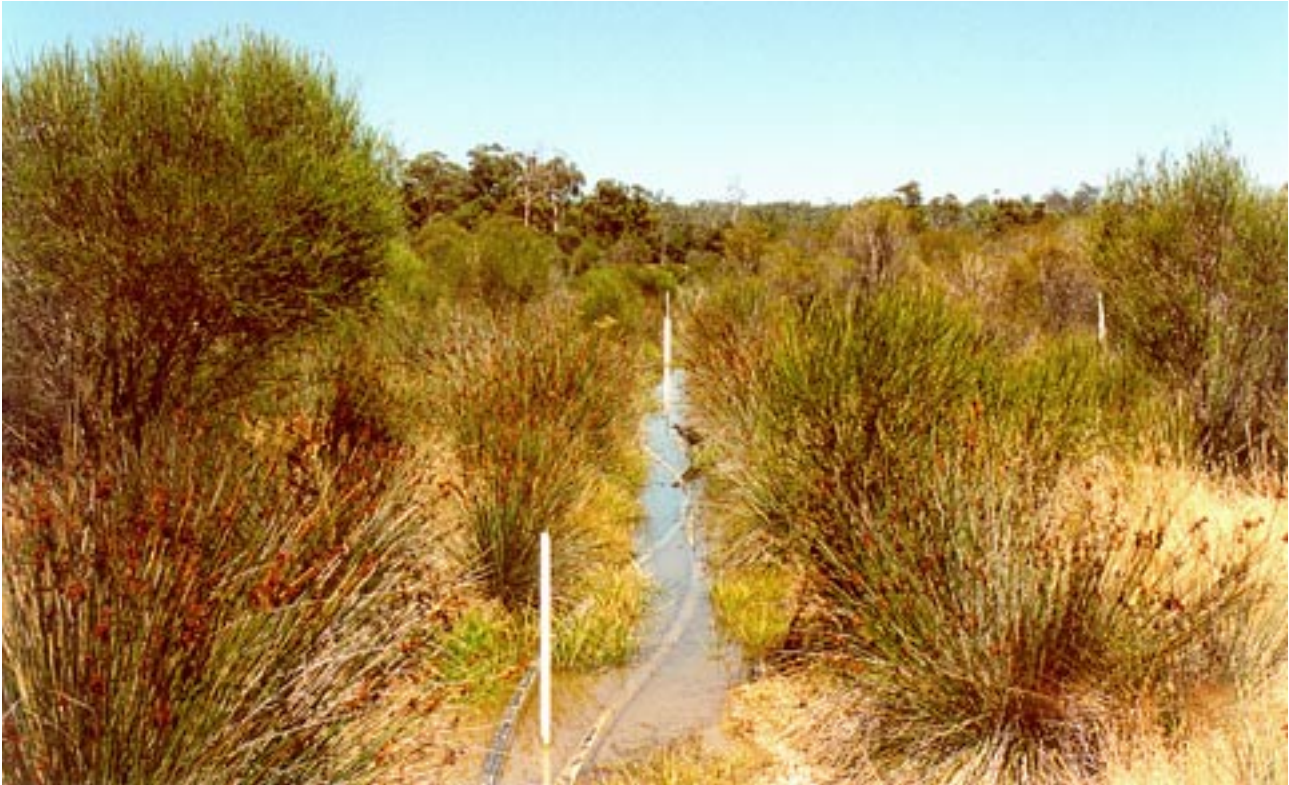
**Photo 4: WW2 – Invasion by spike rush along water pipe. Note the waterbird in water trench.**

Section WW2 is enclosed by good fences and is stockproof. The wetland is dominated by dense native vegetation. Pockets have been invaded by weeds particularly by *Juncus acutus* (spike rush), where vegetation was cleared for the water extraction pipes, other disturbed areas, and where a large patch of trees have fallen.

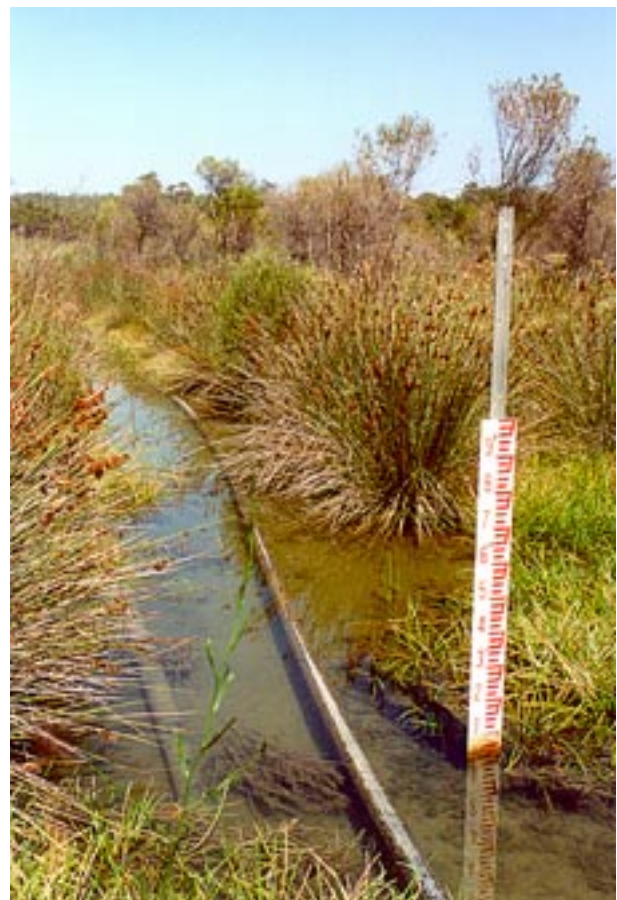
**Photo 5: WW2 – Staff gauge for monitoring surface water levels in the wetland.**

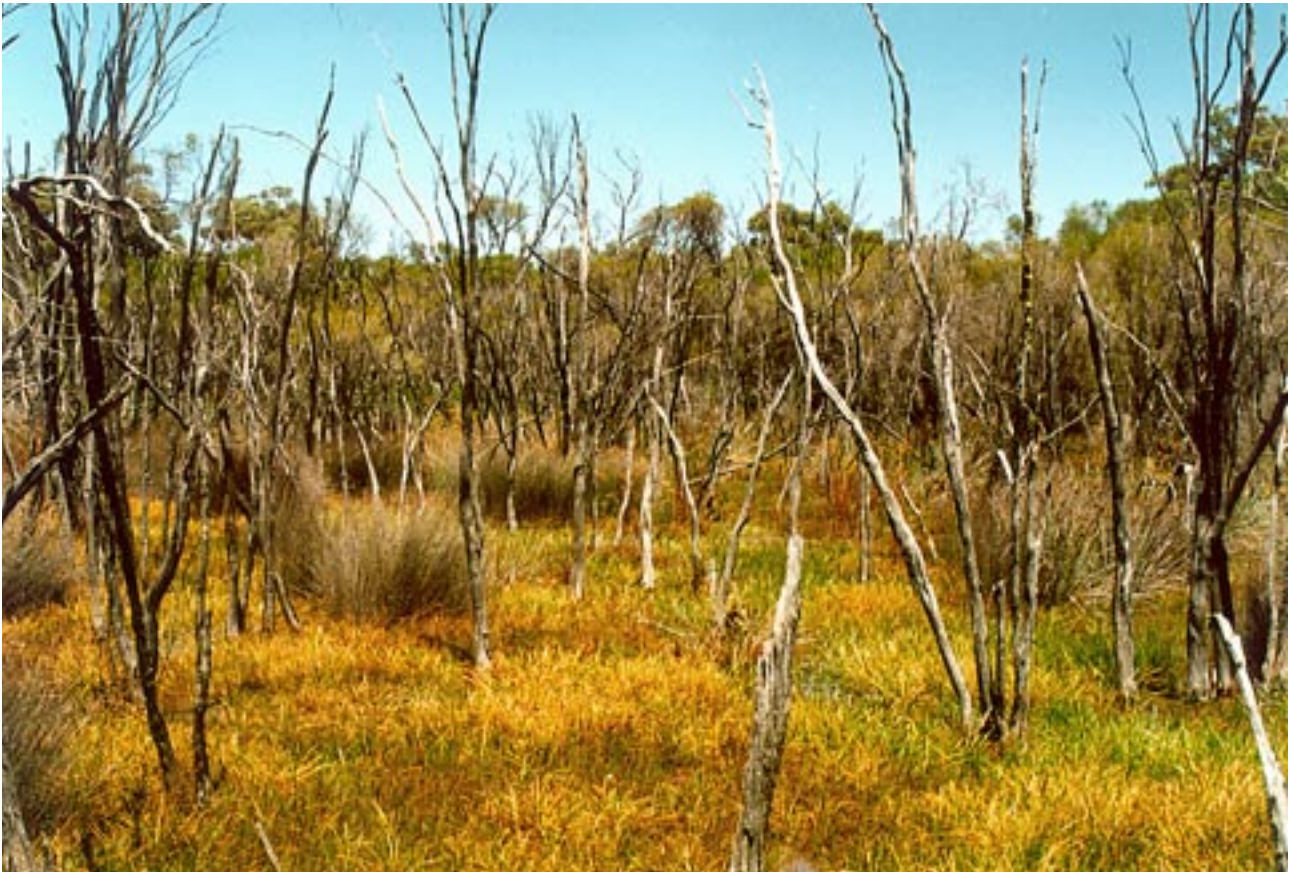
**Photo 6: WW2 – Dead vegetation in the middle of the wetland.**

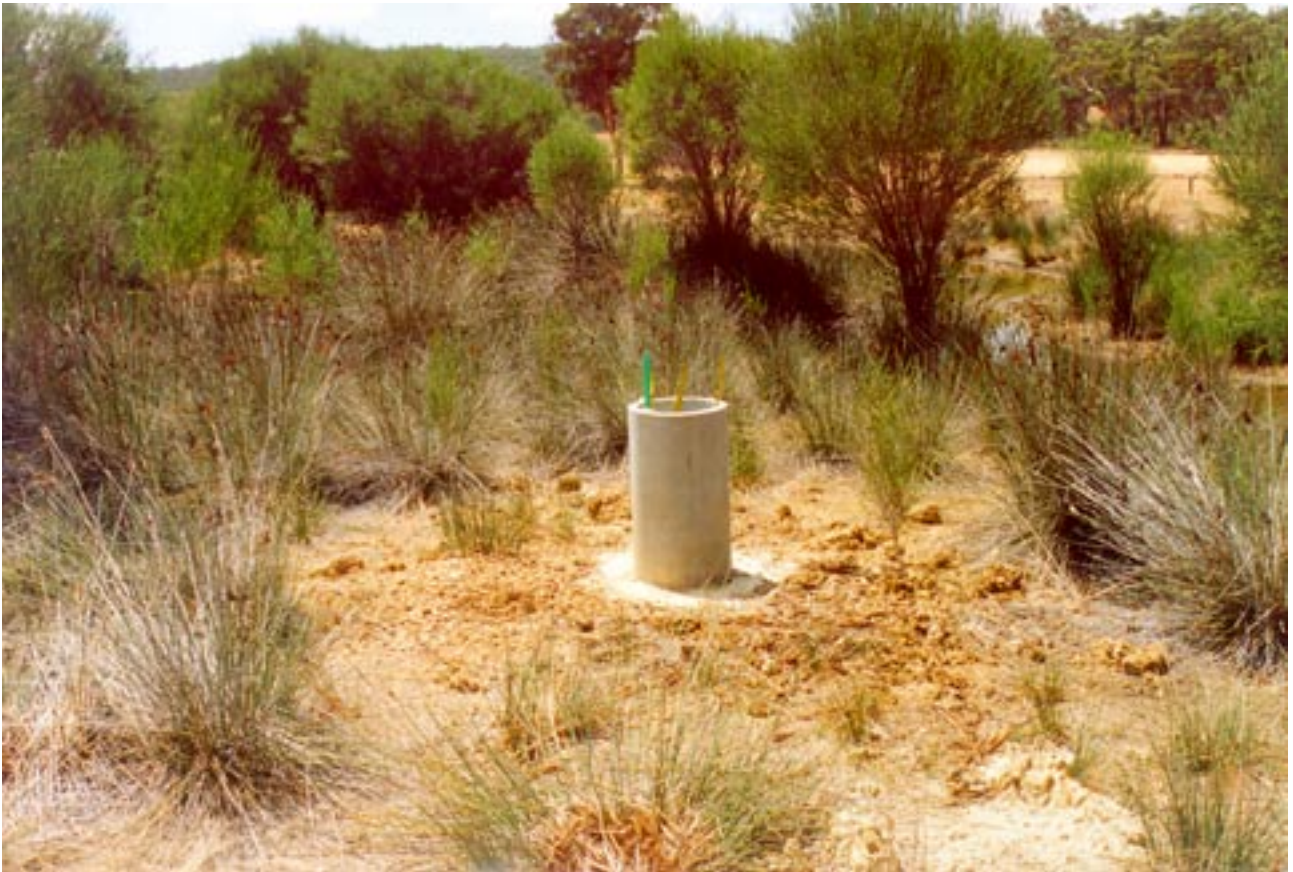
**Photo 7: WW3 – Groundwater monitoring bore at the upstream property boundary.**

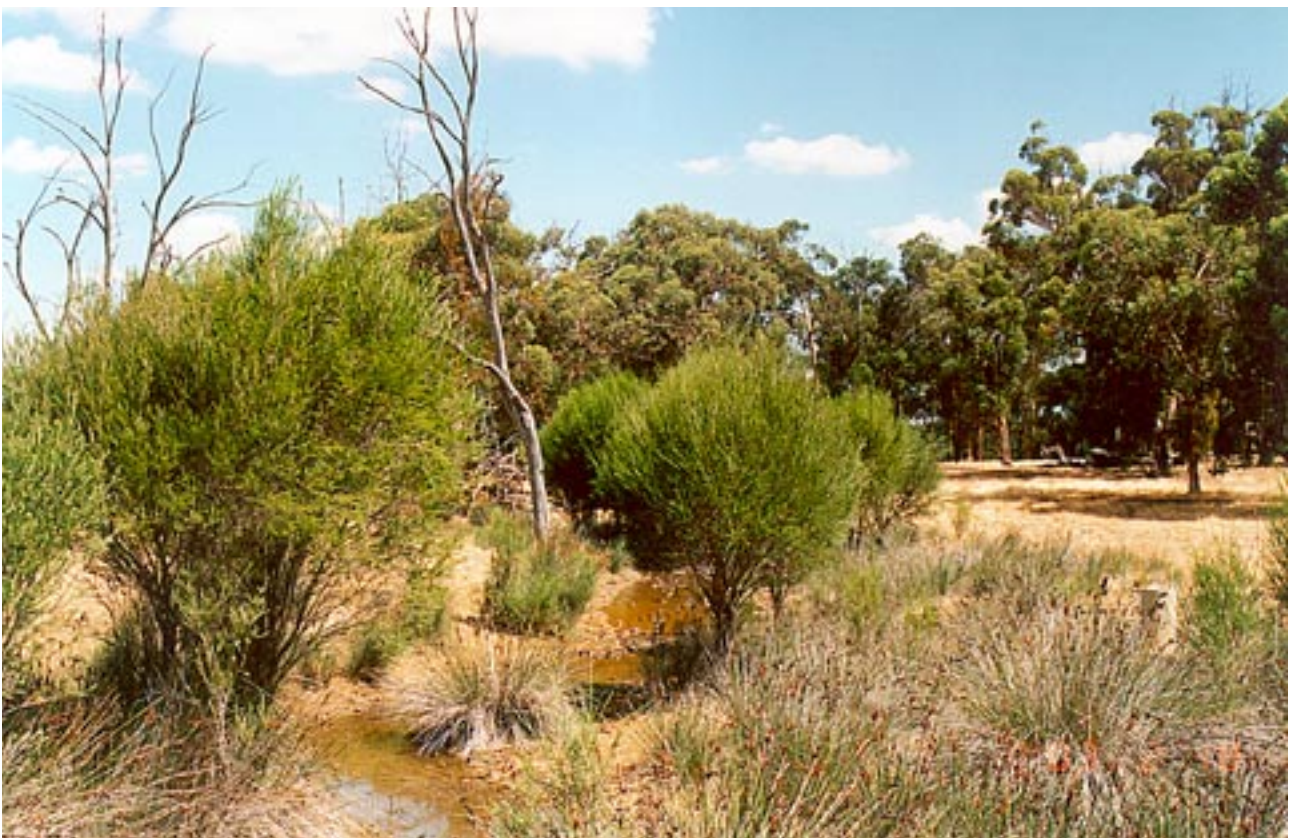
**Photo 8: WW3 – Looking downstream along creek channel, monitoring bore to the west (right of photo), dam to the east.**

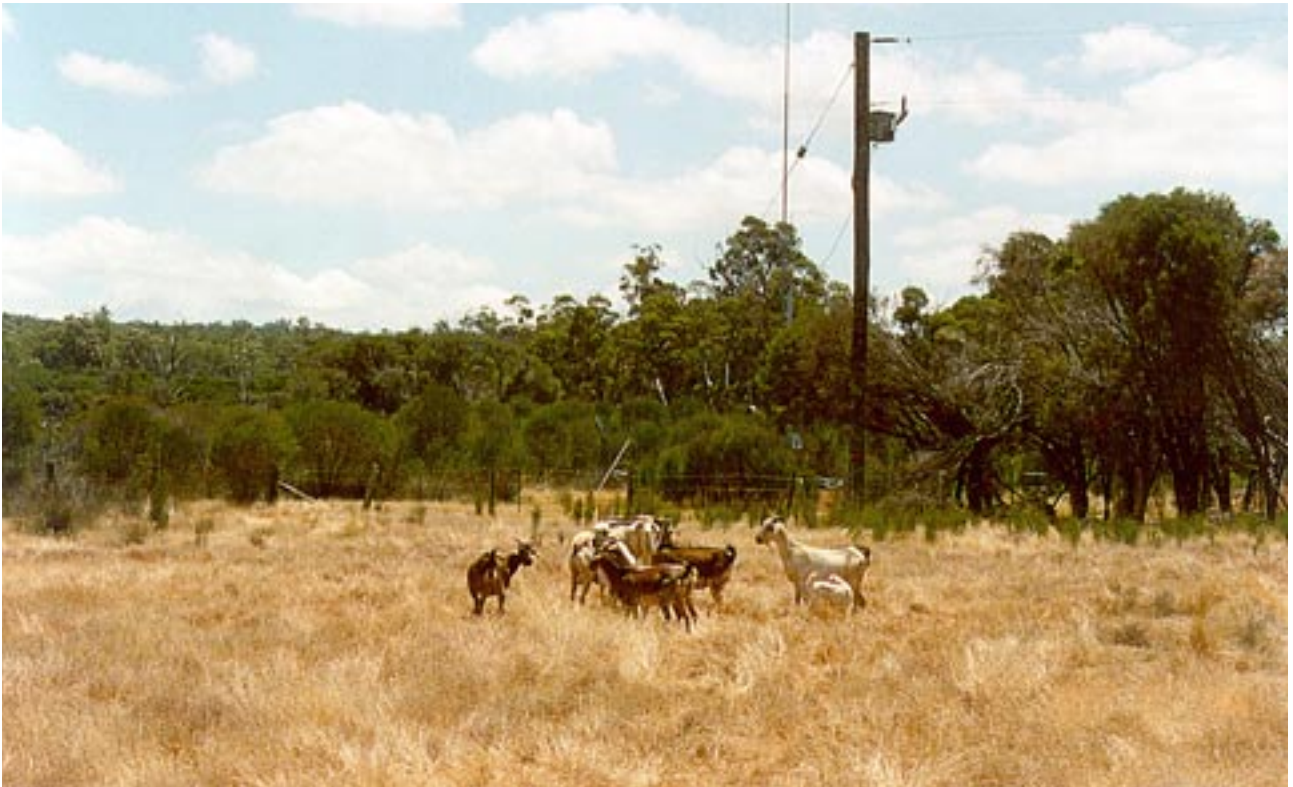
Only the upstream wetland portion of the surveyed section was fenced and these were in poor condition giving stock and feral goats access to the creek.

**Photo 9: WW3 – Goats have access to the foreshore.**

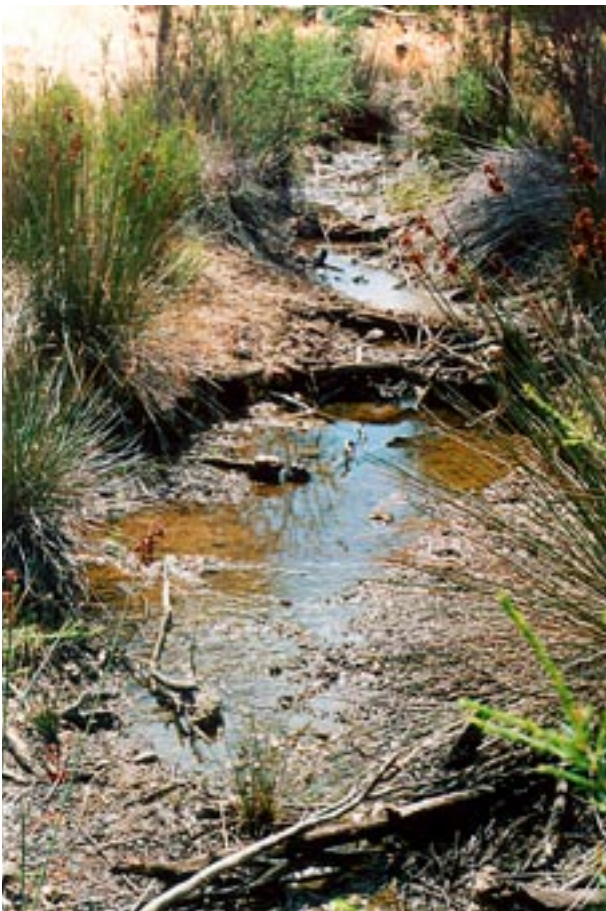
**Photo 10: WW3 – Woody debris in creek channel, bed material increasing in roughness.**

coarser with the addition of gravel further downstream. This portion of the section contained some woody debris and a natural rock riffle which helps to increase the habitat diversity.

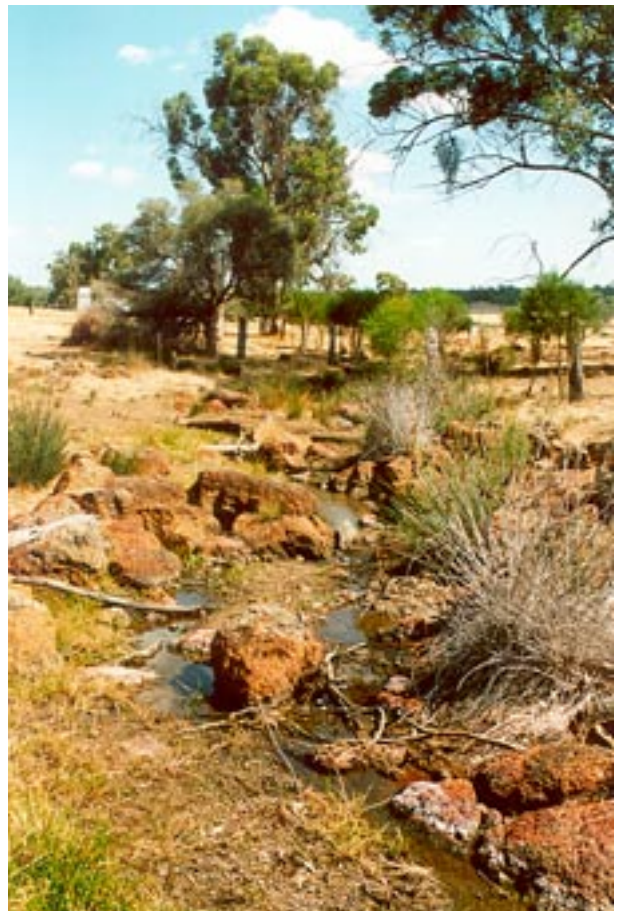
**Photo 11: WW3 – Natural rock riffle.**

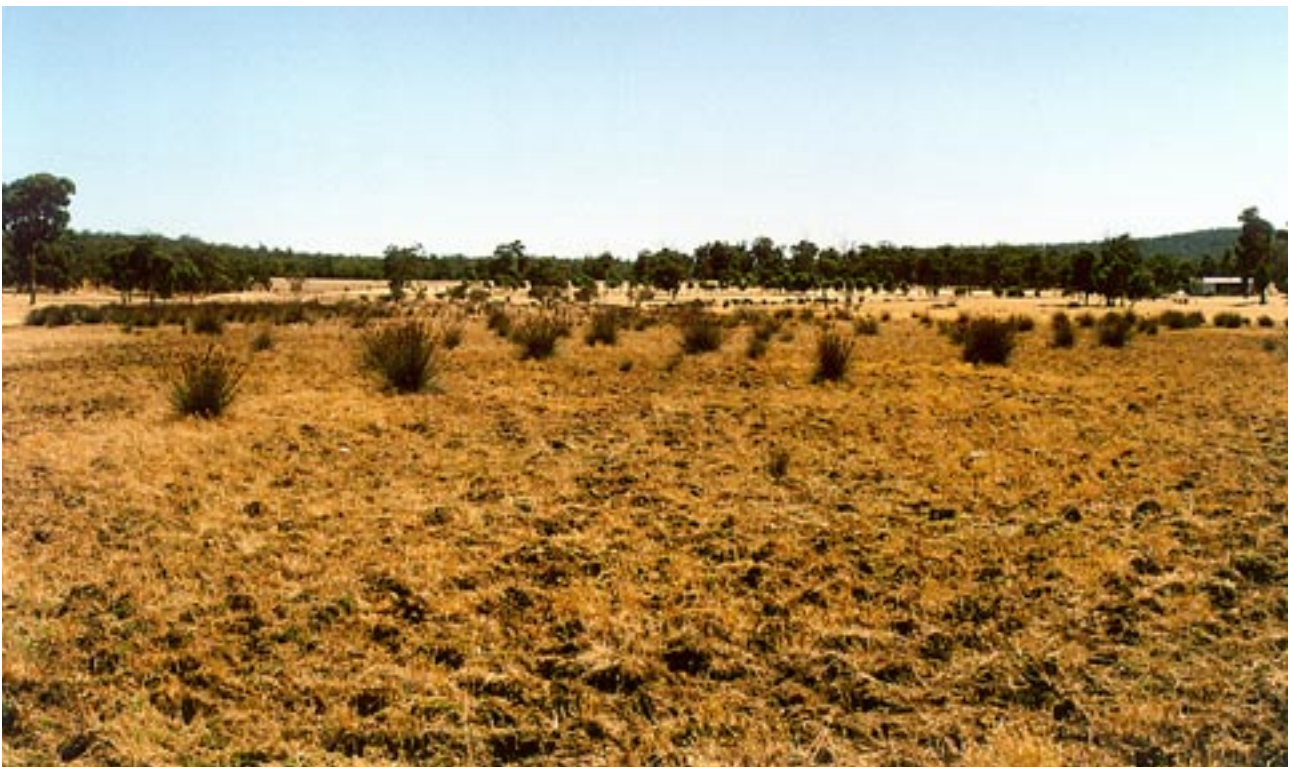
The channel was not well defined in the downstream portion of this section. From the vegetation and condition of the paddock it appeared that the creek, when flowing, spreads out into the paddock. A minor tributary containing a dam overflows to join the creek channel on the left bank (west).

**Photo 12: WW4 – Poorly defined channel forming into a dried wetland area.**

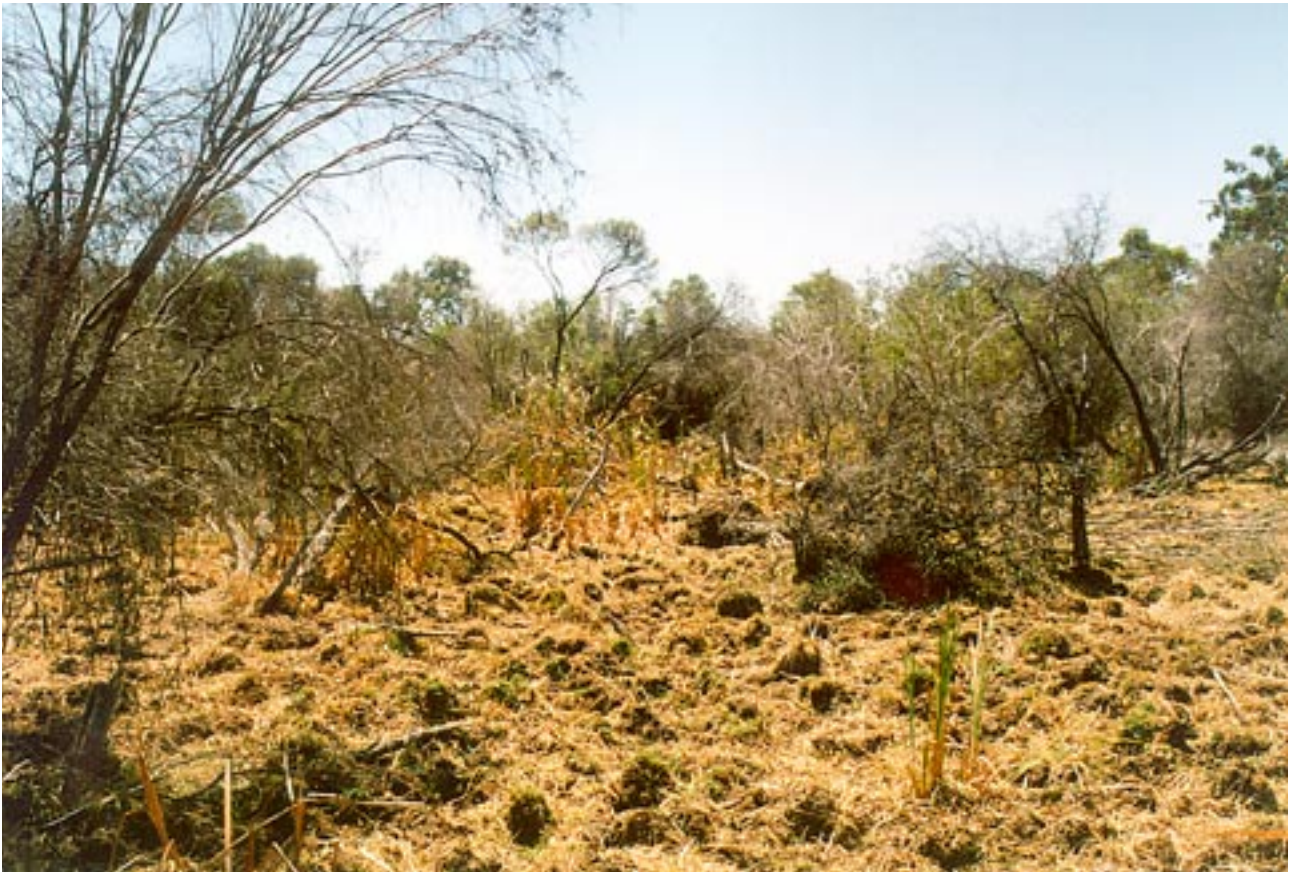
**Photo 13: WW5 – Dying vegetation in the middle of the wetland.**

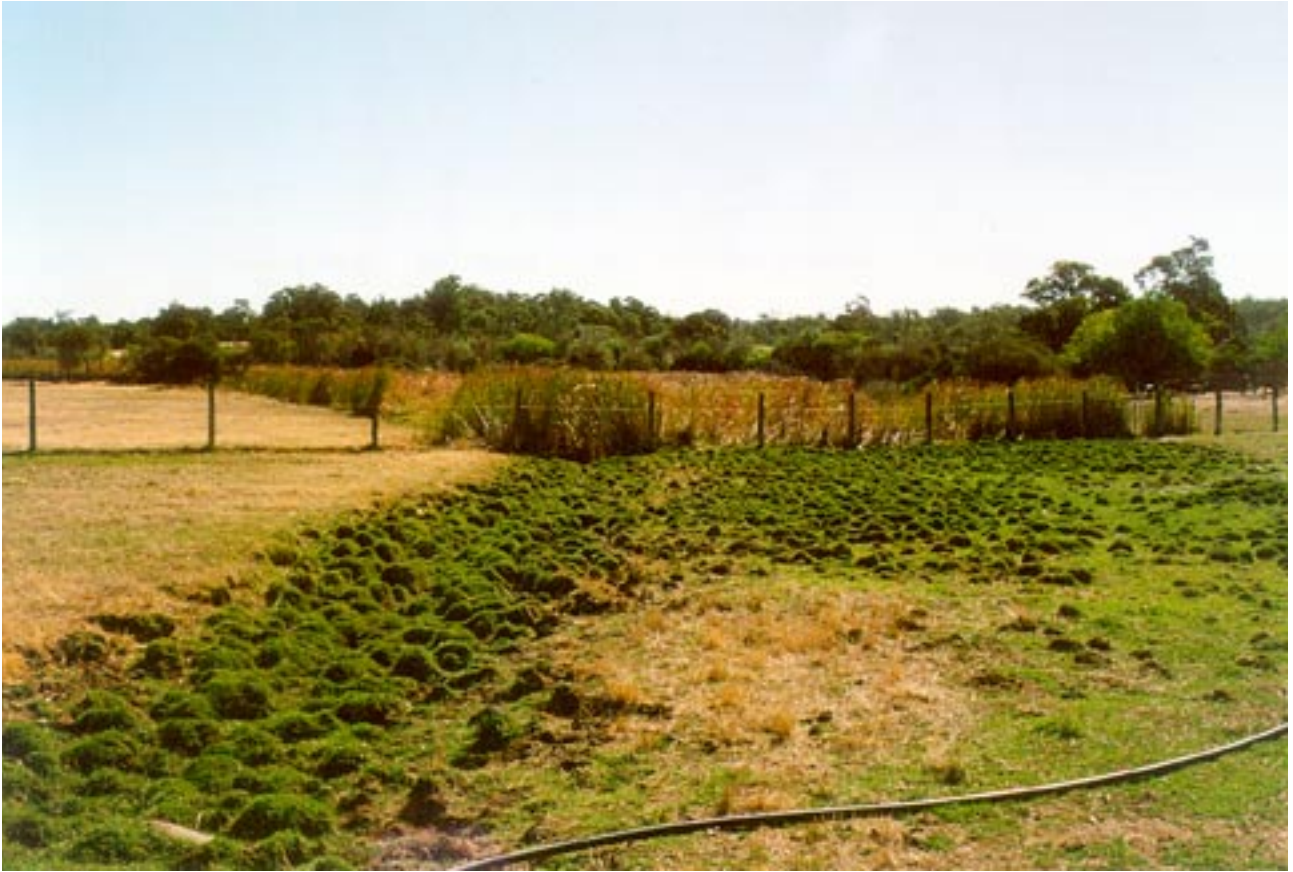
**Photo 14: WW6 – A soak towards the downstream boundary of this property flows into the creek channel keeping the foreground area slightly moist.**

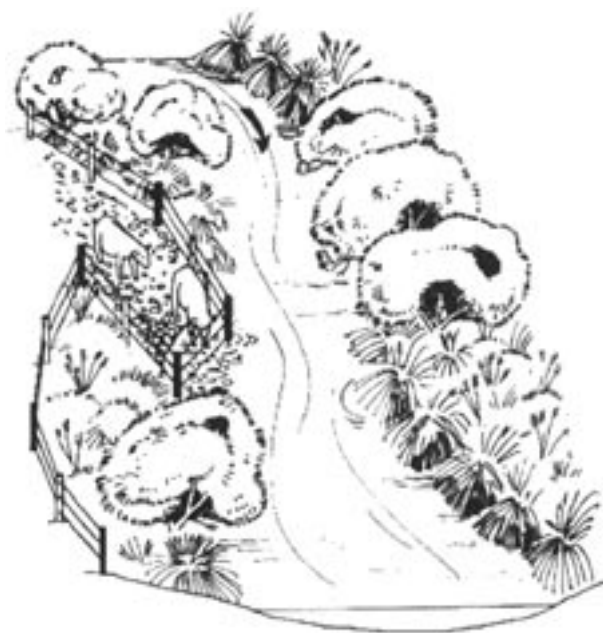
**Figure 4: Stock watering point.**

Some sections of the wetland and creek may be suitable for stock watering access for example the inside of a meander bend. Other ways to protect riparian vegetation and the banks while still providing a watering point for stock are by installing a:

- pump
- tank in the paddock; and
- rocky access point down to the bank.

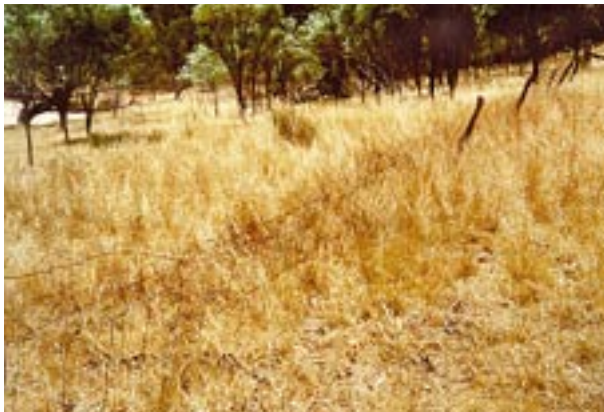
*Fence condition:*  
POOR.

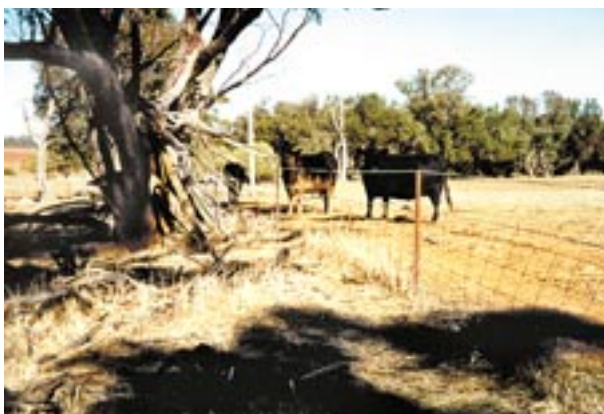
*Fence condition:*  
MODERATE.

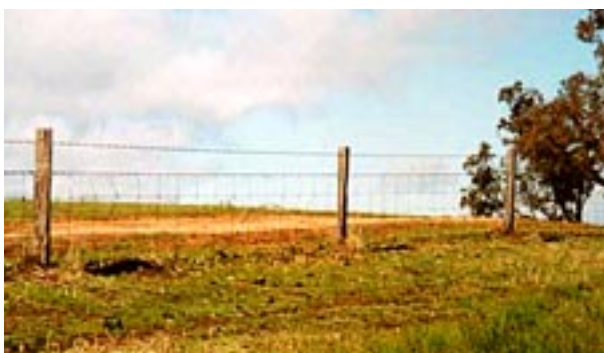
*Fence condition:*  
GOOD.
