# PHILLIPS RIVER ACTION PLAN

DEPARTMENT OF ENVIRONMENT  
WATER RESOURCE MANAGEMENT SERIES  
REPORT NO WRM 40  
MAY 2003

The purpose of this plan is to provide information on the state of the Phillips River. It also provides management recommendations to address the major processes threatening the health of the river.

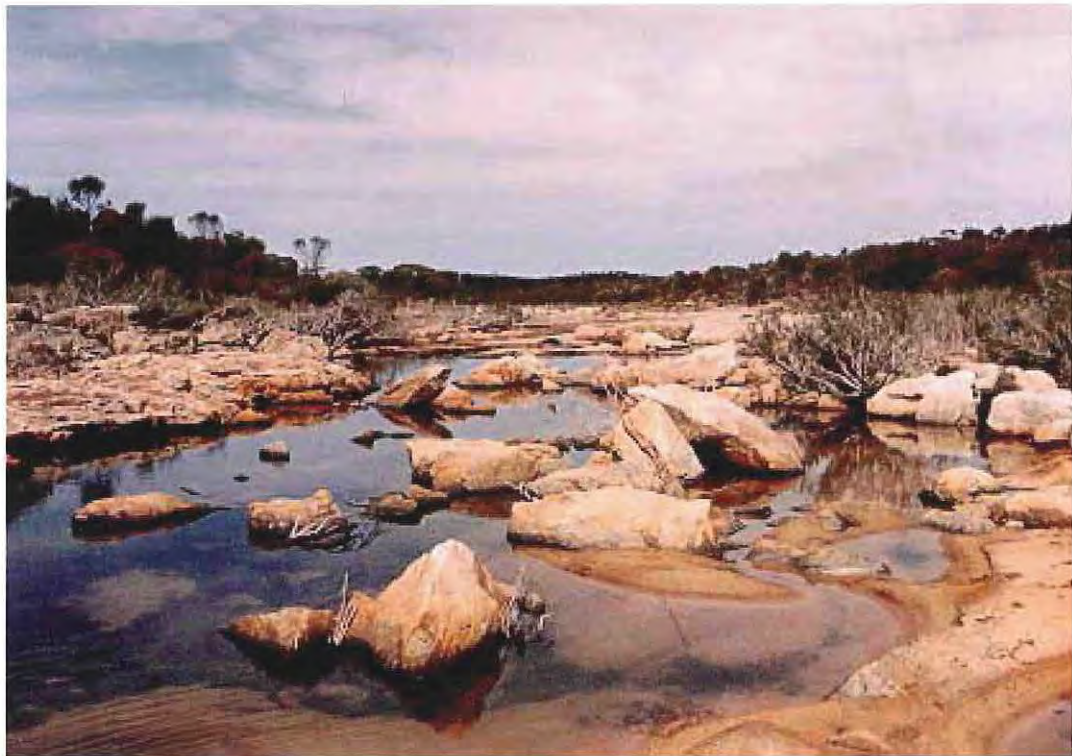
*A Grade vegetation of the Phillips River – pristine to near pristine condition*

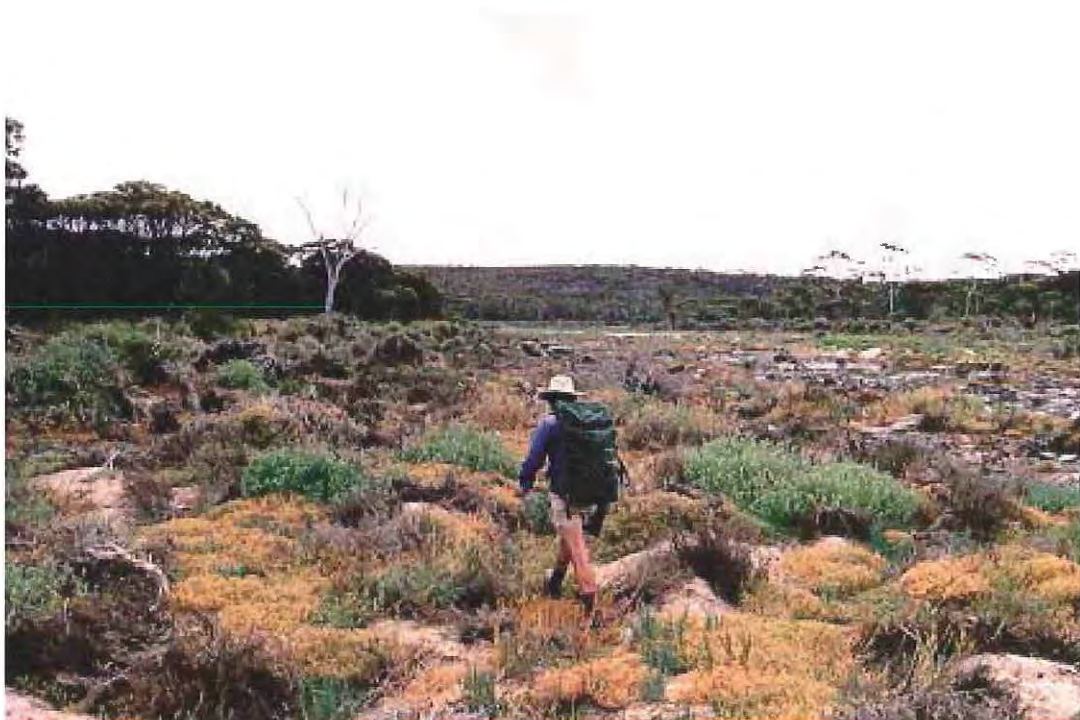
*B Grade condition – note the weeds, although this is probably largely influenced by the 2000 flood event*

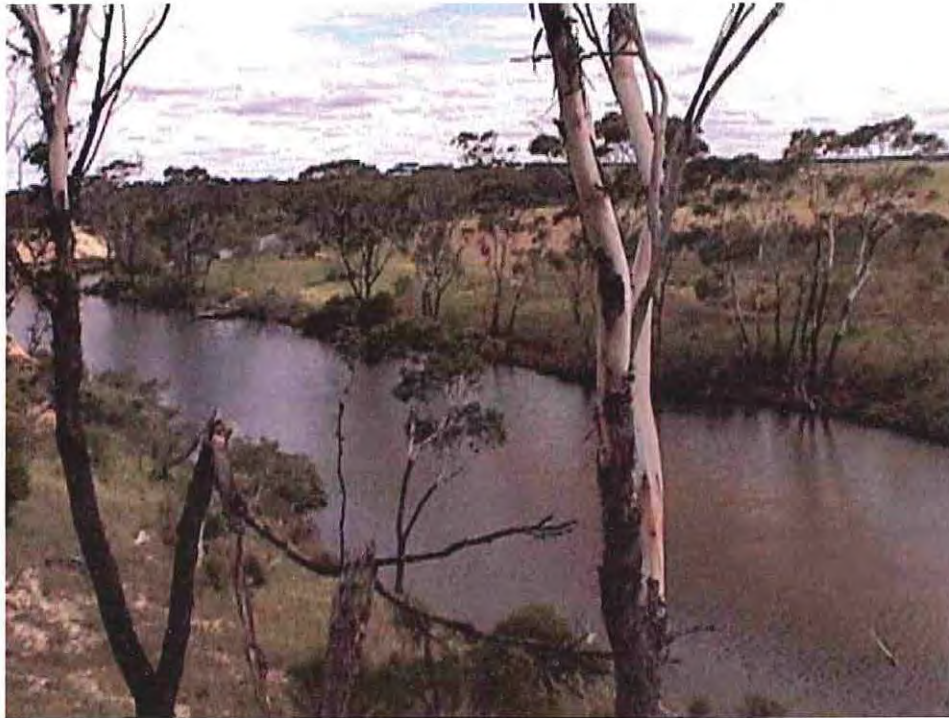
*C Grade – note the overstorey remains however the understorey is sparse and weed dominated. This site has since been fenced*

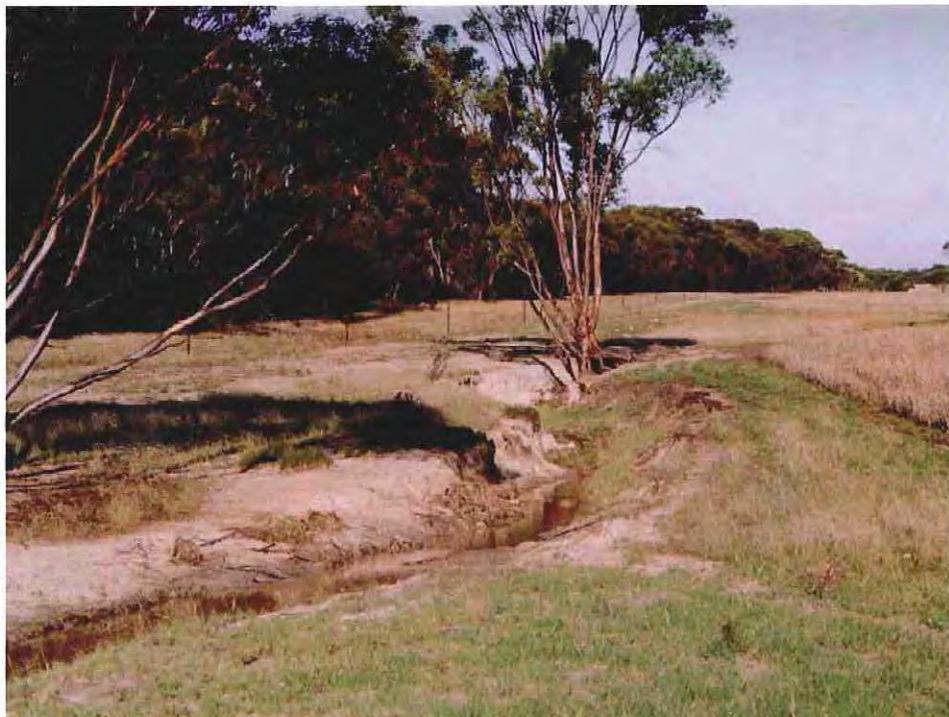
*D Grade – note the erosion and lack of understorey species. This is a tributary of the Phillips as there were no sections on the Phillips that were D grade condition*

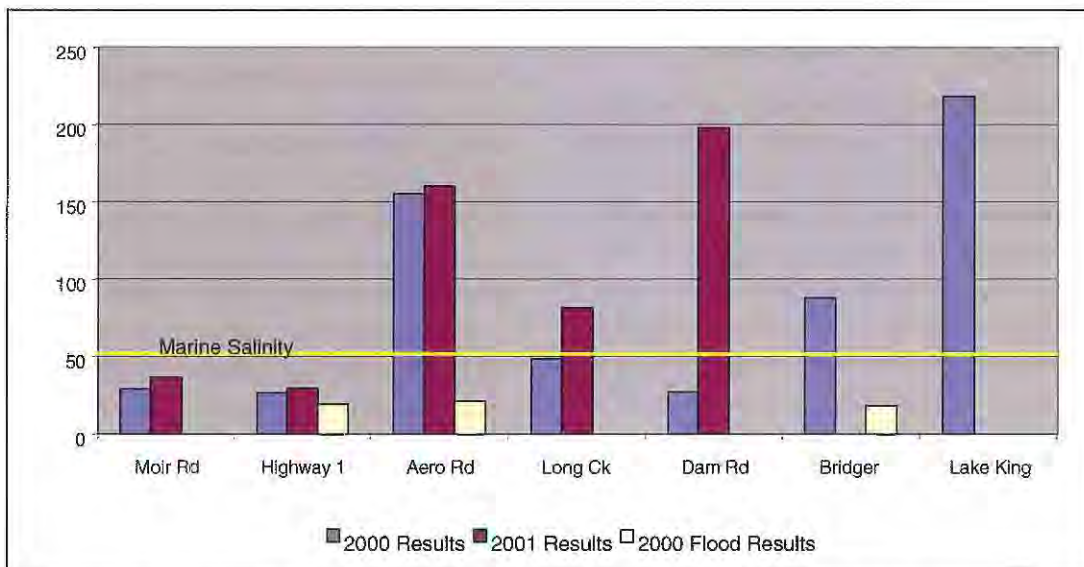
Figure 2. Conductivity levels (salinity) of various sites of the Phillips River (mS/cm)

The Water and Rivers Commission conducted a 'snapshot' of river water quality in 1999, 2000 and 2001 and recorded salinity measurements (figure 2, table 3). This data does not enable any trend analysis, however indicates differing salinity levels in the river at different sites, and for different times. This data showed that the Phillips River is considerably more saline towards the north of the catchment, and becomes fresher towards the coast.

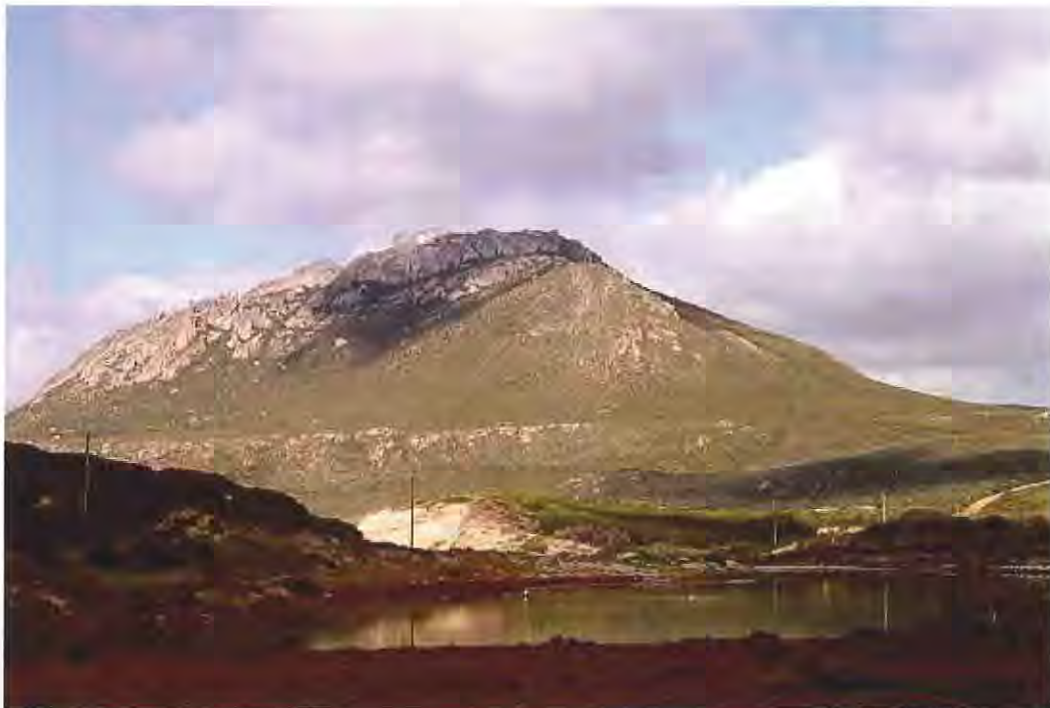
Culham Inlet 1998

The Inlet has a narrow fringe of salt-tolerant flora dominated by the paperbark *Melaleuca cuticularis* backed by coastal moort and yate. *Acacia cyclops* and *Eucalyptus tetragona* on the higher ground. The paperbarks (*Melaleuca cuticularis*) and the coastal moorts (*E. occidentalis* var. *occidentalis*) along the eastern shore of the Inlet died following the prolonged 1989-90 flooding with saline water. The previously limited areas of samphire (*Sarcornia quinqueflora*) have expanded greatly while the water level has been low since 1993. The aquatic *Ruppia megacarpa* was present but not abundant.

Filamentous green algae *Chaetomorpha indica* with traces of *Cladophora* were recorded in 1994 (Bennett and George, 1994).
