JERDACUTTUP RIVER ACTION PLAN

WATER AND RIVERS COMMISSION
WATER RESOURCE MANAGEMENT SERIES
REPORT No WRM 43
JUNE 2004

The purpose of this Action Plan is to provide information on the condition of the Jerdacuttup River. The report describes the condition of the river, its vegetation, water quality, channel features, and then provides specific management advice for further works needed to protect the river. In summary, the River Action Plan provides:

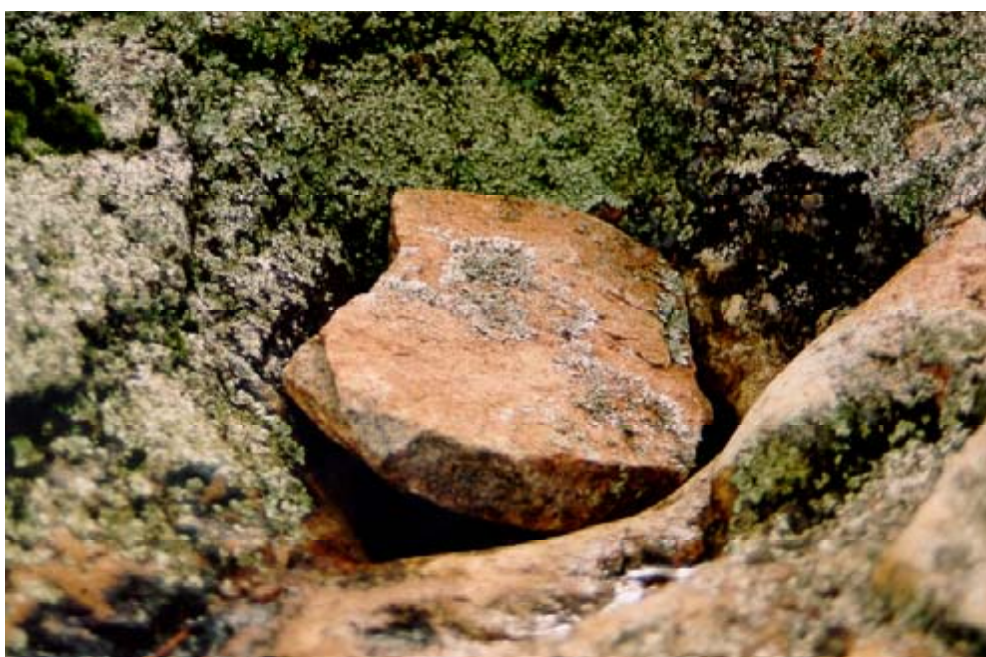
Gnamma hole on the river at the Carlingup Road crossing (photograph Kaylene Parker)

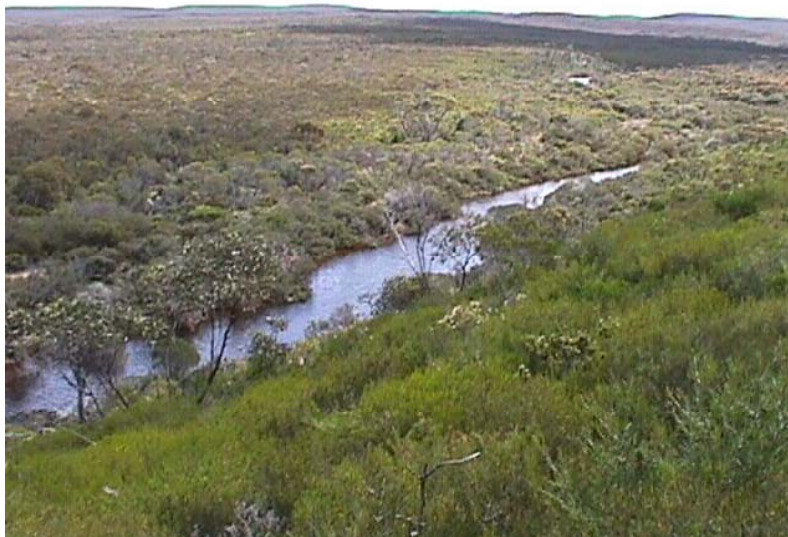
Section of river graded as A grade condition (photograph Kaylene Parker)

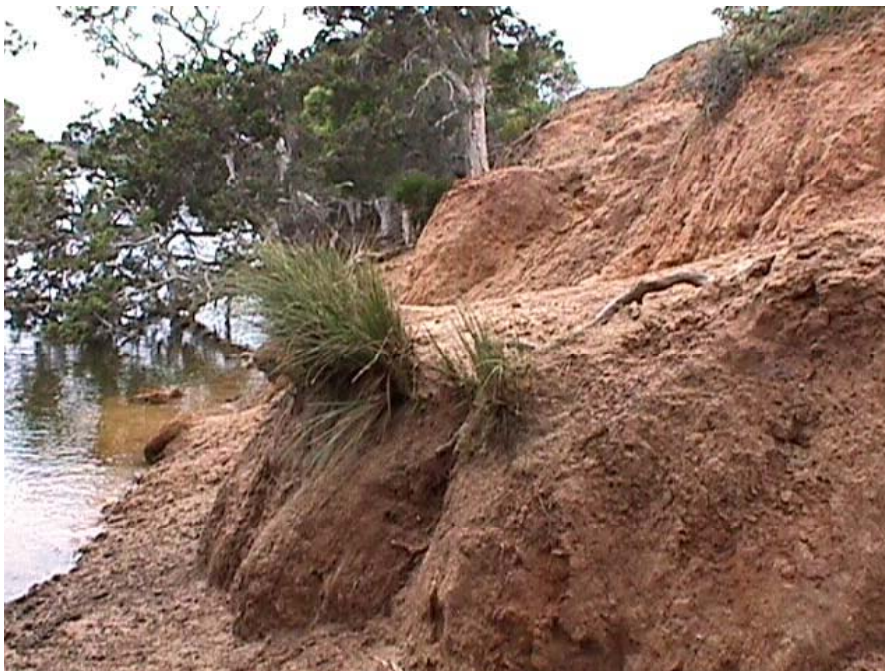
Erosion and sedimentation were recorded in sections of the river designated as B or C class. Although a certain degree of either of these phenomena may be considered a ‘natural’ part of river function, erosion in particular was observed where tributary flow from cleared lands entered the main channel. At these points, soil is usually completely lost and plants, if still present, have exposed roots.

Section of the Jerdacuttup River showing erosion of the bank – caused by cattle access and the resultant loss of foreshore vegetation (photograph Kaylene Parker).

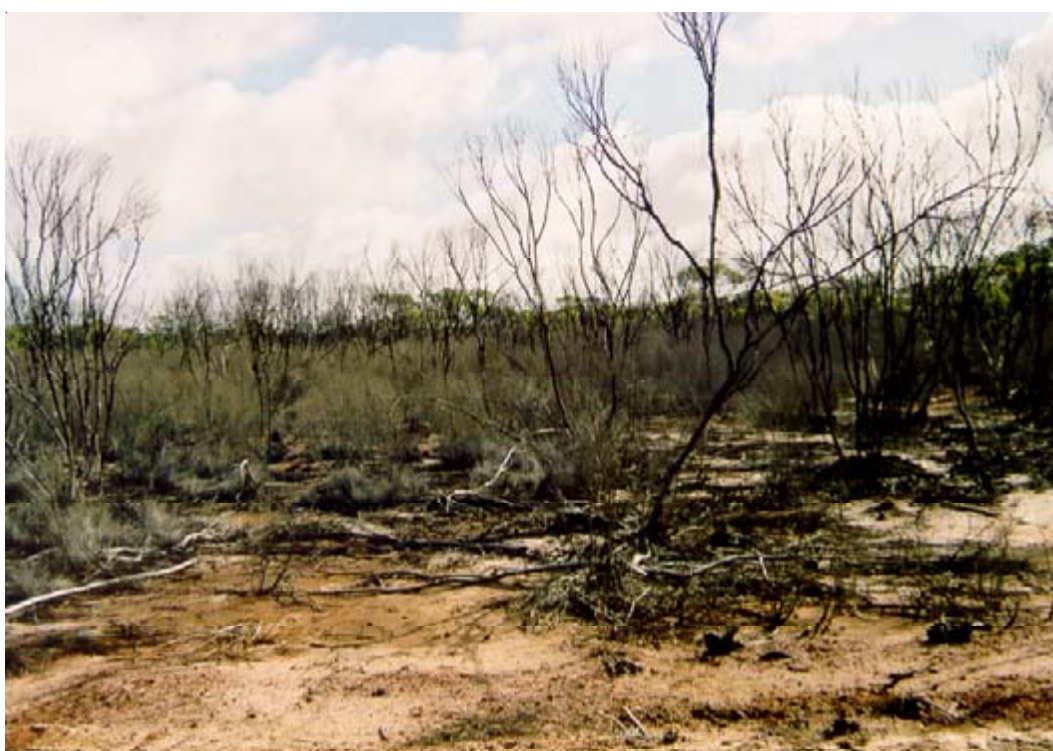
Dead vegetation on Woodenup Creek crossing/Woodenup Road due to waterlogging and possibly secondary salinisation (photograph Kaylene Parker)

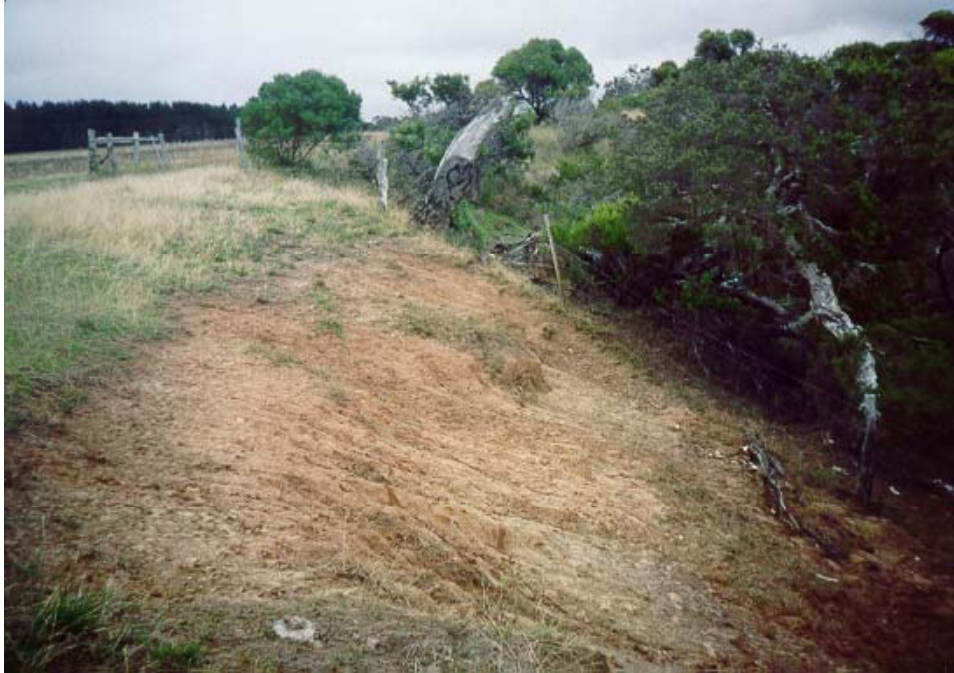
Fence line showing the difference between an unfenced and a fenced river corridor. Note the erosion and bank slumping in the unfenced section, in comparison to the well vegetated adjacent foreshore (photograph Andy Chapman)

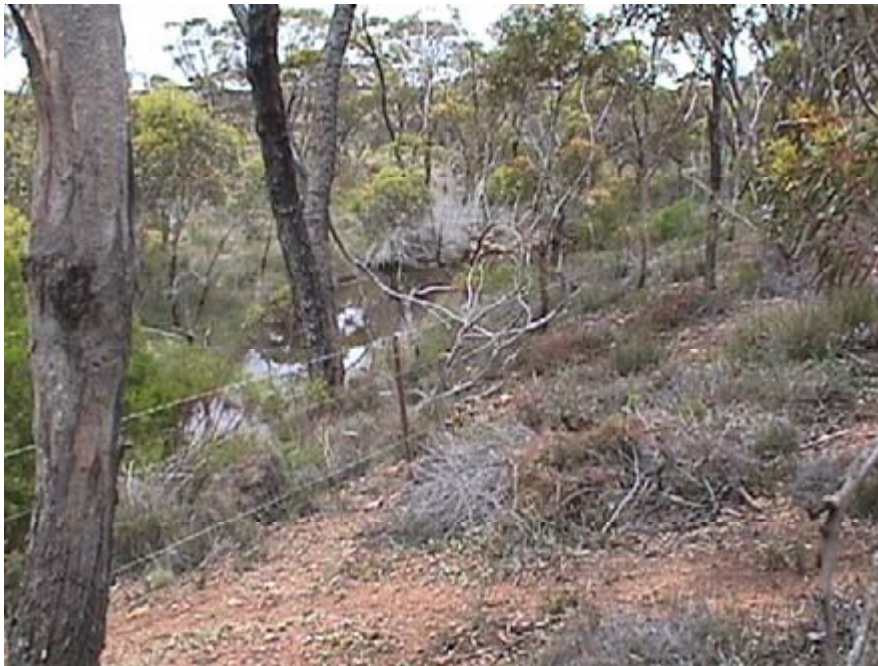
Inappropriate fence location due to inadequate foreshore reserve width (photograph Kaylene Parker)

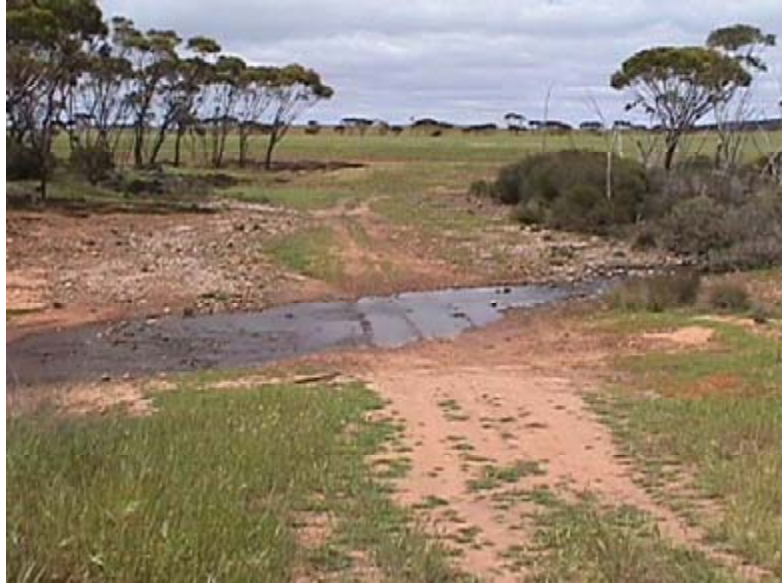
Crossing showing good design – following the contour. Small rocks could be placed to minimise the amount of water the vehicle drives through (photograph Kaylene Parker).

Crossings should be established where sediment deposition is occurring rather than erosion, and where the bedrock is rocky and hard. The crossing should preferably use the existing base of the channel and lined with small stones rather than the use of culverts, which increase the erosive power of the water downstream. The following are some basic principles for crossing design.

1. *Firm foundations* – choose a site that has stable soil or visible rocks in the river. Sandy bottoms and river pools are the worst locations, with rock sheets and clay soils being the best.
2. *Straight river section and crossing* – choosing a straight section of river is very important if you want your crossing to survive those big storm events and floods. Putting a crossing on a bend means in high flows the erosive force of the river acts mainly on one point of the crossing rather than equally on all points of the crossing if on a straight stretch of river.

Crossings on bends will wash out more often than crossings on straight sections. Also make sure the crossing goes straight across the river and not on an angle or the same principle applies.

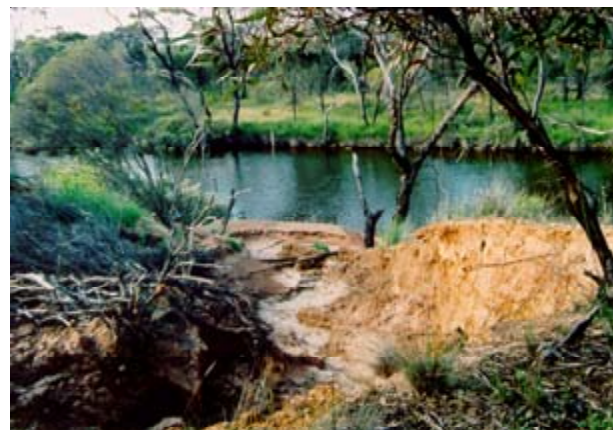
Headcut north of Highway #1 from an access track. This has deposited considerable amounts of sediment into the river pool (photograph Kaylene Parker)

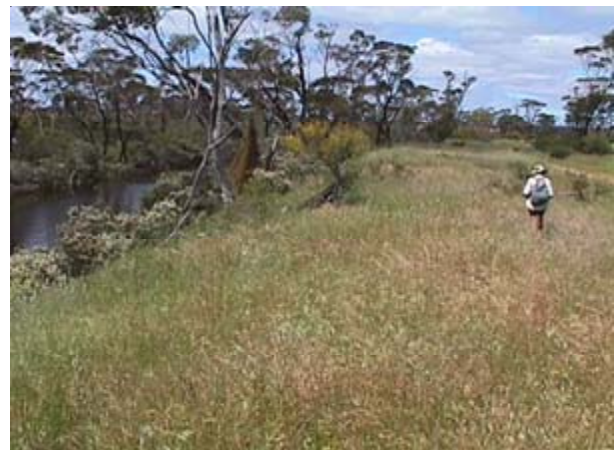
Weed invasion where the foreshore vegetation has been grazed. Revegetation is required in this section of the river (photograph Kaylene Parker)

- **formulate a weed action plan to control African boxthorn and bridal creeper.**
- **The Department of Environment, the LCDC and the landholder discuss means of localised erosion remediation, especially for actively eroding crossings and the headcuts.**
- **The Department of Environment and the Ravensthorpe LCDC discuss with the landholder options to fence unfenced sections of the river and revegetate sections where the yate trees are suffering.**
