Waterway assessment of the upper Lockhart River: Camm River confluence to Newdegate

Water resource management series
Looking after all our water needs

Report no. WRM 58
December 2009

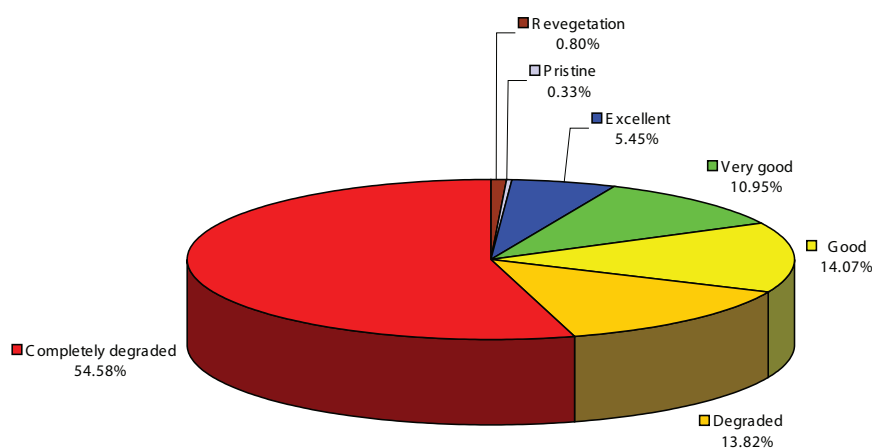
Figure 2 Estimated area of vegetation surveyed within each vegetation condition rating

An estimate of the area of vegetation in each vegetation condition category is shown in **Figure 2** below. Although this figure is an estimate (based on the approximate percentage of each condition in each remnant and an estimate of the proportion of vegetated area in each remnant), it shows that most of the vegetation surveyed is in *completely degraded* condition.

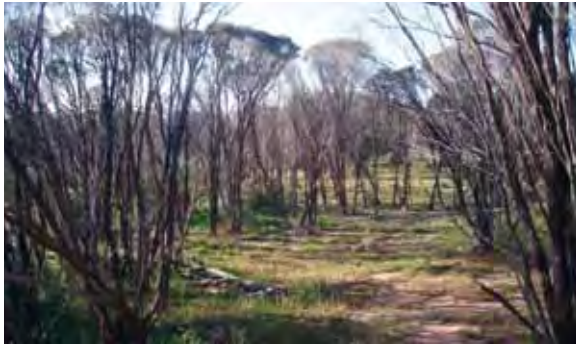
Photo A1.1: ULR01

Very good condition vegetation association 1: *Melaleuca lateriflora* and *M. teuthidoides* Scrub with scattered *Eucalyptus spathulata* over *Rhagodia preissii* and *Enchylaena tomentosa* Open Dwarf Scrub over mixed annual Herbs

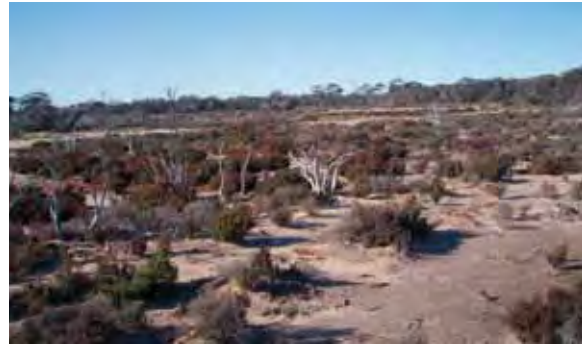
Photo A1.2: ULR01

Degraded condition vegetation association 2: *Tecticornia* spp. Dwarf Scrub over *Mesembryanthemum nodiflorum*, *Gunniopsis septifraga* and *Senecio* sp. Very Open Herbs

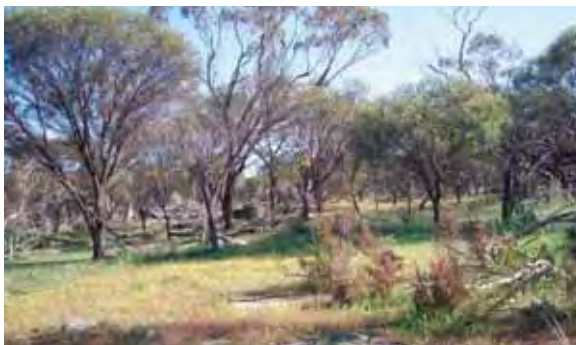
Photo A1.3: ULR01

Excellent condition vegetation association 3: *Eucalyptus loxophleba* subsp. *loxophleba* Open Low Woodland over *Acacia acuminata* Low Woodland over *Maireana brevifolia* and *Enchylaena tomentosa* Open Low Scrub over mixed annual Dense Herbs

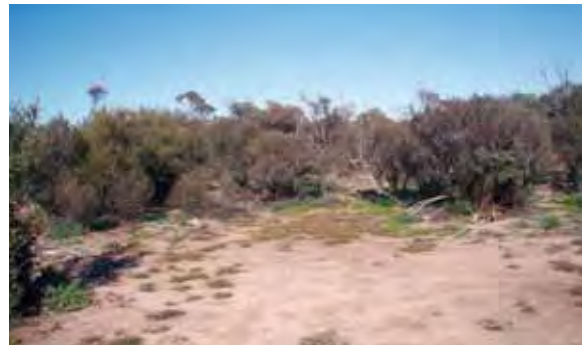
Photo A1.4: ULR01

Good condition vegetation association 4: *Melaleuca carrii*, *Exocarpos aphyllus* and *Hakea kippistiana* Low Scrub over *Atriplex hymenotheca* and *Enchylaena tomentosa* Open Dwarf Scrub over mixed annual Very Open Herbs

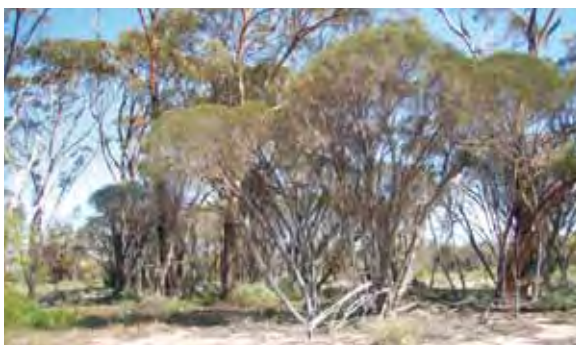
Photo A1.5: ULR01

Very good condition vegetation association 5: *Eucalyptus kondininensis* and *E. spathulata* Open Low Woodland over *Melaleuca atroviridis* and *Acacia acuminata* Open Scrub over *Rhagodia preissii* and *Enchylaena tomentosa* Dwarf Scrub over *Lomandra effusa* and mixed annual Open Herbs

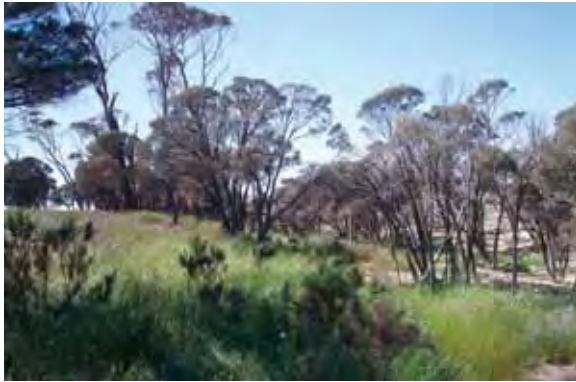
Photo A1.6: ULR02

Degraded condition vegetation association 1: *Eucalyptus kondininensis* Open Low Woodland over *Melaleuca pauperiflora* Open Scrub over *Sisymbrium* sp. Open Herbs and *Lolium rigidum* Open Low Grass

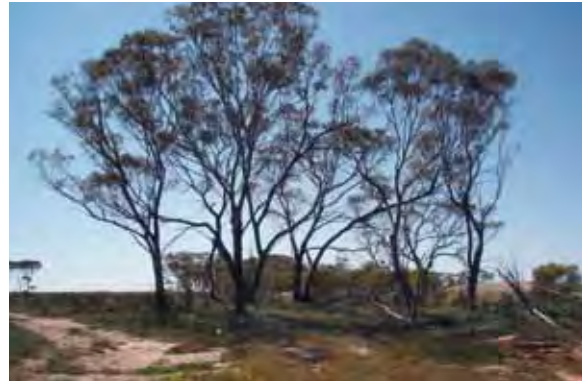
Photo A1.7: ULR02

Very good condition vegetation association 2: *Eucalyptus loxophleba* subsp. *loxophleba* Low Woodland over *Enchylaena tomentosa* Open Dwarf Scrub over *Austrostipa* spp. Open Tall Grass over mixed Open Herbs

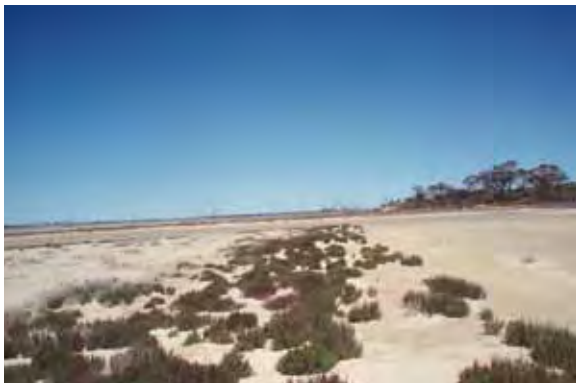
Photo A1.8: ULR02

Completely degraded condition vegetation association 3: *Tecticornia* spp. Dwarf Scrub

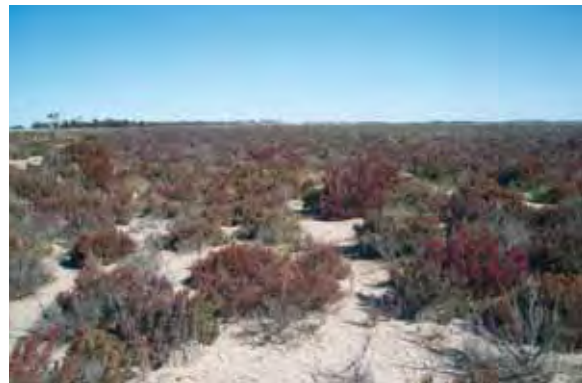
Photo A1.9: ULR02

Good condition vegetation association 4: *Tecticornia* spp. and *Atriplex* sp. Low Heath over mixed Very Open Herbs

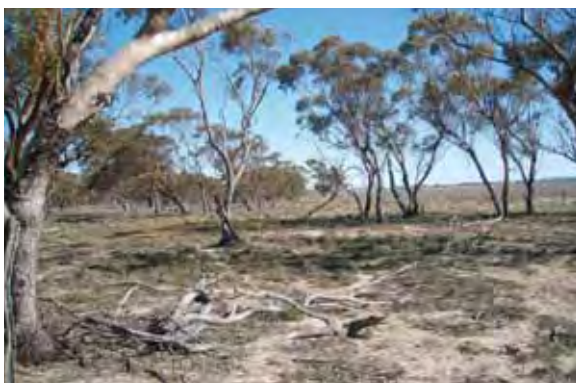
Photo A1.10: ULR02

Good condition vegetation association 5: *Eucalyptus loxophleba* subsp. *loxophleba* and *E. kondininensis* Open Low Woodland over *Maireana brevifolia* Open Dwarf Scrub over *Mesembryanthemum nodiflorum*, *Sclerolaena diacantha* and *Atriplex semibaccata* Open Herbs

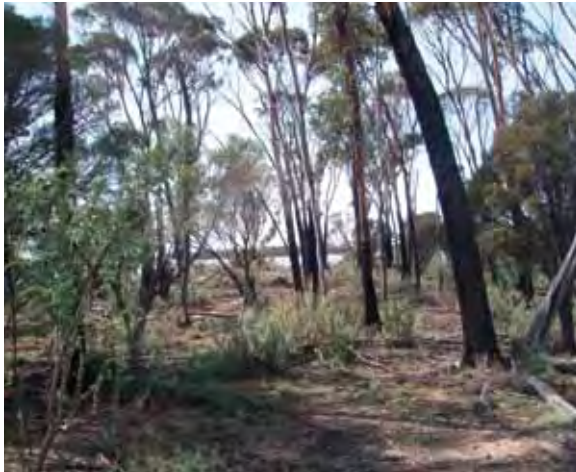
Photo A1.11: ULR03

Very good condition vegetation association 1: Eucalyptus kondininensis Low Woodland over *Melaleuca pauperiflora* Open Scrub over *Atriplex bunburyana* and *Rhagodia drummondii* Open Dwarf Scrub over *Disphyma crassifolium* Very Open Herbs

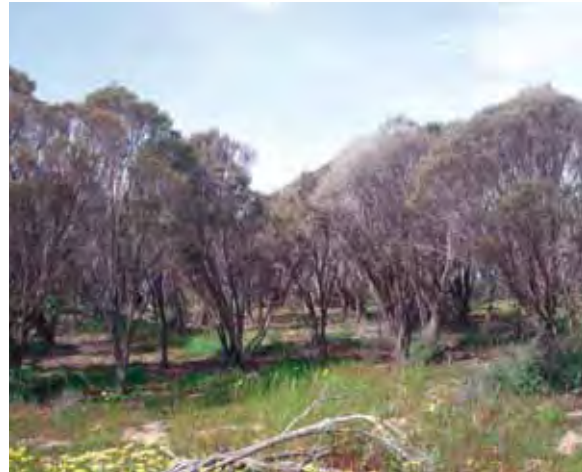
Photo A1.12: ULR03

Good condition vegetation association 2: Melaleuca lateriflora and *Melaleuca teuthidoides* Scrub over *Rhagodia preissii*, Open Dwarf Scrub over mixed introduced annual Dense Herbs

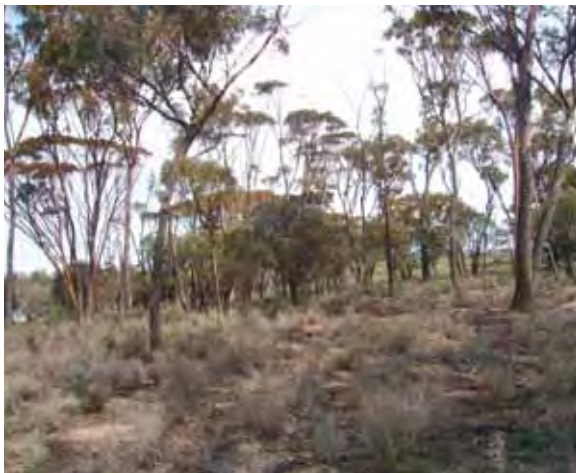
Photo A1.13: ULR03

Excellent condition vegetation association 3: Eucalyptus longicornis and *E. salubris* Open Woodland over *Melaleuca pauperiflora* Open Scrub over *Atriplex bunburyana* Dwarf Scrub over *Austrostipa* spp. Very Open Tall Grass

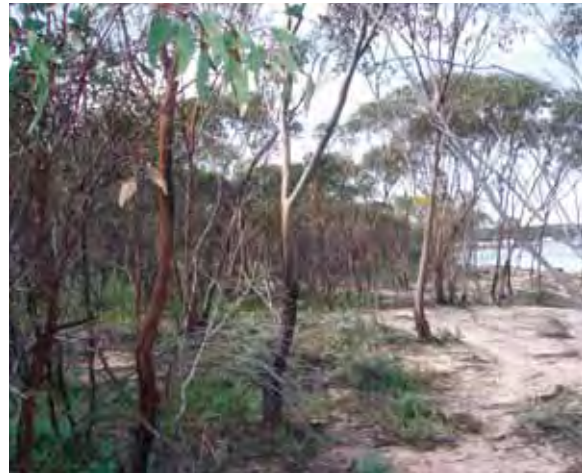
Photo A1.14: ULR03

Good condition vegetation association 4: Eucalyptus loxophleba subsp. *gratae* Open Tree Mallee over *Acacia acuminata* Open Scrub over *Rhagodia drummondii*, *Enchylaena tomentosa* and *Sclerolaena diacantha* Open Dwarf Scrub over mixed introduced annual Open Herbs

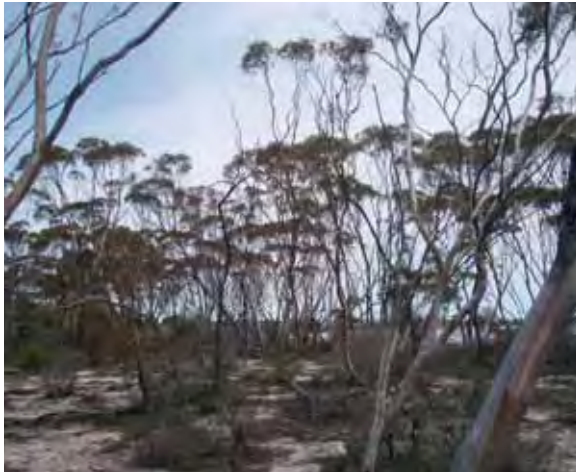
Photo A1.15: ULR03

Very good condition vegetation association 5: *Eucalyptus horistes* Open Tree Mallee over *Melaleuca atroviridis* and *Santalum acuminatum* Open Scrub over *Olearia dampieri*, *Rhagodia drummondii* and *Rinzia crassifolia* Open Dwarf Scrub over *Lomandra effusa* Very Open Herbs and *Lepidosperma* spp. and *Desmocladius* sp. Very Open Low Sedges

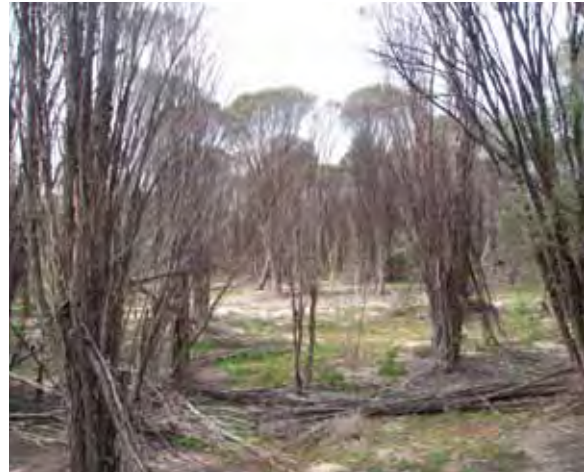
Photo A1.16: ULR03

Good condition vegetation association 6: *Melaleuca atroviridis* and *M. lateriflora* Scrub with scattered *Eucalyptus spathulata* over mixed Open Herbs

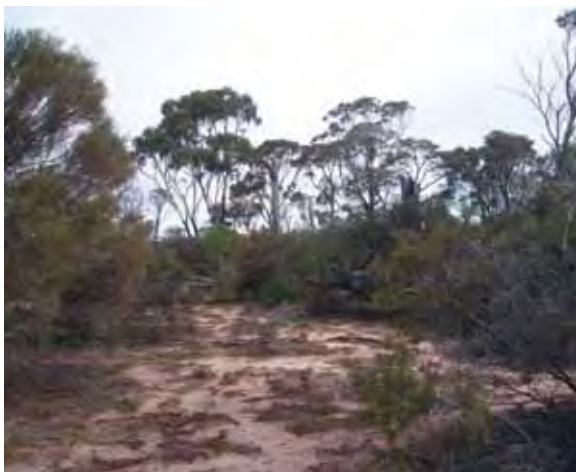
Photo A1.17: ULR03

Very good condition vegetation association 7: *Eucalyptus kondininensis* Open Woodland over *Melaleuca pauperiflora* Open Low Woodland over *Hakea kippistiana*, *Acacia colletioides* and *Rhagodia preissii* Open Scrub over *Scaevola spinescens* and *Lycium australe* Open Dwarf Scrub over *Disphyma crassifolia* Very Open Herbs

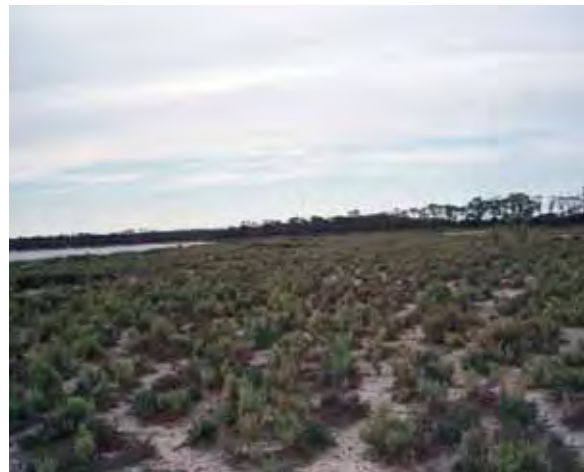
Photo A1.18: ULR03

Very good condition vegetation association 8: *Atriplex* sp., *Frankenia* sp. and *Tecticornia* spp., Dwarf Scrub over *Disphyma crassifolia* Very Open Herbs

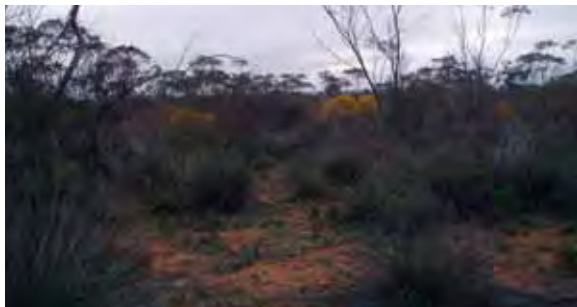
Photo A1.19: ULR04

Excellent condition vegetation association 1: *Eucalyptus subangusta* Very Open Tree Mallee over *Acacia assimilis*, *Alyxia buxifolia* and *Allocasuarina campestris* Open Scrub over *Platysace effusa* Open Dwarf Scrub over *Lepidosperma drummondii* Open Low Sedges over *Amphipogon* sp. and *Spartochloa scirpoidea* Very Open Tall Grass over mixed annual Open Herbs

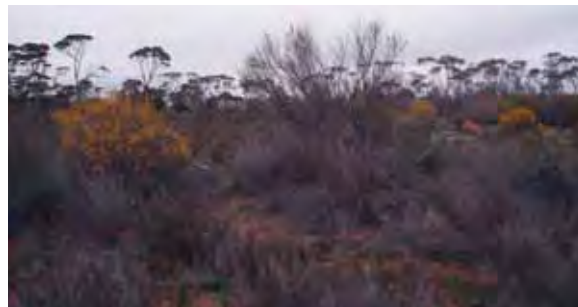
Photo A1.20: ULR04

Excellent condition vegetation association 2: *Leptospermum erubescens* and *Acacia assimilis* Open Scrub over *Spartochloa scirpoidea* Very Open Tall Grass over *Verticordia chrysanthella* and *Platysace effusa* Dwarf Scrub over *Borya sphaerocephala*, *Stylidium repens* and mixed annual Herbs

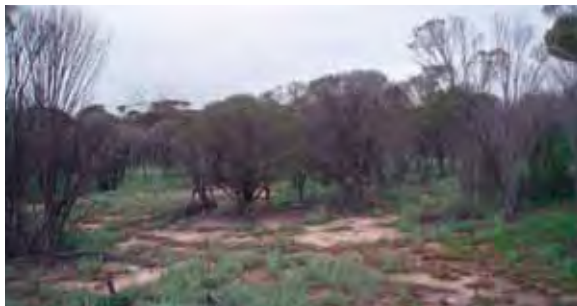
Photo A1.21: ULR04

Very good condition vegetation association 3: *Melaleuca lateriflora* and *Lycium australe* Scrub over *Atriplex bunburyana* Open Dwarf Scrub over *Angianthus tomentosus* and *Mesembryanthemum nodiflorum* Herbs

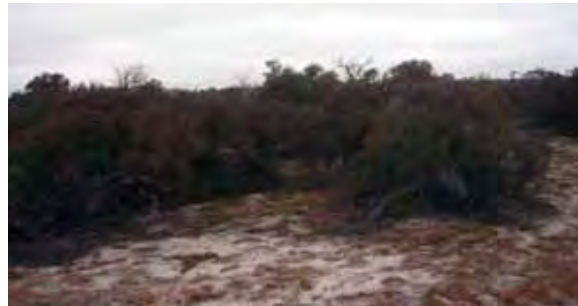
Photo A1.22: ULR04

Very good condition vegetation association 4: *Melaleuca pauperiflora*, *Lycium australe*, *Rhagodia preissii* and *Dodonaea viscosa* subsp. *angustissima* Low Scrub over *Jacksonia* sp. and *Rinzia crassifolia* Open Dwarf Scrub over *Borya laciniata*, *Brachyscome* sp. and *Podolepis capillaris* Open Herbs

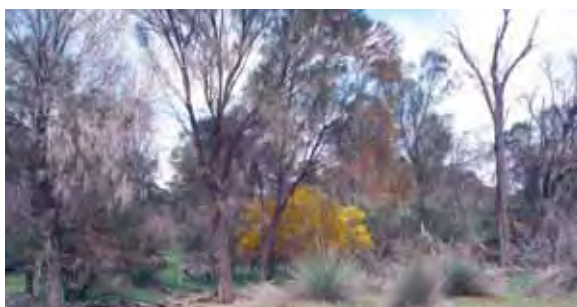
Photo A1.23: ULR04

Excellent condition vegetation association 5: *Allocasuarina huegeliana* Low Woodland over *Leptospermum erubescens* and *Acacia assimilis* Open Dwarf Scrub over *Spartochloa scirpoidea* Very Open Tall Grass over mixed annual Dense Herbs

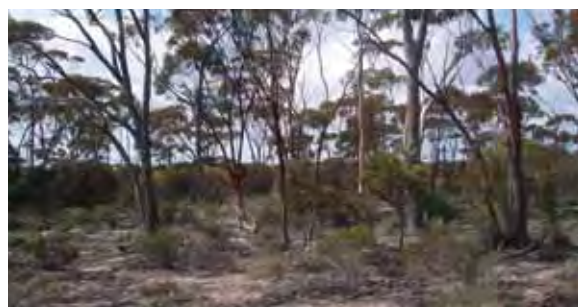
Photo A1.24: ULR04

Pristine condition vegetation association 6: *Eucalyptus salmonophloia*, *E. salubris* and *E. longicornis* Open Woodland over *Santalum acuminatum* Open Low Woodland over *Melaleuca laxiflora* Open Scrub over *Microcybe multiflora*, *Olearia muelleri*, *Scaevola spinescens* and *Atriplex bunburyana* Dwarf Scrub

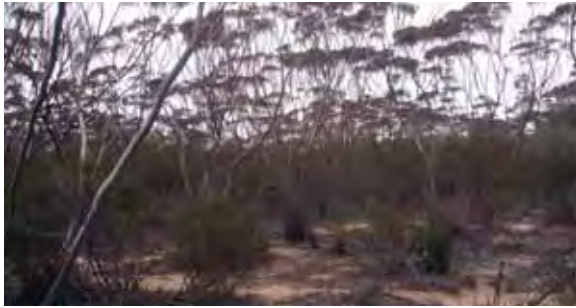
Photo A1.25: ULR04

Excellent condition vegetation association 7:
Eucalyptus horistes Open Shrub Mallee over
Beyeria leschenaultia and *Melaleuca laxiflora* Low
Scrub over *Olearia dampieri* and *Phebalium*
tuberosum Open Dwarf Scrub over
Lepidosperma drummondii, *Lepidobolus*
chaetocephalus and *Desmocladius asper* Very
Open Low Sedges

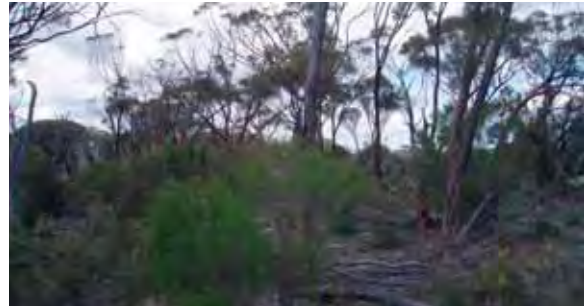
Photo A1.26: ULR04

Excellent condition vegetation association 8:
Eucalyptus spathulata Open Low Woodland over
Dodonaea viscosa subsp. *angustissima* and *Hakea*
kippistiana Low Scrub over *Rhagodia drummondii*,
Rinzia crassifolia and *Enchylaena tomentosa*
Open Dwarf Scrub over *Disphyma crassifolia* and
Carpobrotus modestus Very Open Herbs

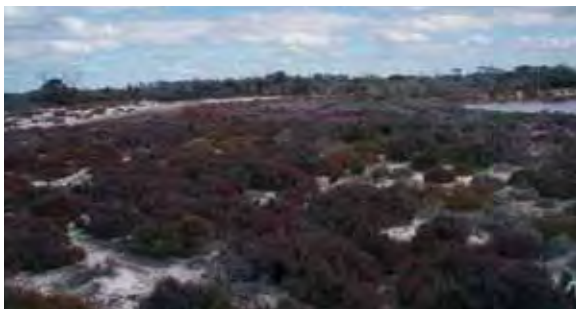
Photo A1.27: ULR04

Very good condition vegetation association 9:
Tecticornia spp., *Frankenia* sp., *Atriplex* sp. and
Roycea spinescens Low Heath over *Crassula*
sp. and *Senecio* sp. Very Open Herbs

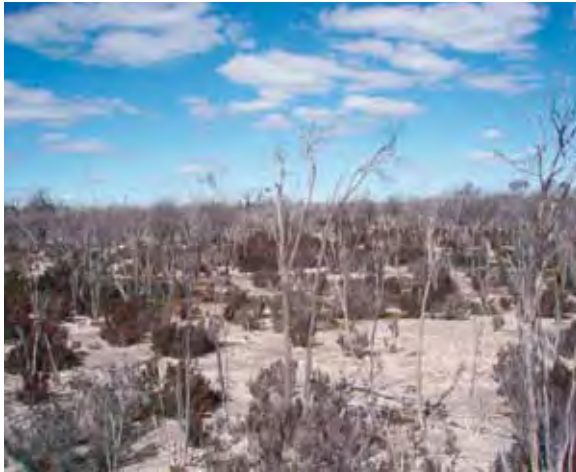
Photo A1.28: ULR05

Completely degraded condition vegetation association 1: *Tecticornia* spp. Dwarf Scrub over *Mesembryanthemum nodiflorum* and *Cotula bipinnata* Very Open Herbs and *Parapholis incurva* Very Open Low Grass

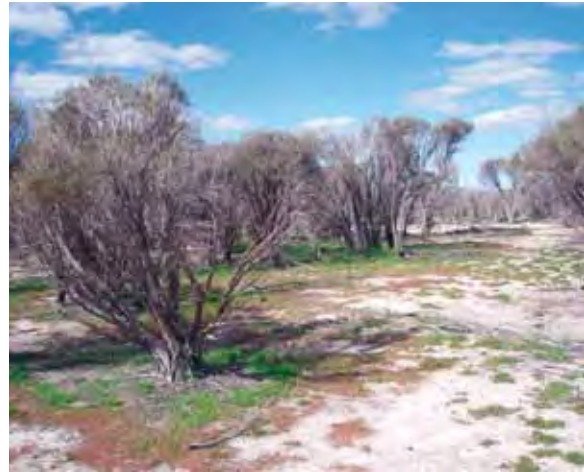
Photo A1.29: ULR05

Good condition vegetation association 2: *Melaleuca lateriflora*, *M. pauperiflora*, *M. acuminata* and *M. scalena* Scrub to 4 m over mixed annual introduced Herbs

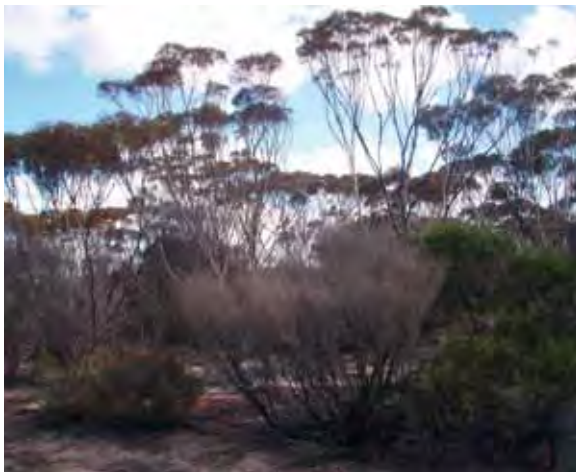
Photo A1.30: ULR05

Very good condition vegetation association 3: *Eucalyptus horistes* Open Shrub Mallee over *Melaleuca scalena*, *M. carrii*, *Leptospermum erubescens*, *Leptomeria* sp. and *Grevillea hookeriana* Open Scrub over *Calytrix leschenaultia* and *Baeckea* sp. Open Dwarf Scrub over *Neurachne alopecuroidea* and *Triodia rigidissima* Very Open Low Grass

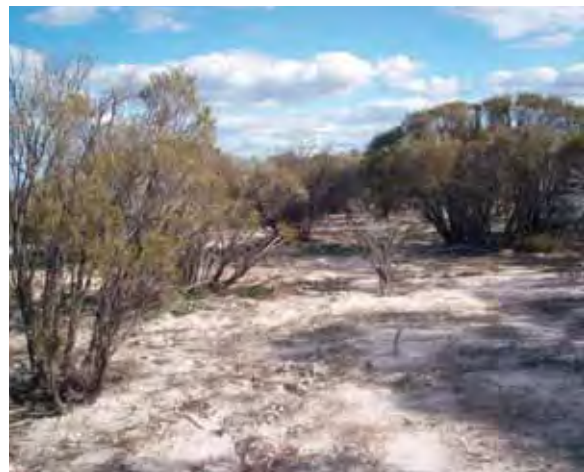
Photo A1.31: ULR05

Very good condition vegetation association 4: *Melaleuca lateriflora* and *M. pauperiflora* Scrub over *Rhagodia preissii*, *Maireana* sp. and *Enchylaena tomentosa* Open Dwarf Scrub over mixed annual Open Herbs

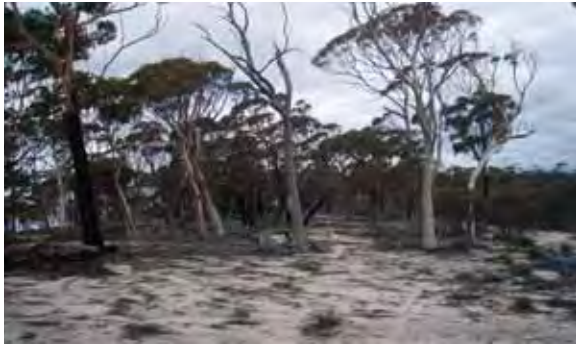
Photo A1.32: ULR06

Good condition vegetation association 1: *Eucalyptus kondininensis*, *E. salicola*, *E. longicornis* and *E. salmonophloia* Woodland over *Lomandra effusa* Very Open Herbs

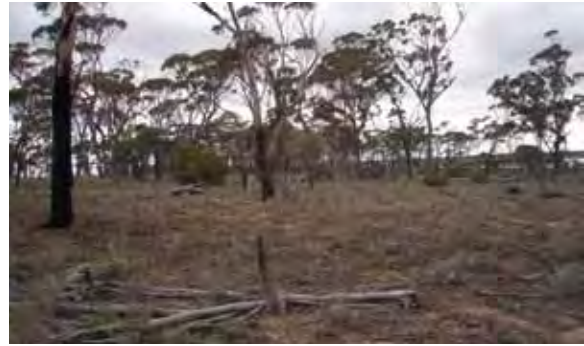
Photo A1.33: ULR06

Very good condition vegetation association 1: *Eucalyptus kondininensis*, *E. salicola*, *E. longicornis* and *E. salmonophloia* Woodland over *Lomandra effusa* Very Open Herbs

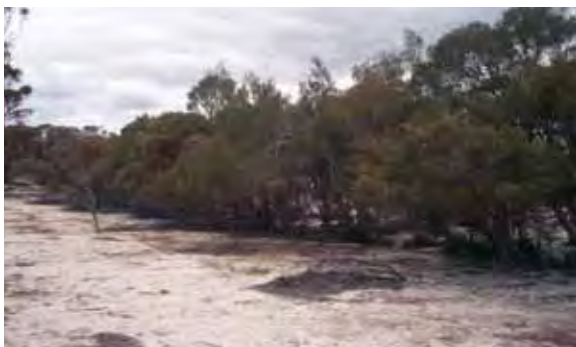
Photo A1.34: ULR06

Good condition vegetation association 2: *Melaleuca carrii* Thicket over *Tecticornia* spp. Open Dwarf Scrub

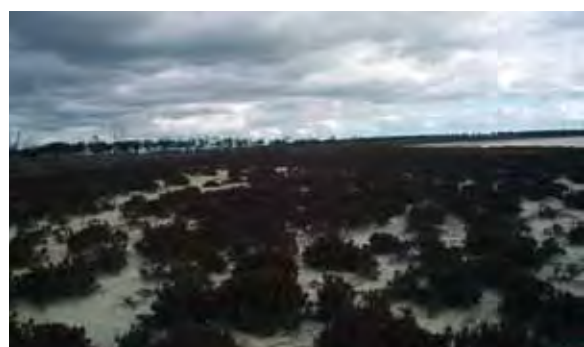
Photo A1.35: ULR06

Good condition vegetation association 3: *Tecticornia* spp. Low Heath over *Disphyma crassifolium* and *Mesembryanthemum nodiflorum* Very Open Herbs and *Parapholis incurva* Very Open Low Grass

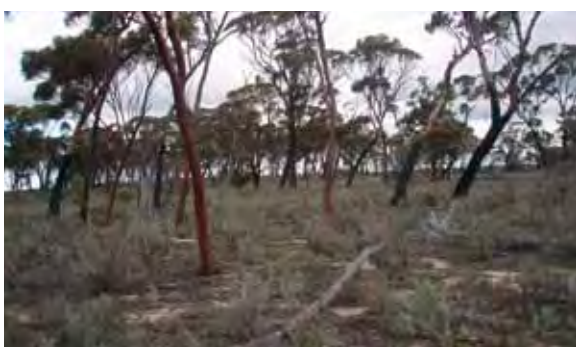
Photo A1.36: ULR06

Excellent condition vegetation association 4: *Eucalyptus salubris* and *E. kondininensis* Open Woodland over *Atriplex bunburyana* Dwarf Scrub over *Sclerolaena diacantha* and mixed annual (native) Very Open Herbs

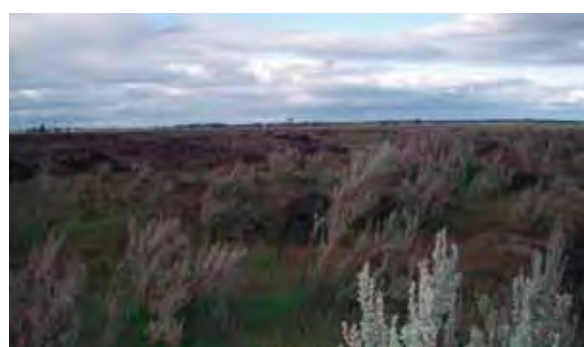
Photo A1.37: ULR06

Degraded condition vegetation association 5: *Atriplex bunburyana* Low Scrub over *Tecticornia* spp. and *Maireana brevifolia* Dwarf Scrub over *Avena fatua*, *Lolium rigidum* and *Bromus rubens* introduced Low Grass

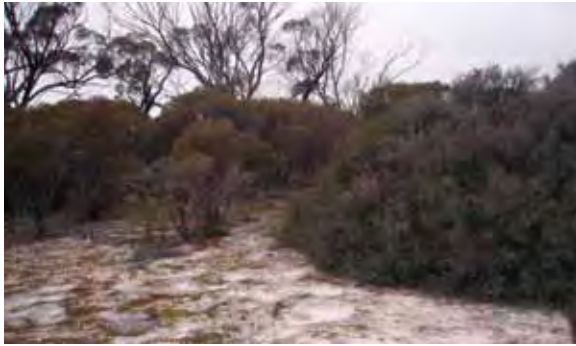
Photo A1.38: ULR07
 Very good condition vegetation association 1:
Eucalyptus spathulata Open Low Woodland
 over *Melaleuca pauperiflora* and *M. thyoides*
 Open Scrub over mixed annual Herbs

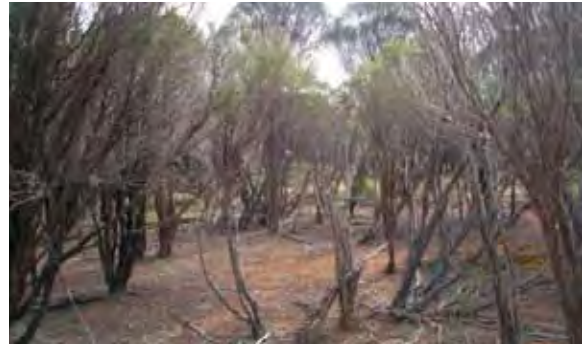
Photo A1.39: ULR07
 Very good condition vegetation association 2:
Melaleuca lateriflora, *M. atroviridis* and *M. acuminata* Thicket over mixed Open Herbs

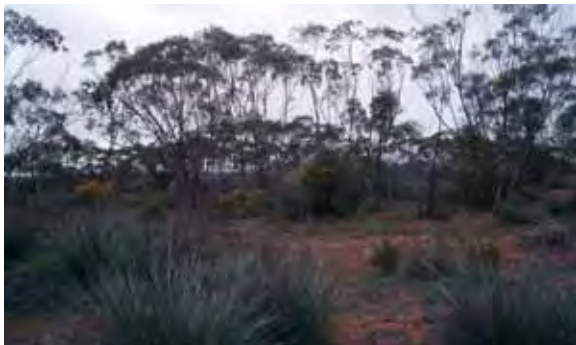
Photo A1.40: ULR07
 Excellent condition vegetation association 3:
Eucalyptus subangusta Very Open Shrub Mallee
 over *Spartochloa scirpoidea* and *Amphipogon*
 sp. Very Open Low Grass and *Lepidosperma*
drummondii and *Lepidobolus chaetocephalus*
 Open Low Sedges over *Borya constricta* and
 mixed annual Herbs

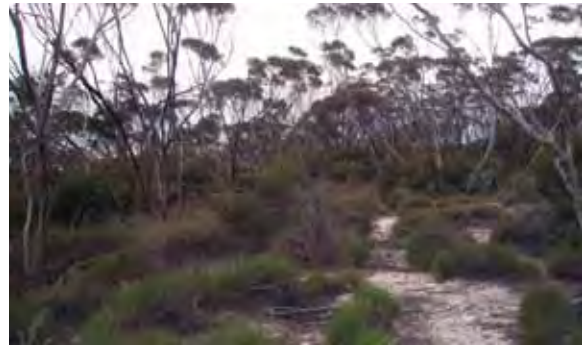
Photo A1.41: ULR07
 Excellent condition vegetation association 4:
Eucalyptus horistes Very Open Shrub Mallee
 over *Jacksonia* sp. and *Melaleuca carrii* Low
 Scrub over *Triodia rigidissima* Open Low Grass

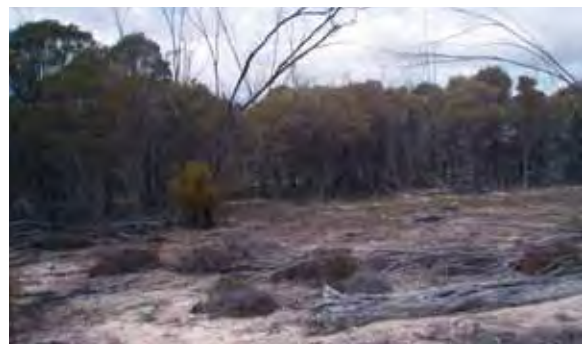
Photo A1.43: ULR07
 Good condition vegetation association 6:
Melaleuca pauperiflora Thicket over *Sclerolaena*
diacantha and mixed annual Very Open Herbs

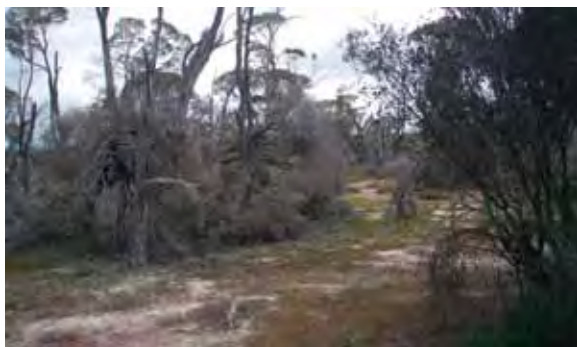
Photo A1.44: ULR07

Excellent condition vegetation association 7: *Melaleuca pauperiflora* and *M. cucullata* Open Woodland over *Melaleuca lateriflora* and *Acacia* sp. Open Scrub over mixed annual Open Herbs. Melaleucas senescent but seedlings present.

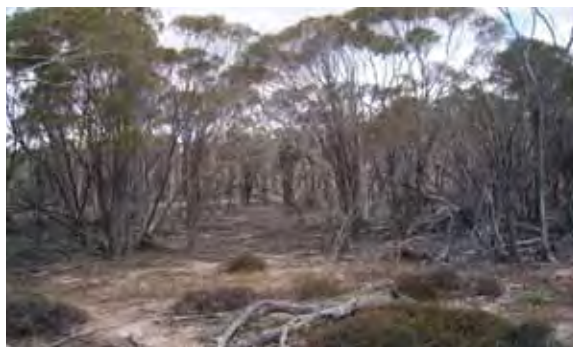
Photo A1.45: ULR07

Excellent condition vegetation association 8: *Eucalyptus celastroides* Open Tree Mallee over *Melaleuca pauperiflora* Scrub over *Acacia acanthoclada* and *Eremophila decipiens* Low Scrub over *Sclerolaena diacantha* and mixed annual Open Herbs

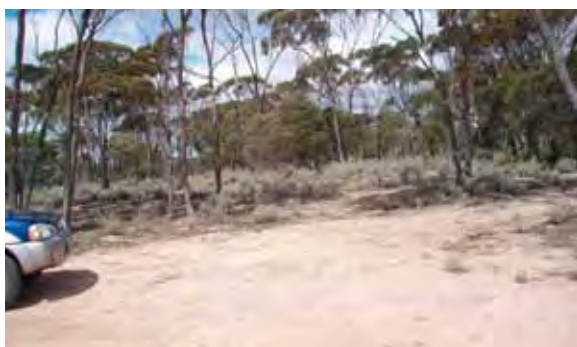
Photo A1.46: ULR07

Excellent condition vegetation association 9: *Eucalyptus longicornis*, *E. salubris* and *E. salmonophloia* Open Woodland over *E. yilgarnensis* Very Open Tree Mallee over *Melaleuca pauperiflora* Open Scrub over *Atriplex bunburyana* Open Dwarf Scrub

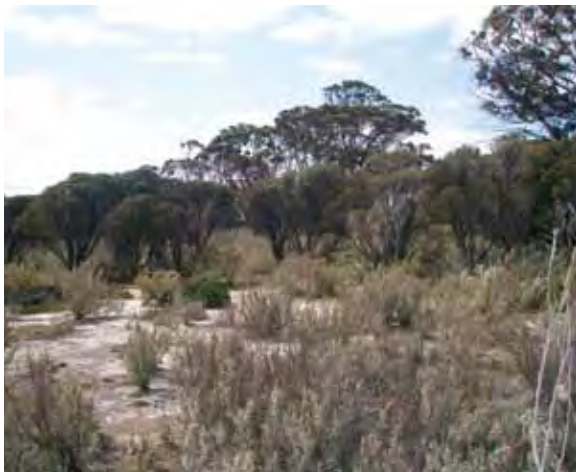
Photo A1.47: ULR08

Very good condition vegetation association 1: Eucalyptus kondininensis Open Low Woodland over Melaleuca pauperiflora and M. lateriflora Open Scrub over Atriplex bunburyana Dwarf Scrub over Mesembryanthemum nodiflorum introduced Very Open Herbs

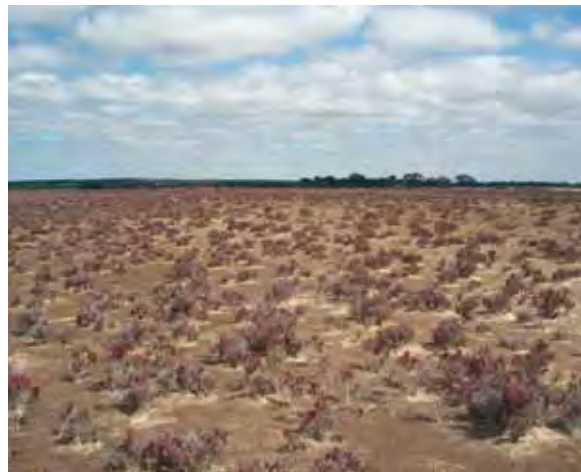
Photo A1.48: ULR08

Very good condition vegetation association 2: Tecticornia spp. Open Dwarf Scrub over bare soil

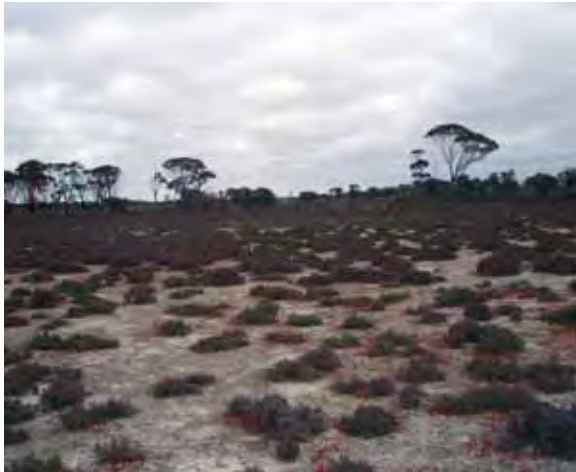
Photo A1.49: ULR09

Good condition vegetation association 1 (varies from completely degraded to good in less saline areas): *Tecticornia* spp. Dwarf Scrub over *Mesembryanthemum nodiflorum* Very Open Herbs

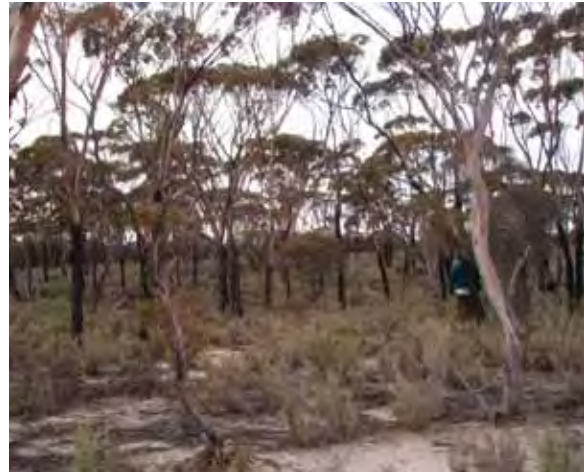
Photo A1.50: ULR09

Very good condition vegetation association 2: *Eucalyptus kondininensis* Low Woodland (previously cleared) over *Melaleuca pauperiflora* Scrub over *Disphyma crassifolium* and *Mesembryanthemum nodiflorum* Very Open Herbs

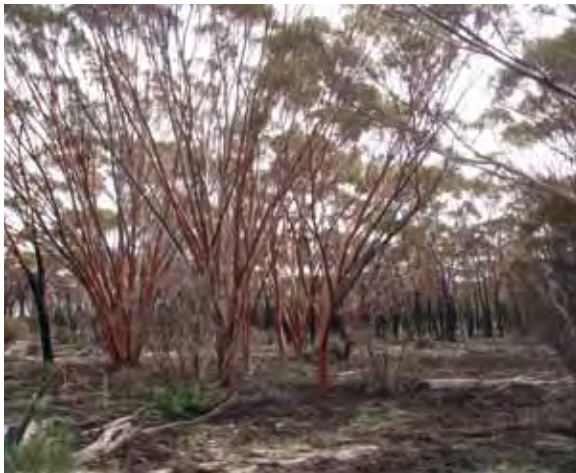
Photo A1.51: ULR09

Very good condition vegetation association 3: *Eucalyptus calycogona* Open Tree Mallee over *Melaleuca hamulosa* Open Scrub over *Helichrysum leucopsidium* Very Open Herbs

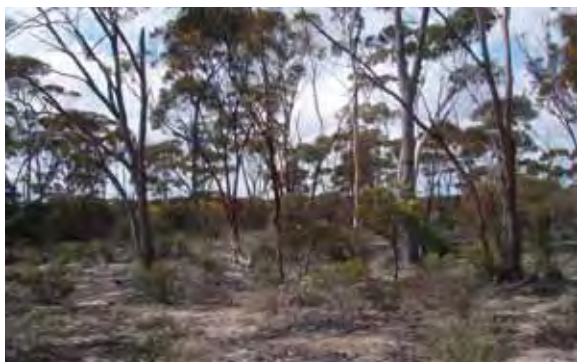
Photo A3.1

Pristine condition woodland, Crown Reserve 28547 (ULR04 vegetation association 6).

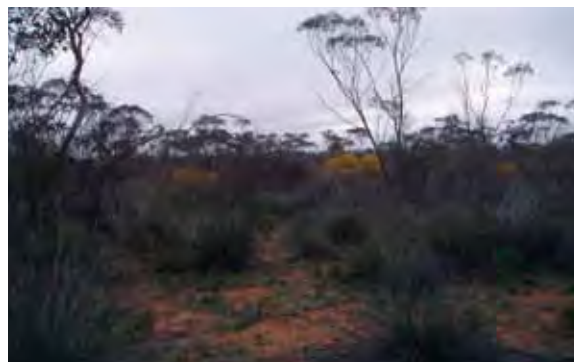
Photo A3.2

Excellent condition tree mallee, Crown Reserve 28547 (ULR04 vegetation association 1).

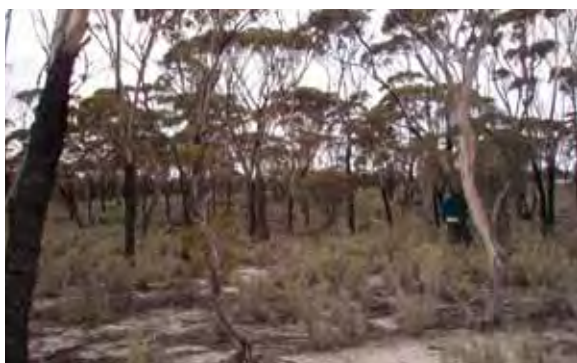
Photo A3.3

Very good condition woodland, Guelfi's (ULR09 vegetation association 2).

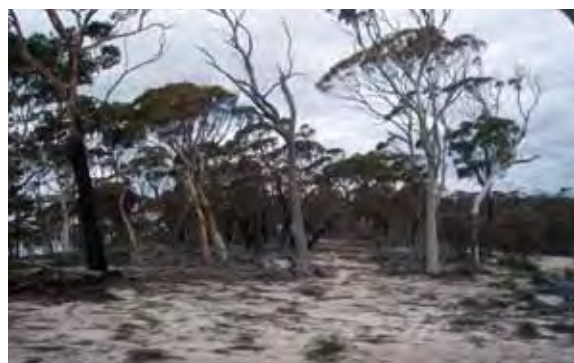
Photo A3.4

Good condition woodland, Williamson's (ULR06 vegetation association 1).

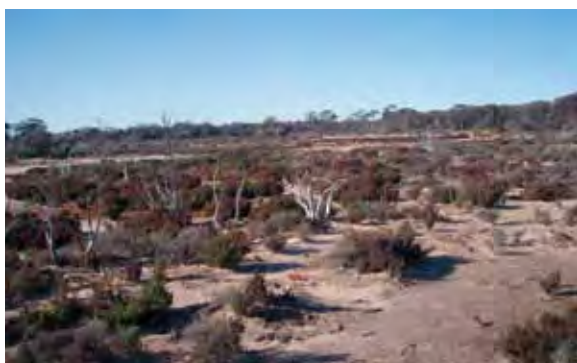
Photo A3.5

Degraded samphire (formerly *Melaleuca* sp.), Lucca's (ULR01 vegetation association 2).

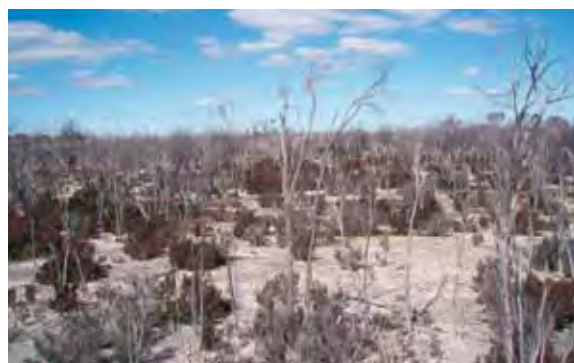
Photo A3.6

Completely degraded samphire (formerly *Melaleuca* sp), Stone's (ULR05 vegetation association 1).
