RIVERCARE

Guidelines for Ecologically Sustainable
Management of Rivers
and Riparian Vegetation

Occasional Paper No 03/95

A.W. Raine and J.N. Gardiner

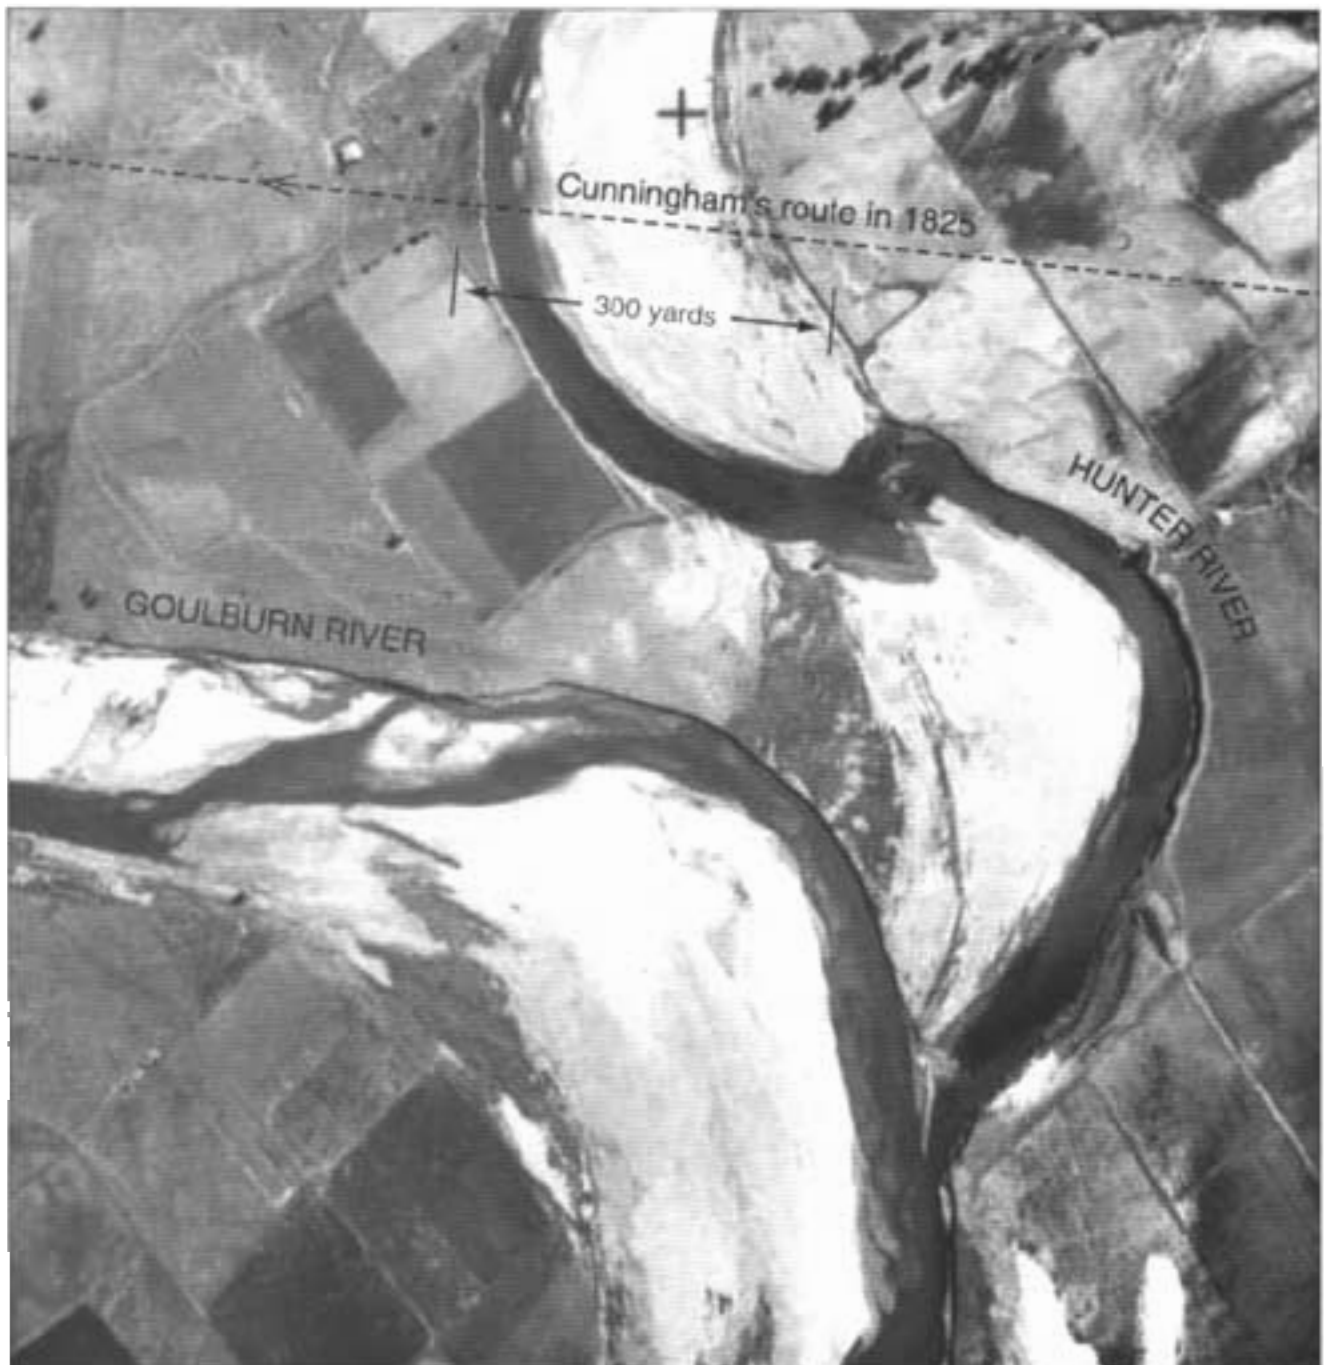
Plate 1. Aerial photograph of the junction of the Upper Hunter and Goulburn rivers in 1955, showing the place at which explorer Allan Cunningham in 1825 described the Upper Hunter as 'deep and not above 50 yards wide'.

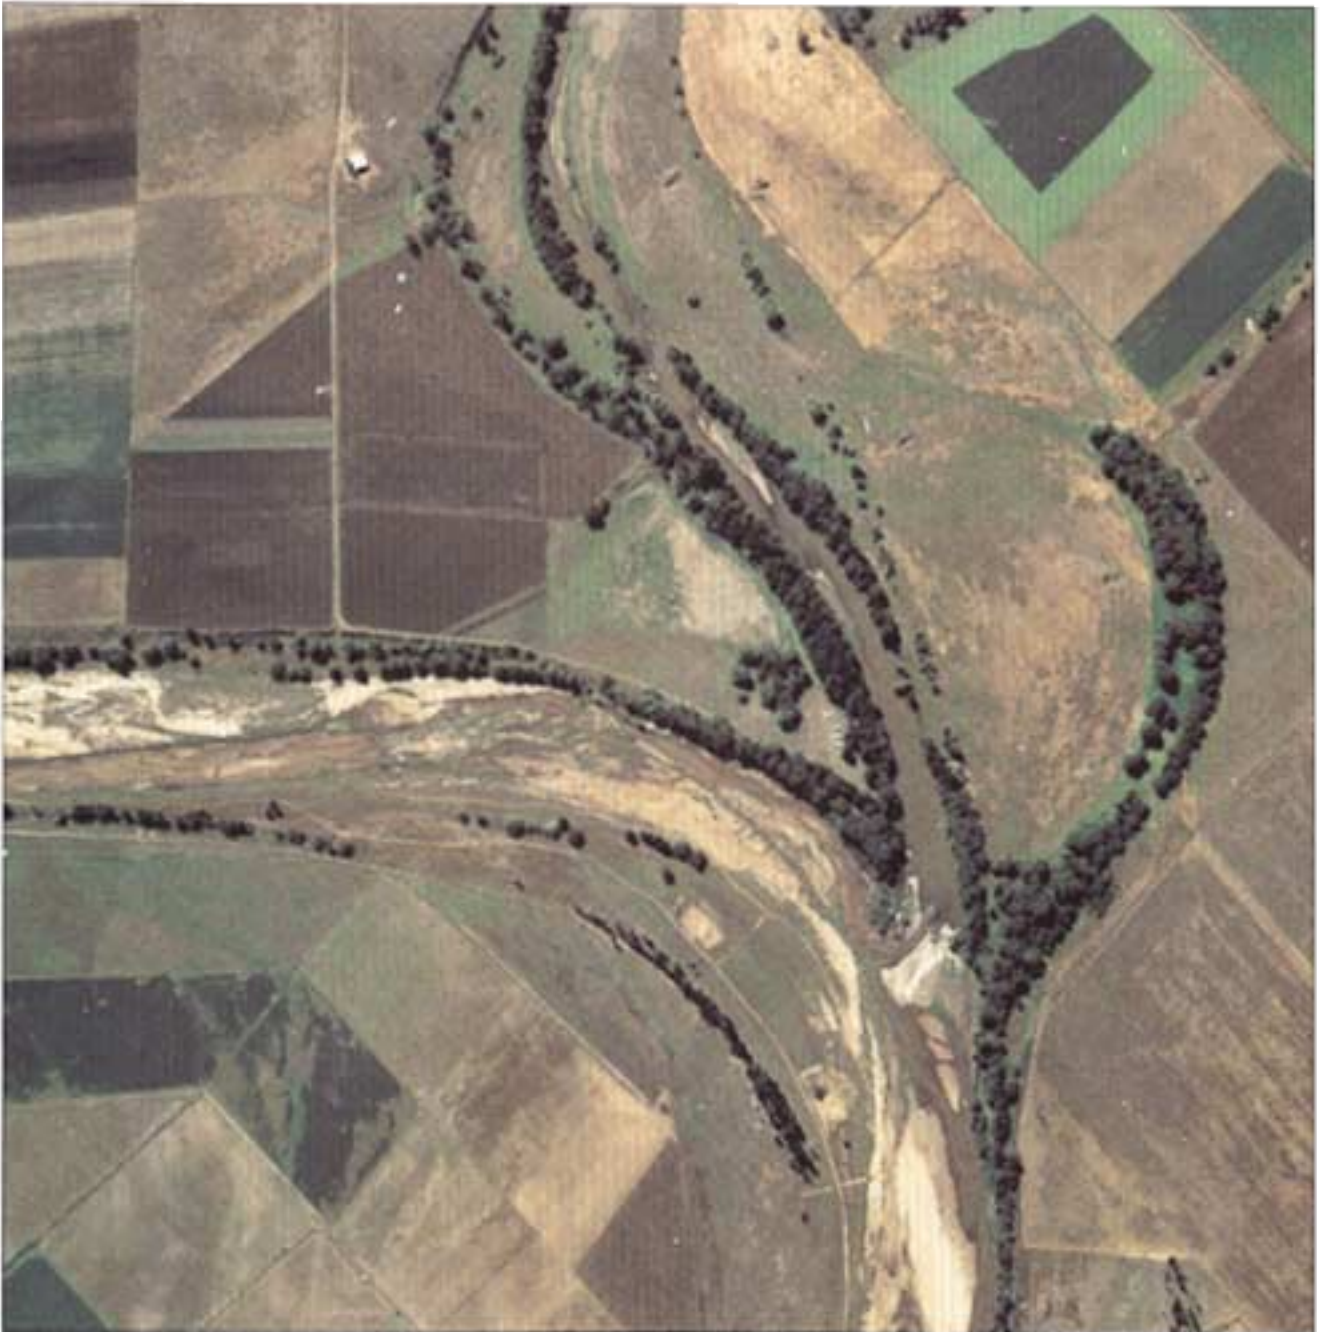
Plate 2. Aerial photograph of the junction of the Upper Hunter and Goulburn rivers in 1993. Comparison with Plate 1 shows the results of extensive river training and realignment works undertaken after the 1955 flood.

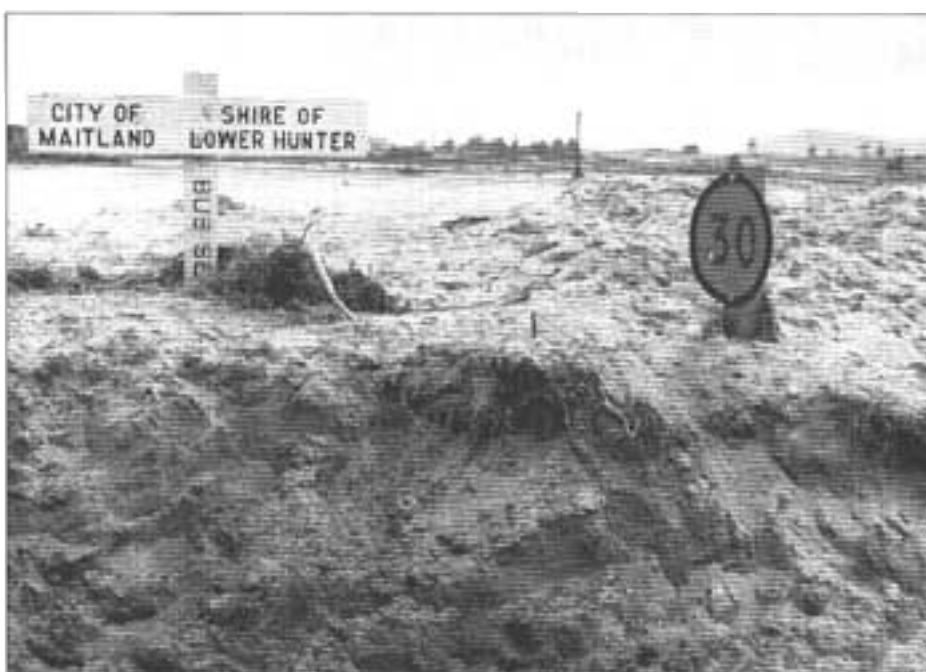
Plate 3. Sediment deposited by the Hunter River at Maitland following the 1955 flood.

The disastrous flood of 1955 further brought home the extent of the deterioration of the Hunter River's condition, fulfilling the foregoing prediction (see Plate 3). A report (Parliament of New South Wales 1956) of the Committee of Advice on Flood Control and Mitigation that was subsequently established quotes the conclusions of Mr H.G. Strom, Divisional Engineer for Rivers and Streams, State Rivers and Water Supply Commission, Victoria, who was commissioned to investigate river-bank erosion along the Hunter River before and after the flood. Mr Strom reported, *inter alia*:

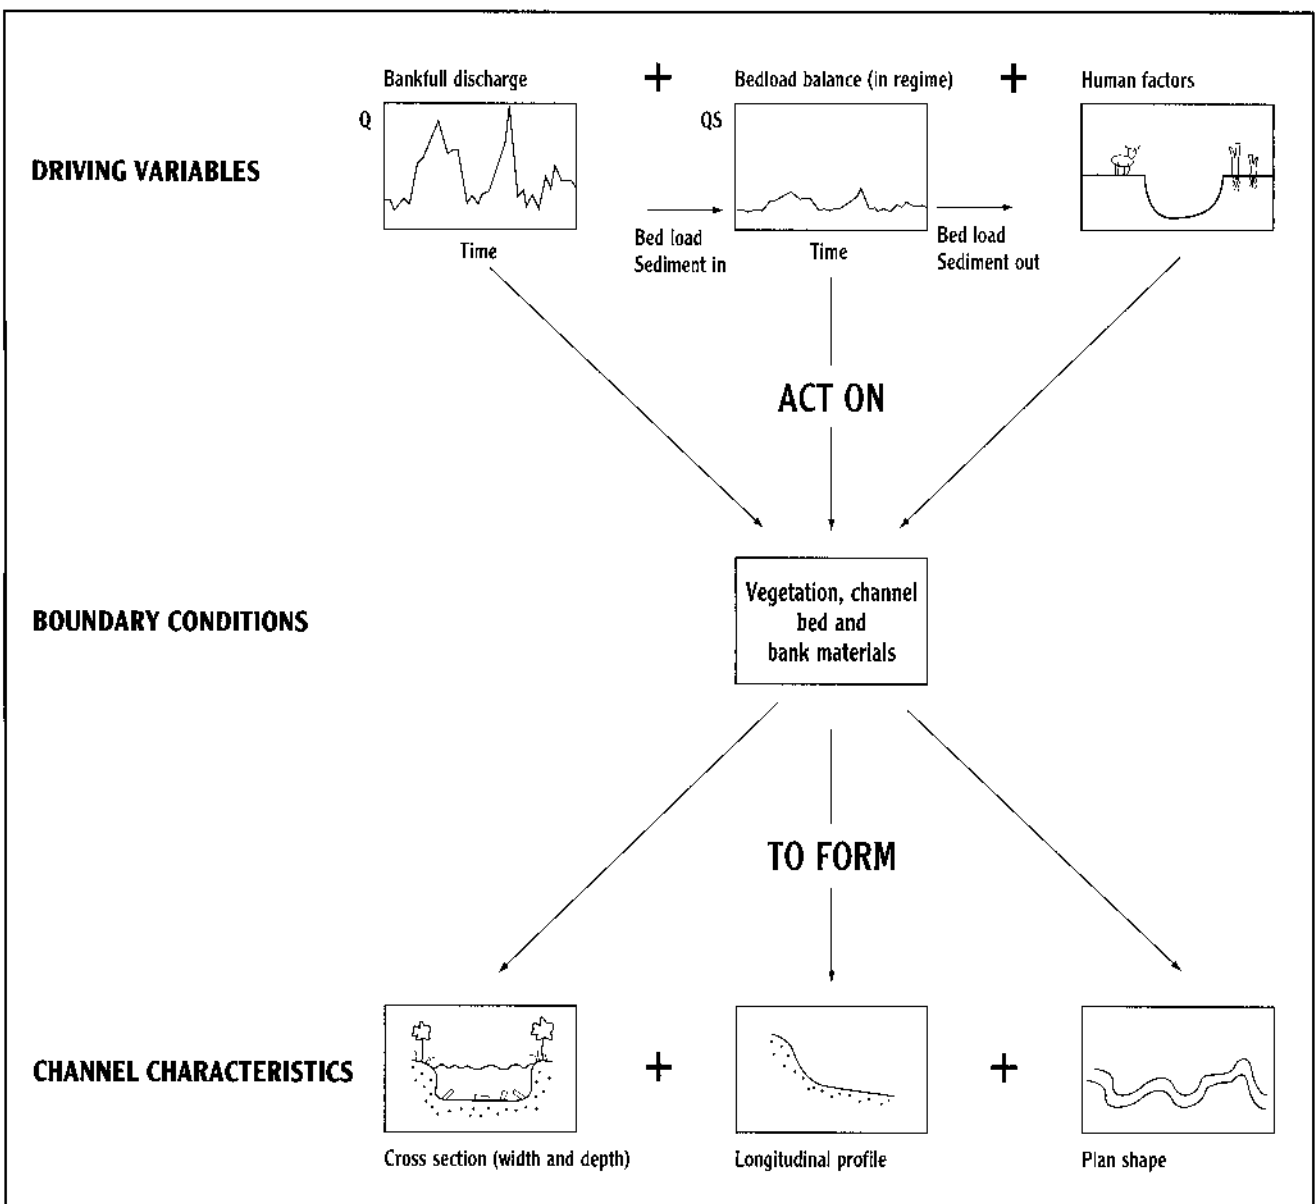
Figure 1. The interaction of discharge and sediment with vegetation in determining river channel characteristics (after Brookes 1992).

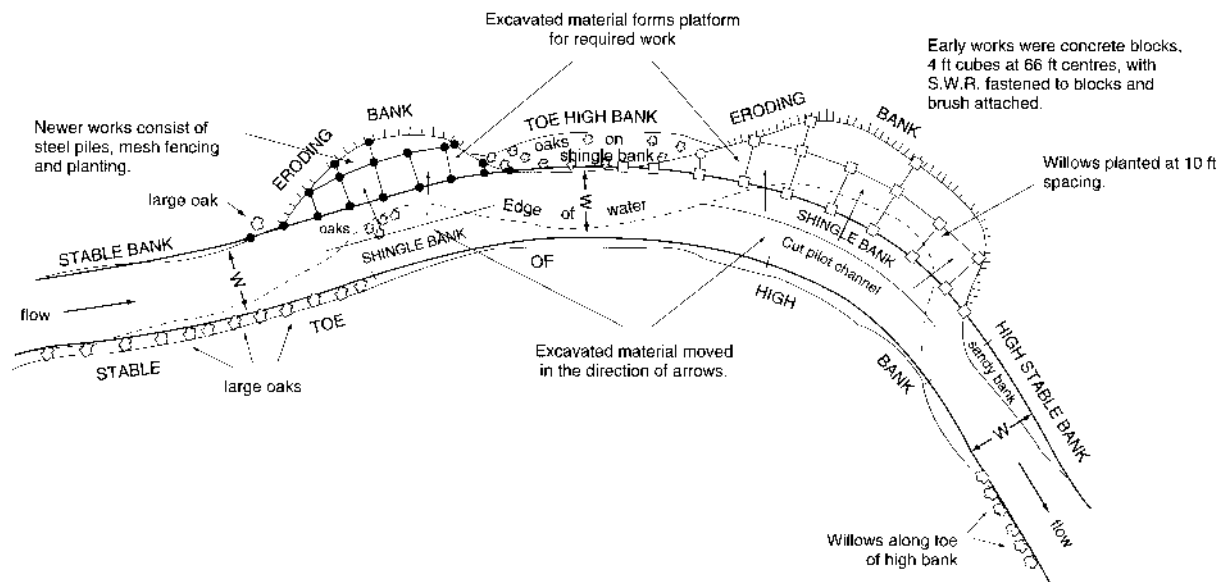
Figure 2. Stream control and realignment.

Forms of protective work were attempted, including concrete blocks secured with steel wire ropes, brush fencing, and stonework, all associated with planting of vegetation such as willows. Figure 2 outlines a typical plan for stream control and realignment.

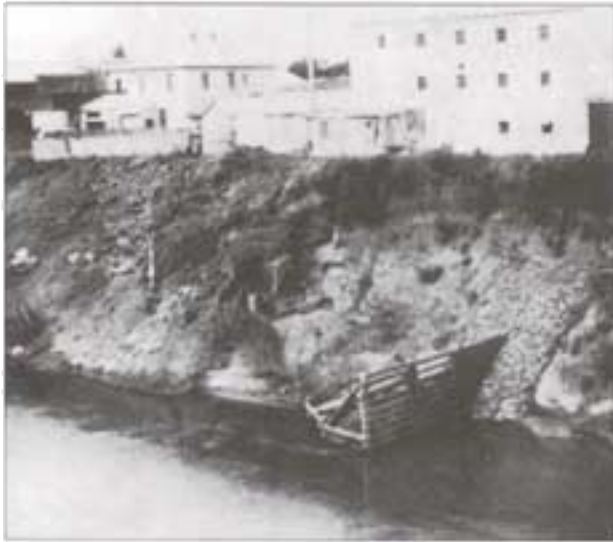
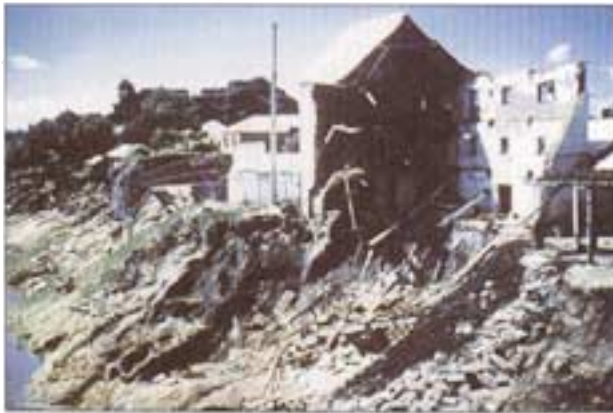
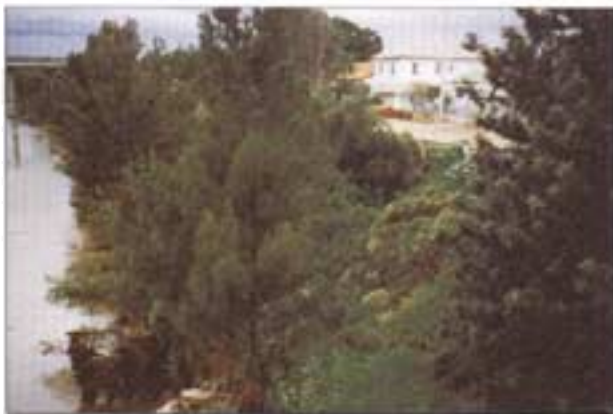
Plate 5. **Upper:** One of a series of groynes built in the Hunter River at Singleton in the early 1950s, to protect the flour mill and bridge abutment. **Middle:** The 'protected' area soon after the 1955 flood. Groynes were later abandoned as a means of bank protection in favour of 'river training' methods. **Lower:** A recent photograph of this area shows bank stability. A rock toe training wall and bank revetment has been used with success to replace the earlier groynes. Note remnants of the old groyne just left of centre at the bottom of the photograph.

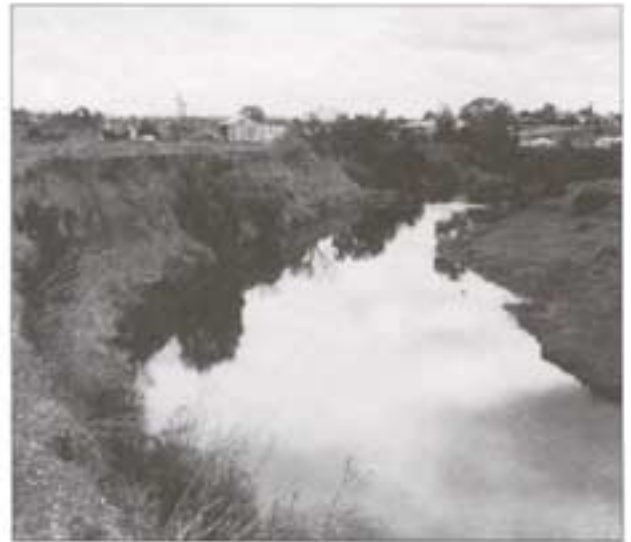
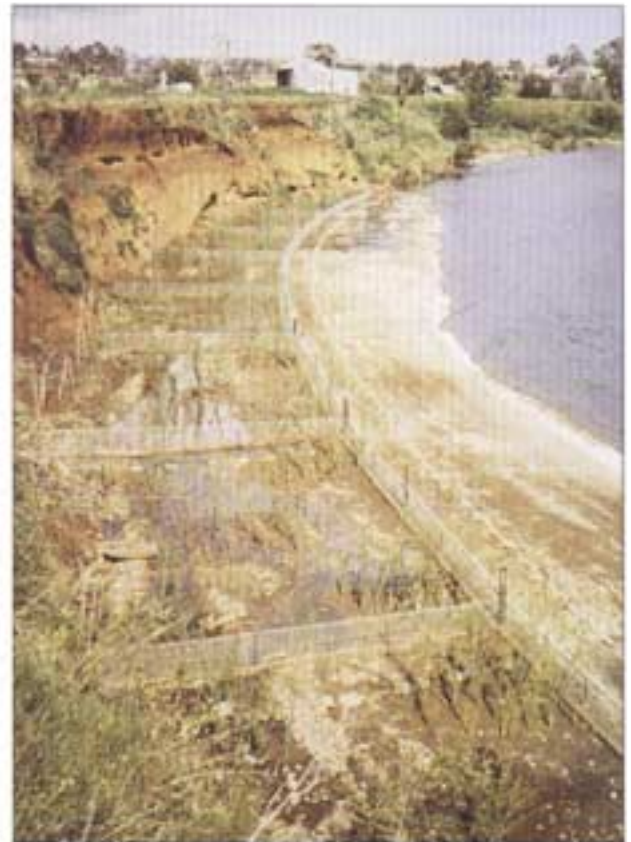
Plate 6. A section of the Hunter River at Muswellbrook before (upper) and after (lower) treatment, looking downstream. The lower photograph shows the set out of the low wire mesh training fences secured to vertical railway track guiding flows away from the eroding high bank. The embayments have been planted with willows.

The technique which has been commonly used for this purpose employs low wire mesh fences formed into paddocks to entrap the silt (Plate 6). Other structural means such as wooden jacks are also being trialled. These act to retard the flow of the river, causing silt to drop. Willow or some other suitable species is planted in the embayments to hold and bind the deposited silt. This vegetation takes over, in time, to become the means of protecting the bank from further erosion. The various zones of the bank—the toe, and the middle and upper zones—present different habitats and thus require

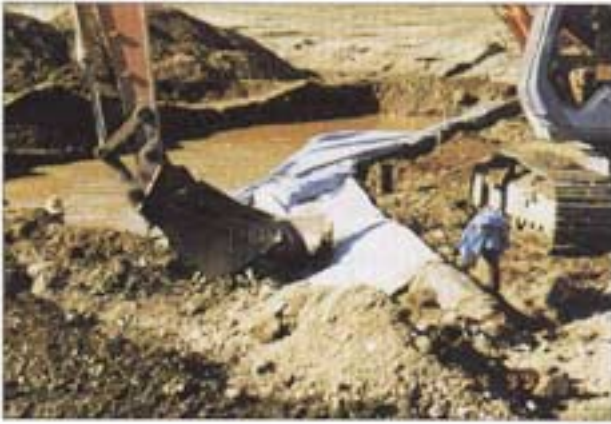
Plate 7. Constructing an experimental log sill in the Nambucca River. The geo-textile membrane reduces undersill seepage and raises the watertable level of the stream.

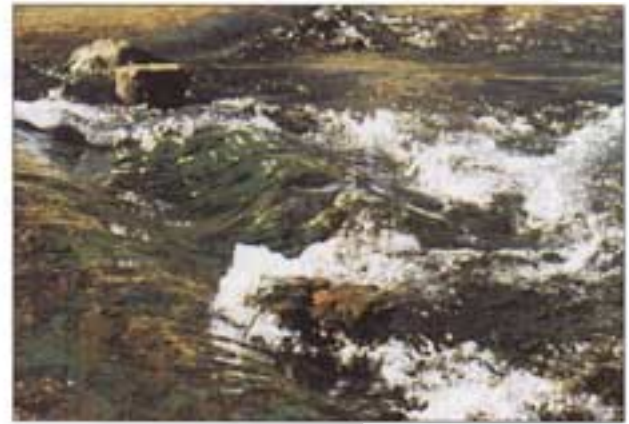
Plate 8. An experimental log sill built recently in the Nambucca River. The sill is recreating the pool-riffle sequence of the river and re-establishing the biological balance.

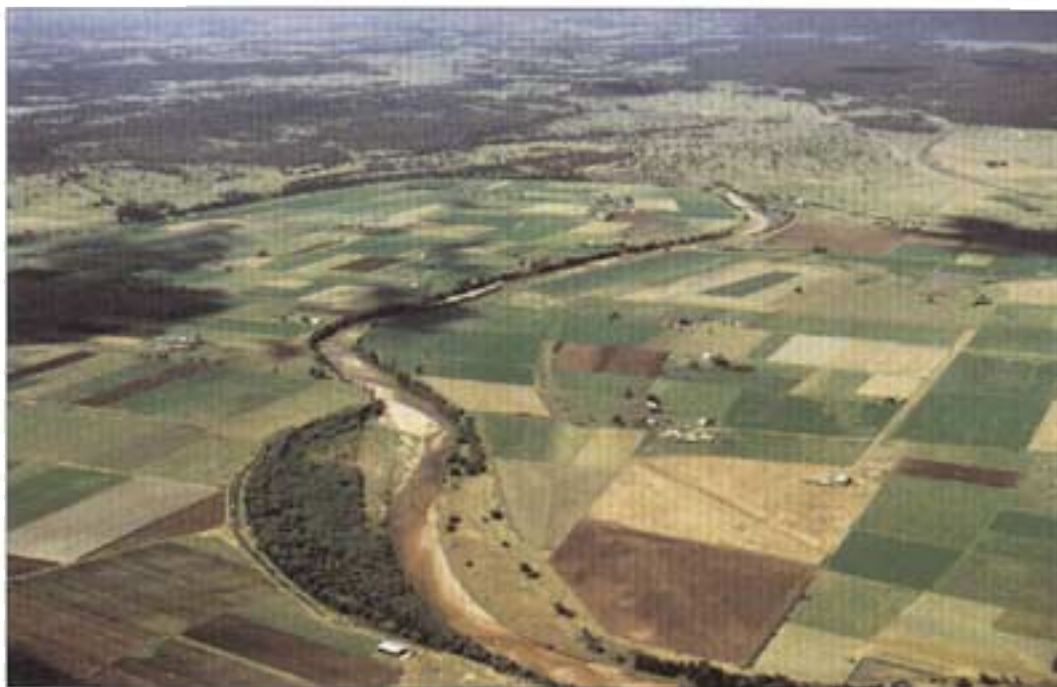
Plate 9. Photograph taken from the left bank of the Hunter River at Scotts Flat, looking downstream. It shows the river being trained past an extensive eroding bank from stable section to stable section. The river works are now well consolidated.

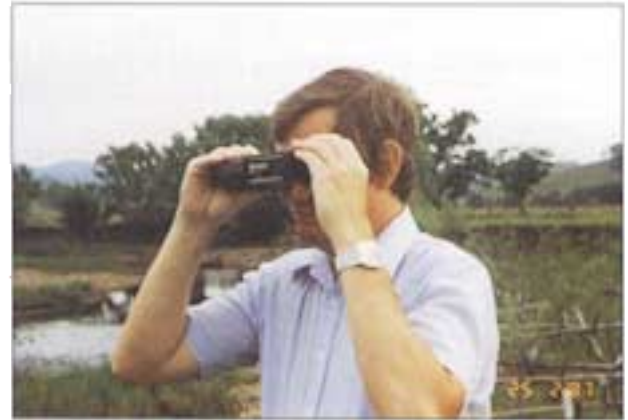
Plate 10. By using an optical range finder, channel widths can be quickly compared with the ideal and an assessment made of the degree of degradation.

- Theoretical calculations (outlined earlier)
- Inspection and measurements from aerial photographs
- An on-ground check at strategic locations using an optical range finder (Plate 10).

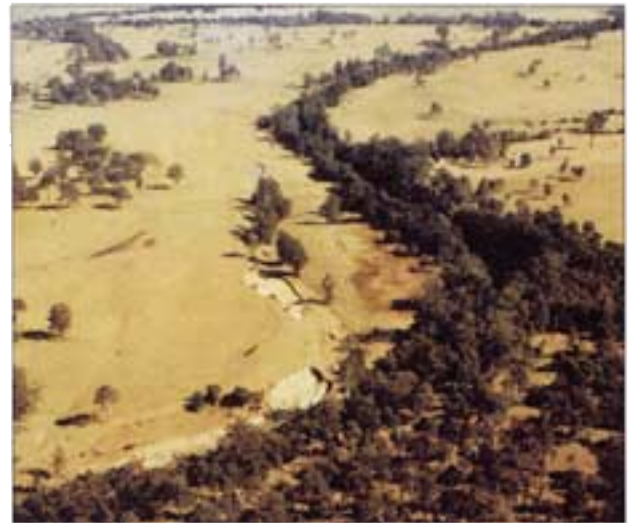
Plate 11. The Williams River looking upstream from below Dungog showing how a choked channel has forced water onto the floodplain, scouring a new channel. Judicious clearing of the main river, particularly the inside points, has remedied this potential diversion.

If such channels are allowed to narrow to below their critical width, then excessive scour of the vegetation can cause undermining and destruction of the integrity of the river banks. Also, or alternatively, the high flows can tend to bypass the choked section and cause damage to the flood-plain. Such a process is often compounding unless remedial action is taken (Plate 11).

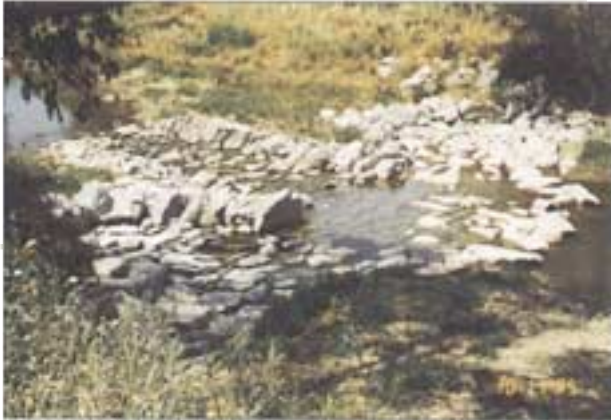
Plate 12. The Cockburn River near Tamworth, New South Wales, looking upstream from the right bank. A rock-bed control weir and fishway are being used to prevent bed lowering in a stream on which sand and gravel mining has been excessive.

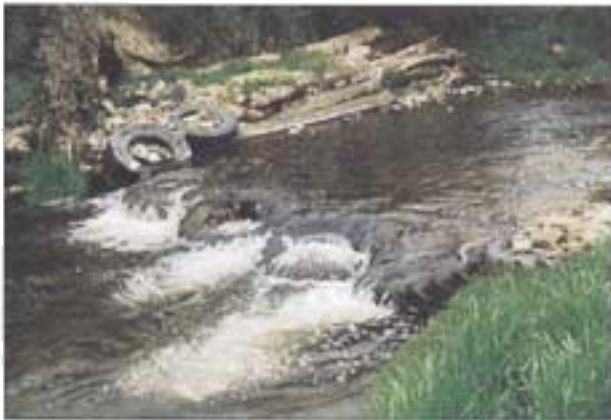
Plate 13. Bed/riffle control structure across the Great Forester River, Tasmania, made by the Springfield Landcare Group from truck tyres wired to pig netting fence.

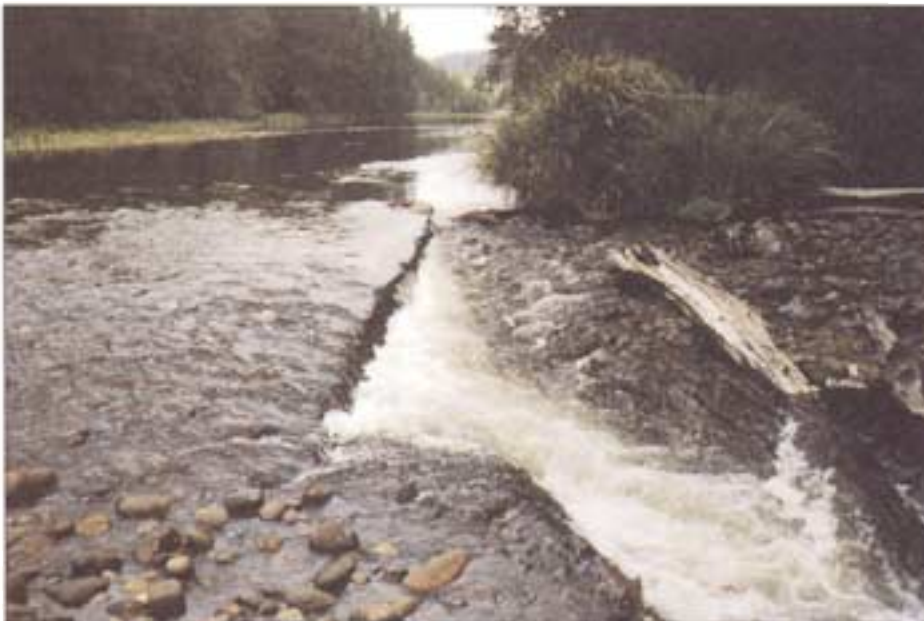
Plate 14. Partly submerged log controlling the pool level upstream and forming a scour hole downstream (Hastings River at Lonely Point).

Other important functions include natural bed level controls by roots and large woody debris. Such controls can help reduce bed degradation and also cause scouring, thereby maintaining pools in certain sections of streams (Cummins 1993) (see Plates 14 and 15). The hydraulic roughness of the bed is increased by logs and other large woody debris, thereby reducing the energy level of the stream.

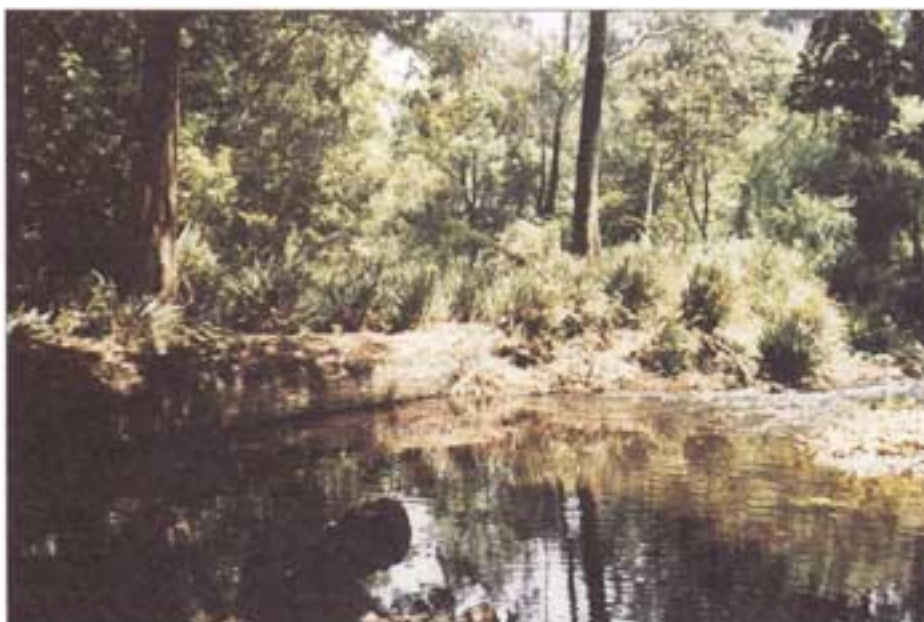
Plate 15. Partly submerged log controlling the pool level and riffle sequence. Sediment build-up on the downstream side has been colonised by *Lomandra* sp. (Orara River near Nana Glen).

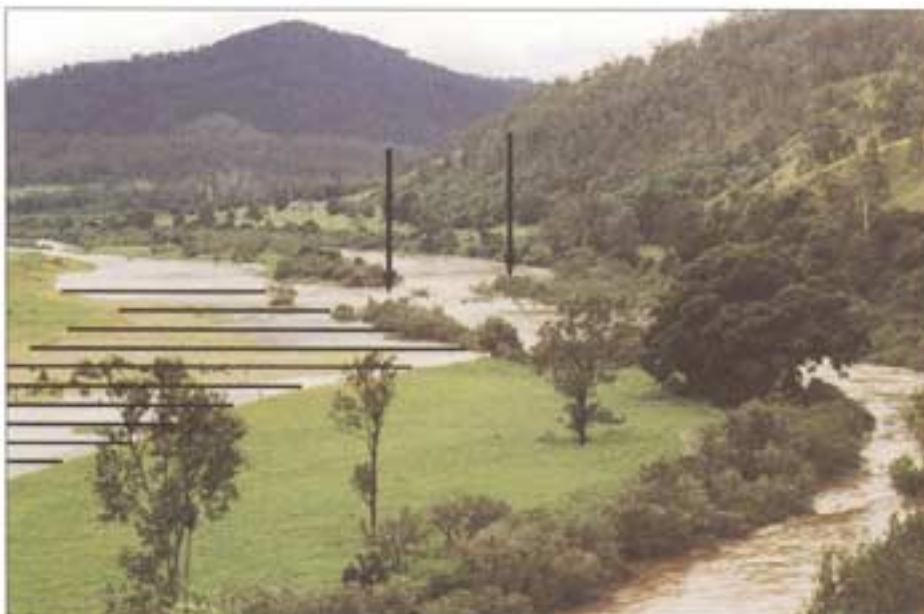
Plate 16. View of floodplain stripping along the Manning River at Charity Creek. The horizontal rules to the left of the picture mark out the stripped area, the left arrow the break-out point, and the right arrow sedimentation and consolidation by vegetation on a mid-channel bar.

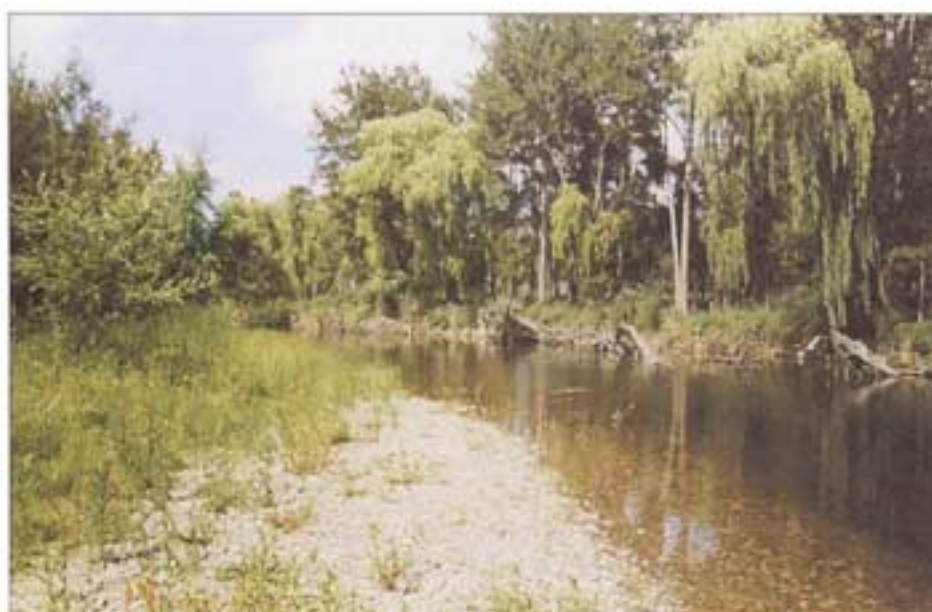
Plate 18. View of the Gloucester River immediately upstream of the Gloucester Caravan Park. Willows used here for erosion control have reached the end of their life span and are falling into the stream (right of picture). The bank has migrated several metres from the original alignment of the works (the original piles can be seen amongst the debris within the stream).

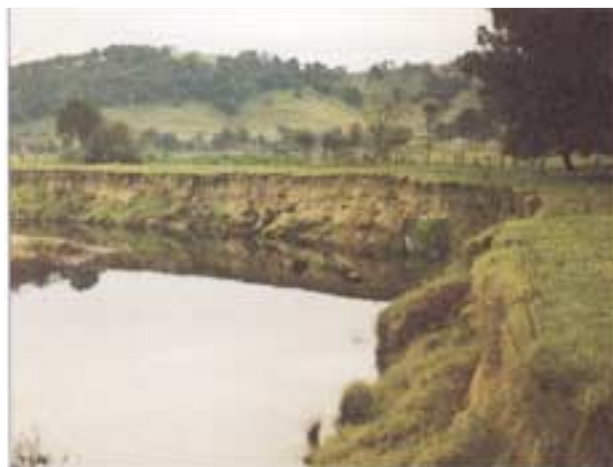
Plate 17. Bank erosion along the outside of a meander bend along the Gloucester River at Gloucester.

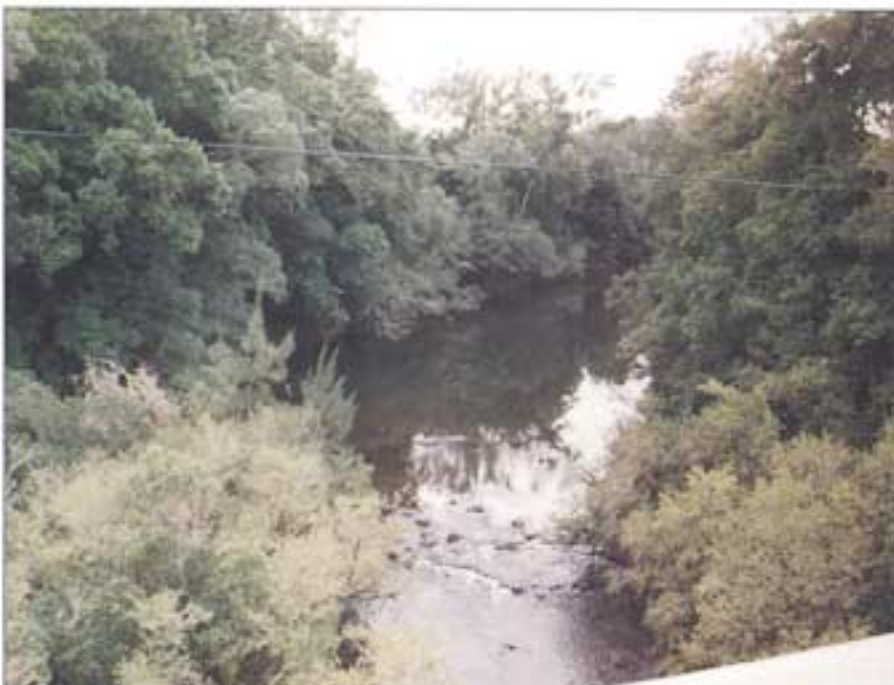
Plate 19. Riparian community of the *Tristaniopsis laurina*–*Waterhousea floribunda* suballiance along Dingo Creek at the Wherral Flat Road bridge crossing. Note the dominance of *Callistemon viminalis* and *Tristaniopsis laurina* between the high banks where flood-flow velocities are higher (front of photo), as compared to deeper, slower flowing areas which are flanked by *Waterhousea floribunda* (dark foliage) and large specimens of *Tristaniopsis laurina* (pale foliage). Scattered emergent *Casuarina cunninghamiana* can be seen in the background.

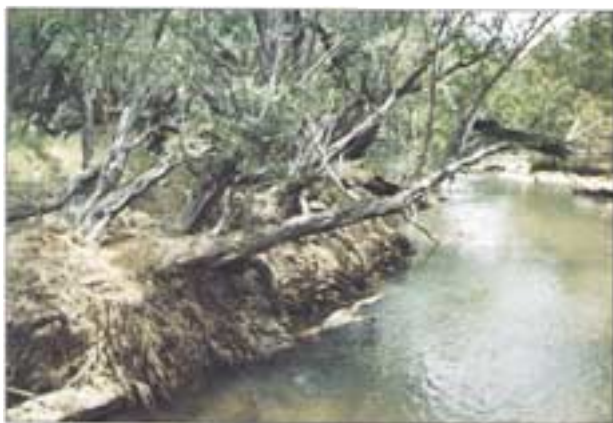
Plate 28. An example of *Callistemon viminalis*, with its multiple-trunked habit and spreading mat-like root system, stabilising an alluvial bench on the Orara River (Clarence catchment).

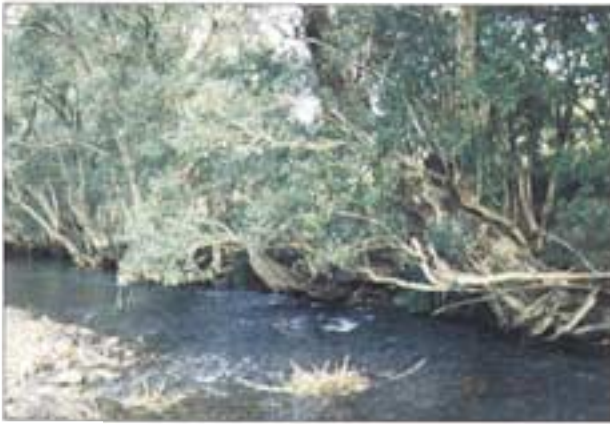
Plate 29. Plants of *Tristaniopsis laurina* (dark green foliage) fringing more flood tolerant species such as *Callistemon viminalis* and *Leptospermum brachyandrum* (adjacent to the low-flow channel) along the Orara River (Clarence catchment).

T. laurina is a species generally confined to stream banks, often occupying the area from the toe to the floodplain. On wider streams it often fringes a more flood-tolerant species such as *C. viminalis* (Plate 29).

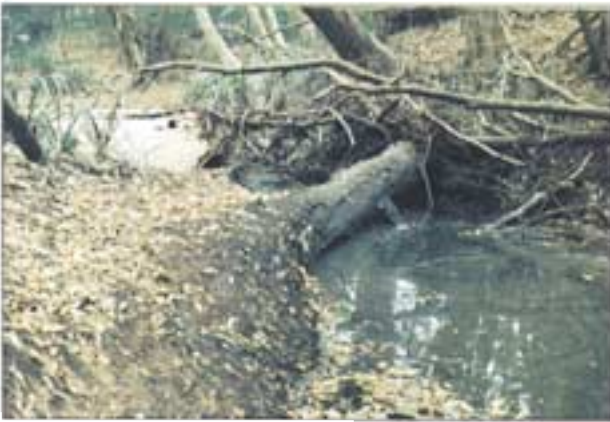
Plate 30. Fine, mat-like root system of *Waterhousea floribunda* growing over a log along the Stewarts River (Camden Haven catchment).

W. floribunda is similar in habitat to the exotic willow (*Salix* spp.) and has weeping pendulous branches that bend with floodwaters. Like willows, it forms extensive mats of fine roots (Plates 30 and 31) which have the ability to grow over recently deposited sediment and have been observed at distances up to 8 m from the tree. On smaller streams, the roots of this species often act as a bed control, extending to a metre below low-flow water level.

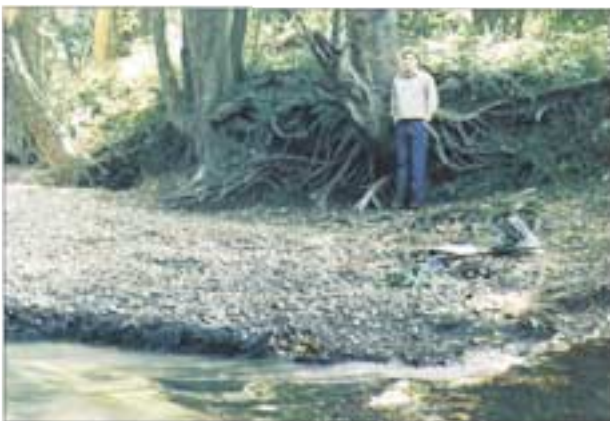
Plate 31. Mat-like root system of *Waterhousea floribunda* extending for a distance of about 5 m from the base of the trunk and consolidating a gravel bar (the fine black roots can be seen protruding from the gravel adjacent to the low-flow channel) along the Kalang River (Bellinger catchment).

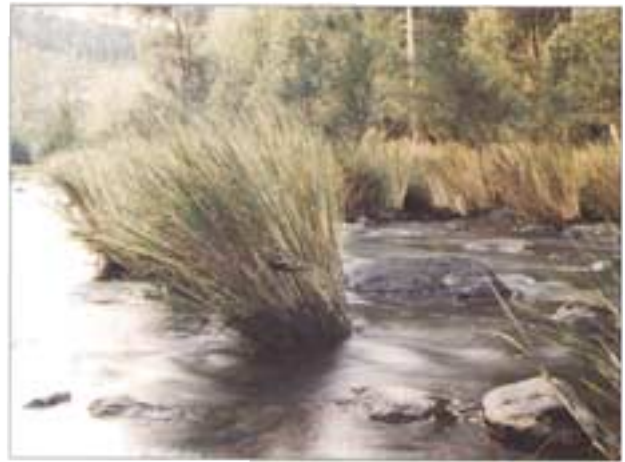
Plate 32. Plants of *Potamophila parviflora* growing in a high velocity section of the Little Manning River near Gloryvale Reserve.

P. parviflora is a semi-aquatic grass (Plate 32) which generally grows within the bed and along the banks of larger

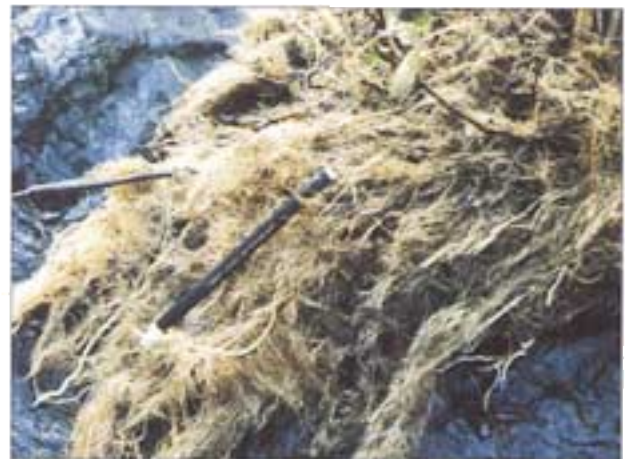
Plate 33. The fine, mat-like root system of *Potamophila parviflora*.

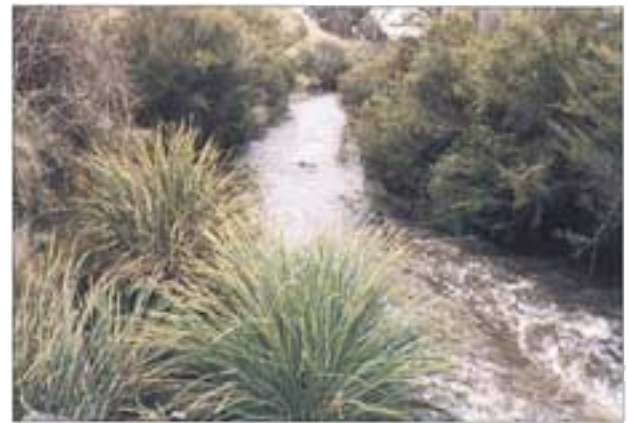
Plate 34. Plants of *Carex gaudichaudiana* (tussocky plant on left of photo) growing along the Tia River near Tia. The shrub species present is *Leptospermum polygalifolium*.

C. gaudichaudiana is a semi-aquatic plant commonly found growing within the bed, or along the toe of the bank where access to moisture is assured (Plate 34). It usually occurs as scattered clumps, though in some areas it may form a relatively dense colony. It is most often found on the smaller, narrower streams or those at higher elevations, and sometimes replaces *Lomandra* spp. as the dominant riparian herb. Its presence reduces the velocity of flood-flows adjacent to the bank, by increasing the hydraulic roughness at the soil–water interface. Its root system appears relatively dense.

L. polygalifolium ssp. *montanum* is generally found at higher elevations and is largely confined to stream banks, usually growing along the toe where access to water is assured. It is the dominant riparian species on most tableland streams, often in association with *C. gaudichaudiana* (see Plate 34).

Like most species adapted to riparian environments, it has a multi-stemmed habit and is flexible under the force of floodwaters (see Plate 34). It has a relatively extensive root system which extends below low-flow water level, and performs a stabilising role in substrates ranging from heavy basalt-derived soils to sand and river gravel.

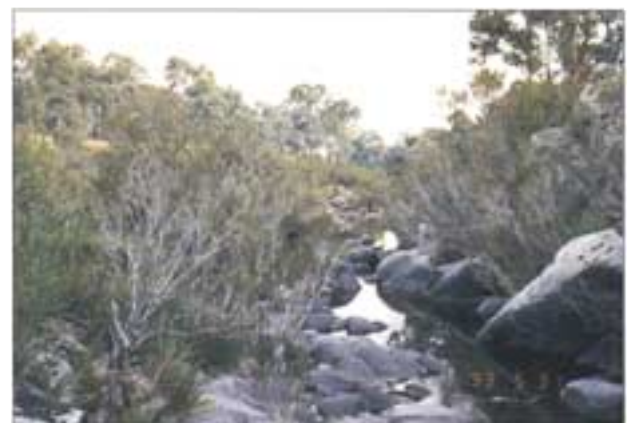
Plate 35. *Callistemon sieberi* growing along a high velocity section of the Chandler River (Macleay catchment). *Lomandra longifolia* can be seen in the herb-layer (left of photo). *Eucalyptus nova-anglica* can be seen adjacent to the riparian zone (top of photo).

C. sieberi is a species confined to streambanks and on the North Coast generally occurs at higher elevations. It usually dominates larger streams and is common where bedrock outcrops occur and stream gradients are relatively steep, tending to replace *L. polygalifolium* ssp. *montanum* as the dominant species in such areas, particularly along sections of stream where plants become wholly inundated during flood-flows (Plate 35).

C. sieberi has a multi-branched habit and flexible branches which bend under the weight of floodwaters (Plate 35). Plants are usually flood-battered and permanently bent in alignment with flow. It has a spreading adventitious root system and stabilises the bed and the toe of the bank where access to moisture is assured. Growth substrates range from gravel to cracks in bedrock.

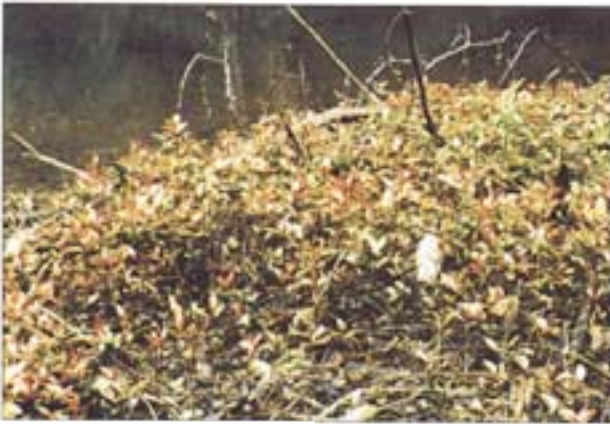
Plate 36. Dense colonisation of freshly deposited alluvium by *Waterhousea floribunda* seedlings along Caparra Creek (Manning Catchment).

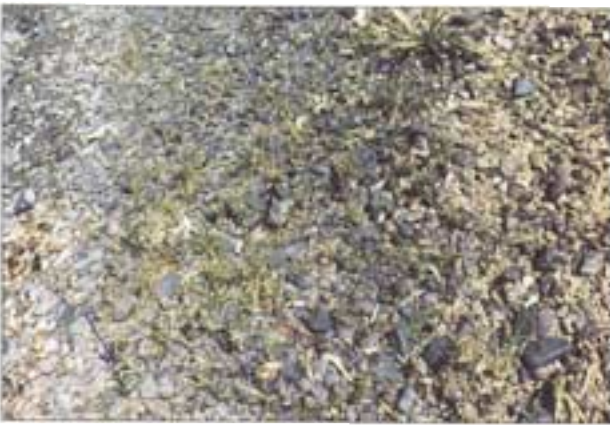
Plate 37. Seedlings of *Lomandra hystrix* (black arrow), *Leptospermum brachyandrum* (blue arrow), and *Tristaniopsis laurina* (red arrow), colonising gravel alluvium along the Orara River (Clarence Catchment).

From observations of regenerating riparian species, it is apparent that moisture levels within the sand/gravel substrate are critical for germination and early seedling establishment. Riparian species such as *C. viminalis*, *C. cunninghamiana*, *T. laurina*, *L. hystrix*, and *W. floribunda* have been observed densely colonising sand and gravel recently deposited immediately adjacent to the low-flow channel, where moisture levels are assured for a considerable period (see Plates 36 and 37). The seed of these species is transported by water and appears to be deposited during receding floods.

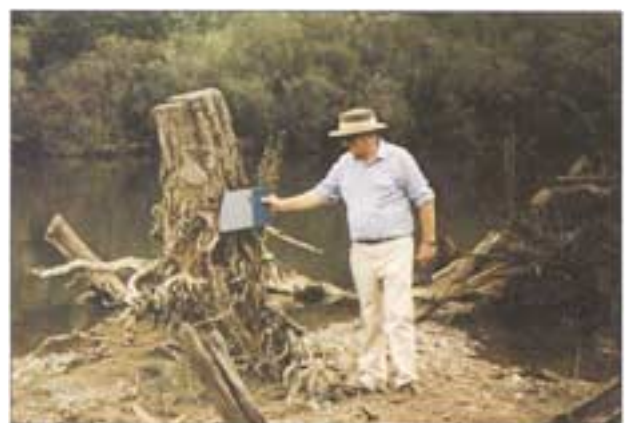
Plate 38. Example of a site where vegetation has been trimmed at a break-out point and the decrease in hydraulic roughness resulted in removal of bed material, thereby increasing the main channel capacity. The folder marks the original bed level. The remaining roots control the process.

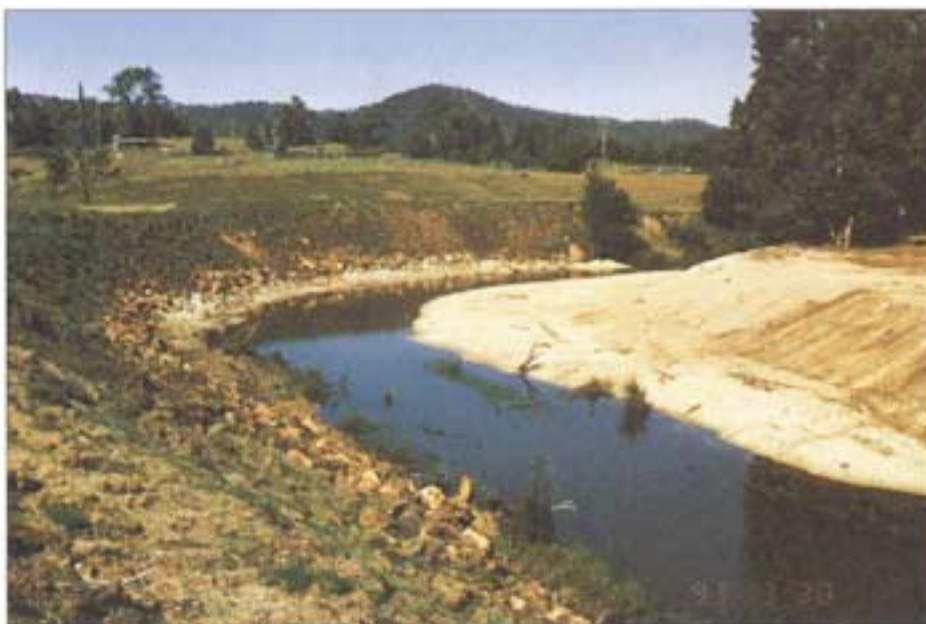
Plate 39. View of a riverbank revegetation trial. The gravel bench between the low-flow channel and a rock revetment has been densely planted with seedlings of *Waterhousea floribunda*.

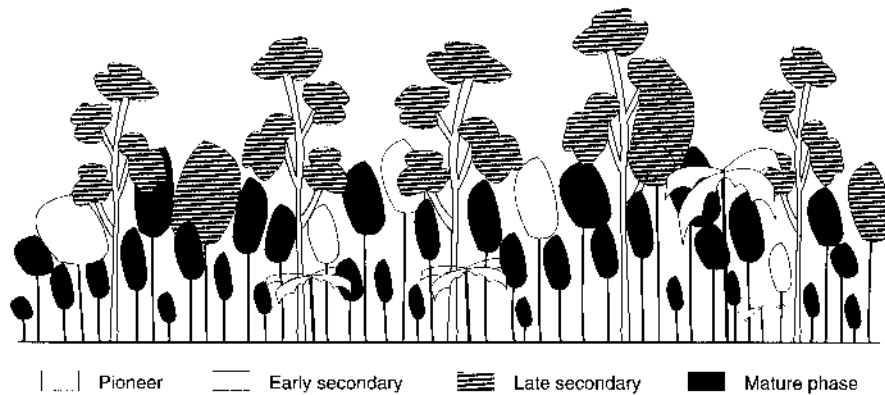
Figure 23. Example of late successional model—accelerated succession, mixed species—for revegetation (adapted from Kooyman 1995).

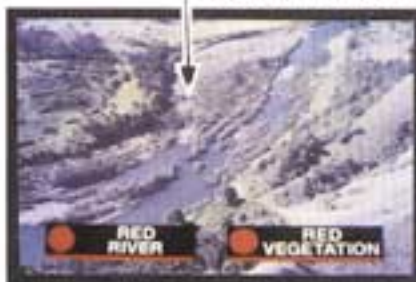
THIS SHOWS A RIVER WHICH HAS OVERGROWN in the main channel and has forced flood flows over the flood plain and is removing topsoil from the flood plain and back to raw gravel. The channel continues to overgrow with vegetation.

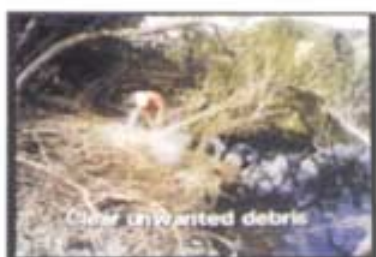
Clear unwanted debris

A RIVER WHERE THE CHANNEL IS BLOCKED

- i) Cut back obstructing or exotic vegetation.
- ii) Leave root system intact to reduce the impact on the banks of the rivers.

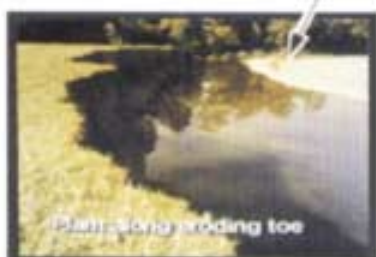
Plan along eroding toe

A RIVER WHERE OBSTRUCTING VEGETATION HAS CREATED EROSION ON OUTSIDE BENDS

- i) Keep inside points and bars clear of obstructing vegetation within the alignment width - where needed.
- ii) This can be done by cutting back and/or the judicious use of an approved herbicide such as Round-up. (R).

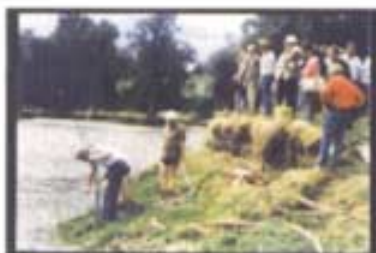
Jet planting Willow cuttings

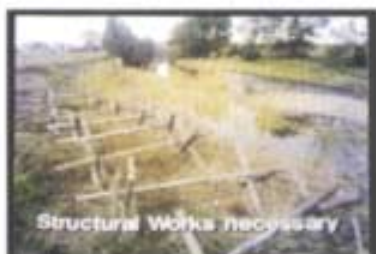
Structural Works necessary

Jacks planted with Willows

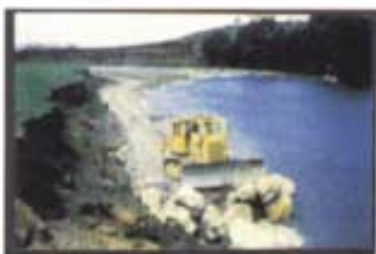
Rock toe protection
