RIVER RECOVERY PLAN

Section 11/12 – Gwambygine to Edwards Crossing

WATER AND RIVERS COMMISSION
RIVER RECOVERY PLAN
REPORT NO RRP 6
NOVEMBER 2001

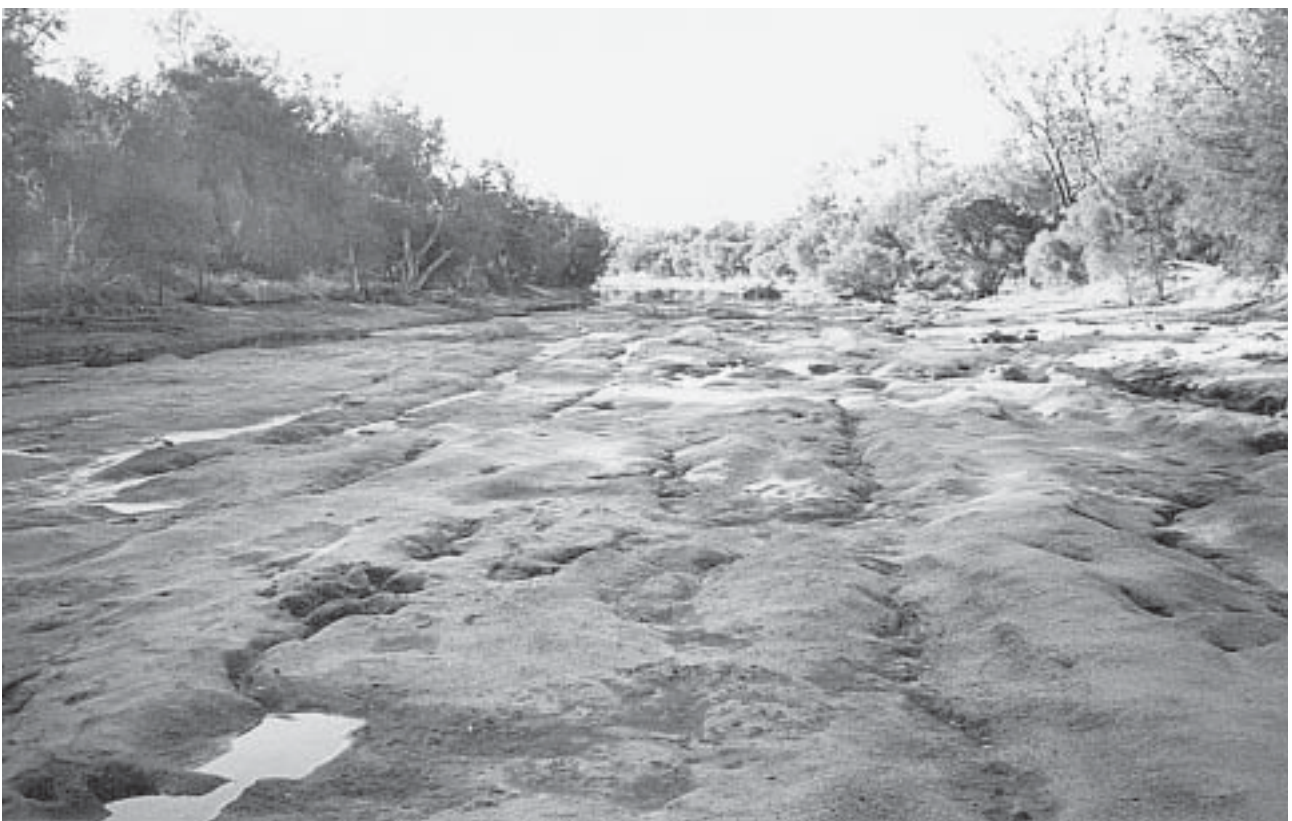
Photo 1: Clay bed showing rip lines from the River Training Scheme.

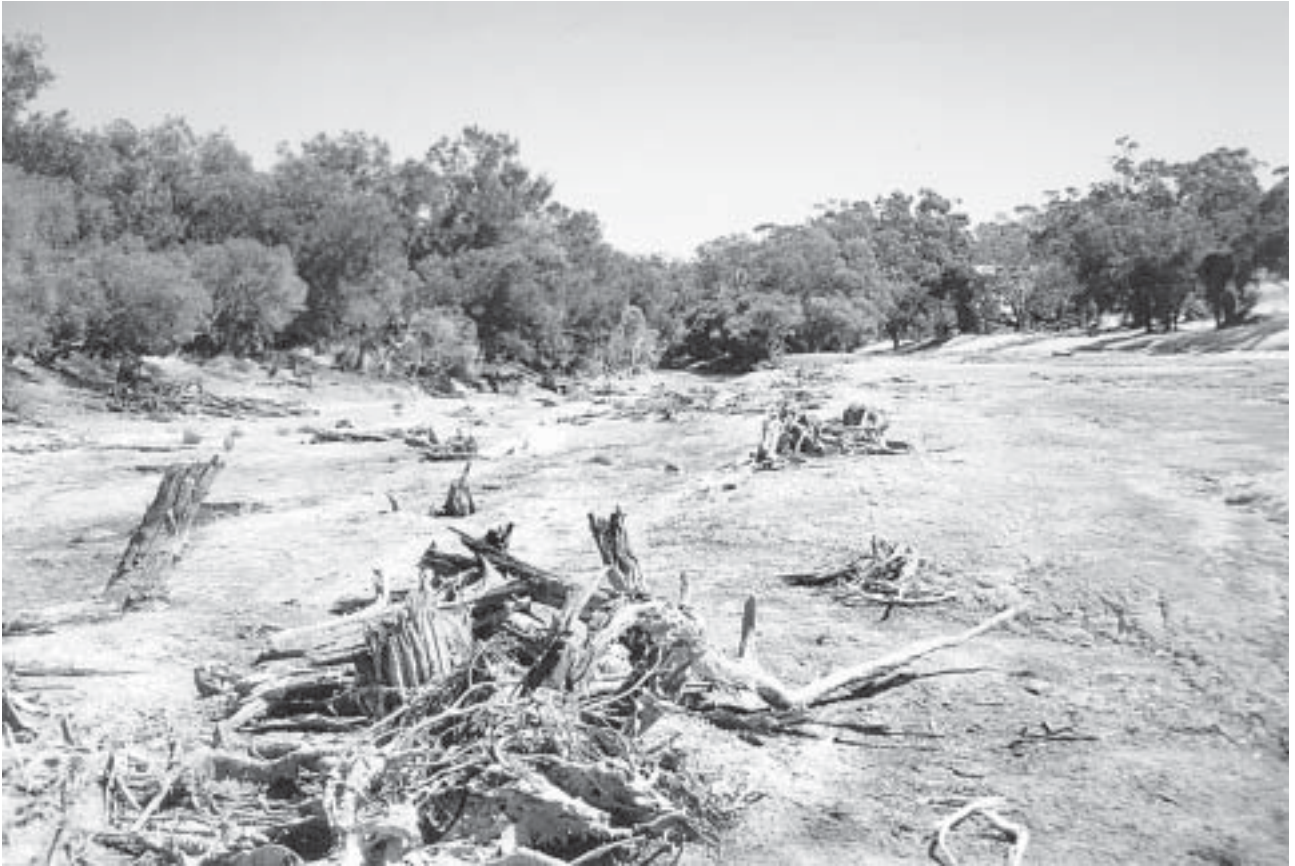
Photo 2: Stumps of river vegetation remaining from the River Training Scheme.

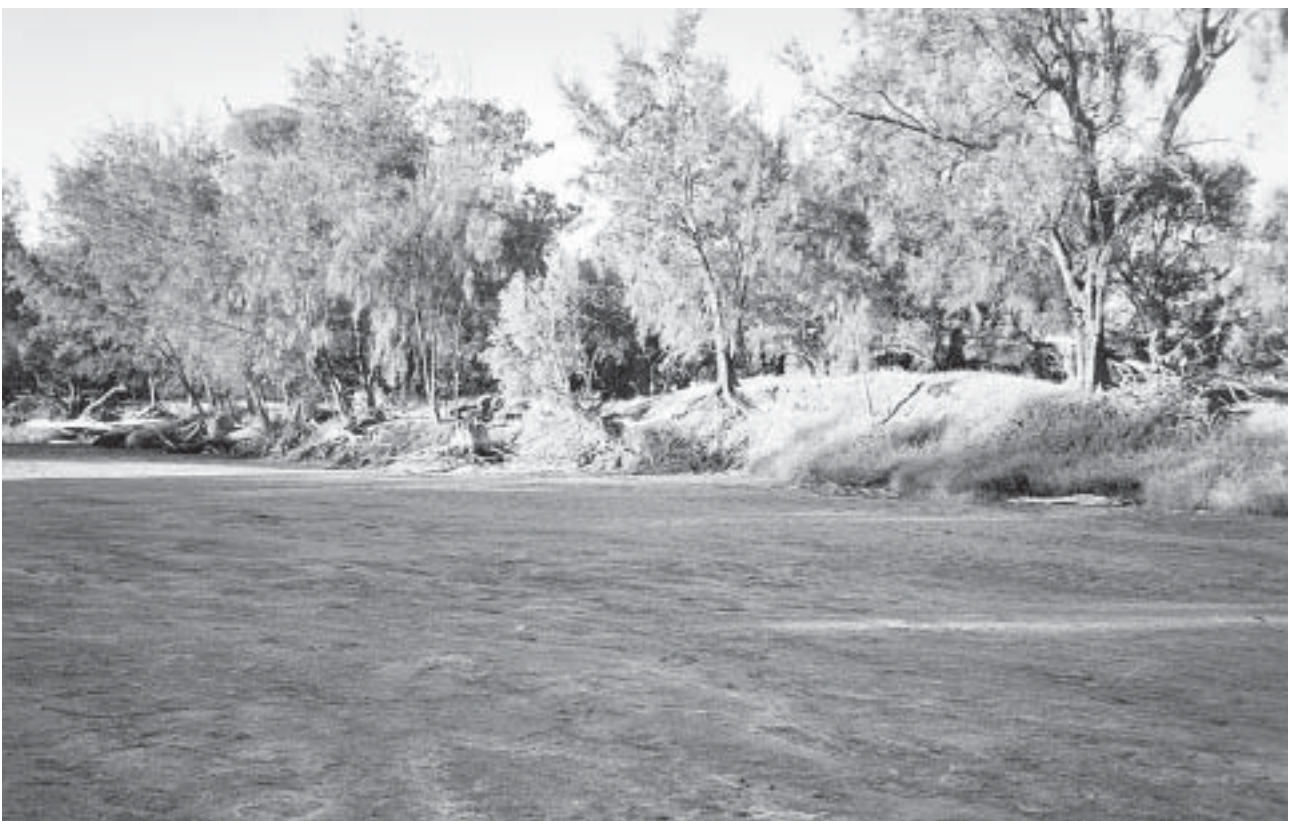
Photo 3: Spoil levees formed during the River Training Scheme.

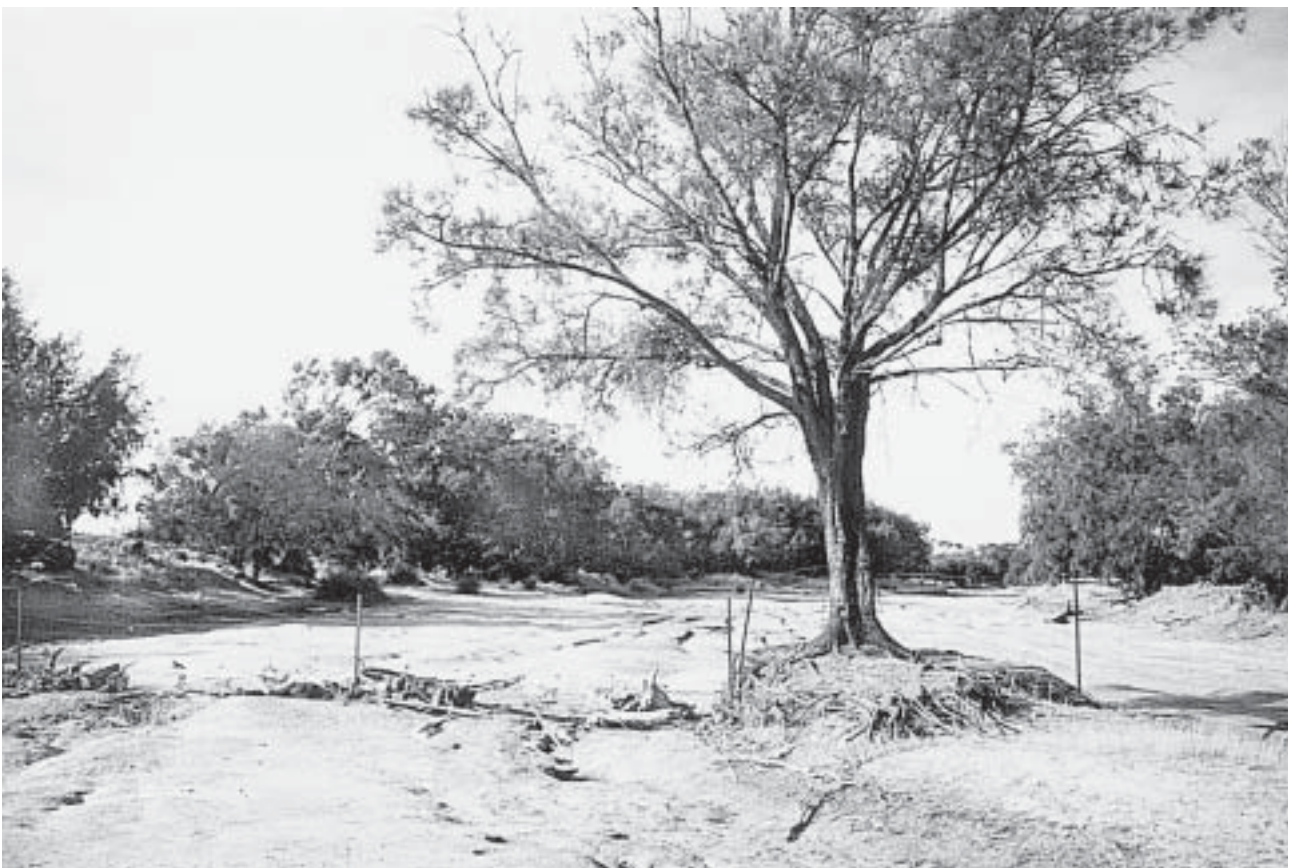
Photo 7: Isolated tree with roots exposed by channel erosion.

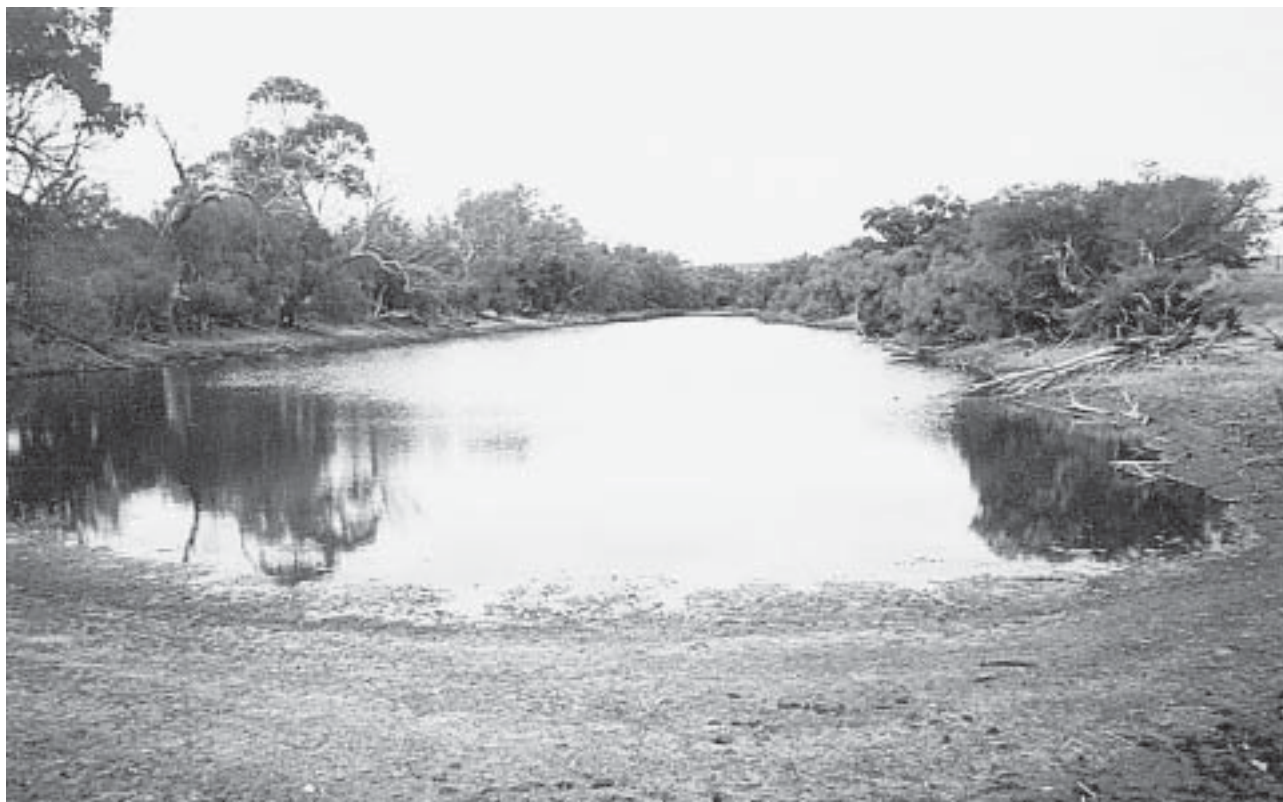
Photo 8: Seaton Ross pool.

Seaton Ross: this pool is not significantly filled by coarse sediments although it does have high fine sediment deposition. Phosphorus attached to the fine sediment is the main cause of the high phosphorus concentration measured in the sediments and water. The phosphorus concentration in water indicates the potential for eutrophication (i.e. it is more than 0.120 mg/L). The pool is not fenced. Riparian vegetation is not regenerating.

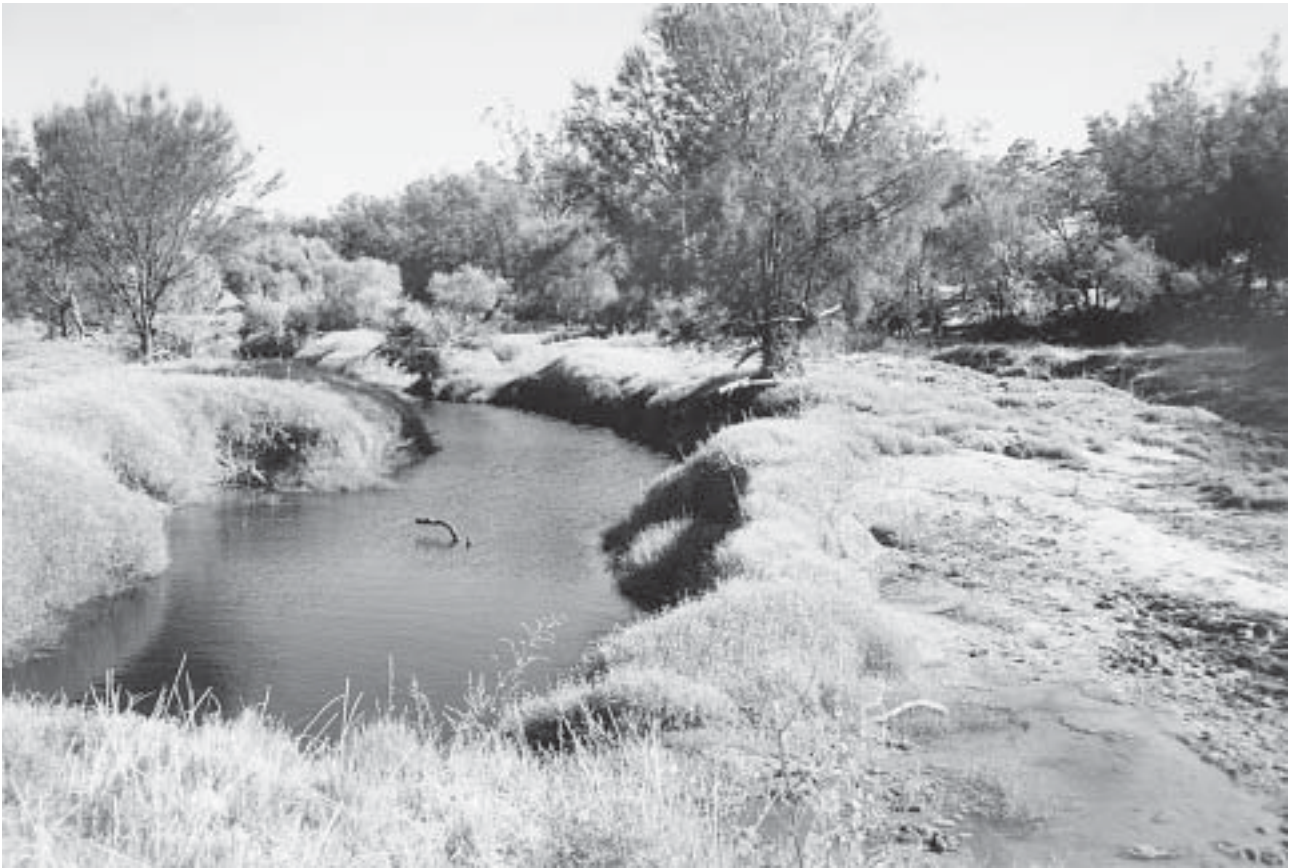
Photo 9: The confluence of the Dale and Avon rivers.

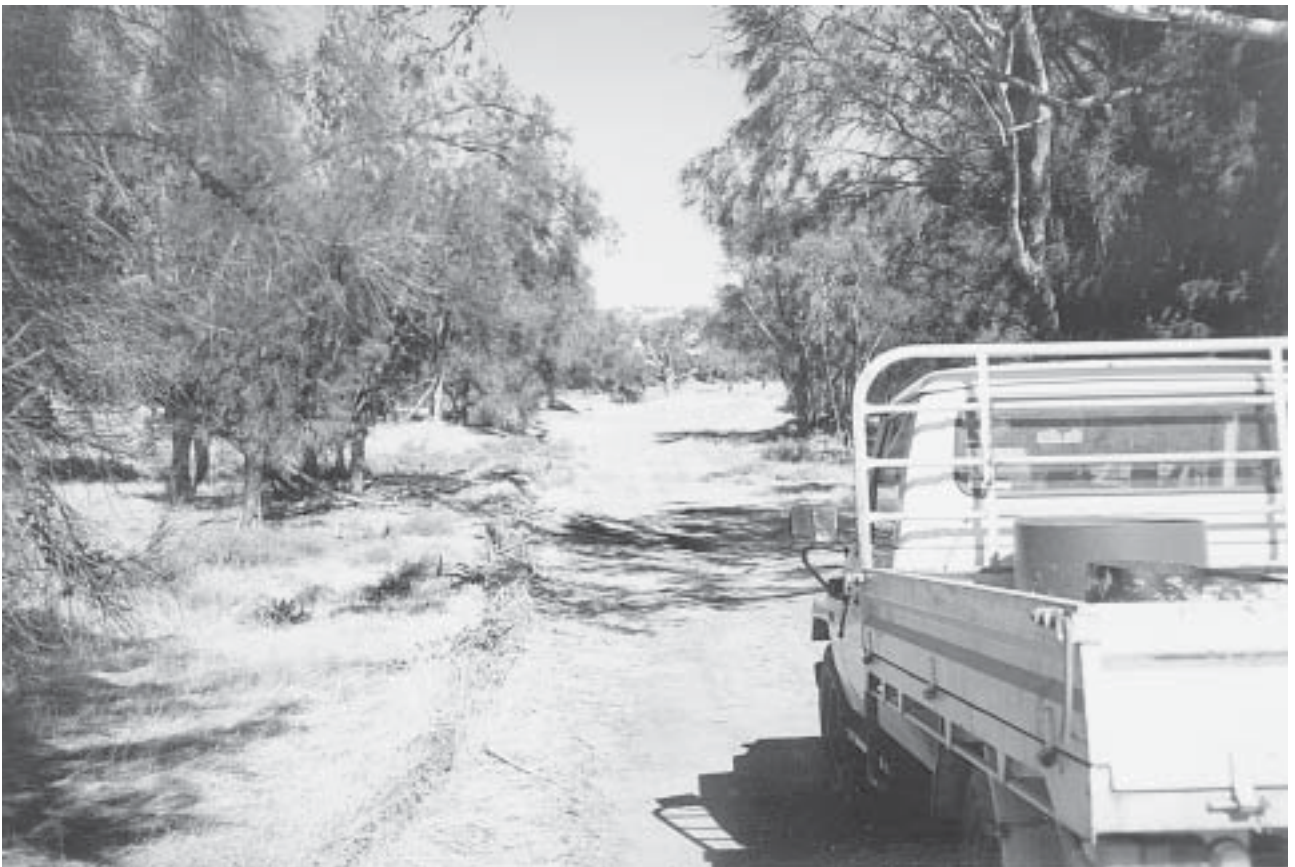
Photo 10: Farm crossing.

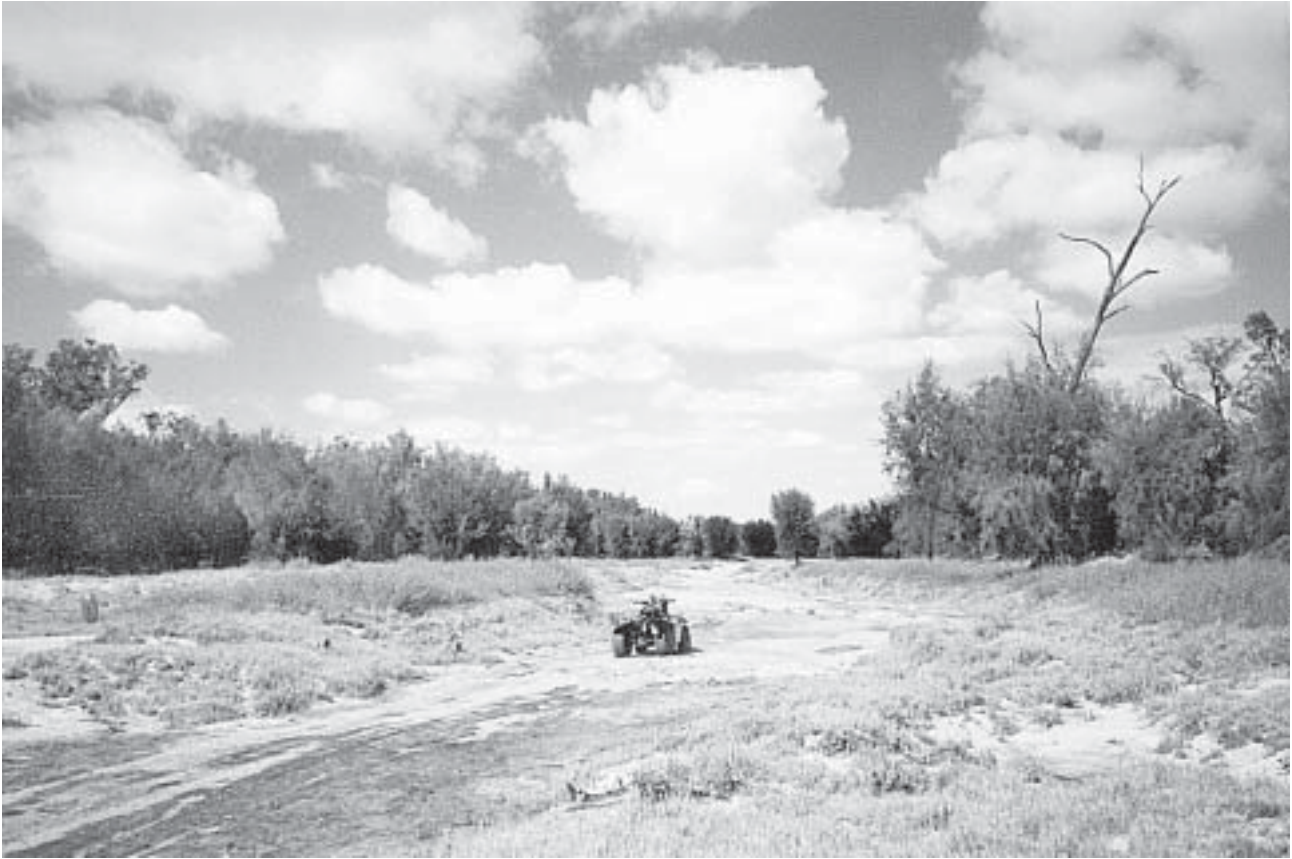
Photo 11: *Paspalum vaginatum* stabilising coarse sediment in the river bed.

Salt Water Couch Grass (*Paspalum vaginatum*) is a voracious coloniser of unconsolidated sands in the river channel. It is reported by Recovery Team members to be spreading rapidly. When established, it is very effective in stabilising coarse sediments and trapping mobile sediments. The spread of this introduced perennial plant within the river system could reduce the risk of further erosion of the river channel and sedimentation of river pools.

However, *P. vaginatum* seems restricted to areas with access to soil moisture during summer. It does not colonise well on large coarse sand islands (where moisture retention capacity is low) nor does it invade the adjacent riparian vegetation. The perennial plant is salt-tolerant.

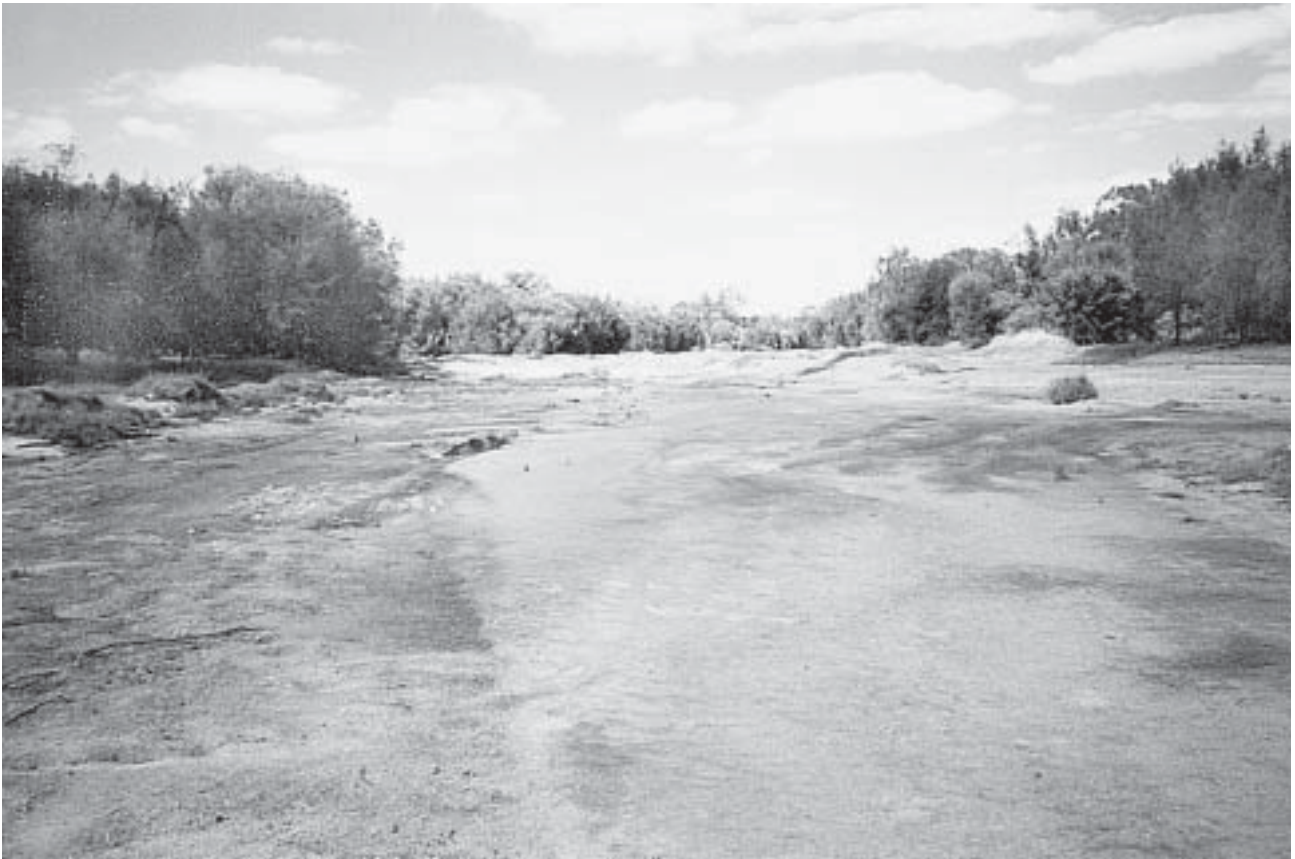
Photo 12: Bare river channel bed with early sediment island formation.

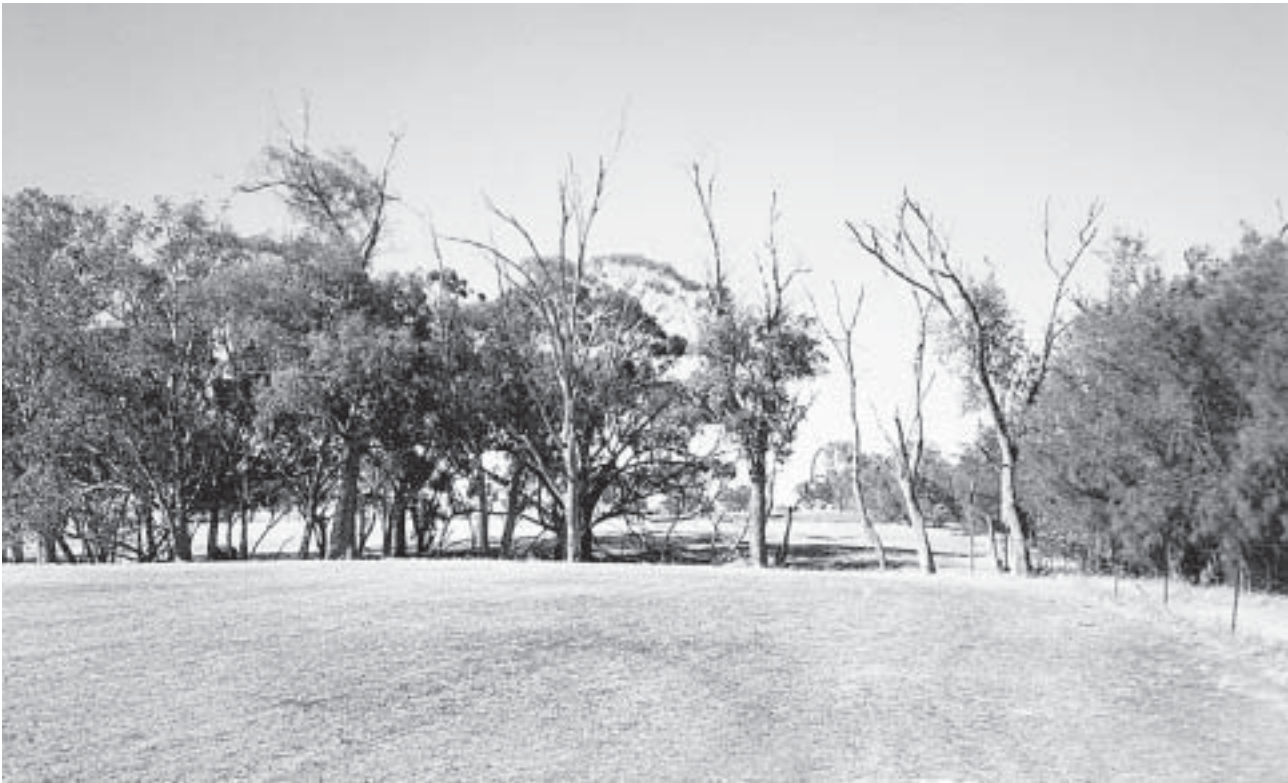
Photo 13: A stand of *Eucalyptus rudis* affected by salinity.

Localised salinity may be exacerbated by altered channel characteristics following the River Training Scheme. The lowered river bed has effectively drained the fresh perched groundwater aquifers of the adjacent floodplain. Less frequent flooding results in less recharge to these aquifers. These changed hydraulic conditions probably allow greater salinisation of river bed soils and the likely cause of very low regeneration of *E. rudis* and *M. raphiophylla*.
