AVON WATERWAYS COMMITTEE

RIVER RECOVERY PLAN

Sections 1 and 2 – 'Avon Gorge' and 'Deepdale Valley'

WATER AND RIVERS COMMISSION
RIVER RECOVERY PLAN
REPORT No RRP 7
AUGUST 2002

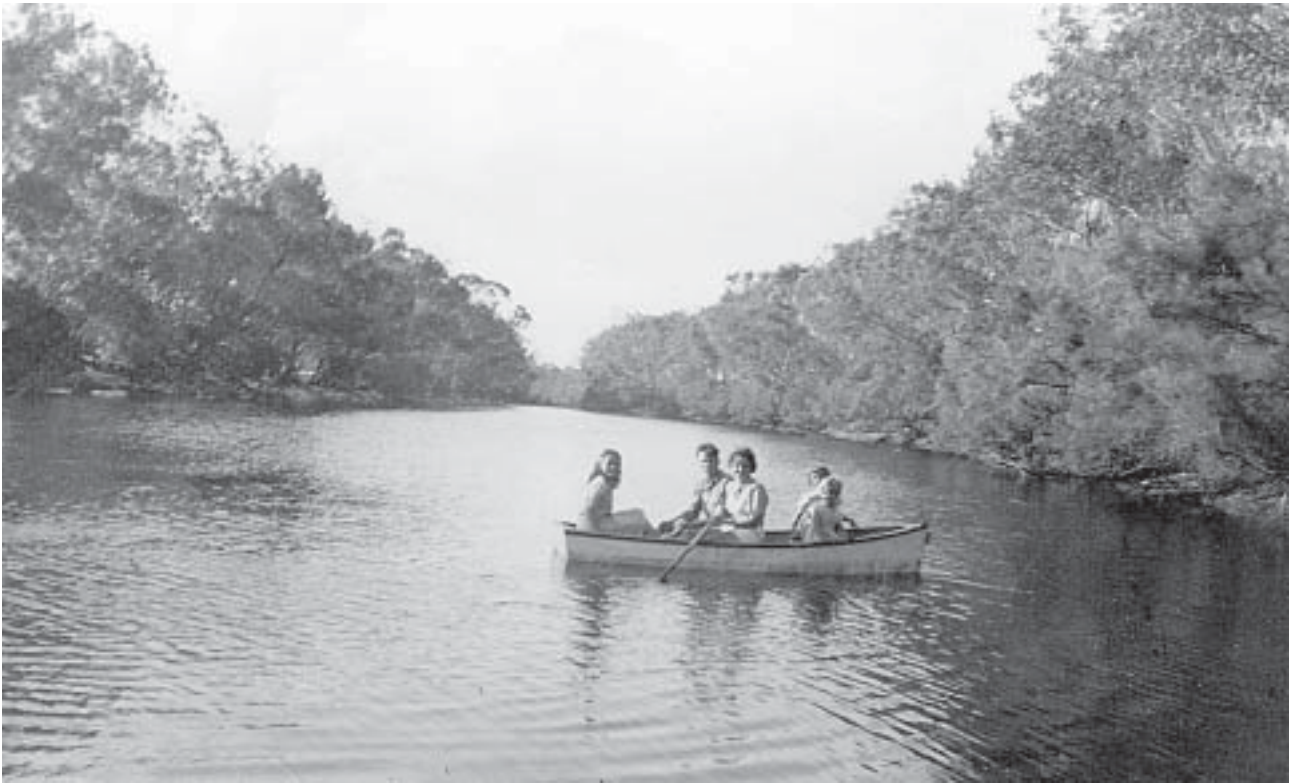
Photo 1: Deepdale Pool, circa 1950, used for boating and swimming prior to the River Training Scheme

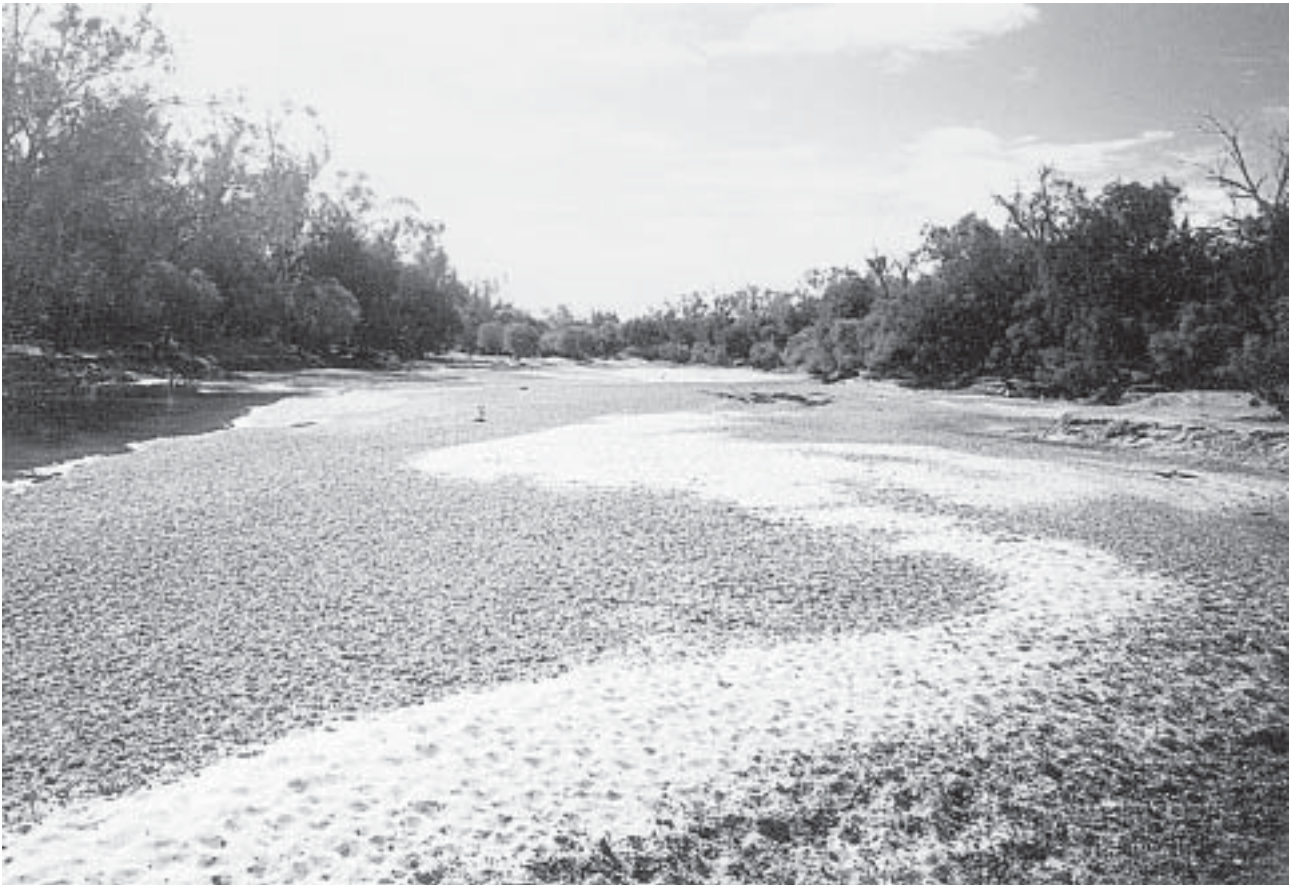
Photo 2: Deepdale Pool filled with sediment

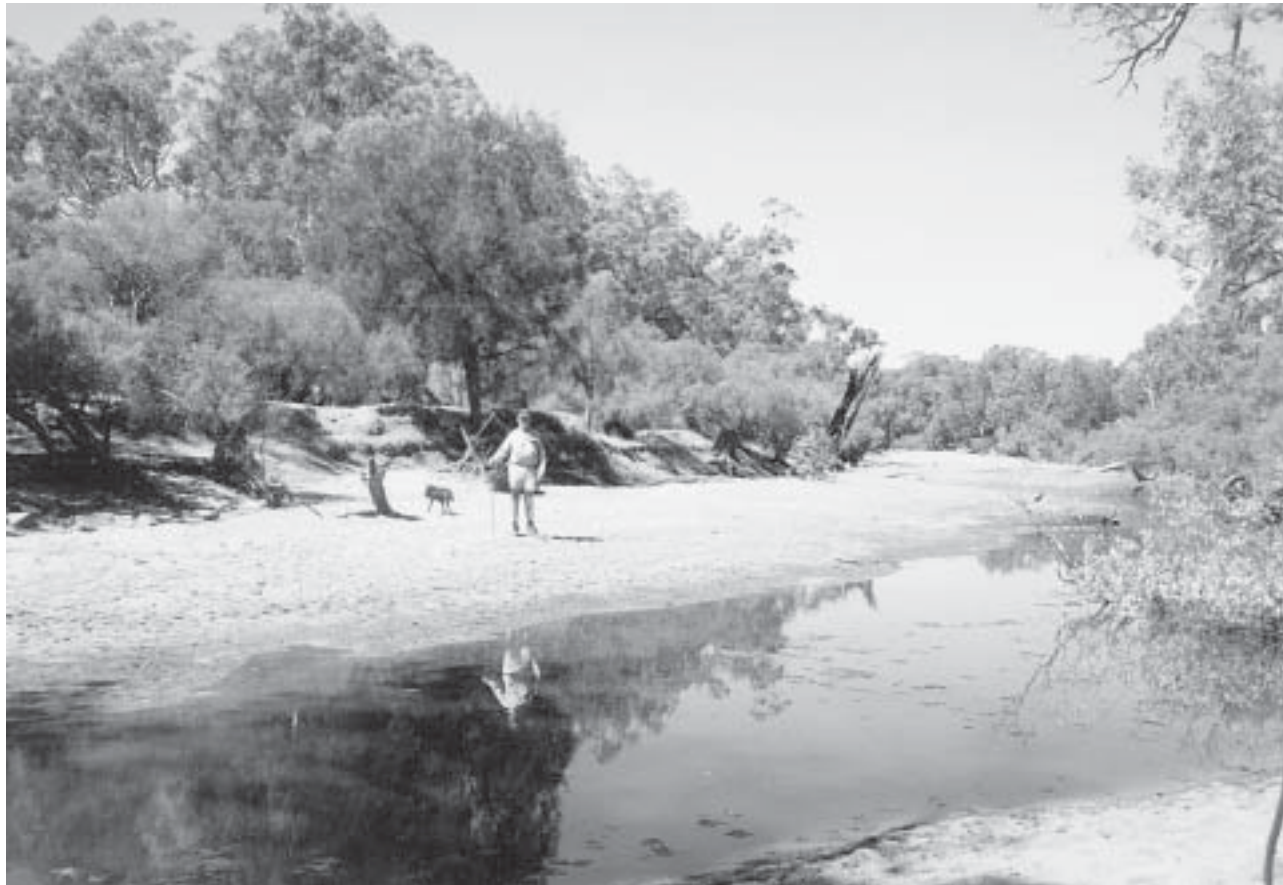
Photo 3: Sediment in the downstream end of Jimperding Pool

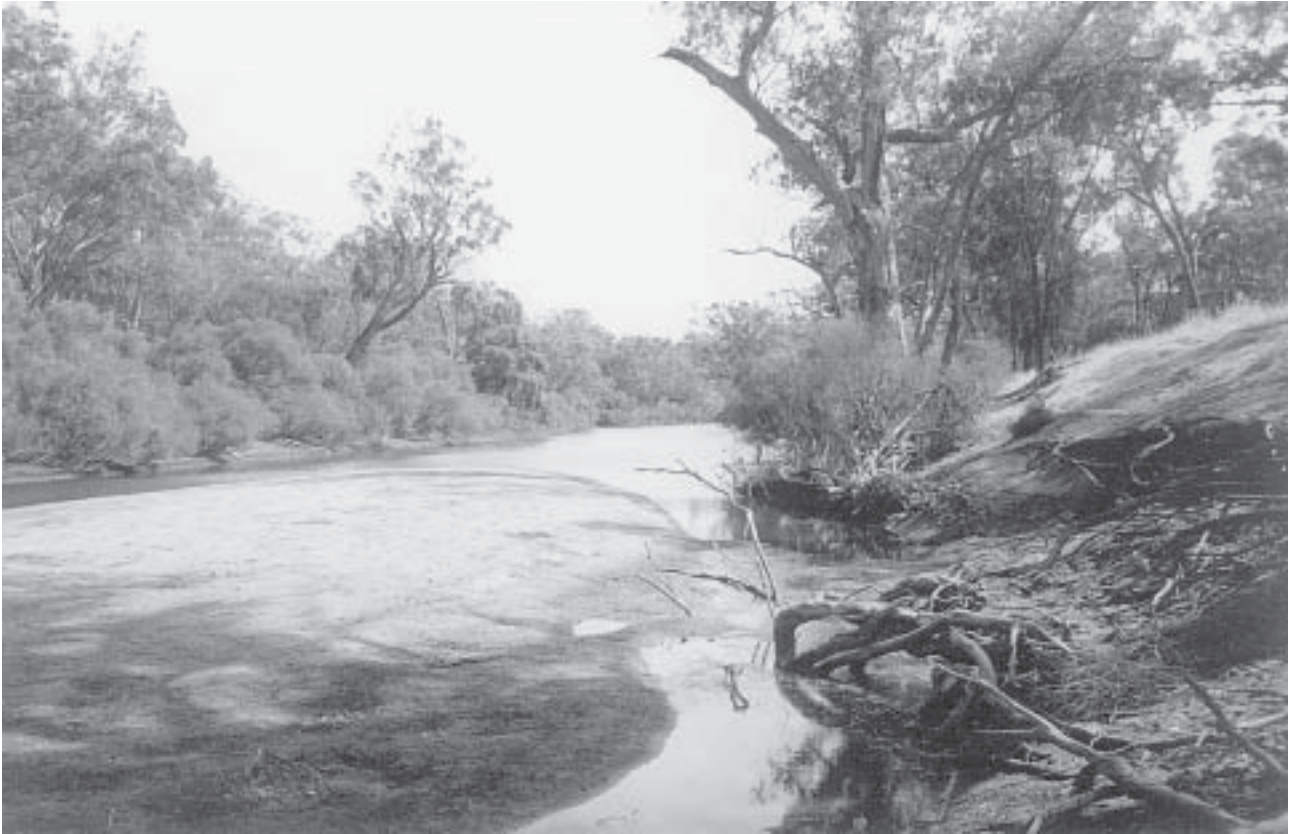
Photo 4: Sediment infill to Long Pool

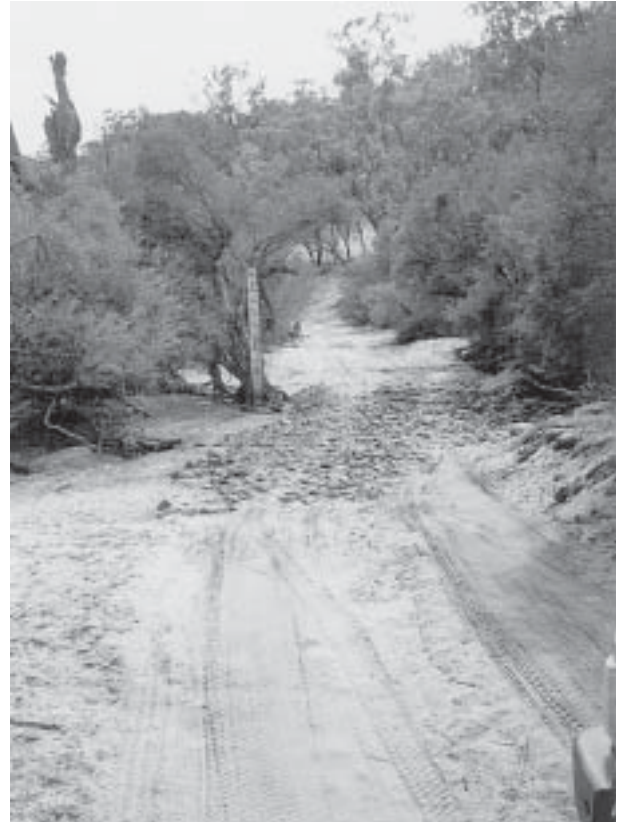
Photo 5: River crossing for property access at the upstream end of Long Pool

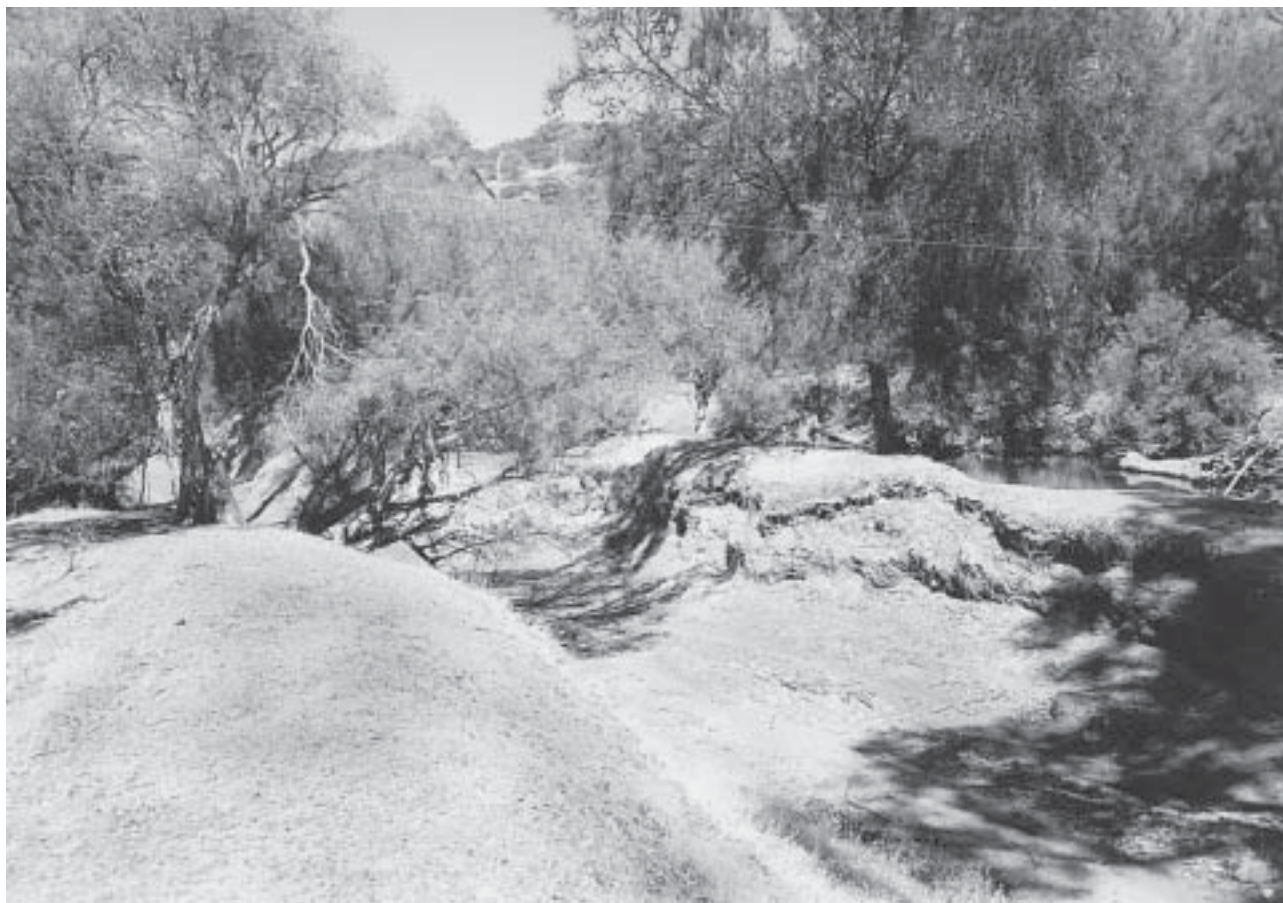
Photo 6: Sediments trapped in the braided channel of the 'Avon Gorge' river section
