AVON WATERWAYS COMMITTEE

RIVER RECOVERY PLAN

Sections 4 and 5 – Northam to Toodyay

WATER AND RIVERS COMMISSION
RIVER RECOVERY PLAN
REPORT No RRP 8
OCTOBER 2002

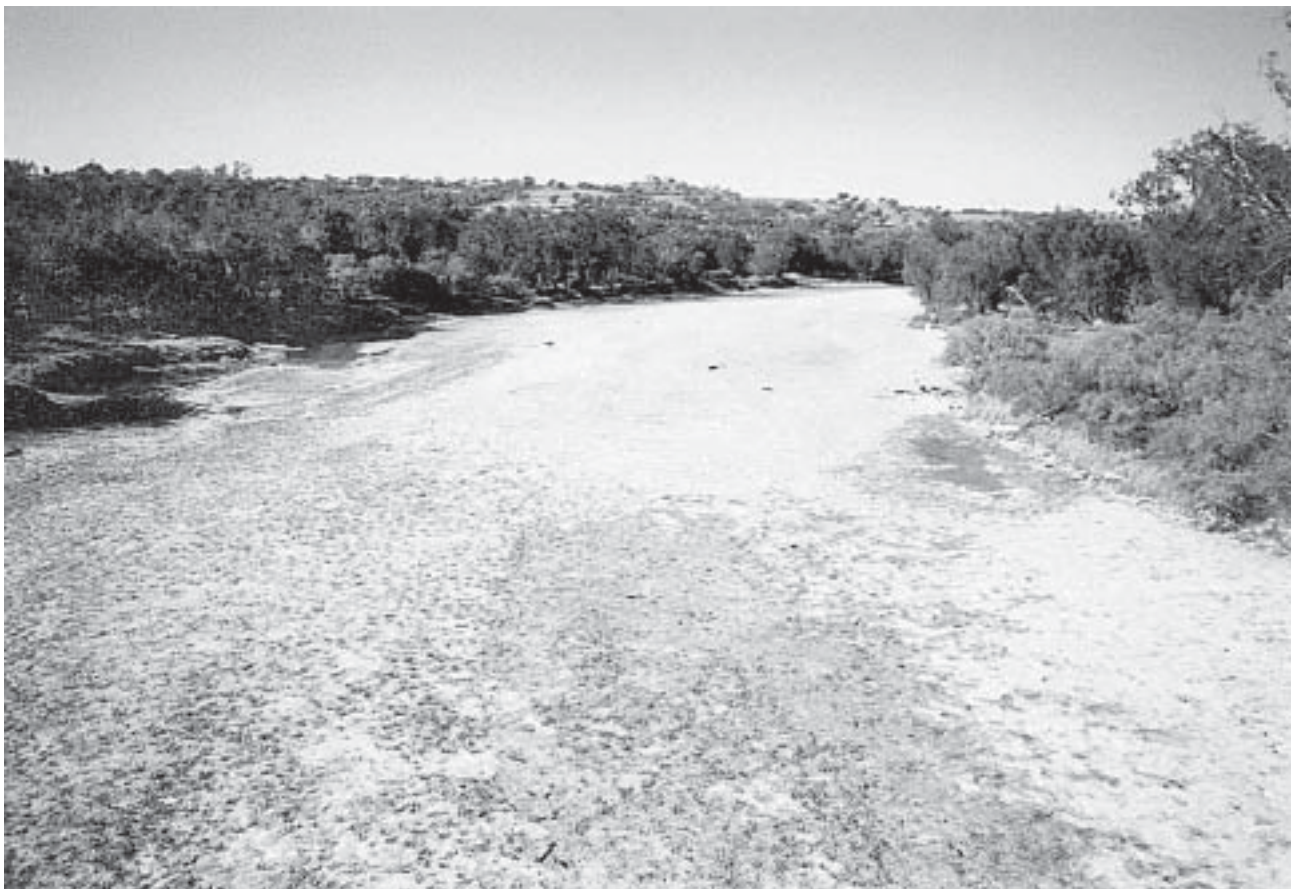
Photo 3: Unstabilised coarse sand in the river bed

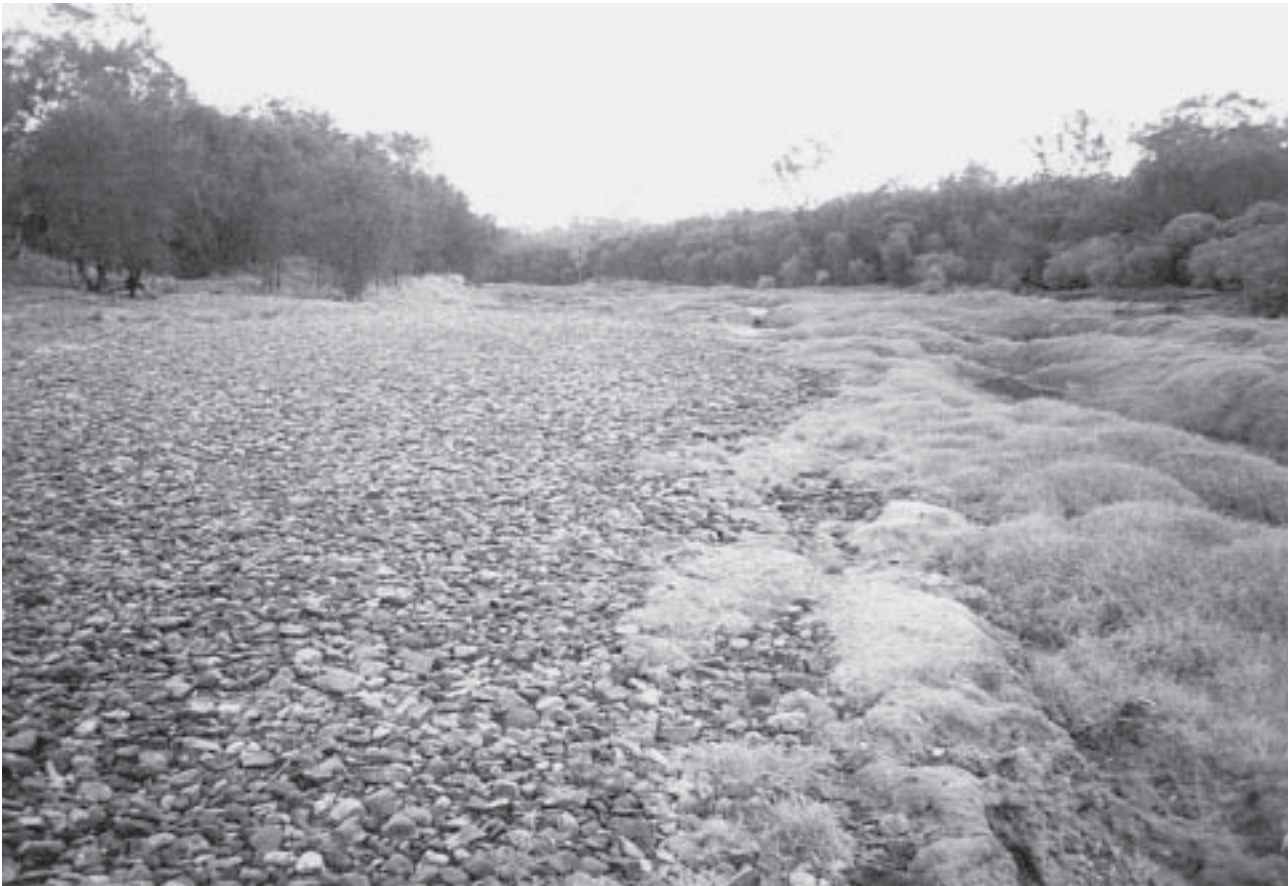
Photo 4: Cobbles in the river downstream from Red Banks Pool

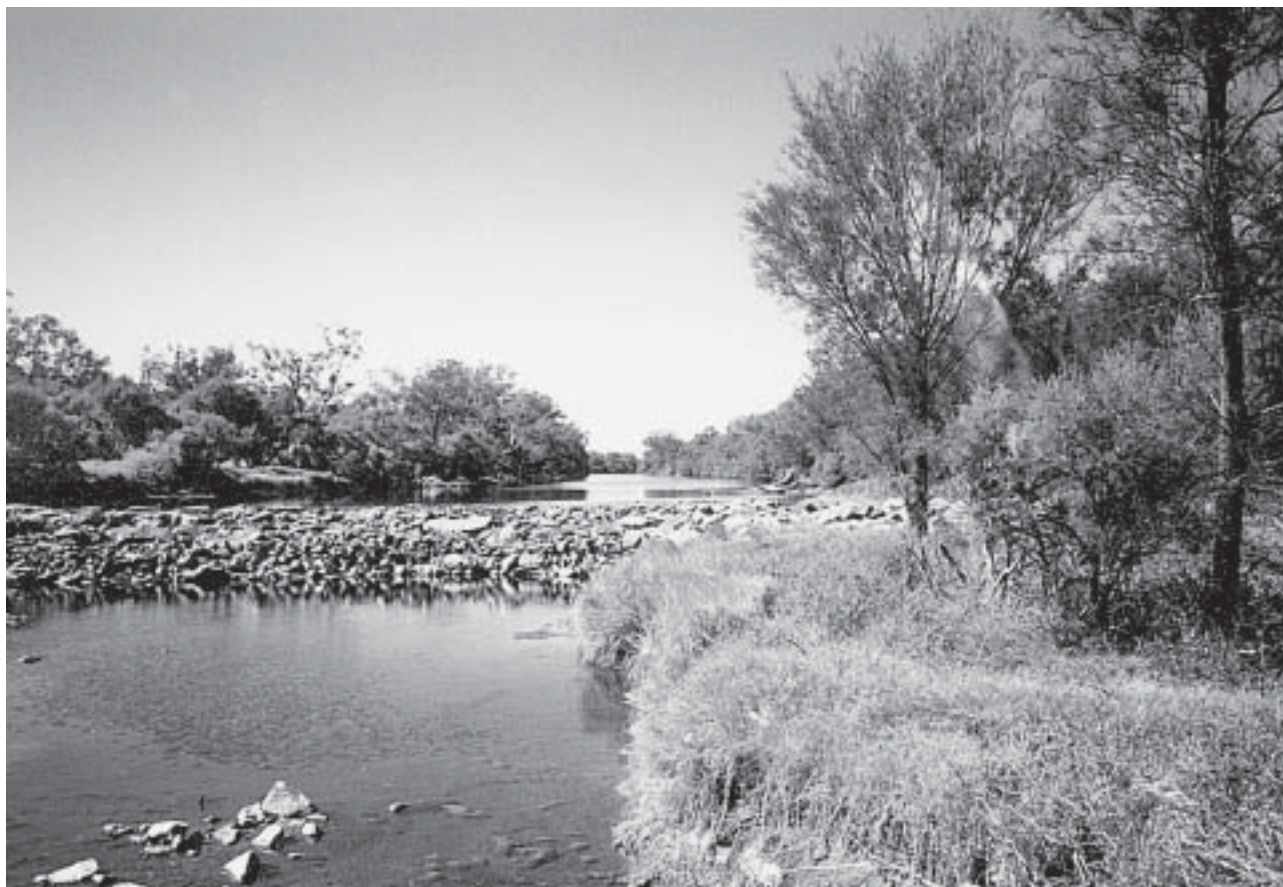
Photo 6: Glen Avon Weir

It is important to note that the weirs now perform an important function in maintaining river stability. Damage to or removal of Glen Avon Weir would cause large-scale

sediment mobilisation as the two metre hydraulic head differential would cause significant gully-head erosion in the river channel that could progress upstream for a considerable distance.

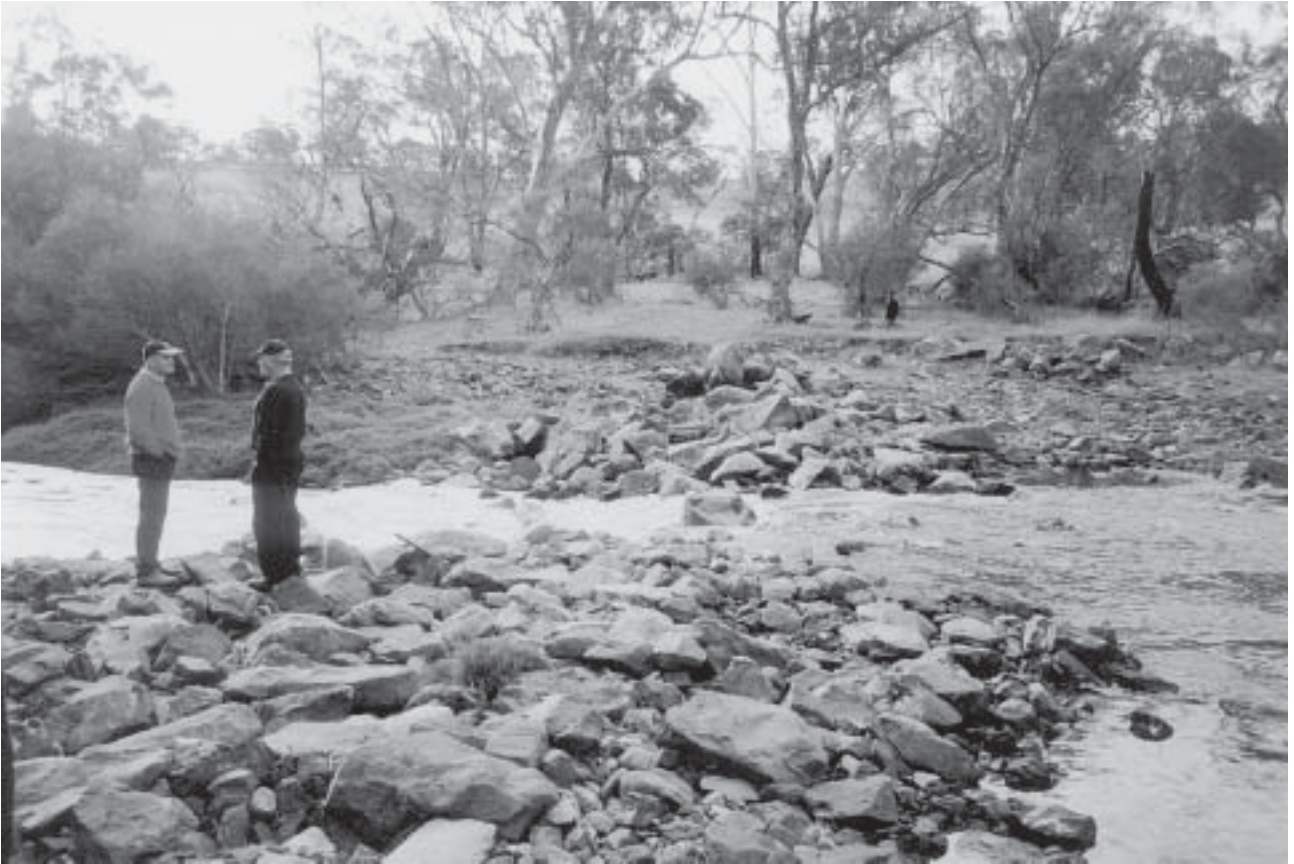
Photo 7: The river bed elevation difference maintained by Glen Avon Weir

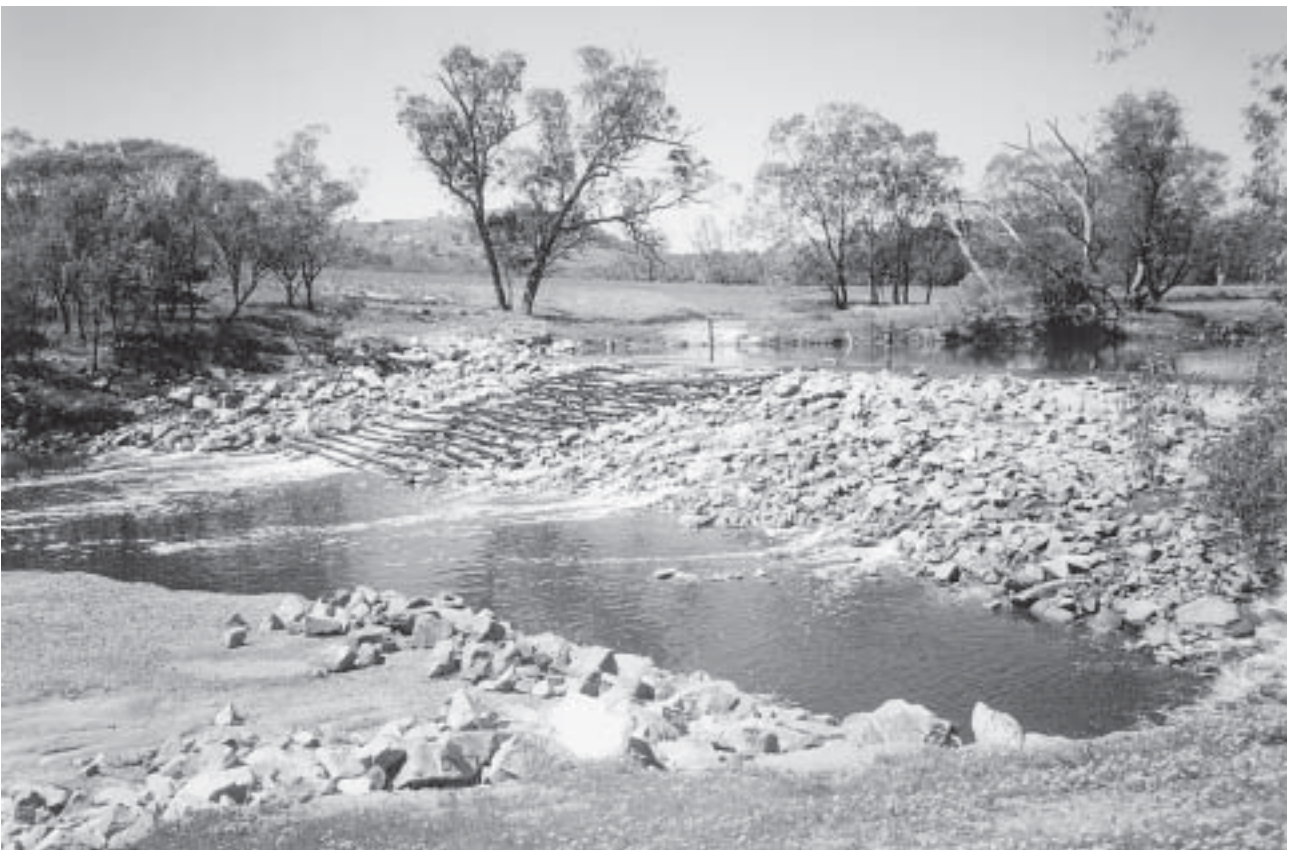
Photo 8: Extracts Weir below Millards Pool

There are recent reports of mullet again in this section of the river following the February 2000 flood. They have been observed in Red Banks Pool but not further upstream, suggesting that Extracts Weir is a barrier to their upstream dispersal. A suggestion to trial a 'fish ladder' has been made. Liaison with organisers of the "Avon Descent" event is required to ensure the installation does not increase public risk.

A dominant influence on the character of the river in this section is Extracts Weir which has caused large scale erosion of the channel downstream of Millards Pool. From 4/0.5-4/1.5.5 the trained channel is flat and eroded preferentially through an indurated clay bed in some areas exposing bedrock. There is deposition of rock over this area but only minor sand deposits. Scour pools are numerous. There is no overstorey regeneration within the Main Channel. (M/C).

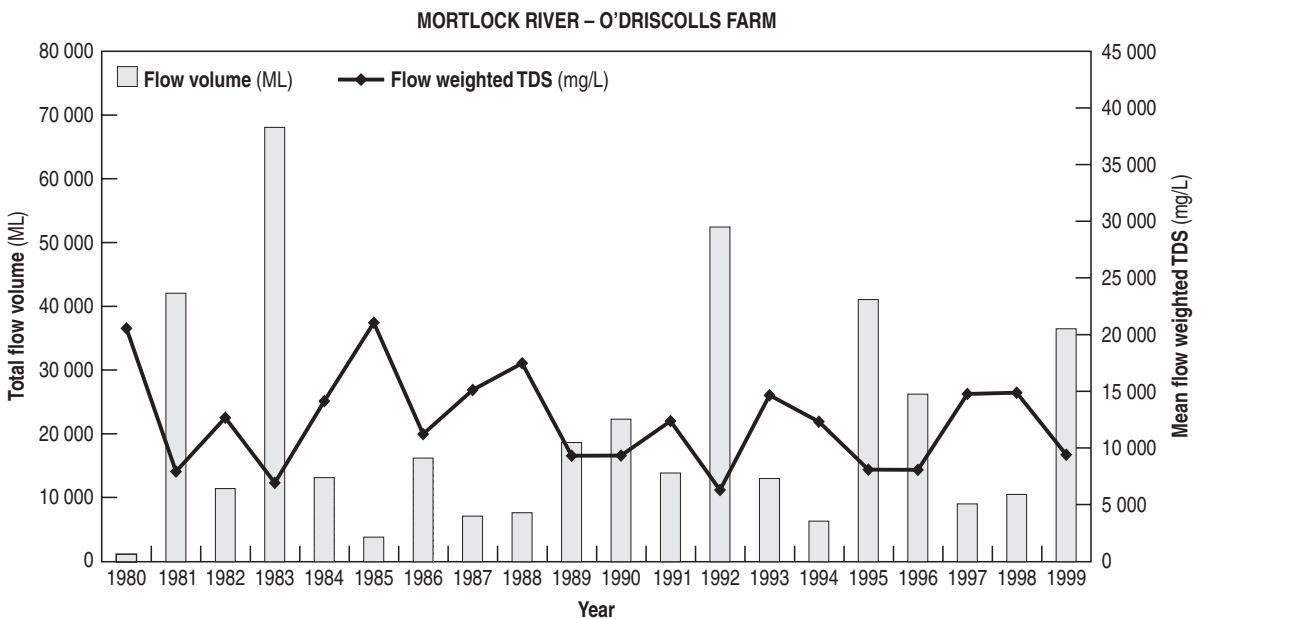
Figures 4: Salinity trends in the Mortlock River
Annual flow weighted TDS derived from discrete sample data versus annual total flow (1980 to 1999)

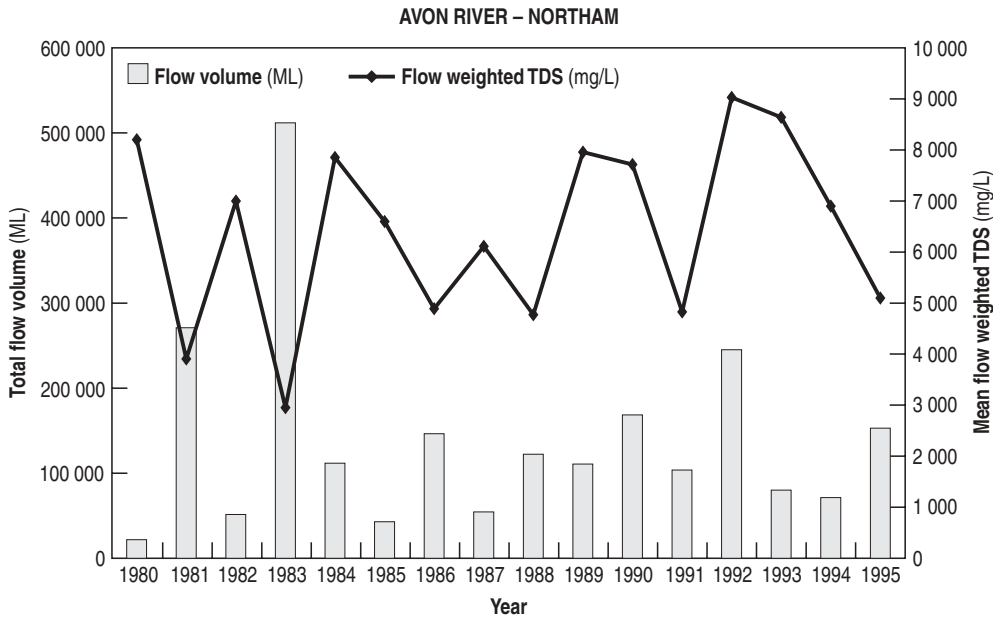
Figure 5: Salinity trends in the Avon River

Annual flow weighted TDS derived from discrete sample data versus annual total flow (1980 to 1995)

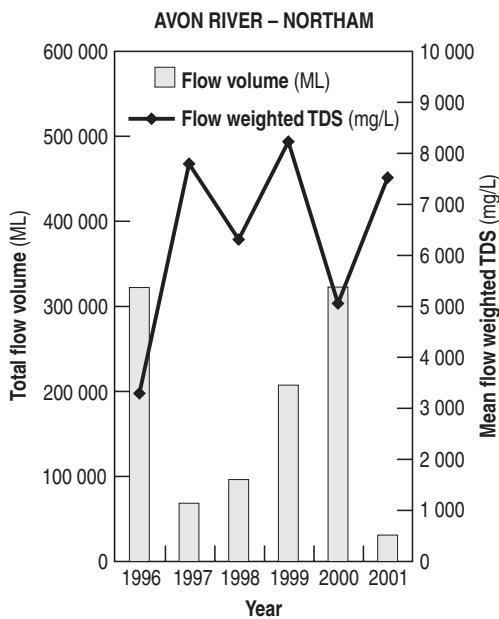
Figure 6: Salinity trends in the Avon River

Annual flow weighted TDS derived from continuous conductivity versus annual total flow (1996 to 2001)

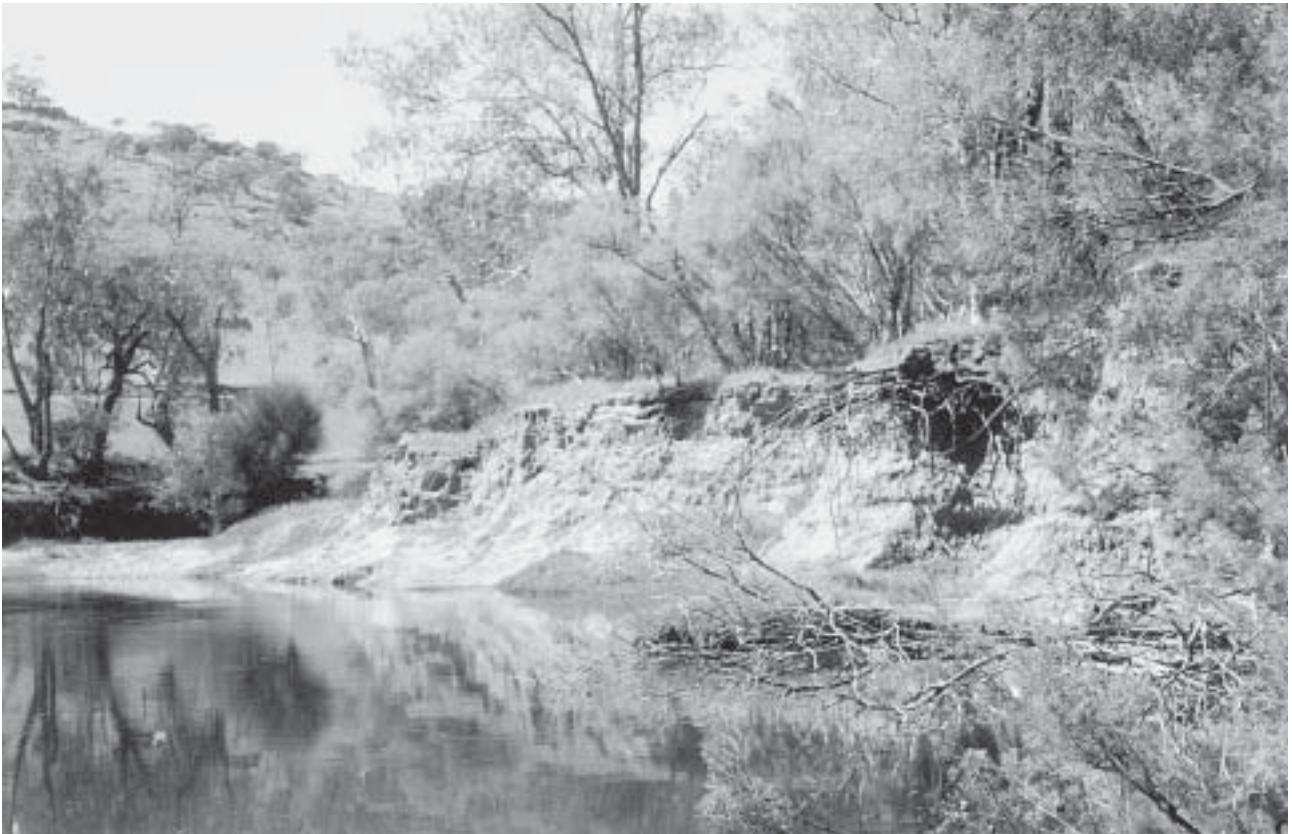
Photo 9: River bank erosion near the confluence of Harpers Brook
